Rail Accident Report

Runaway of a trolley and subsequent collision at North Rode, Cheshire 26 May 2024

Report 07/2025
May 2025

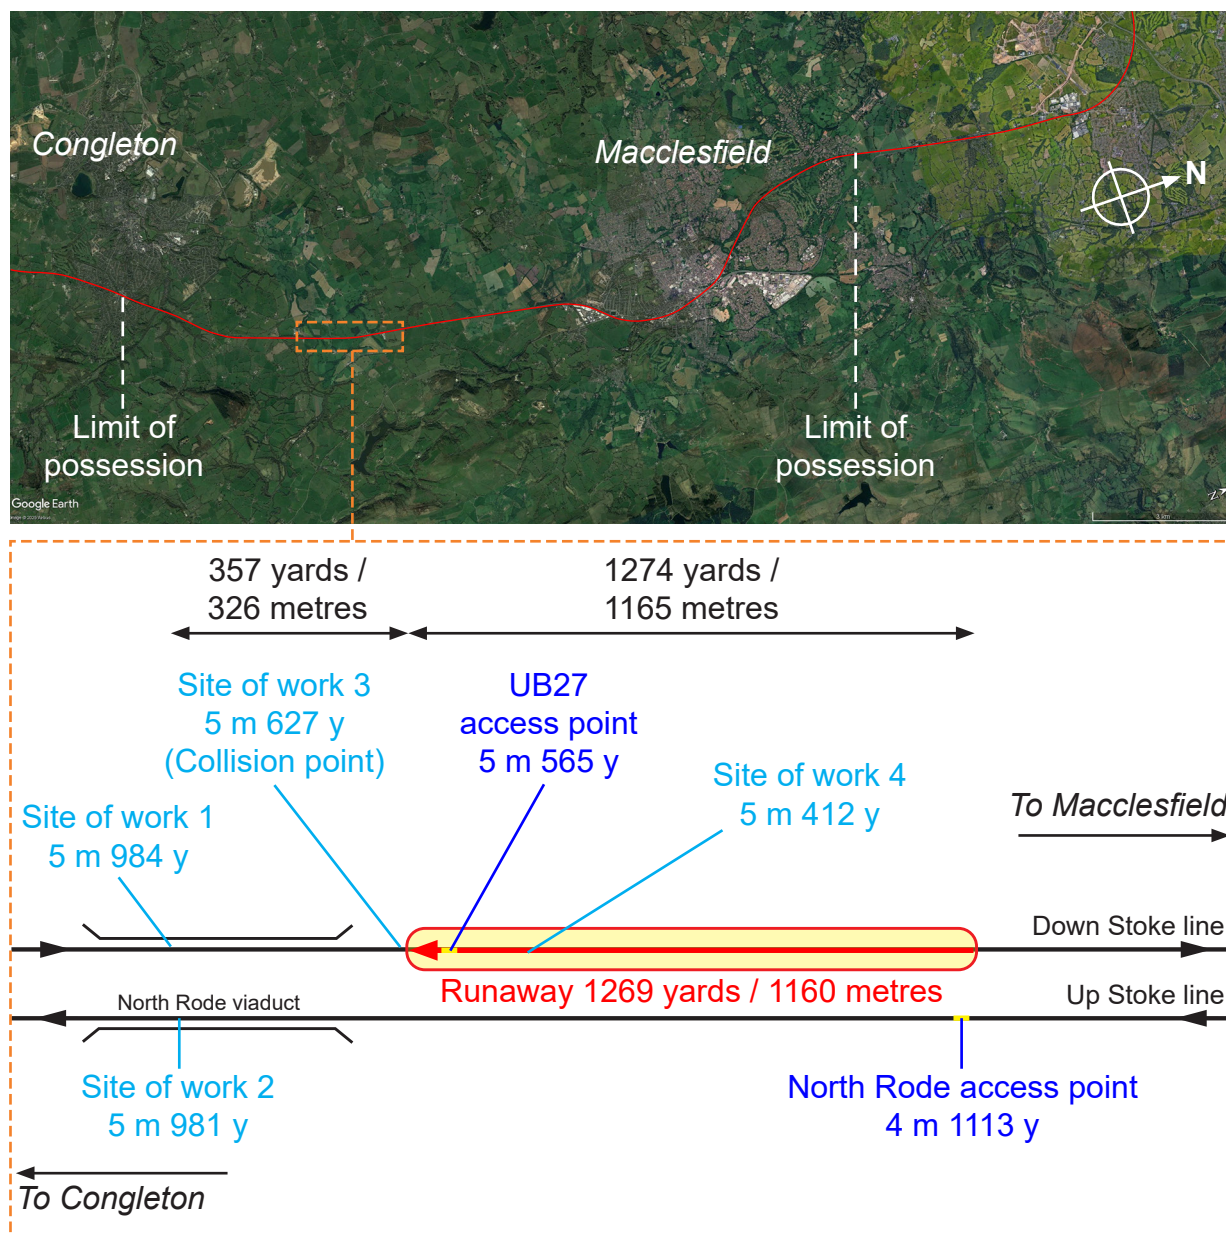
Figure 3: Schematic showing the possession between Macclesfield and Congleton, and the accident site of work track layout, including access and related sites of work (top image courtesy of Google with RAIB annotations).

- 33 The planned work for the night of Saturday 25 May was to remove four IRJs (numbered 77-80) and replace them each with a section of rail, over four separate sites of work (figure 3). The senior supervisor was responsible for IRJ 80, at site of work 1, and IRJ 79, at site of work 2. The supervisor was allocated site of work 3, where IRJ 78 was being replaced and where the accident occurred. IRJ 77, within site of work 4, was assigned to an agency supervisor.

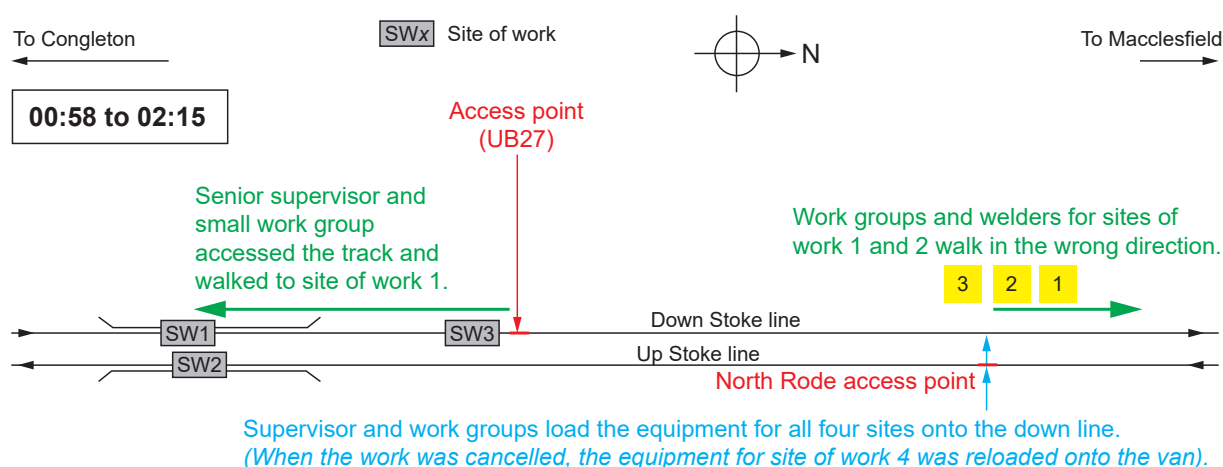
- 38 At 00:58 on Sunday 26 May, with the line now under possession, the ES contacted the COSSs and senior supervisor to grant track access (figure 5). The work group with the senior supervisor put a track trolley on the Up Stoke line at the UB27 access point, loaded it with rail burning equipment and pushed it to site of work 1. Meanwhile, at the North Rode access point, work started to unload tools and equipment onto trolleys. The supervisor drove each of the four vans previously taken to North Rode access point down to the track for the workers to unload equipment (including the trolleys and a pair of ironman trolleys) as the supervisor was the only person insured to drive the vans. The trolleys and welding equipment were placed onto the Down Stoke line in the order of the furthest site of work first – site of work 1 to site of work 4 (figure 3). While this was happening, work had started at site of work 1 to cut out IRJ 80 ahead of the welding team's arrival to insert the new rail sections.

Figure 5: Illustration of the movement of work groups and trolleys/equipment between sites of work on the night of the accident from 00:58 to 02:15 (all timings are approximate).

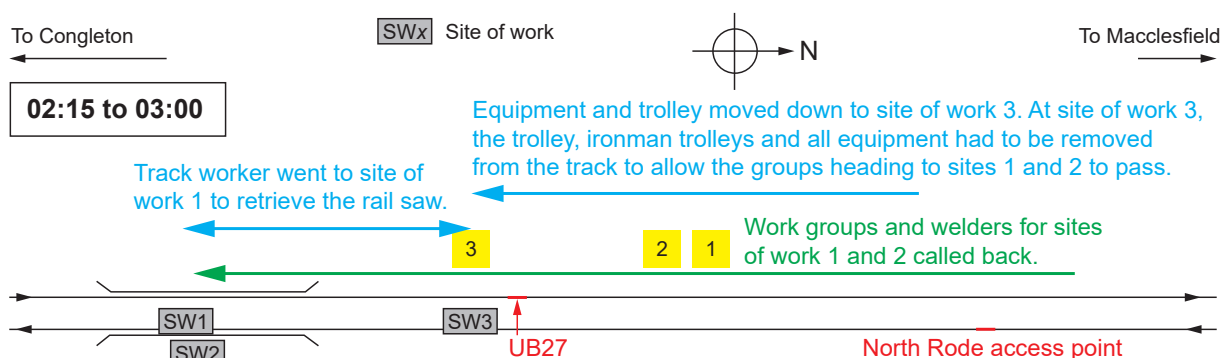
- 41 At approximately 02:15, the senior supervisor called the supervisor to check where the resources were as IRJ 80 (site of work 1) had been cut out and the new rail was ready for welding (figure 6). The phone call made the supervisor realise that they had sent the groups in the wrong direction from North Rode access point. The supervisor called the groups to turn them around, after they had walked an estimated 1370 metres in the wrong direction.

Figure 6: Illustration of the movement of work groups and trolleys/equipment between sites of work on the night of the accident from 02:15 to 03:00 (all timings are approximate).

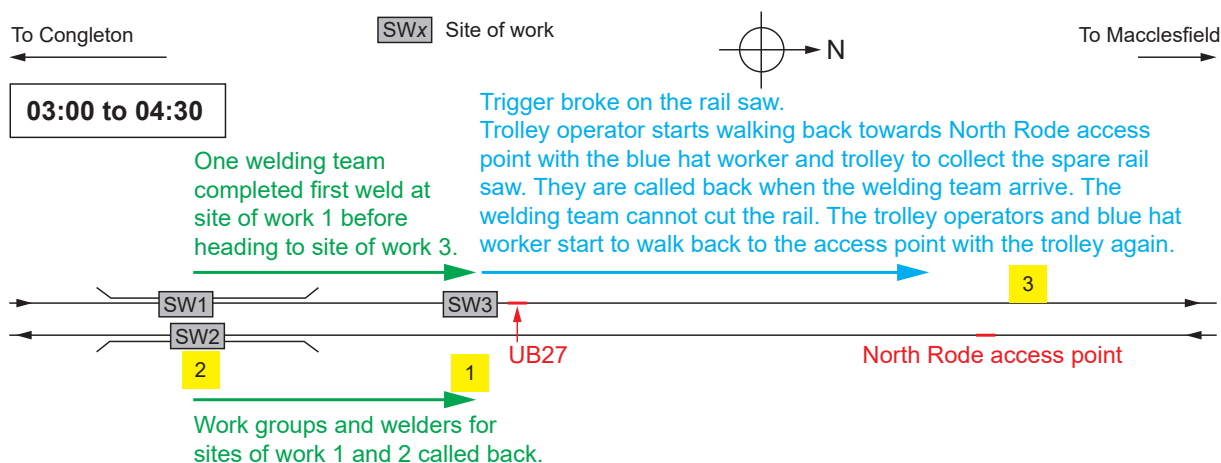
- 45 One of the welding teams, having completed their first weld, left site of work 1 soon after 03:15, to relocate to site of work 3 (figure 7). At this point, IRJ 78 at site of work 3 had been removed and the replacement rail had been moved into position, abutting the existing rail using the ironman trolleys. The replacement rail needed to be cut to size. However, at approximately 03:45, the trigger of the rail saw that was being used to cut the rail broke.

Figure 7: Illustration of the movement of work groups and trolleys/equipment between sites of work on the night of the accident from 03:00 to 04:30 (all timings are approximate).

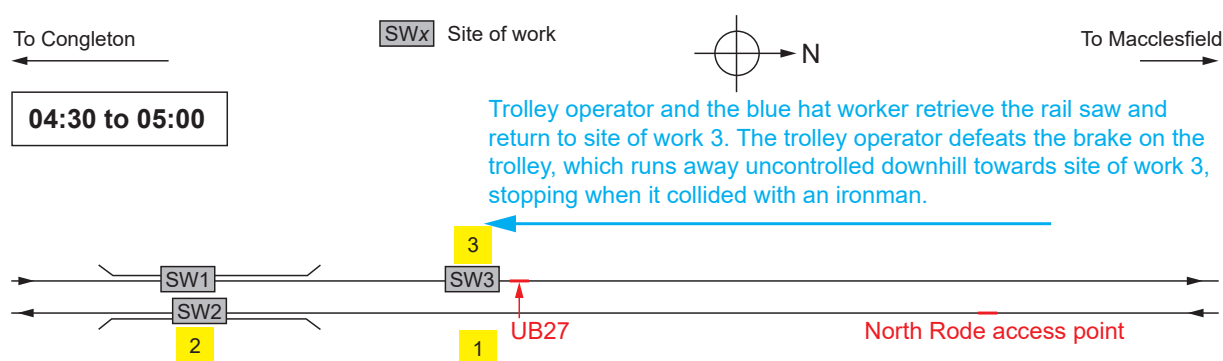
Figure 8: Illustration of the movement of work groups and trolleys/equipment between sites of work on the night of the accident from 04:30 to 05:00 (all timings are approximate).

- 48 At approximately 04:30, the team at site of work 1 (including a COSS) loaded their equipment onto a trolley located on the Up Stoke line and walked towards the North Rode access point, stopping at site of work 3 as they did so (figure 8). The senior supervisor remained with one work group and one welding team to complete the work on site of work 2.
