Serious Incident

Aircraft Type and Registration:	Airbus Helicopters EC175 B, G-MCSH	
No & Type of Engines:	2 Pratt & Whitney Canada PT6C-67E turboshaft engines	
Year of Manufacture:	2018 (Serial no: 5034)	
Date & Time (UTC):	17 February 2023 at 0900 hrs	
Location:	Elgin Oil Platform, North Sea	
Type of Flight:	Commercial	
Persons on Board¹:	Crew - None	Passengers - None
Injuries:	Crew - N/A	Passengers - N/A
Nature of Damage:	Four rotor blades detached. Damage to helicopter fuselage	
Commander's Licence:	Airline Transport Pilot's Licence	
Commander's Age:	38 years	
Commander's Flying Experience:	4,703 hours (of which 2,159 hours were on type) Last 90 days - 91 hours Last 28 days - 30 hours	
Information Source:	AAIB Field Investigation

Synopsis

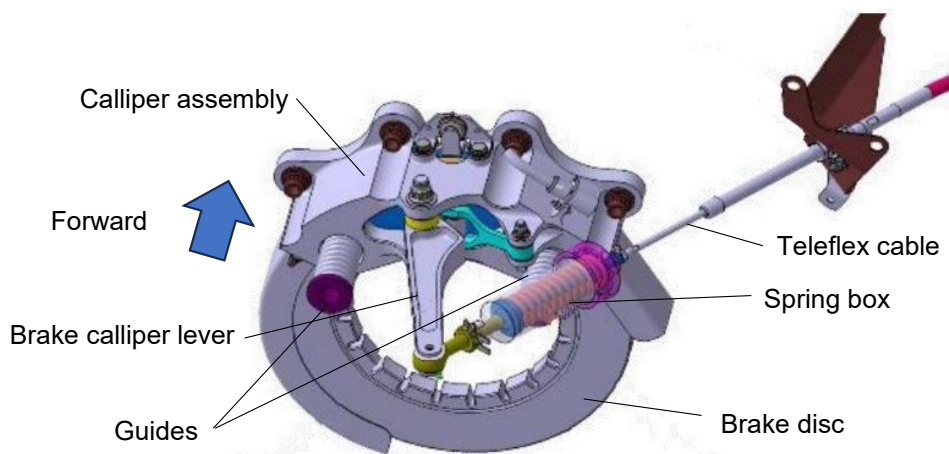
**Figure 3**

The rotor brake consists of a calliper assembly attached to the rear of the main rotor gearbox, which acts on a floating brake disc splined onto the tail rotor output shaft (Figures 3 and 4). When the cockpit rotor brake lever is moved to ON, it pulls on a spring box attached to the brake calliper lever. The spring box is used to apply a progressive force to the brake calliper lever as the cockpit lever is moved, it also allows compensation for brake pad wear. The movement of the calliper lever acts on the back of the rear brake pad, referred to as the mobile pad, moving it forward and clamping the brake disc between it and the forward brake pad, known as the fixed pad. The mobile pad moves along two sprung guides. The springs move the mobile pad backwards, releasing the brake, when the rotor brake lever is moved to the OFF position. To allow for in-service wear, the spring box can be adjusted during maintenance.

EC175 rotor brake assembly
(courtesy of Airbus Helicopters)

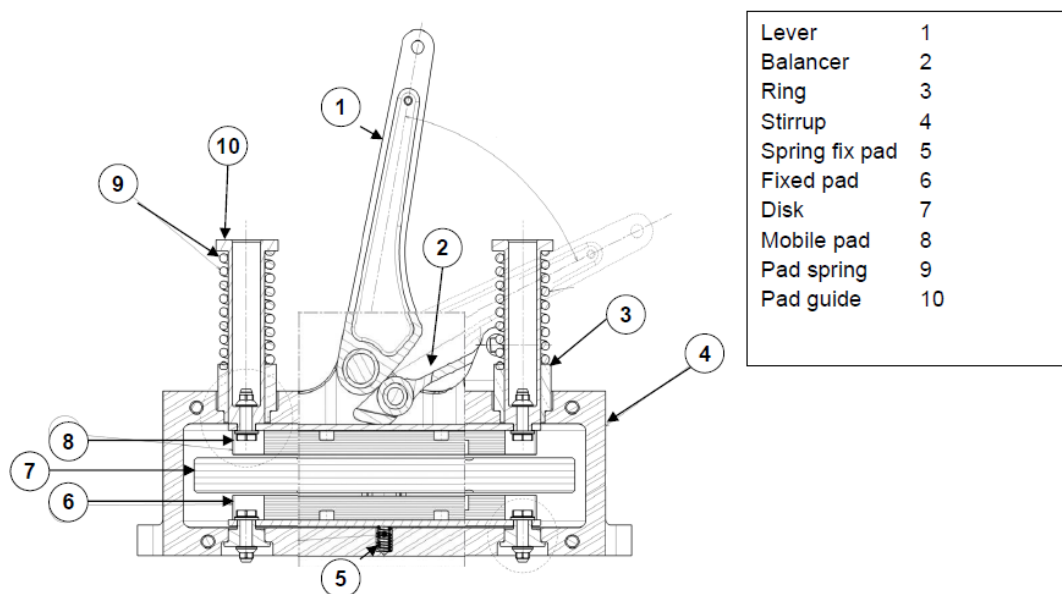
**Figure 4**

Cross section of EC175 rotor brake assembly viewed from below
(courtesy of Airbus Helicopters)

The rotor brake was found to be partially seized, such that when the brake was applied only one of the pad springs would compress. This resulted in uneven pressure being applied to the brake disc, thus reducing the braking force that could be applied to slow and stop the rotor system. The spring box setting was measured to be 15 mm in comparison to 18–20 mm when the brake is setup in accordance with the AMM.

The examination identified that the right brake pad guide had seized in its ring and would not allow movement of the brake pad on that side. The left brake guide was free to move and, therefore, when the brake was applied, the mobile pad moved unevenly only contacting the disc over approximately 1/3 of the brake pad area (Figure 10). Similarly, the fixed pad exhibited uneven but opposite wear (Figure 11).

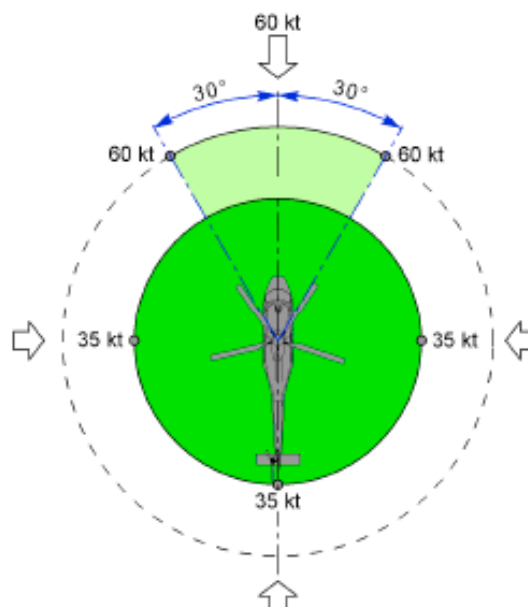
Figure 5

Section 2.4 of the FM identifies the rotor starting and stopping limitations (Figure 5). This states that the maximum wind strength for starting or stopping is 35 kt unless the wind direction is within a 60° arc centred on the nose of the helicopter, in which case the rotor can be started or stopped in wind up to 60 kt. The operator imposed a limit of 25 kt and 50 kt respectively to add an additional safety margin.

EC175 rotor starting and stopping wind limitations.

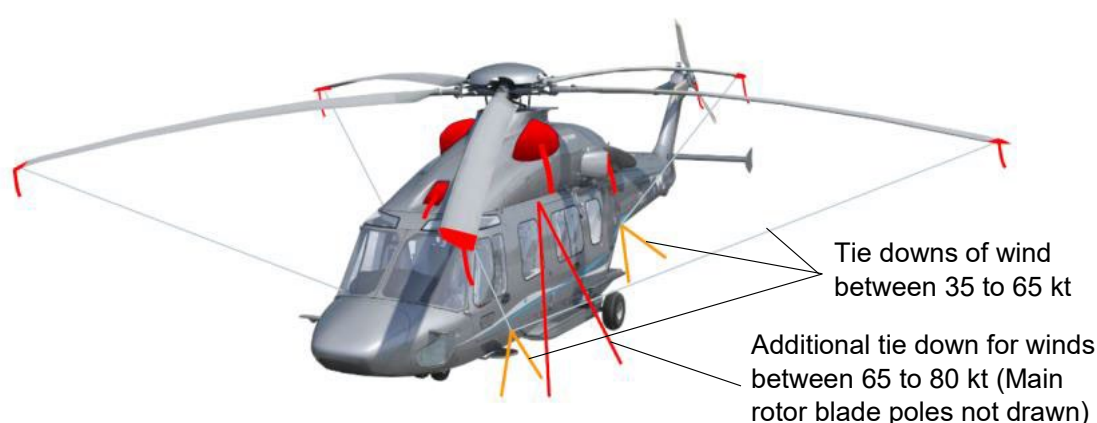
Figure 6

In addition, the FM also provides details of the mooring systems and the wind strengths at which the mooring systems should be used (Table 2). The configuration of the tie downs is shown pictorially in Figure 6.

EC175 mooring for varying wind strengths

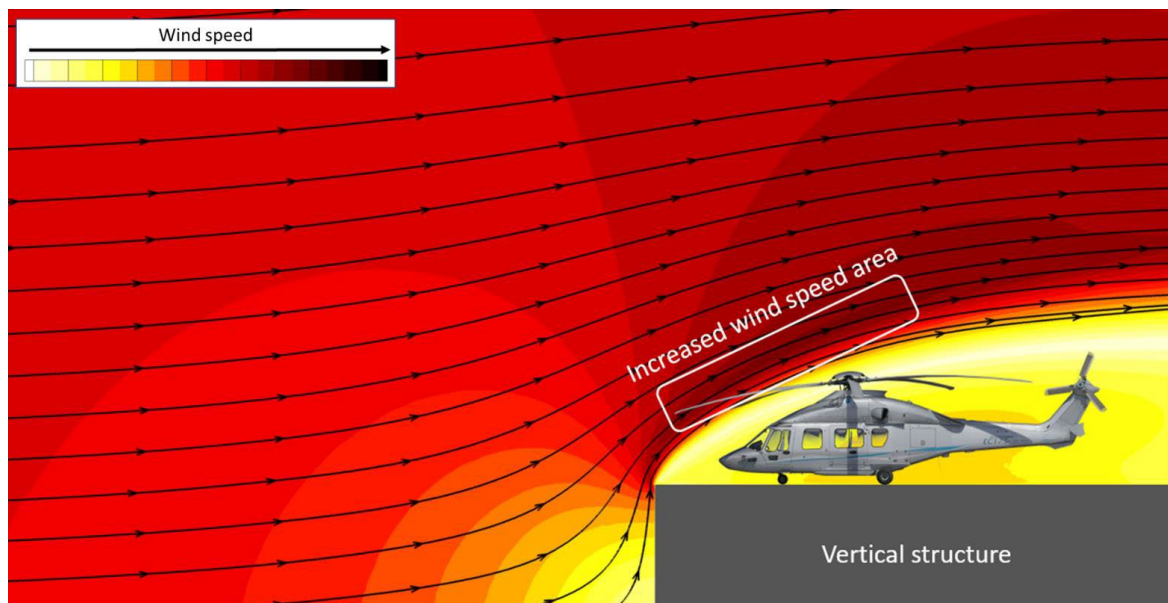
Figure 13

On 11 October 2023 Airbus published SIN No. 3947-S-00 (Appendix 2) describing the 'cliff edge' effect that local topography can have on windspeed and direction. The phenomenon is where wind is funnelled over a structure causing an up draft. This updraft increases the wind incidence of the rotor blades causing them to lift furthermore into the updraft, exacerbating the issue (Figure 13).

Extract from Airbus SIN 3947-S-00 describing cliff edge effect on rotor blades near the edge of vertical structures
