Maritime &
Coastguard
Agency

SS Richard Montgomery: Survey report 2024

December 2nd 2024

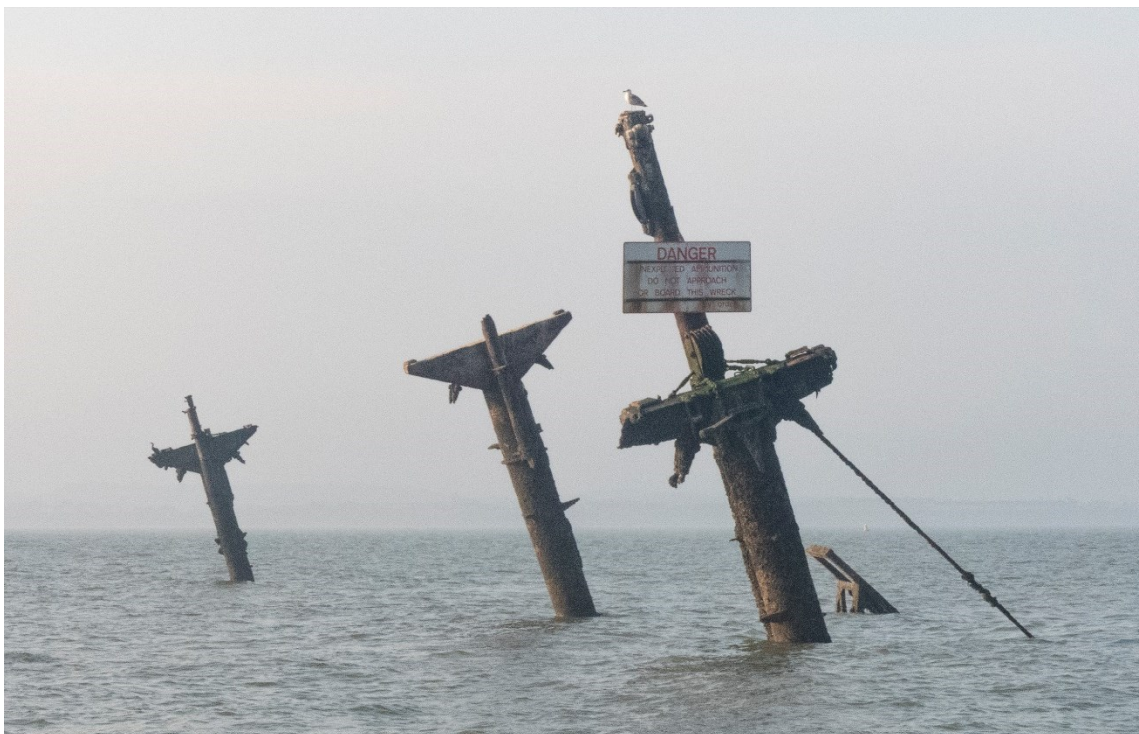
- 2.1.4** The vessel remains on Sheerness middle sand, lying in two sections in its own scour pit and sitting on exposed bedrock which is believed to be London clay. The SSRM lies across the tide and all three masts are visible above the water at all states of the tide (see Figure 2).

Figure 2. Photograph of the three masts of SSRM seen during low tide.

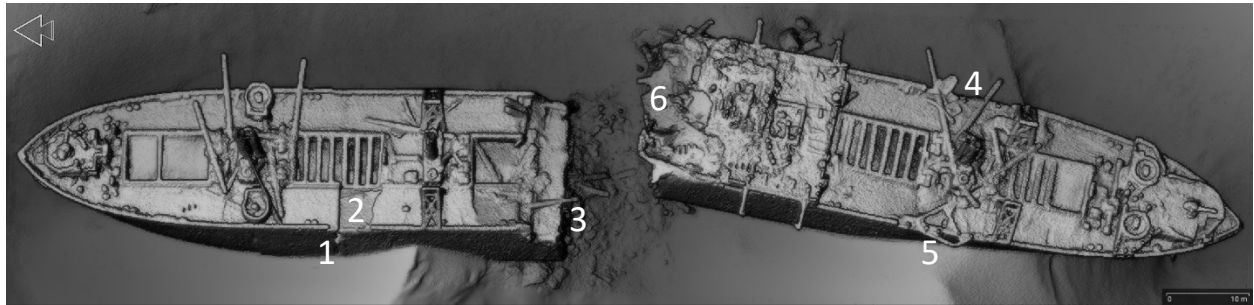
- 2.3.2** The data analysis covers the entirety of the wreck and identifies 97 features on the wreck which have been used in successive surveys as markers for measuring levels of change. In addition to this there are six key areas which have repeatedly demonstrated levels of accelerated deterioration and are therefore a specific focus of each survey (Figure 3).

Figure 3. SSRM top-down image showing the six key areas.

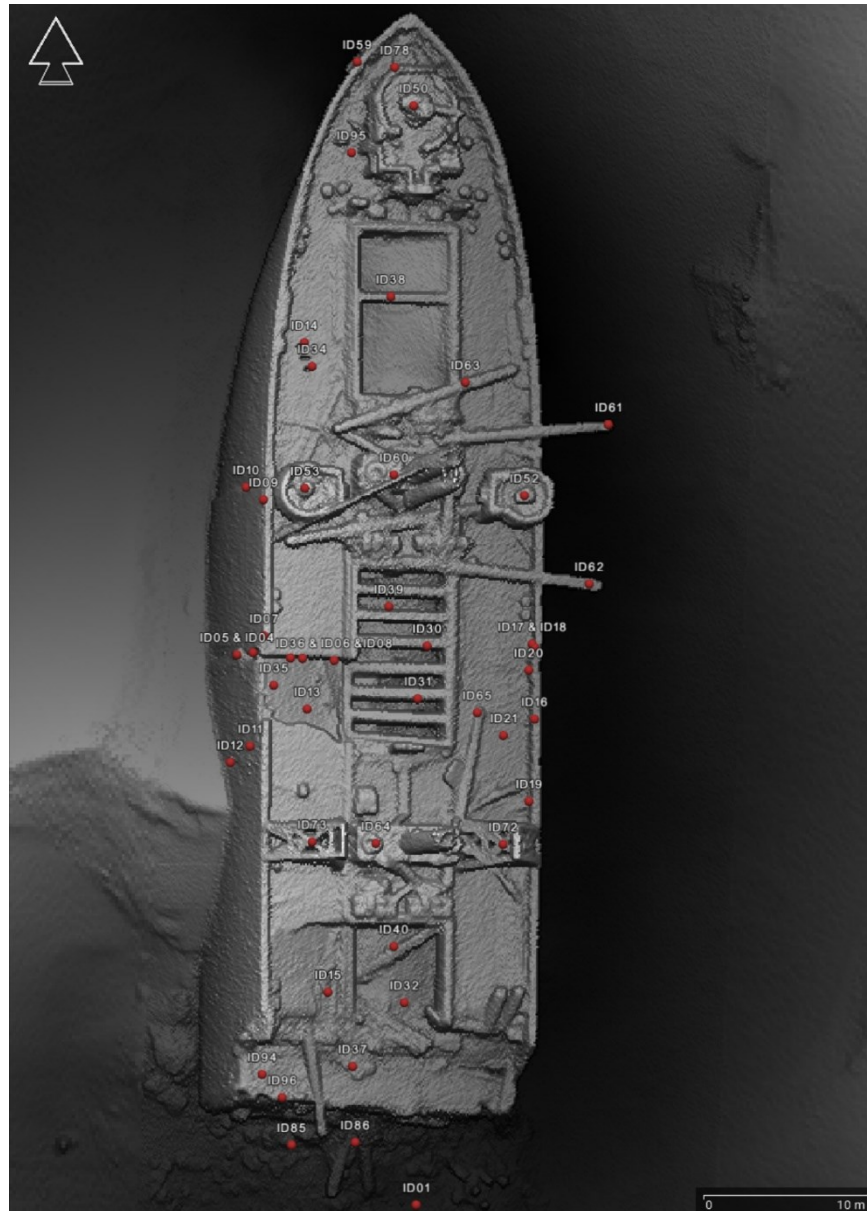
Figure 12. ID features on the forward section.

Over the whole of the wreck, 97 specific features have been used in successive surveys as comparison points for quantifying change and deterioration (Figure 12 and Figure 13).

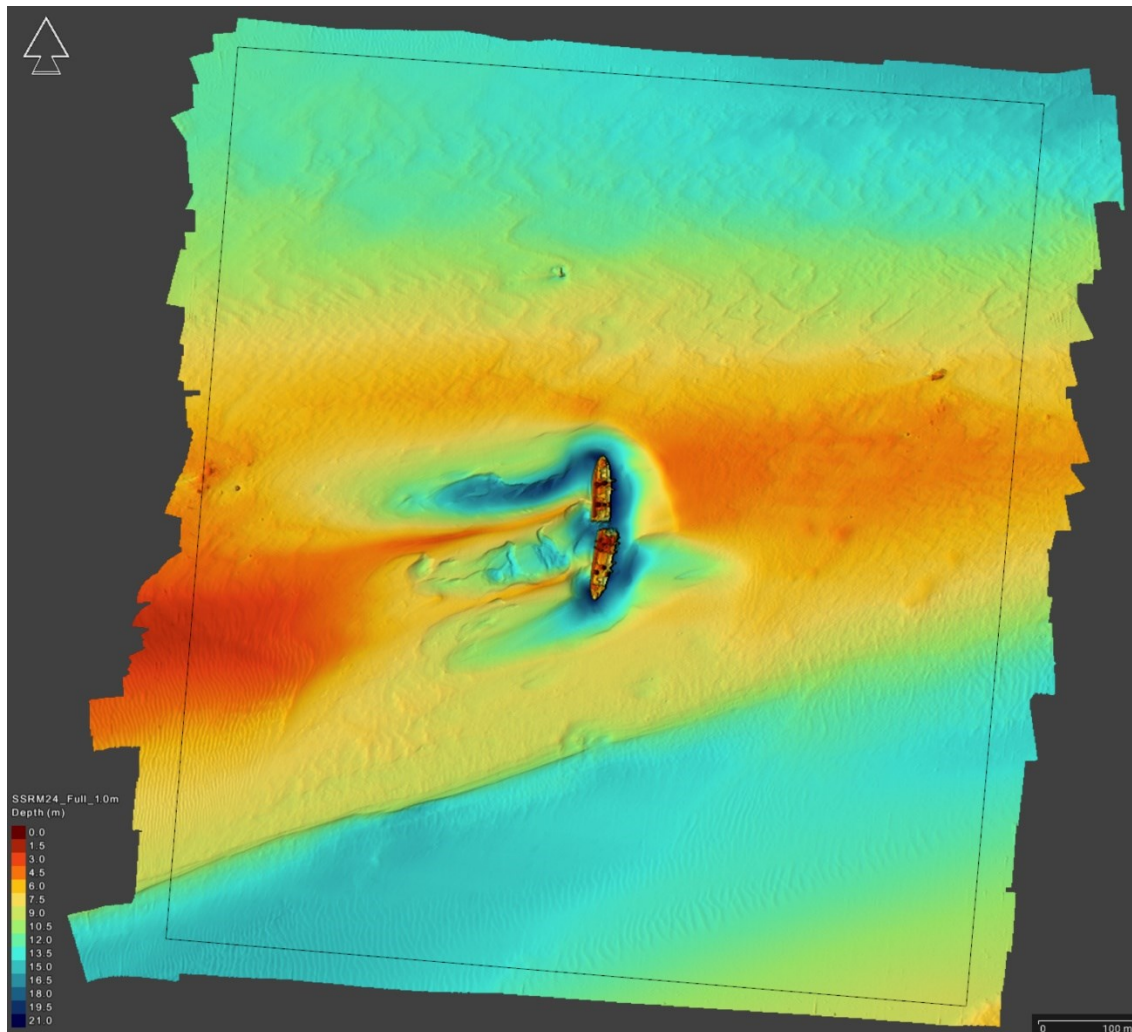
Figure 34. Minimum surface of SSRM and the surrounding seabed.

In the immediate area surrounding SSRM there is a general increase in the depth. Most changes are small and within a range of 0-0.6 meters. One area to the west of the forward section shows larger increases in depth, the most prominent change can be found by the hull close to the main mast where there has been an increase in depth by 1.6 meters between the 2023 and 2024 full surveys (Figure 36). Just north of the wreck one of the few areas where a decrease in depth has occurred can be seen, the decrease is less than 0.82 meters.
