Annual Safety Review 2024

Promoting action to prevent reoccurrence

AAIB
Air Accidents Investigation Branch

Published: 12 June 2025.

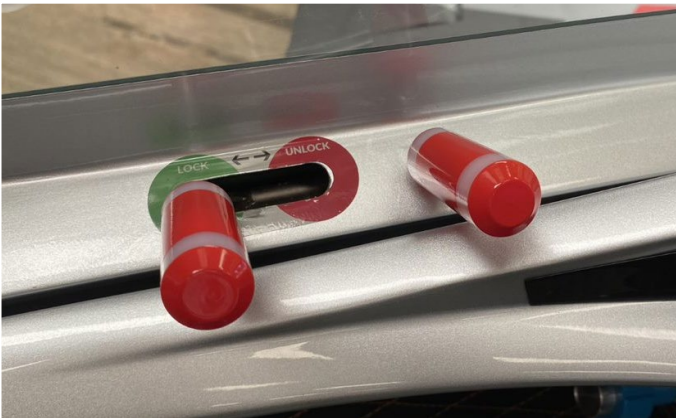
Shoot bolt handles (canopy in the closed and locked position)
