Serious Incident

Aircraft Type and Registration:	ATR 42-500 (600 version), G-LMSA	
No & Type of Engines:	2 Pratt & Whitney Canada PW127M turboprop engines	
Year of Manufacture:	2017 (Serial no: 1213)	
Date & Time (UTC):	23 July 2024 at 1230 hrs	
Location:	Aberdeen International Airport	
Type of Flight:	Commercial Air Transport (Passenger)	
Persons on Board:	Crew - 3	Passengers - 30
Injuries:	Crew - None	Passengers - None
Nature of Damage:	Significant damage to No 1 engine turbine assemblies and fire and heat damage to No 1 engine inside cowlings	
Commander's Licence:	Airline Transport Pilot's Licence	
Commander's Age:	40 years	
Commander's Flying Experience:	2,700 hours (of which 210 were on type) Last 90 days - 181 hours Last 28 days - 62 hours	
Information Source:	AAIB Field Investigation

Synopsis

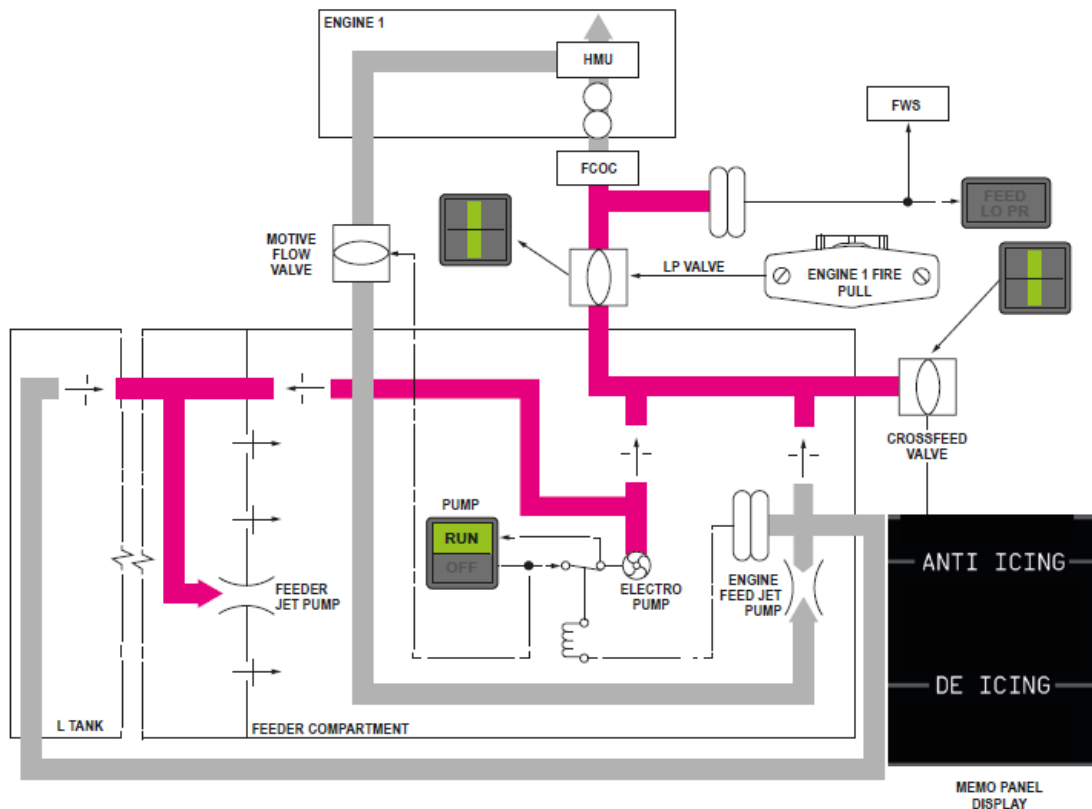
Figure 6

For engine starting the electric fuel pump push-switch is pressed IN, causing the electric fuel pump to operate and supply fuel to the engine. The RUN caption of the push switch is illuminated, and the motive flow valve is de-energised (Figure 6).

Schematic of No 1 engine fuel system, engine starting
(used with permission)

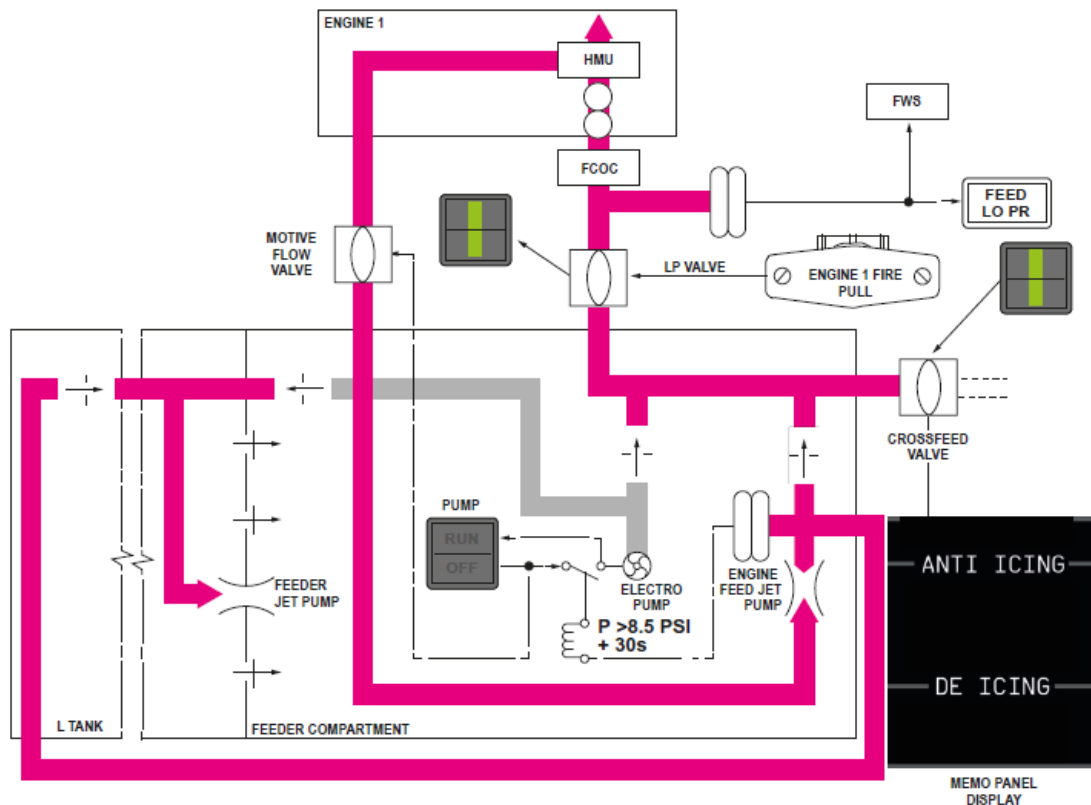
Figure 7

In normal operation, fuel is fed to the respective engine by the engine feed jet pump which is powered by a motive flow of fuel via the motive flow valve (Figure 7). If the fuel pressure from the engine feed jet pump reduces, the electric pump will automatically restart to provide fuel flow, and its RUN caption will illuminate.

Schematic of No 1 engine fuel system, engine normal operation
(used with permission)

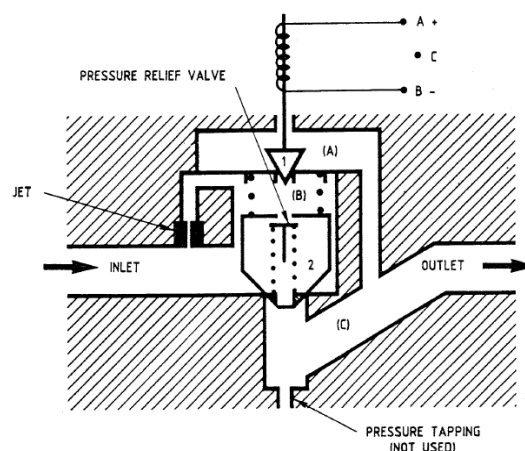
Figure 8

The motive flow valve is used to control the motive flow of fuel from the HMU to the engine feed jet pump. The inlet is connected to the fuel return line from the HMU on the engine, and the outlet is connected to the engine feed jet pump in the header tank. The valve is controlled by an electrical solenoid and motive flow fuel pressure (Figure 8).

Schematic of the motive flow valve (used with permission)
