AAIB Bulletin

6/2025

Aircraft Type and Registration:	Airbus Helicopters EC175 B, G-MCSH	
No & Type of Engines:	2 Pratt & Whitney Canada PT6C-67E turboshaft engines	
Year of Manufacture:	2018 (Serial no: 5034)	
Date & Time (UTC):	17 February 2023 at 0900 hrs	
Location:	Elgin Oil Platform, North Sea	
Type of Flight:	Commercial	
Persons on Board¹:	Crew - None	Passengers - None
Injuries:	Crew - N/A	Passengers - N/A
Nature of Damage:	Four rotor blades detached. Damage to helicopter fuselage	
Commander's Licence:	Airline Transport Pilot's Licence	
Commander's Age:	38 years	
Commander's Flying Experience:	4,703 hours (of which 2,159 hours were on type) Last 90 days - 91 hours Last 28 days - 30 hours	
Information Source:	AAIB Field Investigation

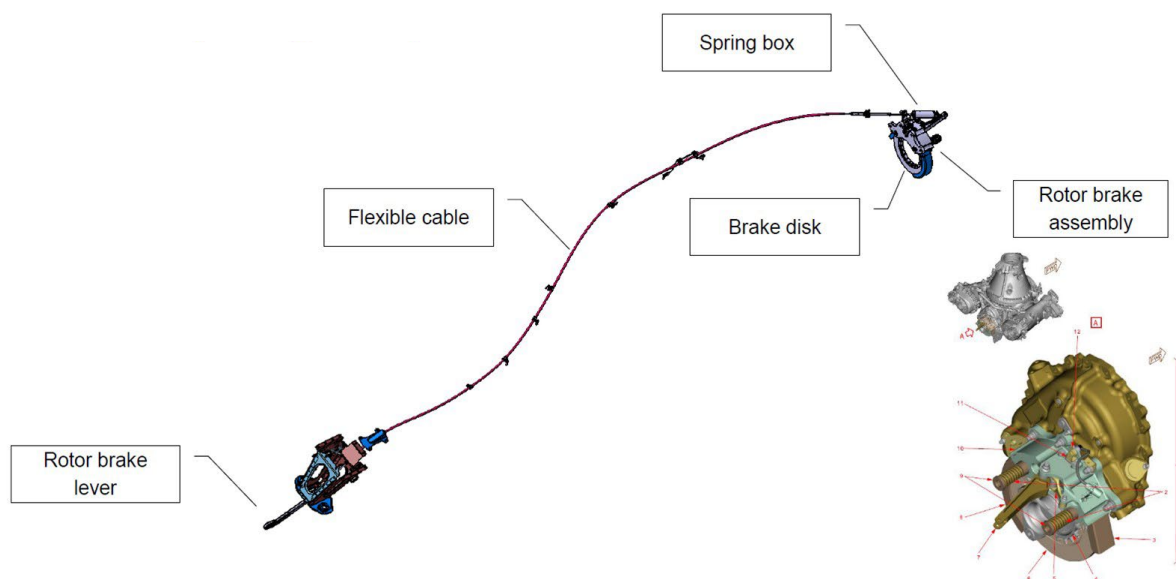
Figure 2

To allow the rotor system to be slowed when the engines are shutdown, and to prevent the rotors from turning when parked, a rotor brake is used. This rotor brake acts on the tail rotor output shaft to the rear of the main gearbox. It is activated by a lever located centrally on the cockpit roof, which is connected to the rotor brake via a flexible cable and spring box (Figure 2).

Rotor brake system from EC175
(courtesy of Airbus Helicopters)

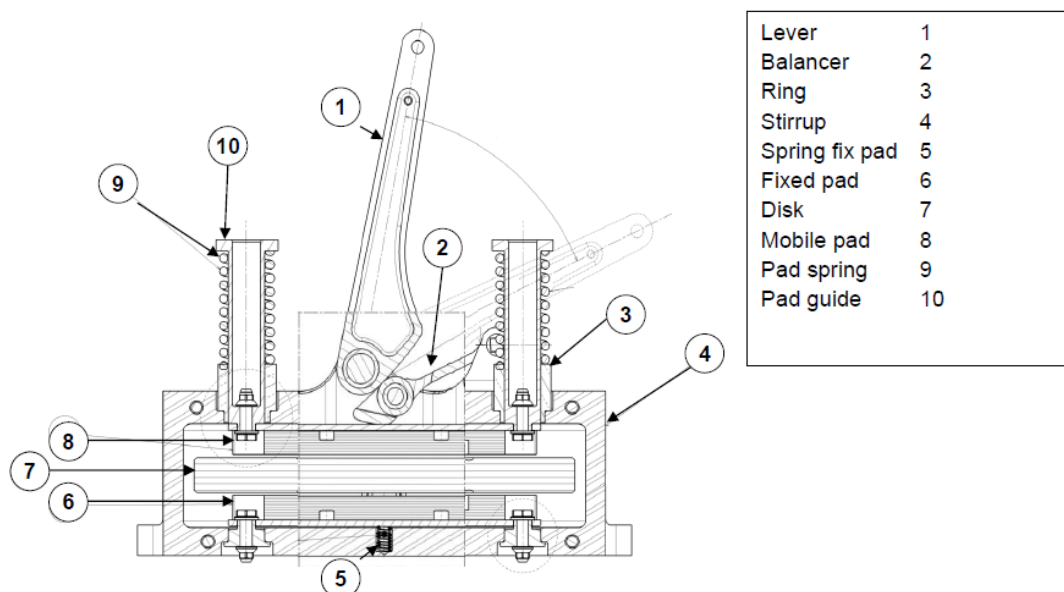
**Figure 4**

Cross section of EC175 rotor brake assembly viewed from below
(courtesy of Airbus Helicopters)

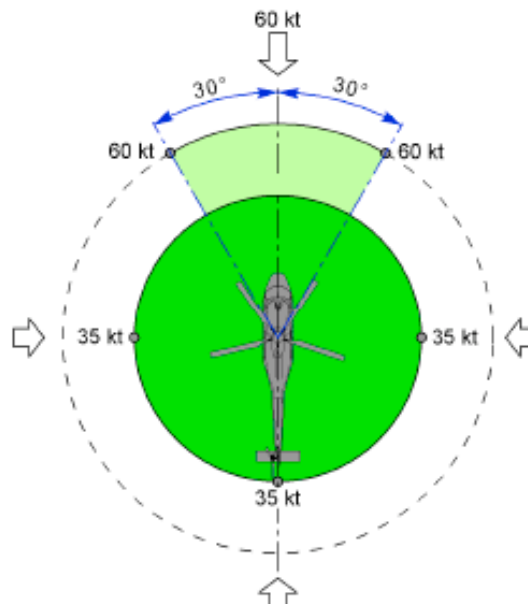
Figure 5

Section 2.4 of the FM identifies the rotor starting and stopping limitations (Figure 5). This states that the maximum wind strength for starting or stopping is 35 kt unless the wind direction is within a 60° arc centred on the nose of the helicopter, in which case the rotor can be started or stopped in wind up to 60 kt. The operator imposed a limit of 25 kt and 50 kt respectively to add an additional safety margin.

EC175 rotor starting and stopping wind limitations.

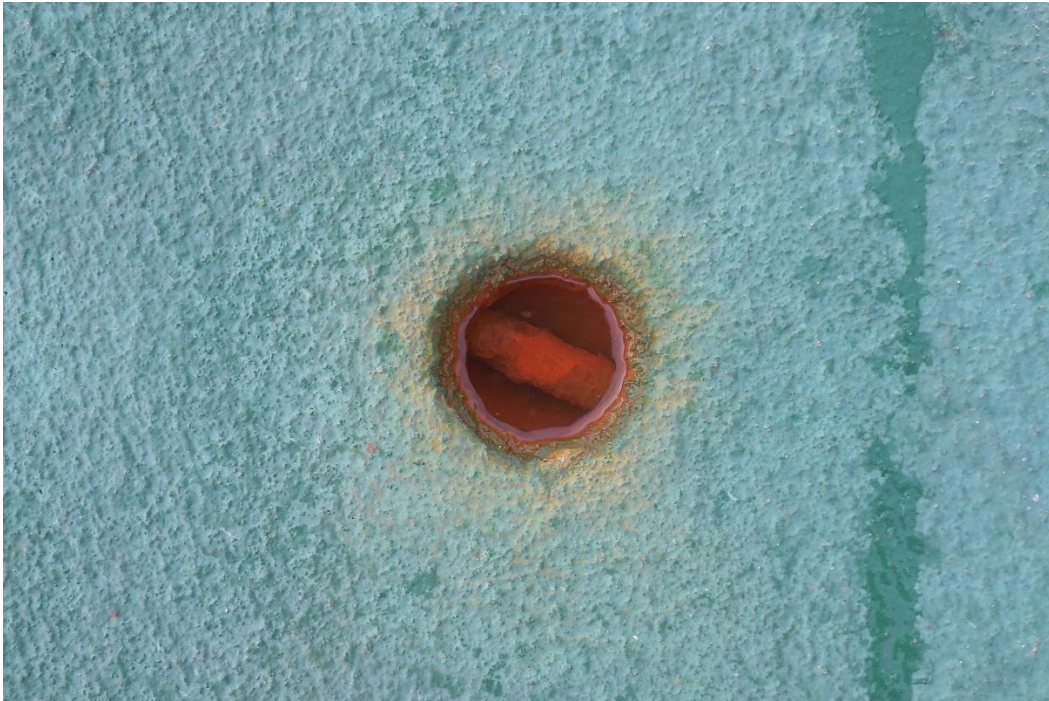
Figure 7

Helicopter mooring kits were required to be stored on offshore helidecks, details of which were included in CAP 437. Helideck owners were required to accommodate the types of helicopters operating to a particular platform and to fit the specific attachment points embedded in the helideck (Figure 7).

Attachment Point on Elgin PUQ Helideck

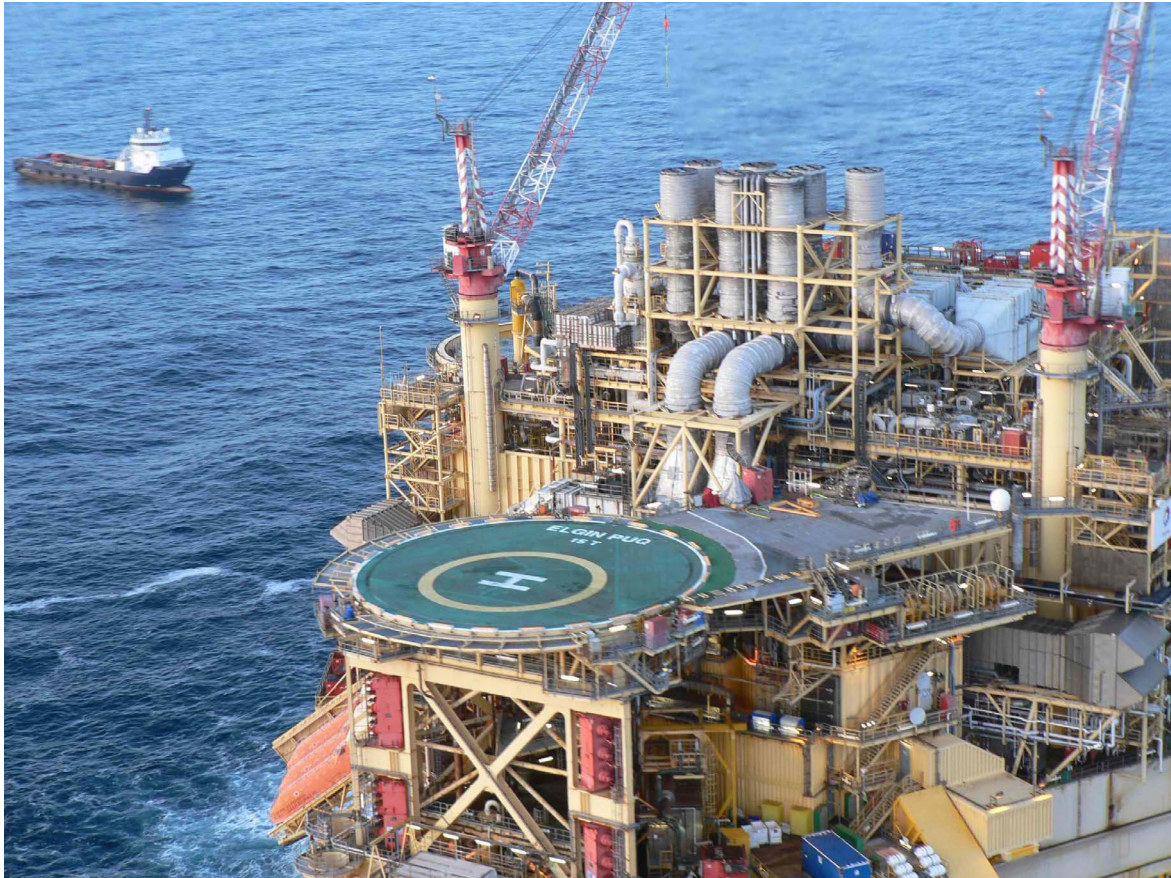
Figure 14

The Elgin PUQ platform is an offshore facility located in the North Sea about 135 nm to the east of Aberdeen Airport. It has a single helideck which is at an elevation of 166 ft (Figure 14). The helideck is situated on the south-west side of the platform where it is exposed to the prevailing wind.

Elgin PUQ platform helideck prior to addition of accommodation block
(used with permission of HCA)

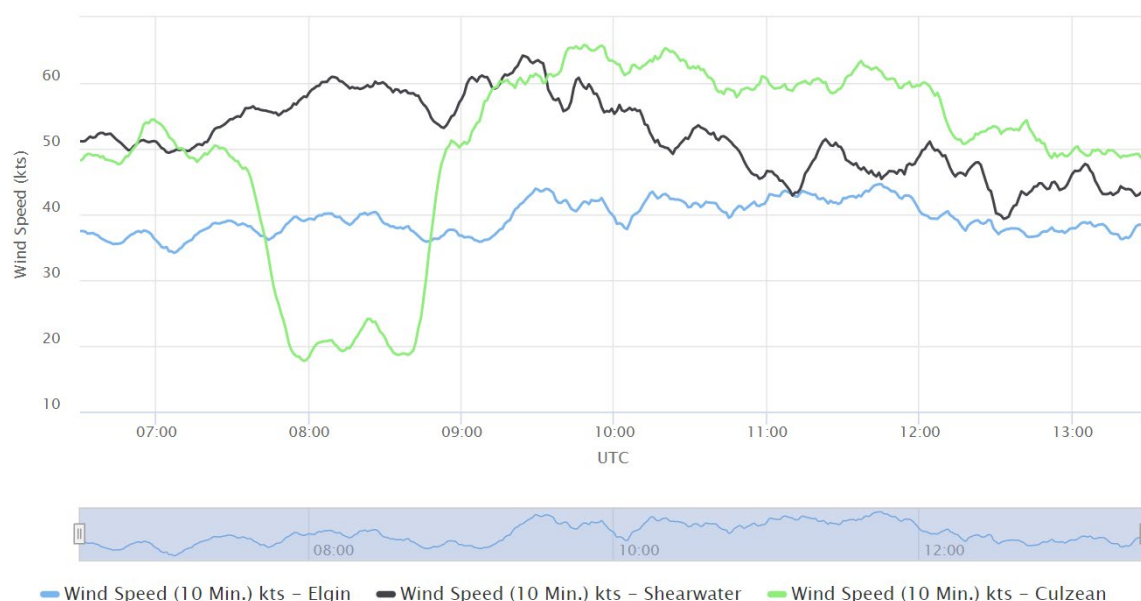
Figure 16

The 10-minute averaged wind speeds for the Elgin PUQ and two neighbouring platforms are presented in Figure 16. The Shearwater platform is 4 nm east-north-east and the Culzean platform is 11 nm north of the Elgin PUQ.

Ten-minute Averaged Wind Speeds for Elgin, Shearwater and Culzean Offshore Platforms

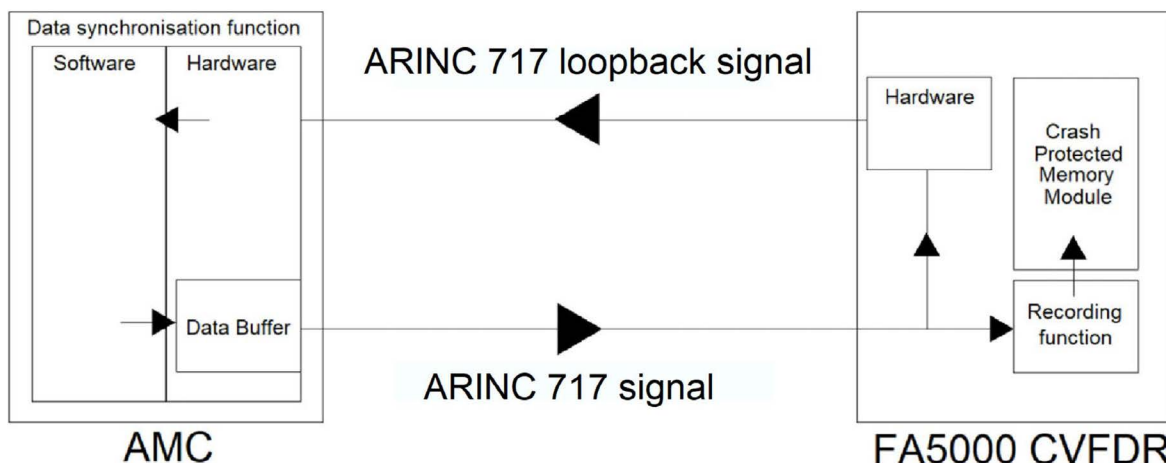
**Figure 20**

The FA5000 provides a loopback of the ARINC 717 signal, which is connected to the AMC on the EC175 and is used to confirm correct data synchronisation (Figure 20). The helicopter manufacturer's analysis of the Helionix Version 8 software operation concluded that if the ARINC 717 loopback signal from the FA5000 was out of specification, this would result in a AMC software buffer overflow error. At a data rate of 512 wps, an error would occur after about 3 hours and 15 minutes of continuous AMC operation. Thereafter a loss of the AMC ARINC 717 output signal to the CVFDR would occur for periods of about 5 seconds every 10 minutes. The data loss would continue until the AMC was subsequently powered off (i.e at helicopter shutdown). Removal of power would then clear the buffer overflow error until the next operation of the AMC for a period of 3 hours and 15 minutes, following which the data loss would occur again.

AMC - FA5000 ARINC 717 loopback signal
