Accident

Aircraft Type and Registration:	Piper PA-23-250, G-BKJW	
No & Type of Engines:	2 Lycoming IO-540-C4B5 piston engines	
Year of Manufacture:	1971 (Serial no: 27-4716)	
Date & Time (UTC):	6 July 2023 at 1845 hrs	
Location:	1 nm south-west of Bagby Airfield, North Yorkshire	
Type of Flight:	Private	
Persons on Board:	Crew - 1	Passengers - None
Injuries:	Crew - 1 (Fatal)	Passengers - N/A
Nature of Damage:	Aircraft destroyed and burnt	
Commander's Licence:	Private Pilot's Licence	
Commander's Age:	21 years	
Commander's Flying Experience:	440 total hours (3 hours on type) to 2 June 2023 ¹ Last 90 days – 46 hours to 2 June 2023 ¹ Last 28 days – not known ¹	
Information Source:	AAIB Field Investigation

Synopsis

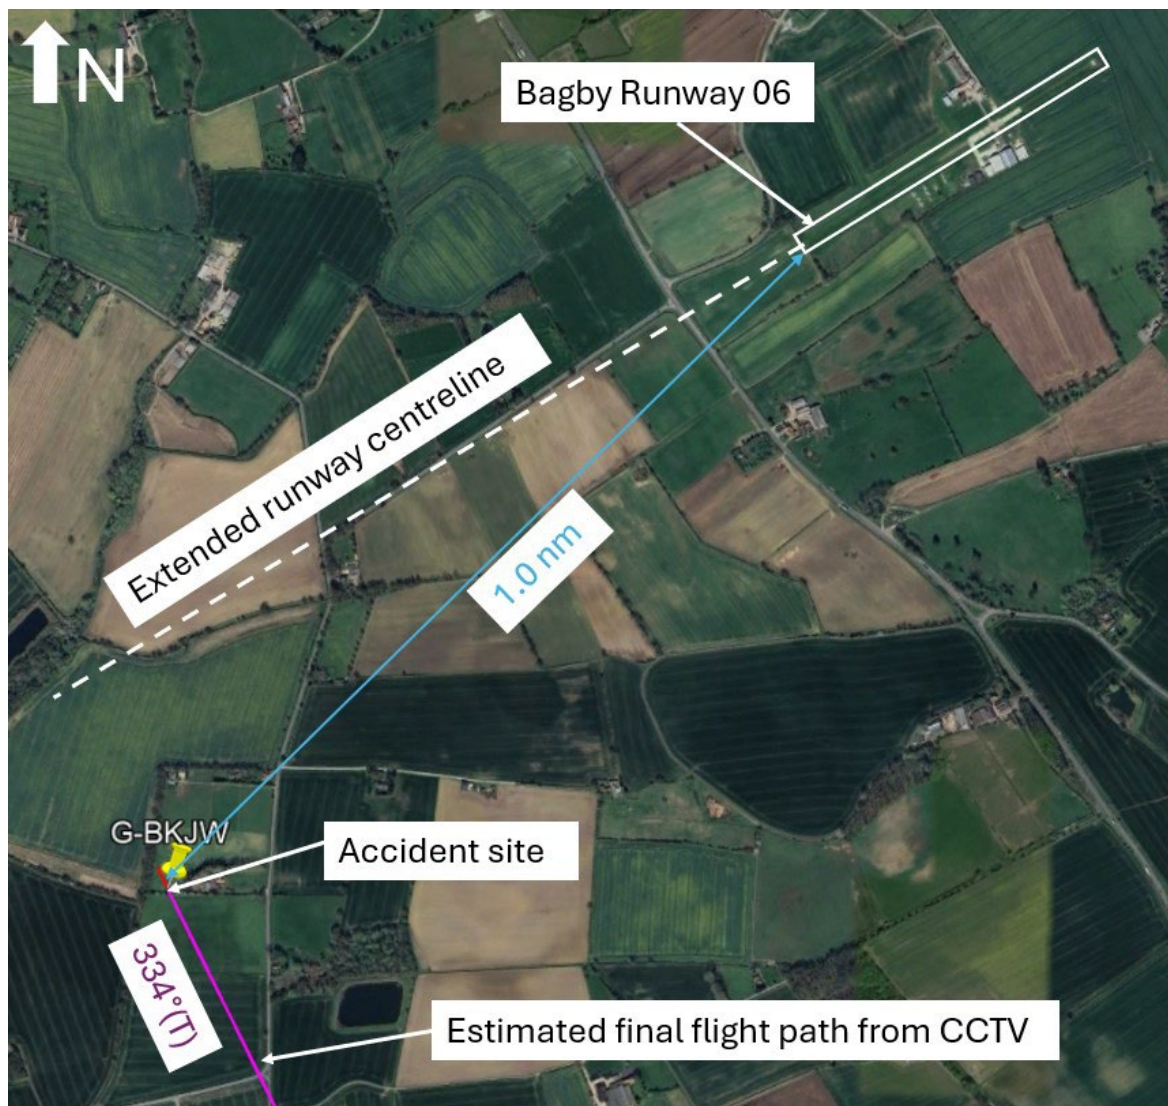
Figure 6

The accident site was located 1.0 nm south-west of the Runway 06 threshold at Bagby airfield (Figure 6). The site revealed that the aircraft had struck trees in a steep nose-down attitude before hitting the ground and catching fire, consistent with the CCTV video. The direction of travel from the trees to the ground and the aircraft fuselage remains was in a line of about 335°(T) (Figure 7). There was no indication of aircraft roll or yaw at impact. Both engines had created similar impact craters, and their location indicated a flight path of about 35° to 40° nose-down from tree impact to ground impact. The wreckage spread was about 47 m and the pilot's body was found 34 m beyond the remains of the fuselage. The wreckage was extensively damaged by fire, but the aircraft's tail section was relatively intact (Figure 8). The horizontal stabilator was free to move and its control cables were connected. The stabilator pitch trim drum was found in a nearly full nose-down trim position. The pre-impact flap and landing gear positions could not be determined.

Accident site location relative to runway at Bagby airfield

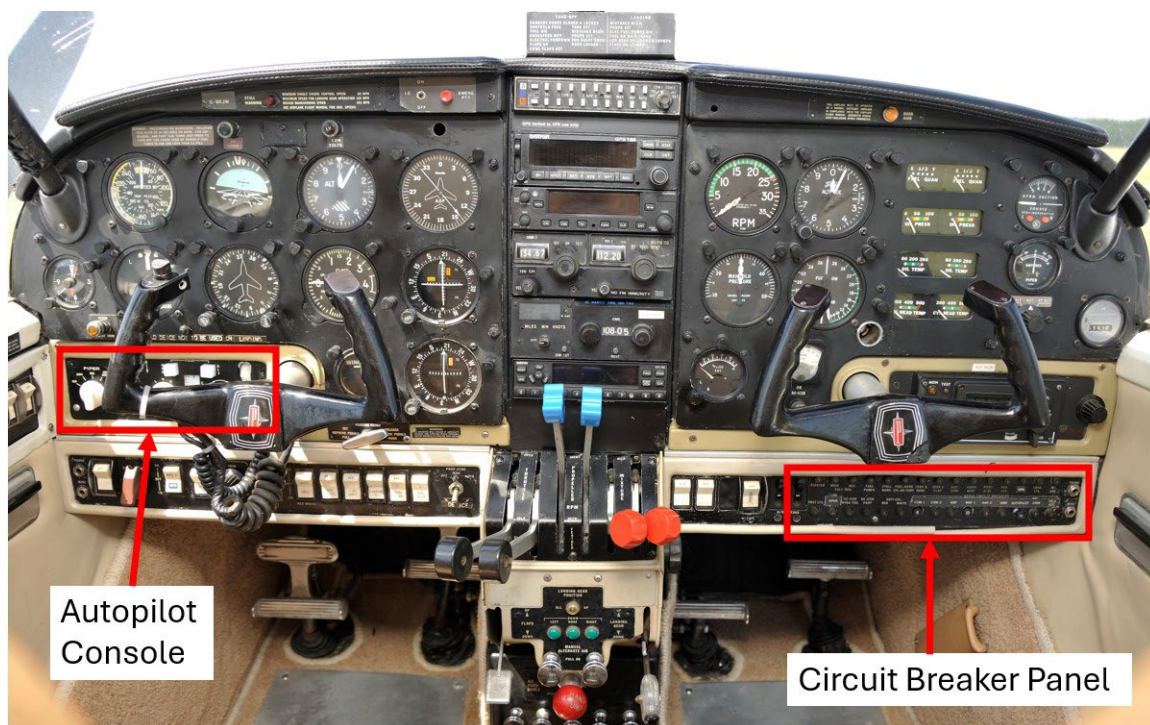
Figure 11

The aircraft was equipped with a Piper Altimatic IIIB autopilot system that was placarded inoperative but known to have some functionality. The build record for G-BKJW revealed that this system had been fitted at original manufacture. It was an analogue autopilot system that had three servos to control the ailerons, the stabilator and the pitch trim tab respectively. Its control console was fitted to the lower instrument panel on the pilot's left side (Figures 11 and 12). The autopilot was turned on by pressing the Autopilot/Roll engage switch. This would engage the autopilot in roll mode which could then maintain a selected bank angle or be used to track a heading after pressing the heading engage button. The pitch mode was engaged using a separate Pitch Engage button. Prior to engaging the pitch mode it was important to centre the trim indicator using the Pitch Command Disk. If this was not done the aircraft would pitch up or down upon pitch mode engagement. Once the pitch mode was engaged the Pitch Command Disk could be used to select a desired pitch angle up to 8° nose-up or 6° nose-down, or the Altitude Selector could be used to select a desired altitude. The autopilot was disengaged by either pressing the Autopilot/Roll Engage switch OFF, or by pressing the autopilot disconnect switch on the control yoke; however, the yoke mounted disconnect switch was not fitted on G-BKJW – there was an empty hole for it (Figure 12).

G-BKJW Instrument Panel (October 2020)
(Copyright Keith Wilson/SFB Photographic)

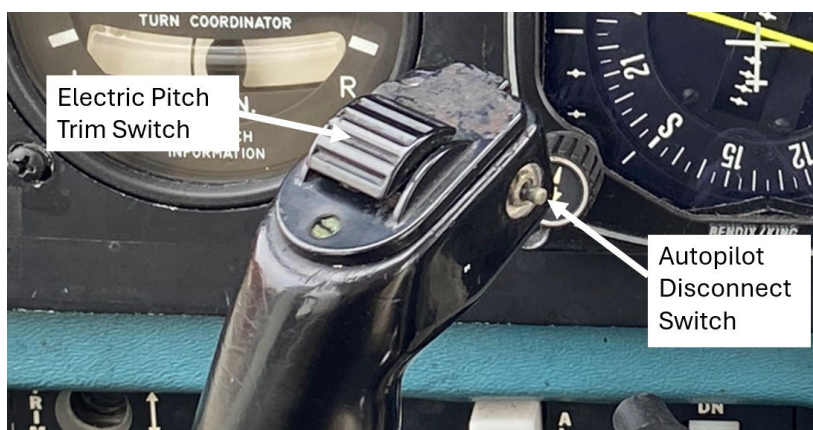
**Figure 13**

Figure 13 depicts the autopilot disconnect switch fitted to a different PA-23-250 that also had an Altimatic IIIB autopilot. The electric pitch trim switch and the autopilot disconnect switch depicted in this figure are the same type as shown in the Piper Altimatic IIIB Operating Instructions². There is a Piper approved kit³ to replace the type of pitch trim switch in this figure with the type of pitch trim switch fitted to G-BKJW but it does not mention the autopilot disconnect switch. The trim switch in Figure 13 was subject to a Service Bulletin as it was known to stick. However, the aircraft manufacturer was not aware of issues with the newer type fitted to G-BKJW.

Pitch trim switch and Autopilot Disconnect Switch in another PA-23-250 aircraft fitted with an Altimatic IIIB autopilot

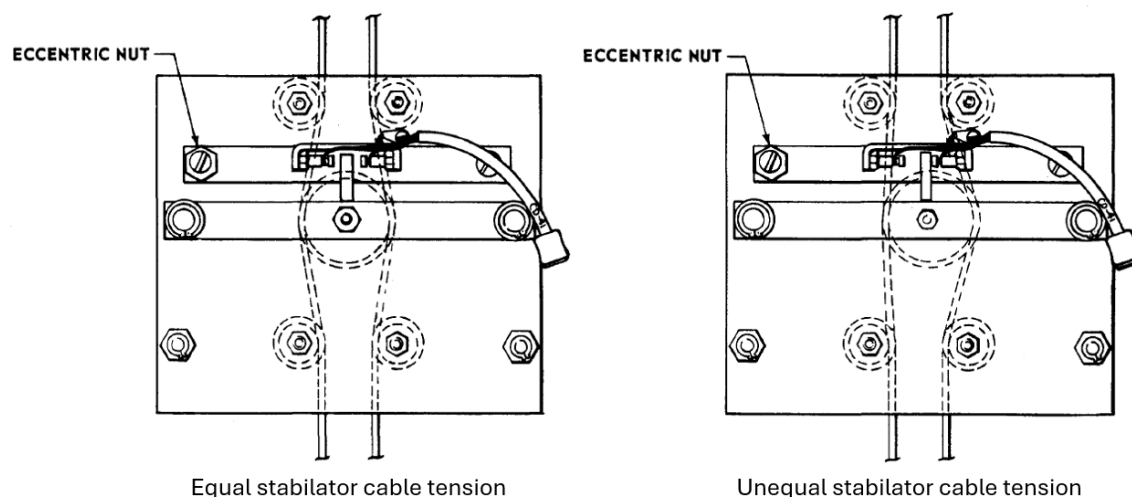
Figure 14
Pitch trim sensor (© Piper Aircraft)

A single fault in the pitch trim sensor, for example the sensor sticking to one side, could cause a pitch trim runaway.

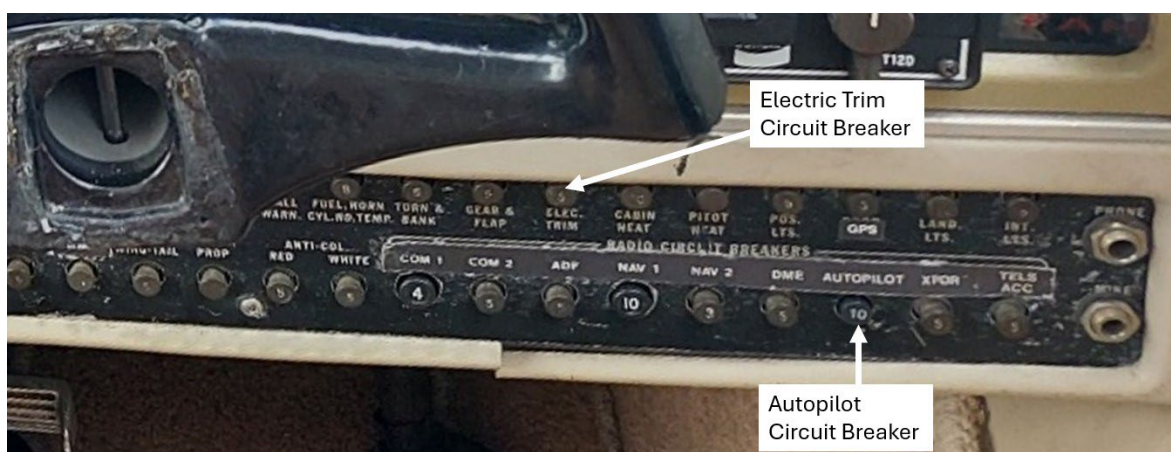
The circuit breaker panel was located on the lower right side of the instrument panel, beneath the right control yoke. Figure 15 shows a pre-accident photo of the circuit breaker panel on G-BKJW, with the location of the electric trim and autopilot circuit breakers highlighted. The maintenance organisation stated that the circuit breakers had been re-labelled during the aircraft's annual inspection with black text on yellow tape to make them clearer, but no photos of this change were available. The circuit breakers automatically open when an overload occurs on the electrical circuit it protects. The circuit breakers can also be manually pulled out to isolate a circuit and manually pushed in to reset it.

Location of electric trim and autopilot circuit breakers (G-BKJW pre-accident photo)

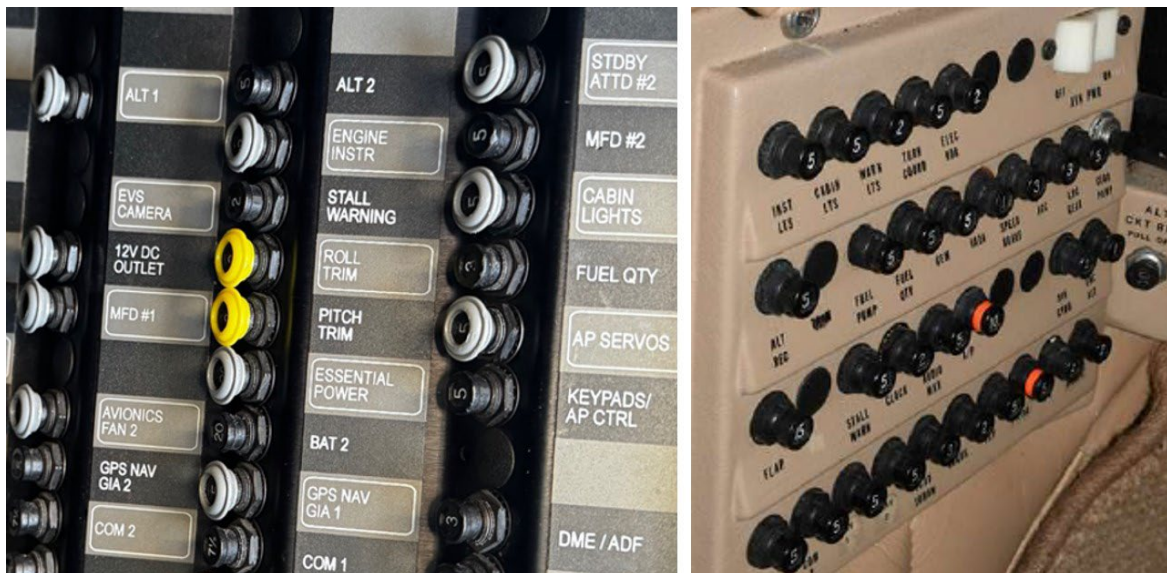
Figure 25

Some aircraft owners fit coloured caps or collars to autopilot and trim circuit breakers to make them easier and quicker to identify in an emergency (Figure 25). A coloured circuit breaker cap can be purchased from aviation suppliers for less than £4.

Coloured circuit breakers caps/collars on a Cirrus SR20 (left) and a Cessna 210 (right)

2. *Tagging the autopilot and electric trim circuit breakers.* Some aircraft owners fit coloured caps or collars to autopilot and trim circuit breakers to make them easier to identify in an emergency (Figure 26). Combined with training, colour tagging these circuit breakers would help a pilot more effectively deal with a pitch trim runaway (see safety action 8).

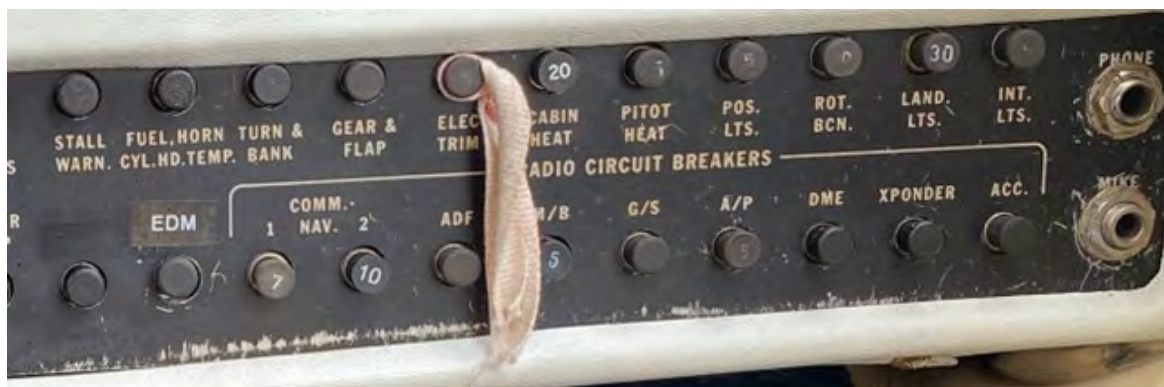
Figure 26

When the AAIB examined a PA-23-250 that was fitted with an Altimatic IIIB autopilot, it was noticed that the electric trim circuit breaker was fitted with a cloth lanyard (Figure 26). This would have enabled the circuit breaker to be easier to identify and easier to pull. This aircraft had not flown since a change of ownership, and despite a few attempts to contact the previous owner, no contact could be made so the reason they decided to install the lanyard could not be established.

Lanyard found installed on the electric trim circuit breaker of a PA-23-250
