# ***AAIB Bulletin***

***6/2025***

Published: 12 June 2025.

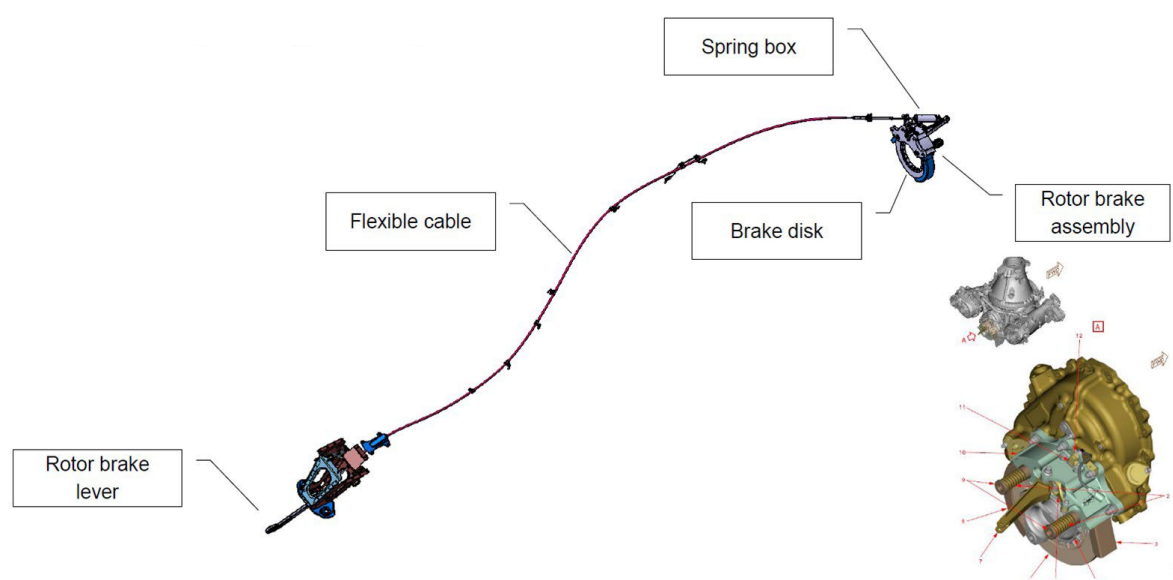
**Figure 2**

To allow the rotor system to be slowed when the engines are shutdown, and to prevent the rotors from turning when parked, a rotor brake is used. This rotor brake acts on the tail rotor output shaft to the rear of the main gearbox. It is activated by a lever located centrally on the cockpit roof, which is connected to the rotor brake via a flexible cable and spring box (Figure 2).

Rotor brake system from EC175  
(courtesy of Airbus Helicopters)

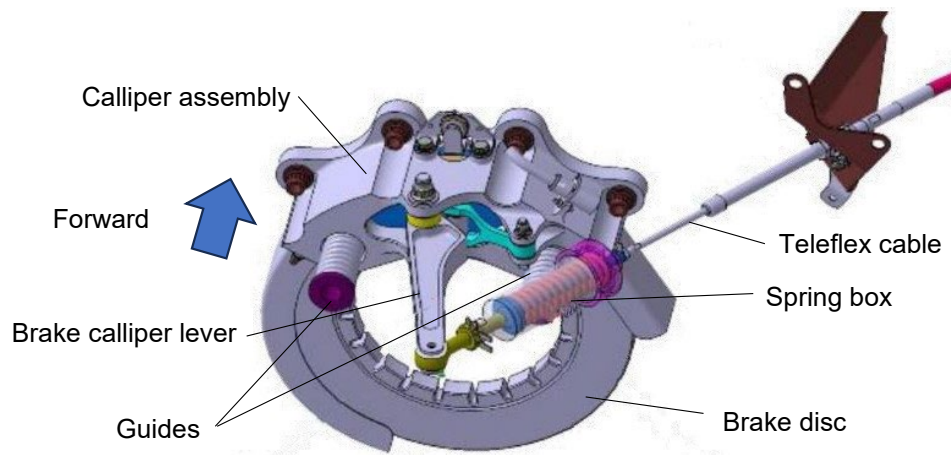
**Figure 3**

The rotor brake consists of a calliper assembly attached to the rear of the main rotor gearbox, which acts on a floating brake disc splined onto the tail rotor output shaft (Figures 3 and 4). When the cockpit rotor brake lever is moved to ON, it pulls on a spring box attached to the brake calliper lever. The spring box is used to apply a progressive force to the brake calliper lever as the cockpit lever is moved, it also allows compensation for brake pad wear. The movement of the calliper lever acts on the back of the rear brake pad, referred to as the mobile pad, moving it forward and clamping the brake disc between it and the forward brake pad, known as the fixed pad. The mobile pad moves along two sprung guides. The springs move the mobile pad backwards, releasing the brake, when the rotor brake lever is moved to the OFF position. To allow for in-service wear, the spring box can be adjusted during maintenance.

EC175 rotor brake assembly  
(courtesy of Airbus Helicopters)

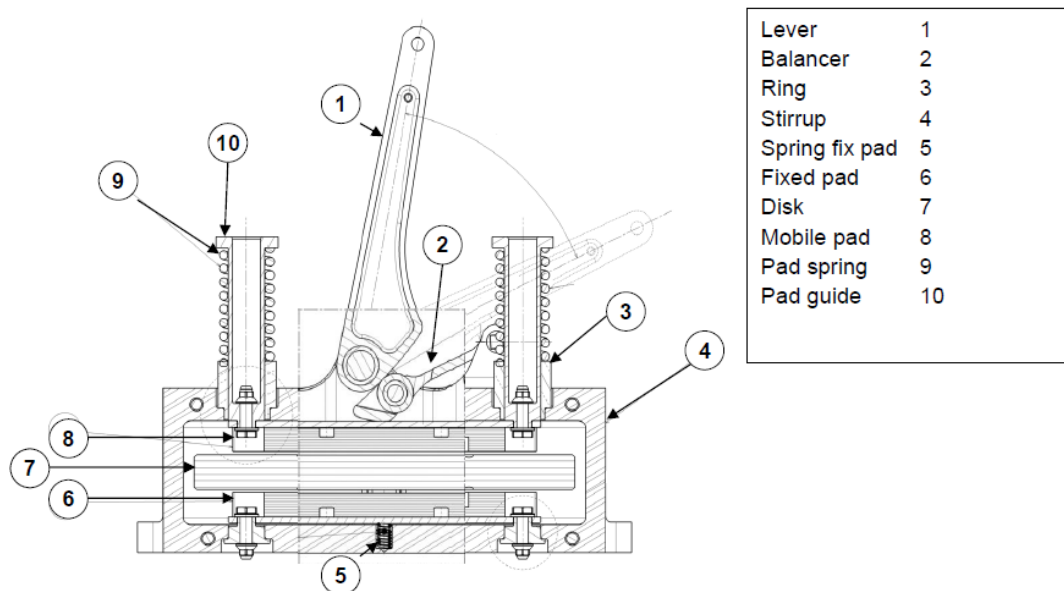
**Figure 4**

Cross section of EC175 rotor brake assembly viewed from below  
(courtesy of Airbus Helicopters)

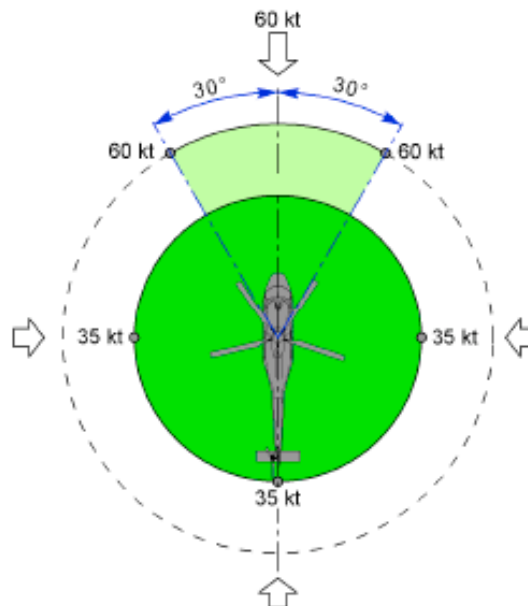
**Figure 5**

Section 2.4 of the FM identifies the rotor starting and stopping limitations (Figure 5). This states that the maximum wind strength for starting or stopping is 35 kt unless the wind direction is within a 60° arc centred on the nose of the helicopter, in which case the rotor can be started or stopped in wind up to 60 kt. The operator imposed a limit of 25 kt and 50 kt respectively to add an additional safety margin.

EC175 rotor starting and stopping wind limitations.

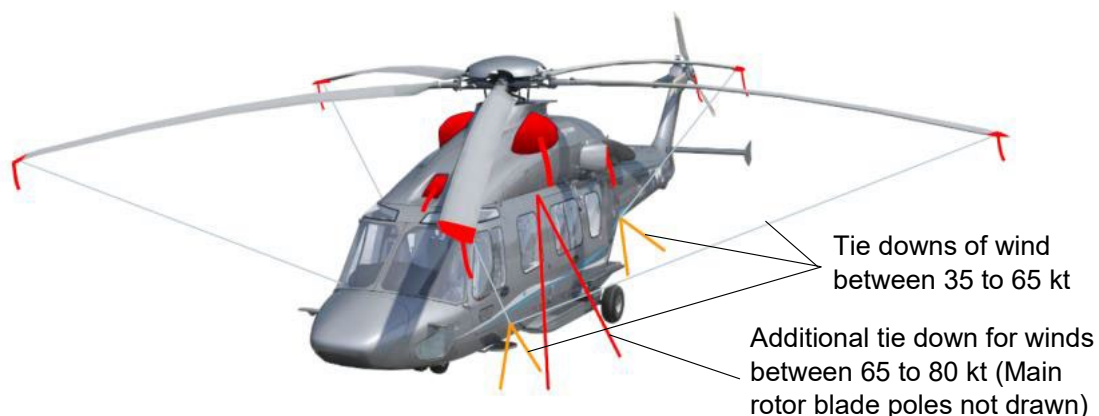
**Figure 6**

EC175 mooring for varying wind strengths

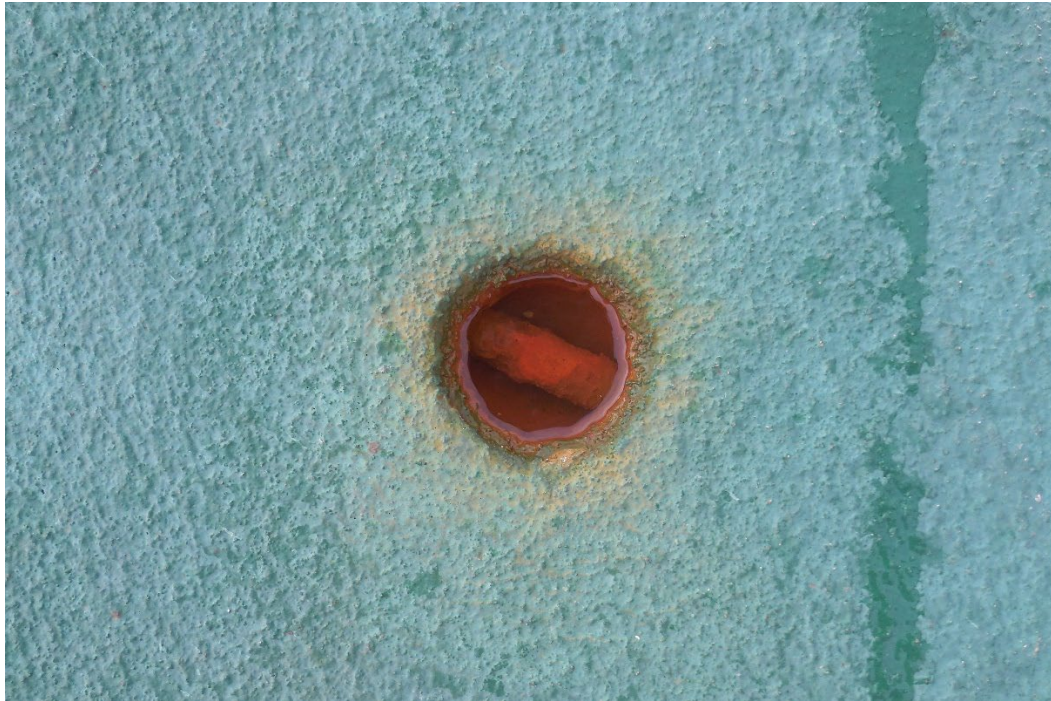
**Figure 7**

Helicopter mooring kits were required to be stored on offshore helidecks, details of which were included in CAP 437. Helideck owners were required to accommodate the types of helicopters operating to a particular platform and to fit the specific attachment points embedded in the helideck (Figure 7).

Attachment Point on Elgin PUQ Helideck

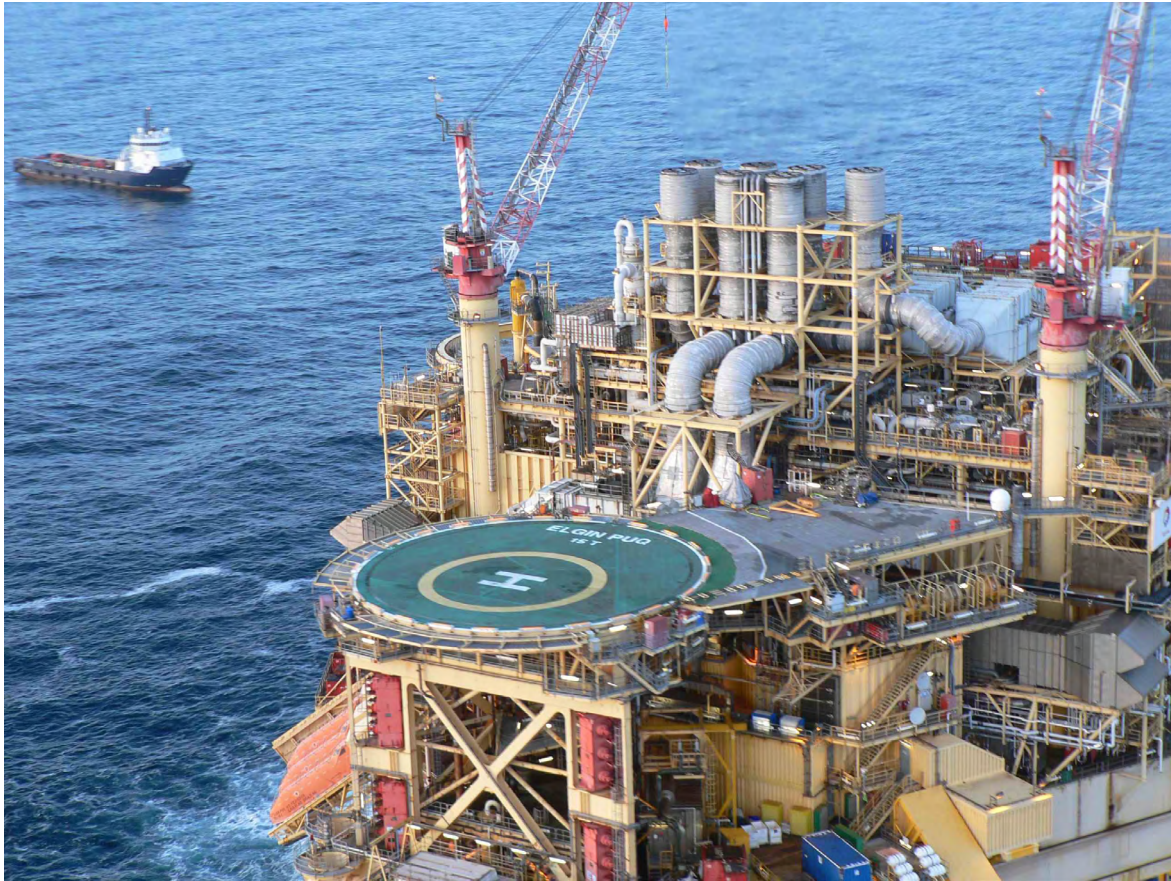
**Figure 14**

The Elgin PUQ platform is an offshore facility located in the North Sea about 135 nm to the east of Aberdeen Airport. It has a single helideck which is at an elevation of 166 ft (Figure 14). The helideck is situated on the south-west side of the platform where it is exposed to the prevailing wind.

Elgin PUQ platform helideck prior to addition of accommodation block  
(used with permission of HCA)

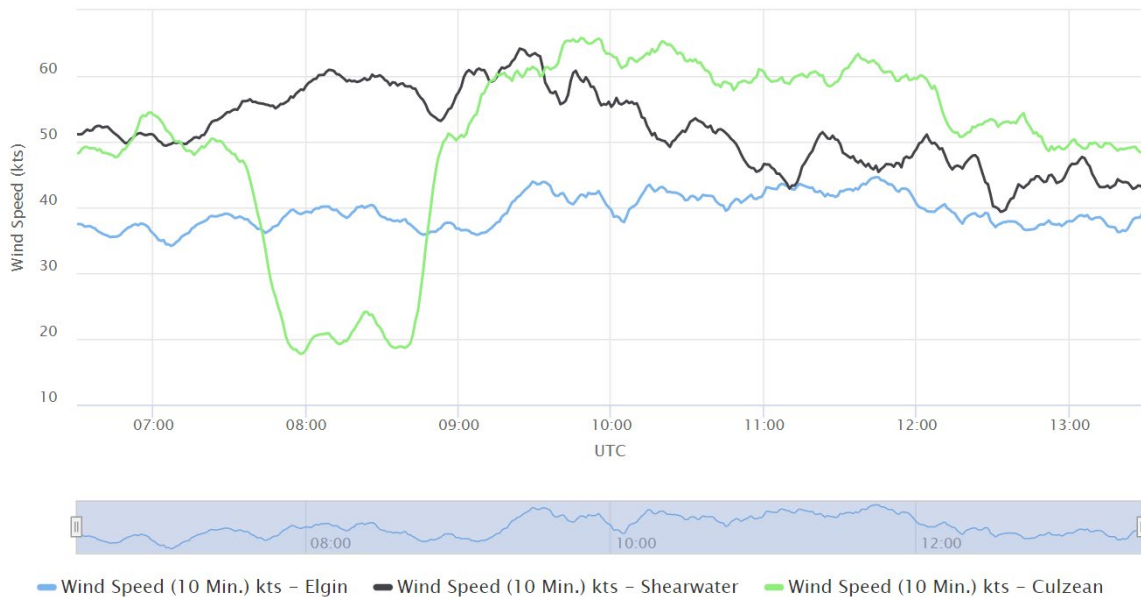
**Figure 16**

The 10-minute averaged wind speeds for the Elgin PUQ and two neighbouring platforms are presented in Figure 16. The Shearwater platform is 4 nm east-north-east and the Culzean platform is 11 nm north of the Elgin PUQ.

Ten-minute Averaged Wind Speeds for Elgin, Shearwater and Culzean Offshore Platforms

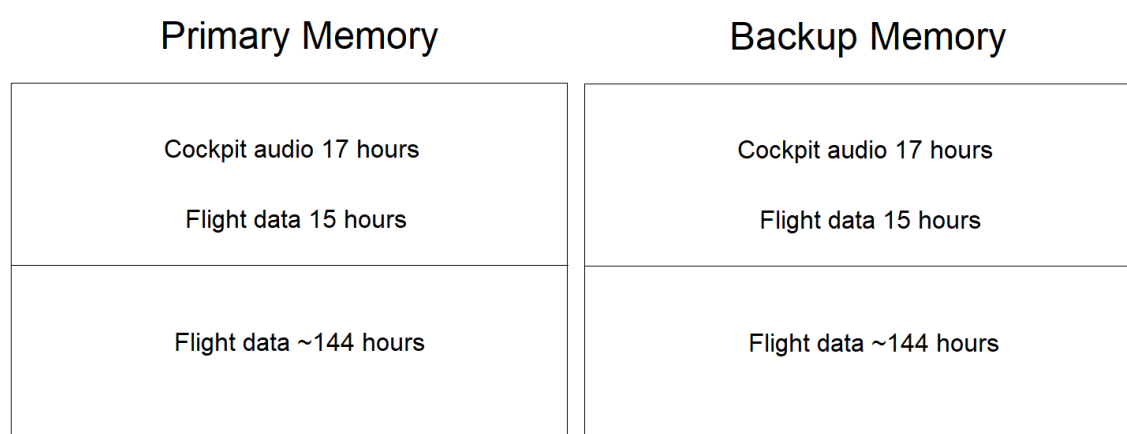
**Figure 19**

The AAIB was subsequently advised by the FA5000 manufacturer that the most recent 15 hours of flight data was also separately recorded with the CVR audio. Figure 19 depicts the memory segregation of the FA5000 CVFDR data. This recording function operated differently to that which stored flight data to the memory area capable of retaining approximately 144 hours. The manufacturer advised that the recording of flight data combined with the CVR audio was incorporated to meet the requirement of ED-112 concerning the maximum permissible time by which data shall have been stored to the crash protected memory.

The recorder manufacturer provided additional software to the AAIB that downloaded the 15 hour recordings of flight data that was combined with the CVR audio. This flight data was found to be chronologically correct for G-MCSH and G-MCSO CVFDRs. However, in both recordings, flights were present with 5 seconds of data missing at 10 minute intervals, as found in the flight data recordings from the larger 144 hour memory areas.

FA5000 CVFDR crash protected memory segregation

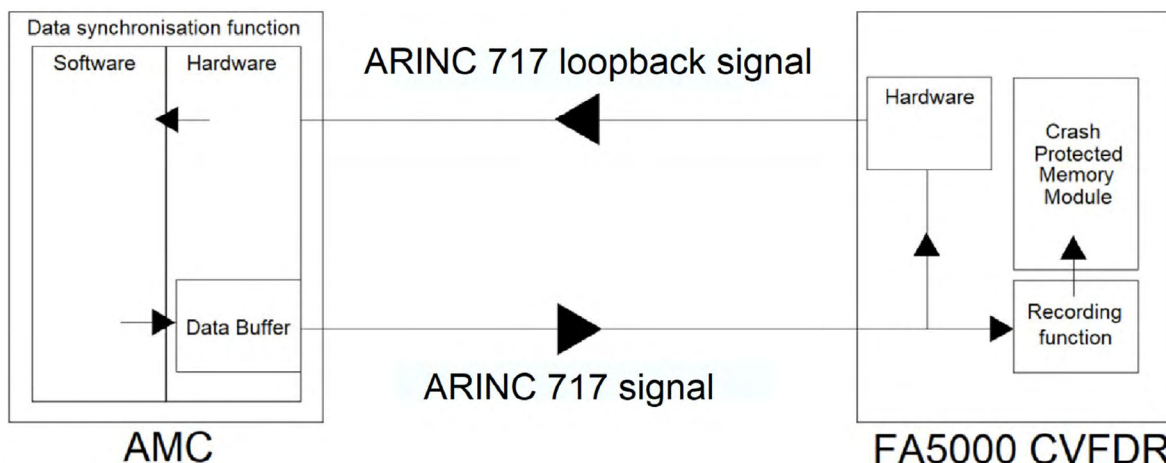
**Figure 20**

The FA5000 provides a loopback of the ARINC 717 signal, which is connected to the AMC on the EC175 and is used to confirm correct data synchronisation (Figure 20). The helicopter manufacturer's analysis of the Helionix Version 8 software operation concluded that if the ARINC 717 loopback signal from the FA5000 was out of specification, this would result in a AMC software buffer overflow error. At a data rate of 512 wps, an error would occur after about 3 hours and 15 minutes of continuous AMC operation. Thereafter a loss of the AMC ARINC 717 output signal to the CVFDR would occur for periods of about 5 seconds every 10 minutes. The data loss would continue until the AMC was subsequently powered off (i.e at helicopter shutdown). Removal of power would then clear the buffer overflow error until the next operation of the AMC for a period of 3 hours and 15 minutes, following which the data loss would occur again.

AMC - FA5000 ARINC 717 loopback signal
