# Annual Safety Review 2024

**AAIB**  
Air Accidents Investigation Branch

I am pleased to present the 2024 Annual Safety Review, which provides a comprehensive overview of occurrences reported to the Air Accidents Investigation Branch (AAIB) during the year, along with the safety actions taken or planned in response to our investigations.

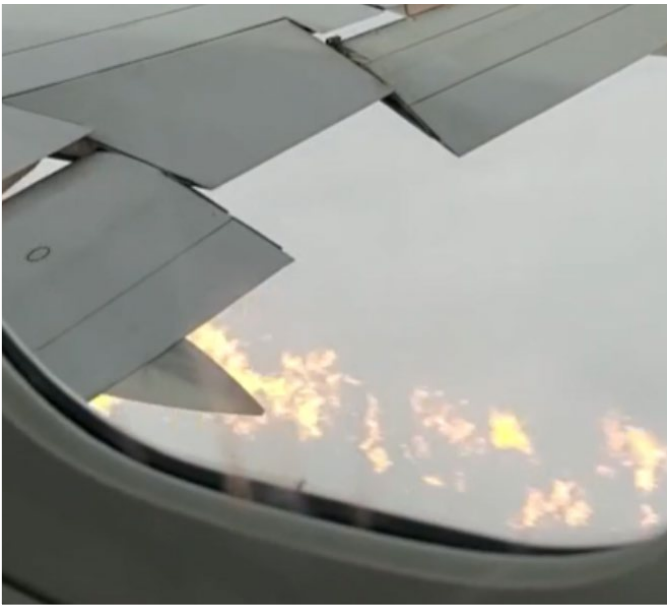
During takeoff from Edinburgh Airport bound for New York, a high-pressure turbine blade fractured in the right engine. The blade damaged a further five blades, but the engine was still capable of producing thrust. The out of balance turbine caused vibrations sufficient to cause a slat track housing drain tube to fracture in the wing which allowed fuel to escape from the right wing fuel tank.

Due to the high engine vibration, the flight crew diverted the aircraft to Prestwick Airport. During the diversion, fuel escaping from the wing was ignited by the hot engine exhaust, and this was recorded on video by a passenger, but the flames extinguished before the landing. The aircraft landed promptly, with full emergency service attendance. After the aircraft arrived on stand, the airport fire service noticed the fuel coming from the right wing and put provisions in place to capture the fuel, preventing it igniting on the hot engine or brakes. The passengers were rapidly disembarked, with no injuries.

Image from a passenger’s video

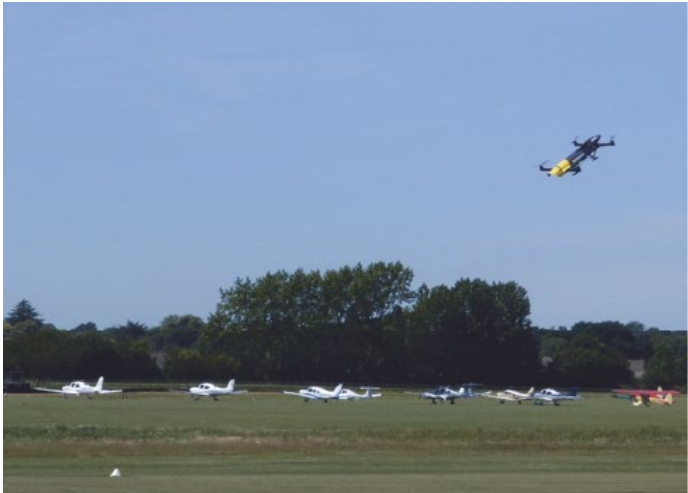
Whilst performing a demonstration flight, the remote pilot lost control of the 95 kg Alauda Airspeeder Mk II scale demonstrator. After the loss of control had been confirmed by the remote pilot, the safety ‘kill switch’ was operated but had no effect. The unmanned aircraft (UA) then climbed to approximately 8,000 ft, entering controlled airspace at a holding point for flights arriving at Gatwick Airport, before its battery depleted and it fell to the ground. It crashed in a field of crops approximately 40 m from occupied houses and 700 m outside of its designated operating area. There were no injuries.

Airspeeder in flight prior to the accident  
(used with permission)

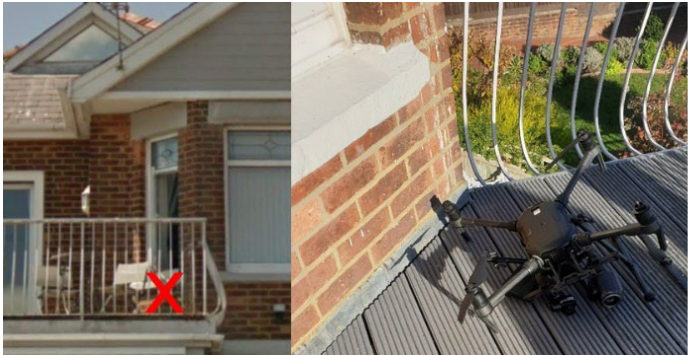
The quadcopter unmanned aircraft (UA) was being flown over the city of Poole during a police operation when the wind at 400 ft exceeded the forecast wind, the manufacturer’s wind limit and the maximum restricted speed of the UA. The UA drifted beyond visual line of sight and then communication with it was lost. When the battery level was low it entered an auto-land mode but collided with the wall of a house, damaging its propeller blades before coming to rest on a balcony.

Accident site location and damage to UA

The investigation revealed that shortly after takeoff one of the UA’s two batteries had disconnected which resulted in its maximum speed being restricted, but this restriction is not referenced in the user manual and neither the remote pilot nor operator were aware of it. When the UA detected that the manufacturer’s wind limit had been exceeded, the message triggered on the pilot’s controller display was ‘Fly with caution, strong wind’ instead of advising the pilot that the limit had been exceeded and that the UA should be landed as soon as possible.

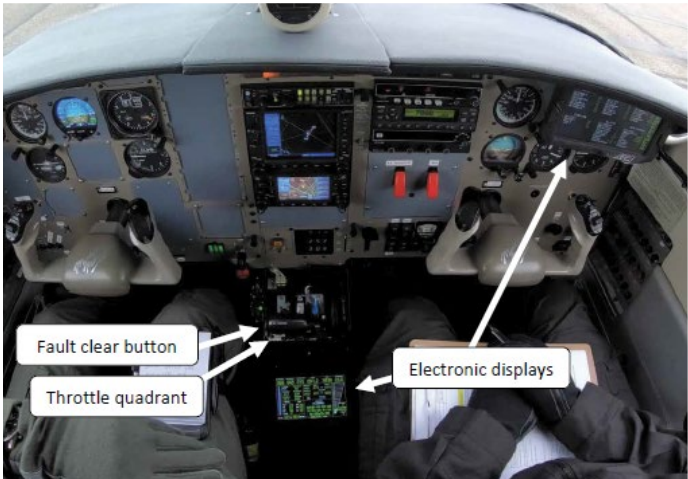
The electrically powered aircraft was undertaking experimental flight tests, under E Conditions CAP1220, when power to the electrical motors was lost. A forced landing was carried out close to Cranfield airfield during which the aircraft was severely damaged.

The loss of power occurred during an interruption of the power supply when, as part of the test procedure, the battery was selected off with the intention of leaving the electrical motors solely powered by the hydrogen fuel cell. During this interruption the windmilling propeller generated a voltage high enough to operate the inverter protection system, which locked out the power to the motors. The pilot and observer were unable to reset the system and restore electrical power.

**View from onboard camera of cockpit instrument panel**

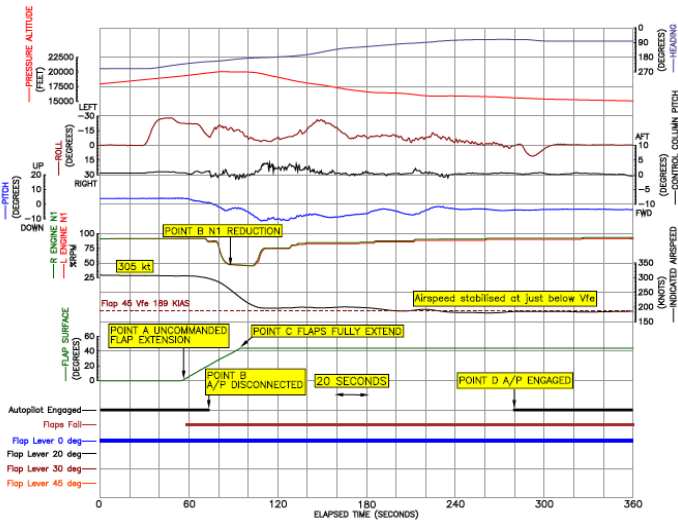
In the climb, after departing Farnborough Airport, D-AAAY had an uncommanded flap movement above the maximum flap extension speed during which the flaps moved to their fully extended position. The aircraft returned to Farnborough with the flaps extended where it landed without further incident.

An uncommanded and unarrested flap movement requires the flaps to move without movement of the flap lever and then for a failure in the flap arrest system to stop this movement. The flap surfaces are moved by two drive motors that are commanded by the sequencing of four extend and retract relays. These four relays also form part of the system to arrest an uncommanded flap movement.

FDR data of uncommanded flap extension

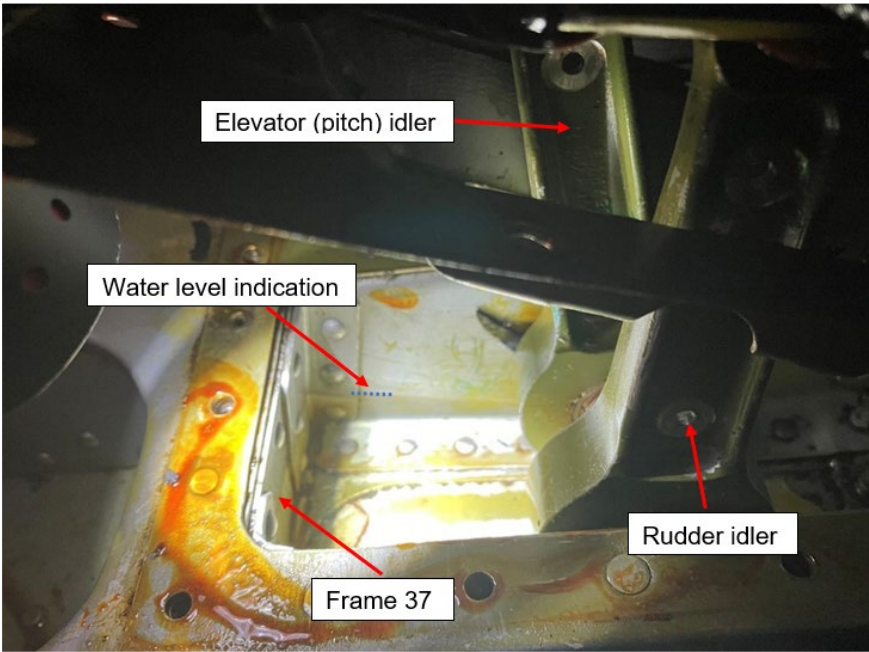
Subsequent investigation determined that the restriction was caused by rainwater collecting in a compartment under the pitch control idler link and then freezing at high altitude.

Control box area in rear fuselage (Image used with permission)

To prevent a recurrence, two safety actions have been taken; a modification by the operator to reduce the possibility of rainwater ingress and a modification by the aircraft manufacturer to increase drainage of the affected compartment.

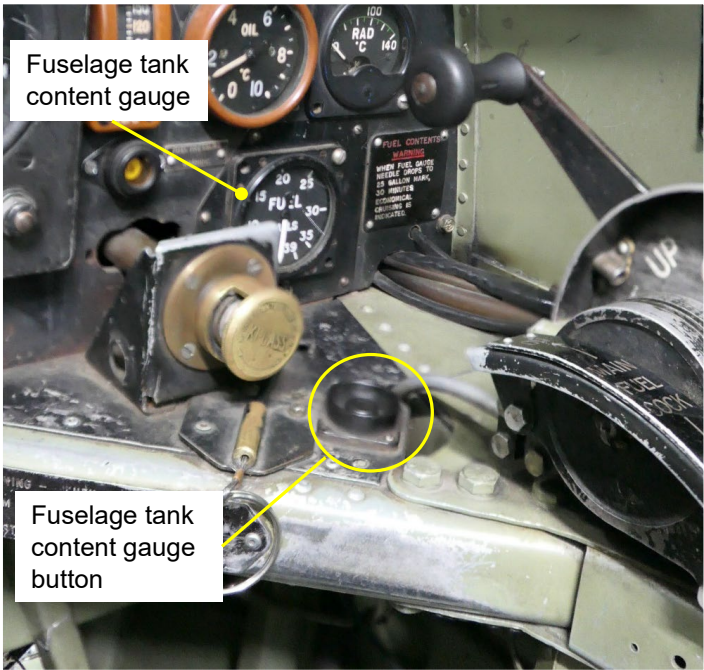
**Spitfire G-LFIX fuselage fuel tank content  
indication gauge**

- As a result of this event, the operator has introduced a requirement in their operating procedures for pilots to confirm the contents of the fuselage tank before changing to it.

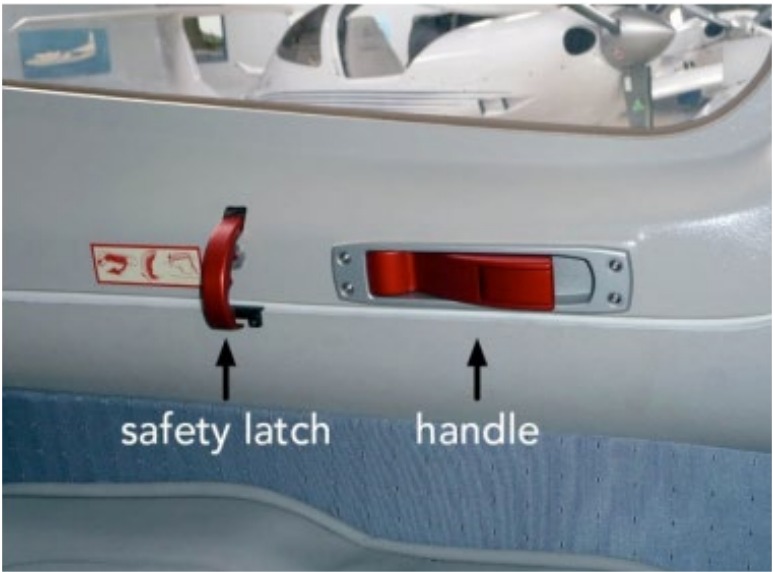
Rear passenger door handle configuration (image used with permission)

- Providing clear guidance to crews on the use of the rear door and latches.
- Amendments to the pre-flight check list to include additional testing of the secondary latch during pre-flight checks and a reminder of the importance of reporting any faulty secondary latches as a defect.

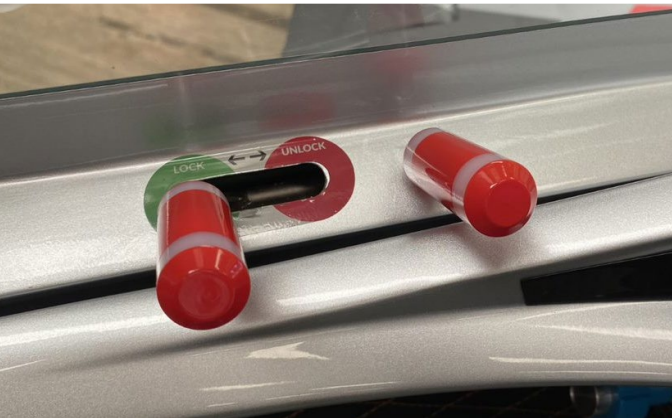
Shoot bolt handles (canopy in the closed and locked position)

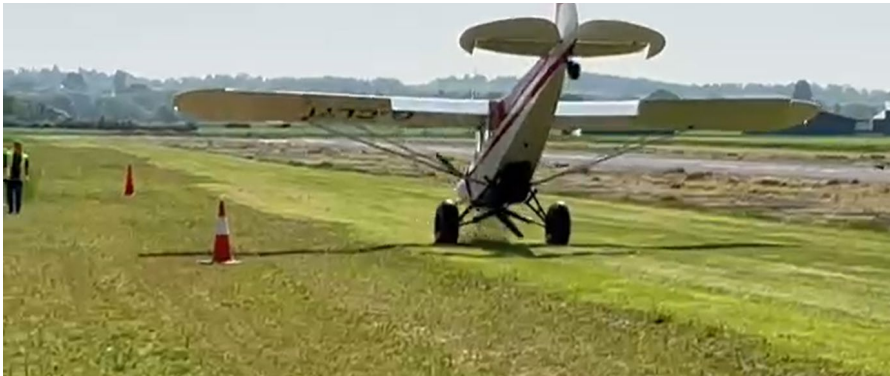
Video screenshot of G-CLYI after landing

- The Safety Management System (SMS) has been updated to include risk management in event planning.
- The airfield manager has gained a Tier 1 Flying Display Director accreditation.

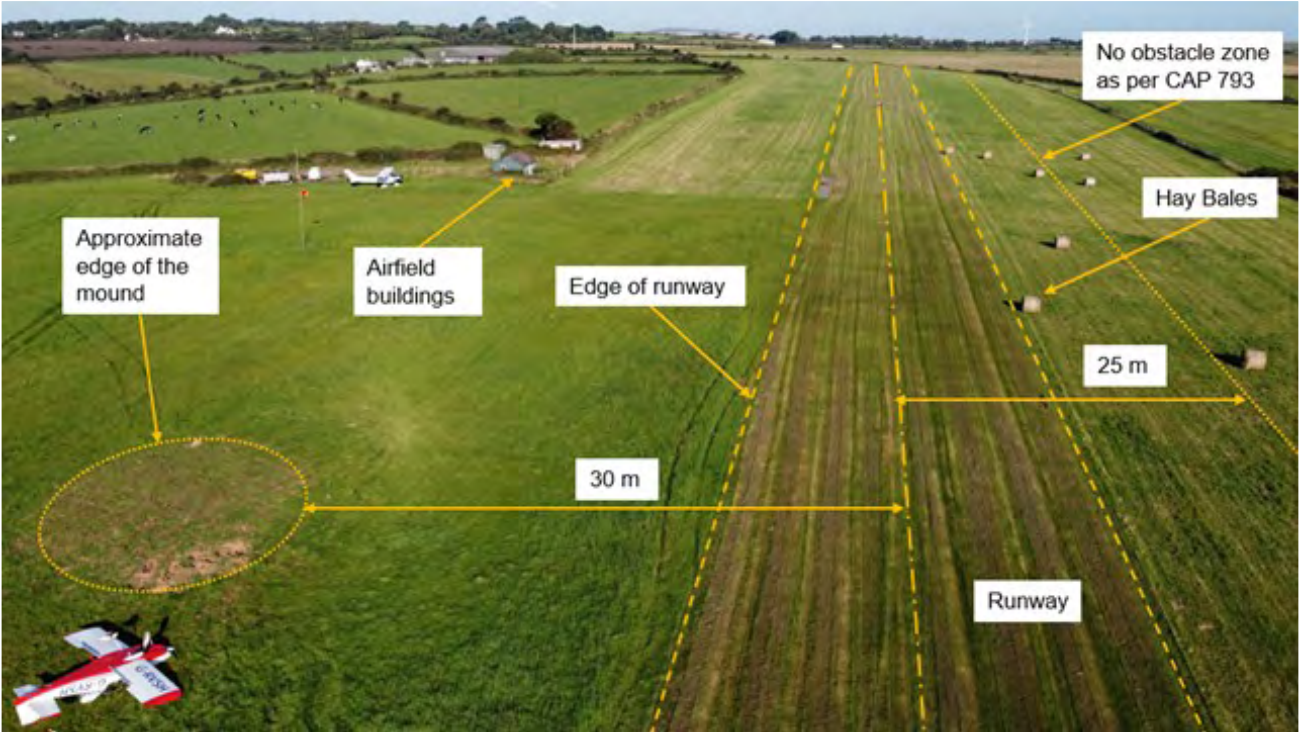
Truro airfield viewed in direction of Runway 32 showing hay bales and the mound

- The airfield owner has instructed the farmers to remove the hay from the airfield as soon as it is baled and not to store it on the airfield.
- The airfield owner has provided additional guidance in the Pooley’s Plate on which runway to use depending upon the wind conditions.
- The airfield owner has removed the training mound.

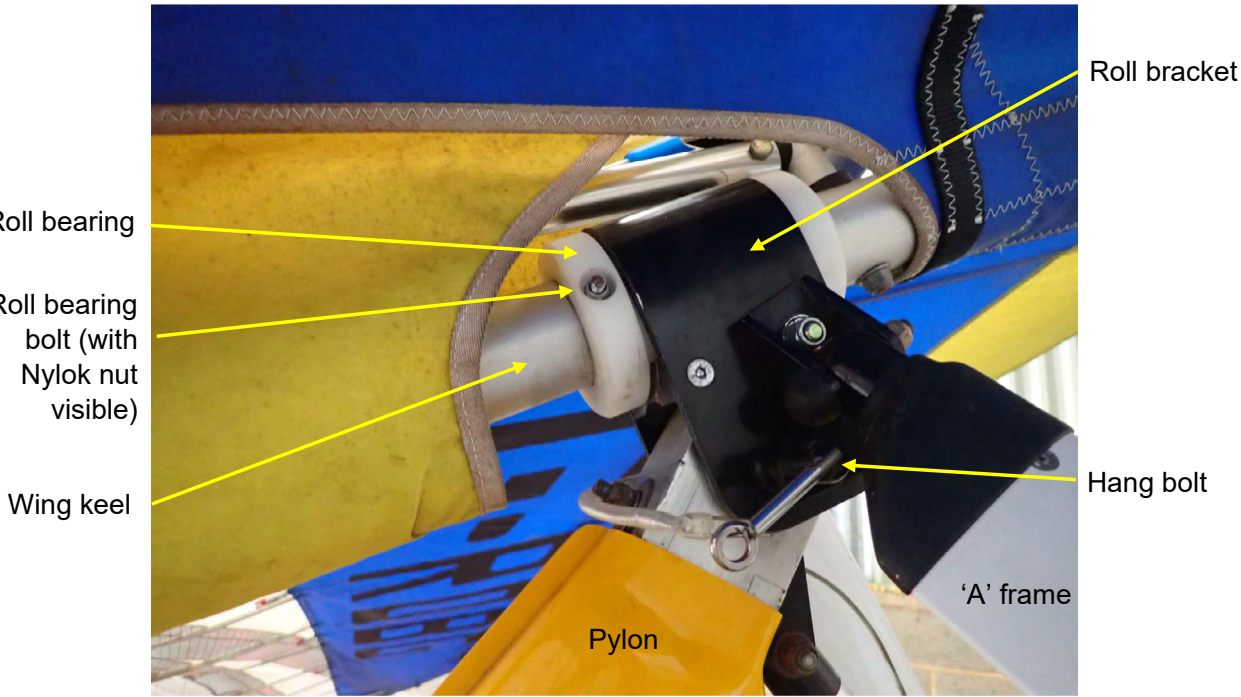
The loss of a securing bolt had caused the roll bearing to move aft along the wing keel. This altered the trim of the aircraft inducing a significant nose-up pitch that was only marginally controllable.

**GT450 wing keel and hang bracket viewed from the right**

*An accident to a GT450 was caused by the 6mm keel roll bearing CG cap head bolt coming out, allowing the roll bearing, hang bracket and control frame top to move back causing a severe pitch up.*

*The roll bracket assembly must be inspected to ensure it moves freely on the roll bearing and that the bearing is not loose on the keel. Nylon roll bearings (dark colour) can swell with moisture over the years, causing friction which puts more stress on the CG bolt and keel hole.*

*If not already fitted, it is strongly recommended to fit the longer bolt, item 13, part no. FCM6-80 with securing M6 T type Nylok nut, item 10, part no. FNM6-NT.'*

- The manufacturer also introduced, via SB 160, a clamp that is fitted to the wing keel aft of the roll bearing to prevent its rearward movement in the event of a roll bearing bolt failure or loss.

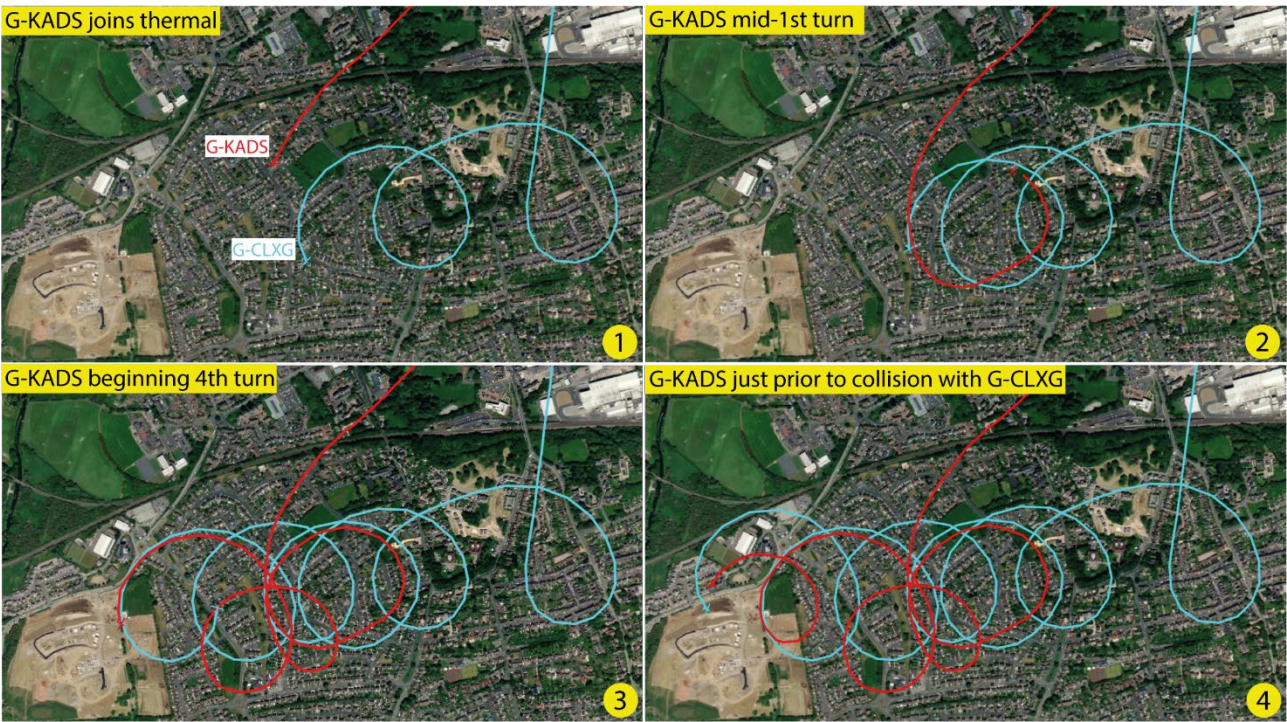
Flightpaths of G-KADS and G-CLXG in a thermal prior to the collision  
© 2022 SeeYou software by Naviter

- The BGA has updated the ‘Managing Flying Risk – Flying in Gliding Competitions’ section of their website.
- The BGA is to deliver a midair collision safety campaign, in the spring of 2024, aimed at pilots taking part in gliding competitions.
- The BGA is monitoring an initiative from FAI8 International Gliding Commission which is evaluating a ‘proximity monitoring tool’ for evaluation of logger traces to identify unusually close proximity between gliders, as an aid to post-flight safety debriefs. If the tool proves to be useful, the BGA plans to adopt it for UK gliding competitions.

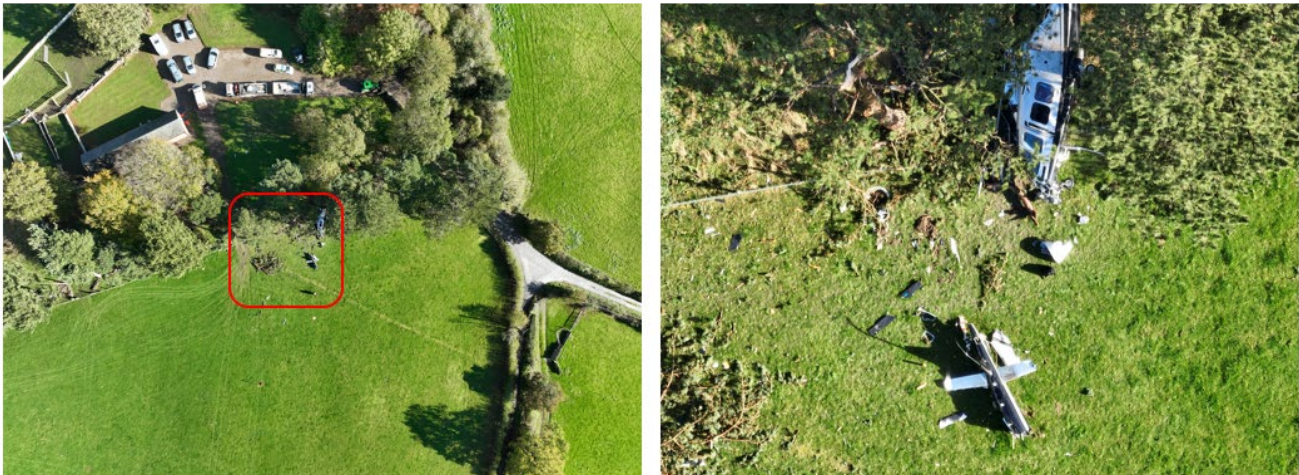
Overhead view of G-RAYN accident site

The passengers did not exert any pressure on the pilot to delay beyond the planned departure time, and the pilot did not consider that a night departure would pose an unacceptable risk. The investigation thought it likely that, had all passengers been secured by their seat harnesses, the level of injuries sustained could have been less severe. For frequent flyer passengers, or those focused on time pressures, it might be tempting to see safety briefings and seatbelts as an unnecessary encumbrance. In helicopters with seating and cabin configurations like G-RAYN’s, once pilots are in their seats, it is not possible for them to visually check the security of their passengers’ seatbelts/harnesses. Nonetheless, it is important for all parties to understand that an aircraft commander is under a legal obligation to ensure passengers are appropriately briefed and have their harnesses secure for all takeoffs and landings.

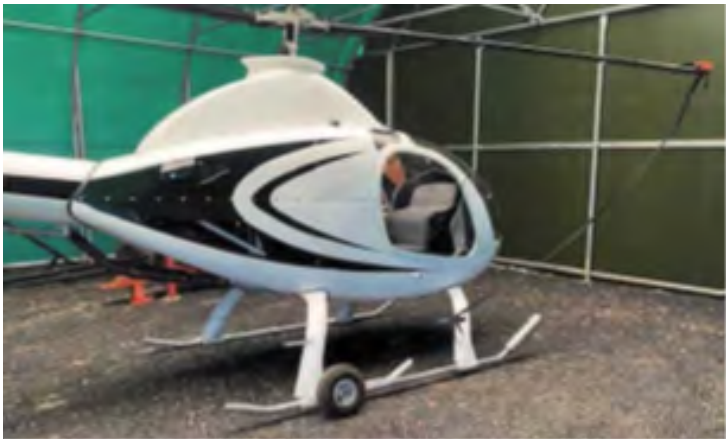
G-ZHWH with ground handling wheel fitted

- Introduced an amended the ‘*START UP, RUN UP AND TAKE OFF*’ checklist by adding ‘*VERIFY THAT BOTH GROUND HANDLING WHEELS HAVE BEEN REMOVED BEFORE FLIGHT*’. Other helicopters’ POH would be amended when undergoing an annual check. This would also be done on all other variants maintained by the Maintenance organisation.
