# ***AAIB Bulletin***

# ***7/2025***

Published: 10 July 2025.

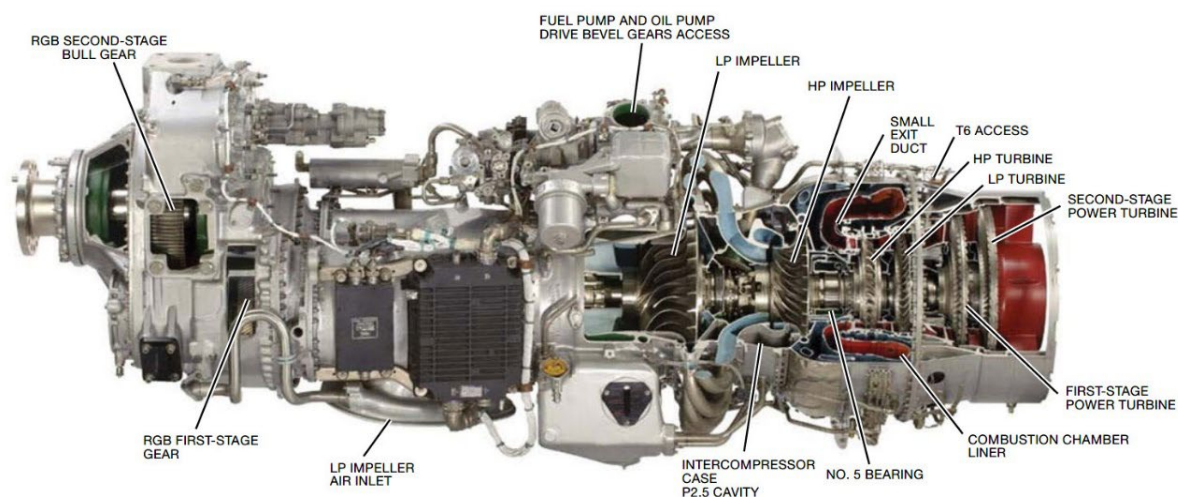
**Figure 5**

Cut away view of general engine arrangement  
(used with permission)

The disassembly of the engine identified that the No 6 bearing had suffered significant degradation resulting in the loss of location of the high-pressure turbine assembly and the damage seen to the turbines and their casings.

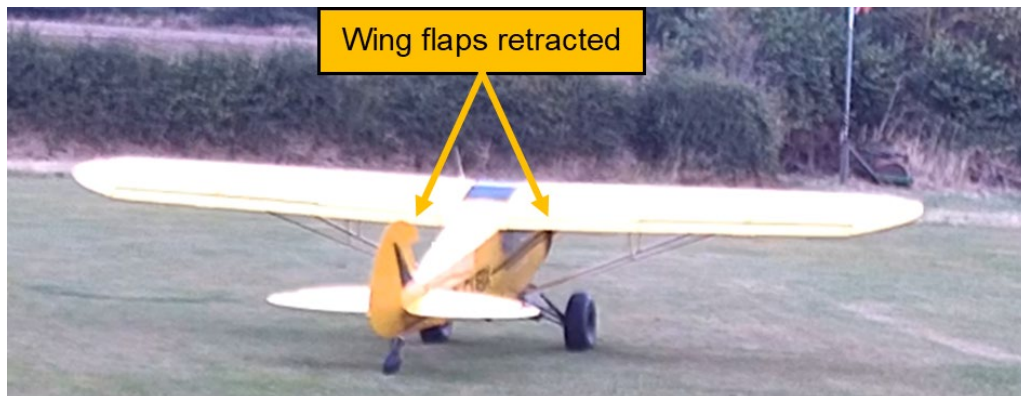
**Figure 1**

On the morning of the accident, the pilot used a remote-controlled aircraft tug to manoeuvre G-CUBX out of its hangar before completing his pre-flight checks. After initially having trouble starting the engine, he taxied out for departure from Runway 28. As the aircraft entered the runway to backtrack, its wing flaps were retracted (Figure 1).

CCTV snapshot showing G-CUBX entering Runway 28 to backtrack for departure

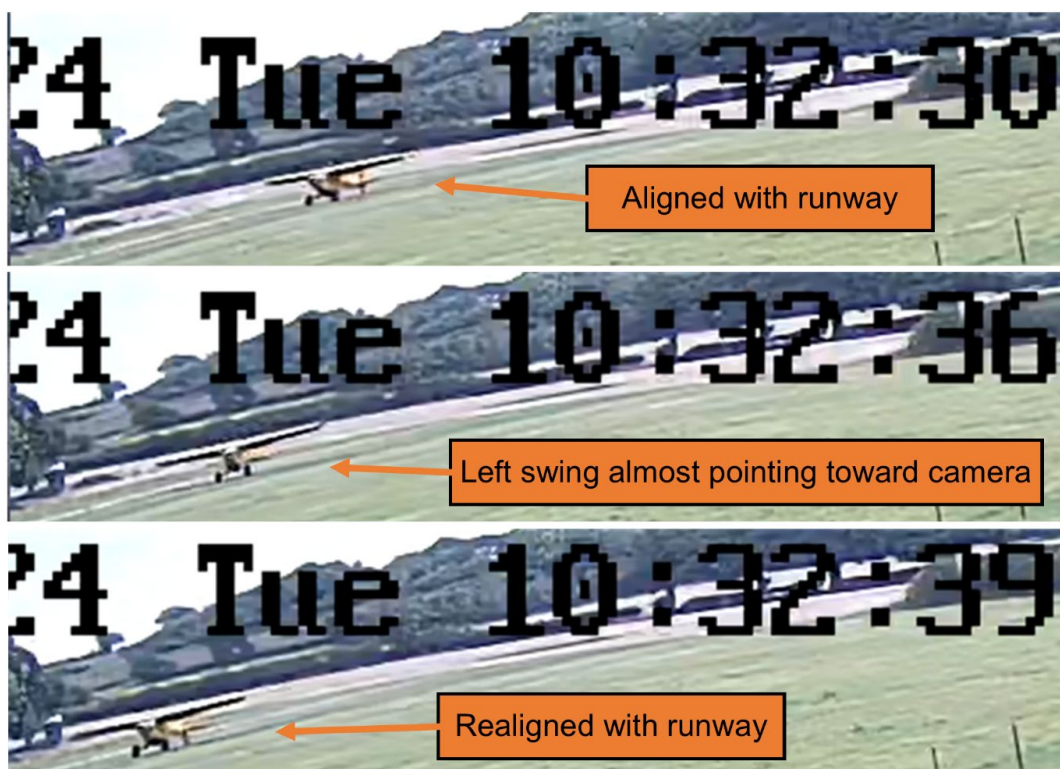
**Figure 2**

Captured on CCTV, while at low speed during the initial phase of the takeoff roll, the aircraft swung to the left before being re-aligned to the runway by the pilot (Figure 2).

CCTV snapshots of G-CUBX at the start of its takeoff roll  
(CCTV shows approximate local time)

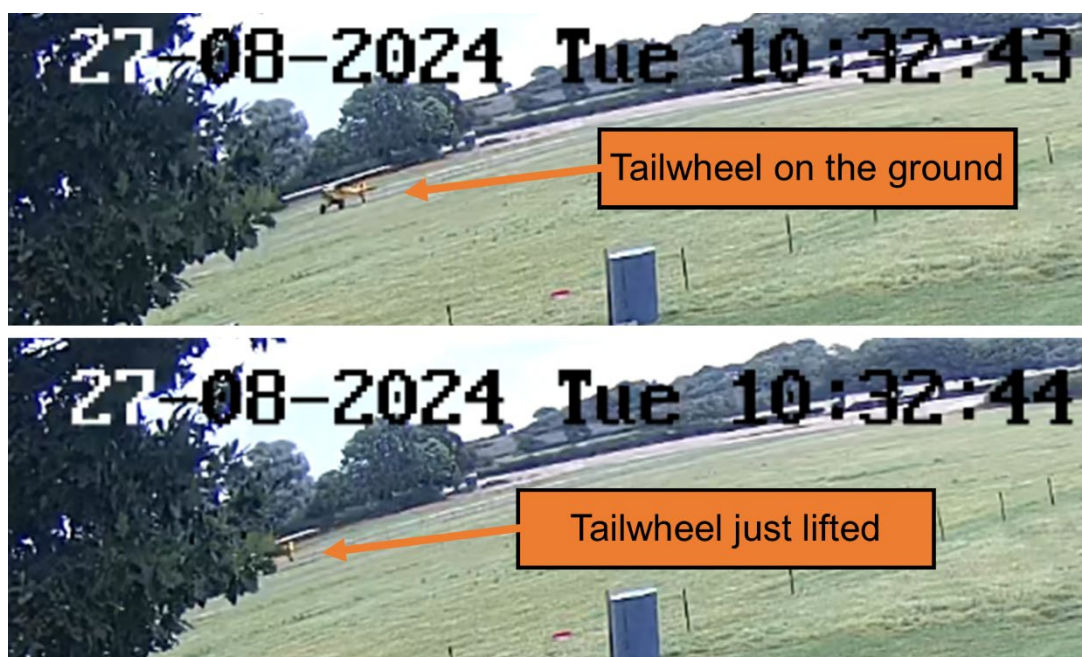
**Figure 3**

After this early yaw divergence, the remainder of the takeoff roll captured on CCTV appeared to progress normally, with the aircraft's tailwheel lifting off just before the aircraft went out of view (Figure 3). Approximately nine seconds later the aircraft reappeared in the CCTV image, close to the camera and in a steep nose down attitude just before it struck the ground. While the CCTV footage was not of a sufficiently high definition to reach a definitive conclusion, it appeared to show G-CUBX's wing flaps in the retracted position before it struck the ground.

CCTV snapshots of G-CUBX showing its tailwheel being lifted from the runway

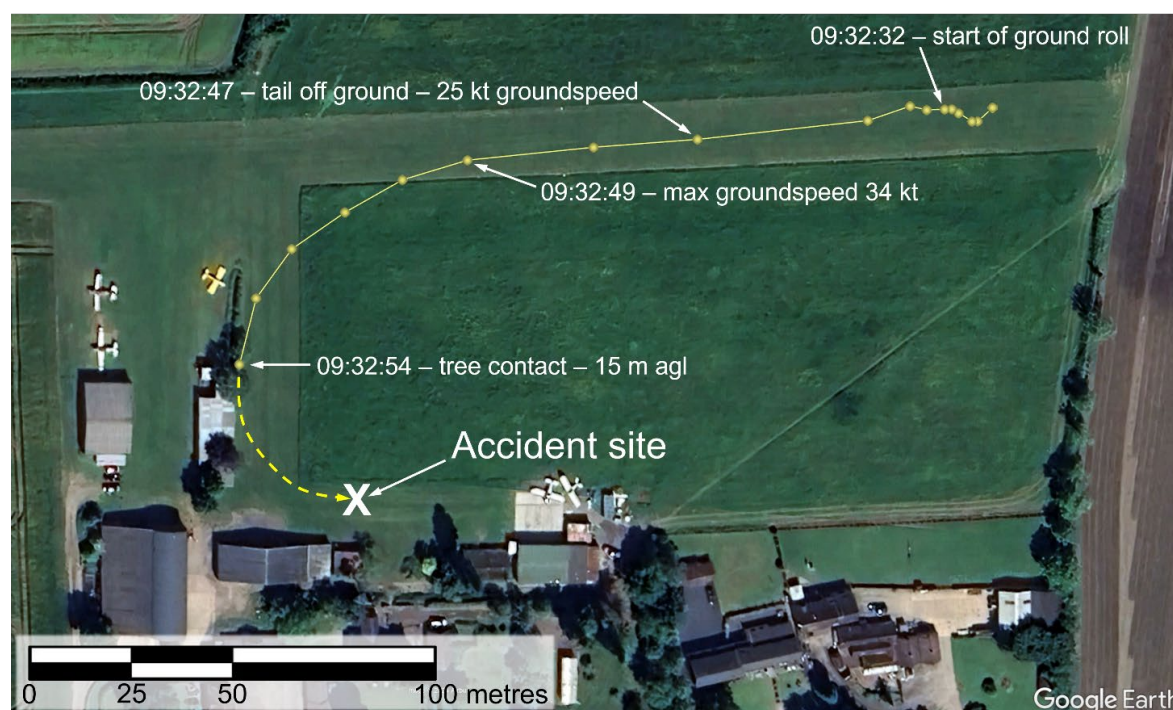
**Figure 5**

The pilot was using a flight-planning and navigation app on a tablet device which recorded the aircraft's GPS flight path. The ground track is shown in Figure 5. Note that the path stops short of the accident site by about three seconds as the recorded positions during this period were unreliable, probably as a result of the aircraft's banked attitude limiting the tablet's view of the GPS satellites.

GPS derived ground track of the flight  
(© 2025 Google, Image © 2025 Airbus)

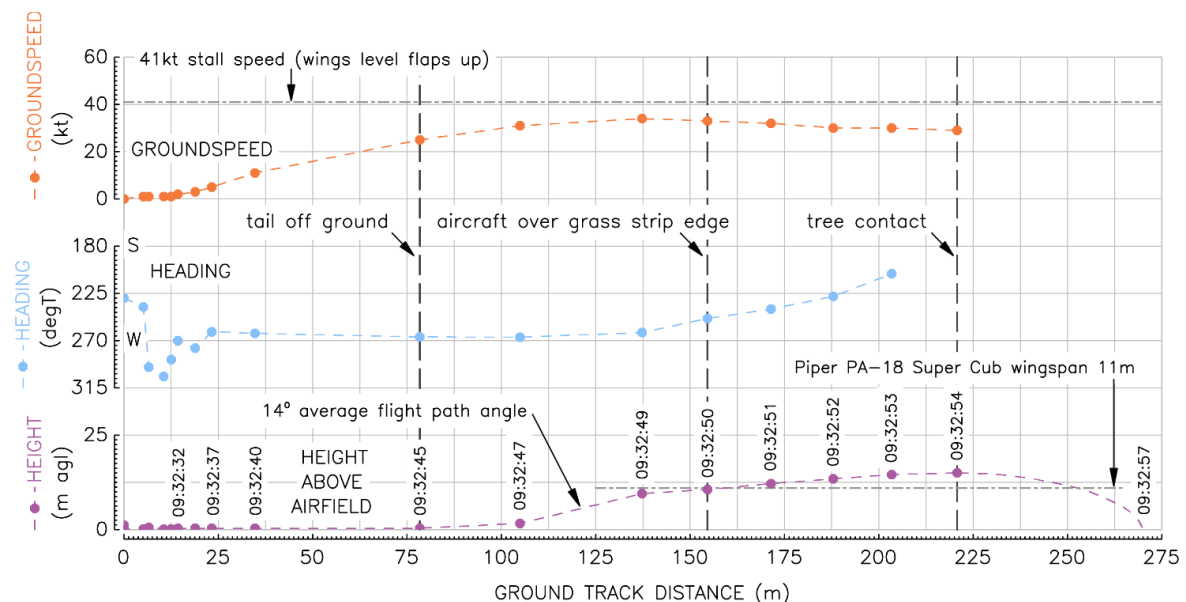
**Figure 6**

A side profile of the flight path is presented at Figure 6 together with other GPS derived data. These data show the aircraft initially lining up on the grass strip before beginning the take off at time 09:32:32.

After five seconds of gentle manoeuvring right, left and right again, the aircraft accelerated down the grass strip, veering slightly left, with the tail of the aircraft coming off the ground 10 seconds later (before going out of view of the CCTV). Within two seconds, the aircraft was airborne, after which it climbed at an average flight path angle of  $14^\circ$  and reached the maximum recorded groundspeed of 34 kt. Now turning left, the rate of climb reduced with the aircraft flying over the left edge of the grass strip at just over 10 m height.

The last recorded reliable position was four seconds later when the aircraft contacted a tree, 40 m to the left of the grass strip edge, at a height of about 15 m. Continuing to turn, and roll left, the aircraft came back into CCTV view descending vertically in a nose-down attitude, wings aligned with the grass strip, left wing first.

GPS derived data of flight  
(PA-18 clean stall speed and wingspan indicated for reference)

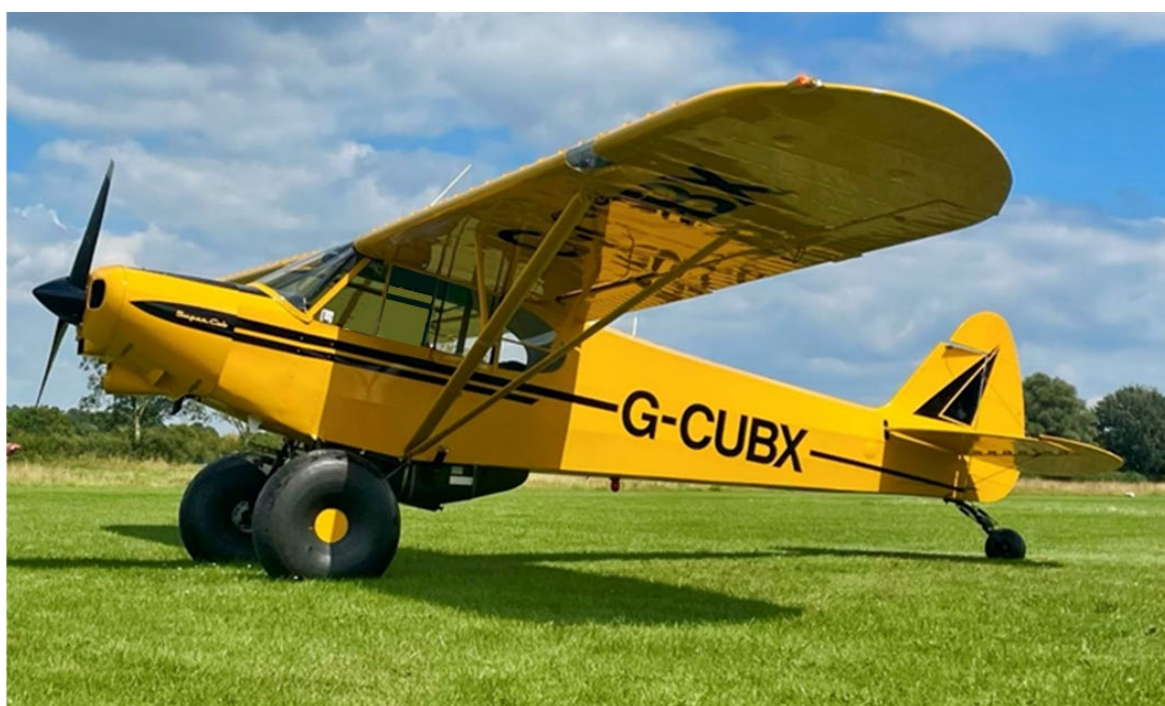
**Figure 7**

G-CLYI was involved in a landing accident in May 2023<sup>2</sup> where it flipped over onto its back whilst braking shortly after touching down on a grass landing strip. The aircraft spent 13 months undergoing repairs during which it was re-registered as G-CUBX in June 2024 (Figure 7). The engine was shock load tested by an approved engine workshop and refitted during the repairs. To improve stall performance and enhance the short takeoff and landing capability of the aircraft, vortex generators had been fitted just aft of the wings' upper leading edges and on the lower surfaces of the horizontal stabilizer, forward of the elevator hinges. These were also replaced during the repair process. G-CUBX received a CAA UK Airworthiness Review Certificate (ARC) on 11 July 2024.

G-CUBX after repair showing features of the Alaskan Bush fit

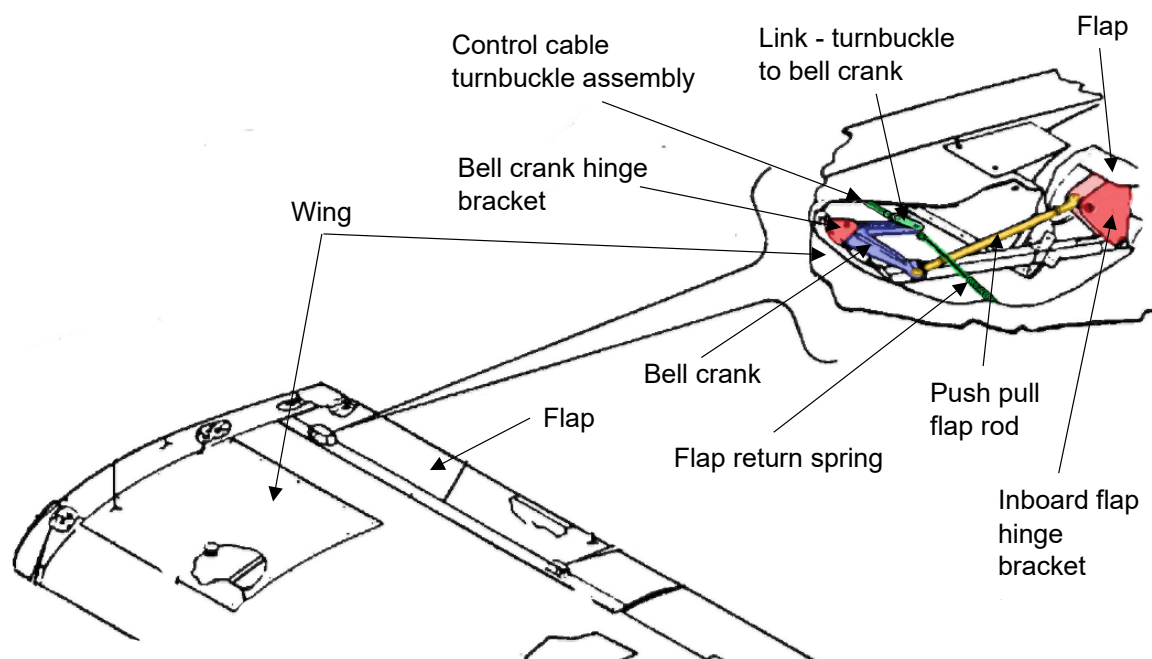
**Figure 8**

Whilst the right flap bell crank was missing (Figure 8), the turnbuckle that should have attached the flap control cable to the bell crank was intact and still attached to the control cable, link and return spring. The bell crank hinge bracket remained in place and attached to the wing. The push pull flap rod, which should have connected the bell crank to the inboard flap hinge bracket, remained attached to the bracket but the bracket had separated from the flap. The left flap control assembly was still connected to the left bell crank and flap although the wing spar section that held bell crank hinge bracket had melted releasing the bracket and bell crank.

Flap control assembly diagram

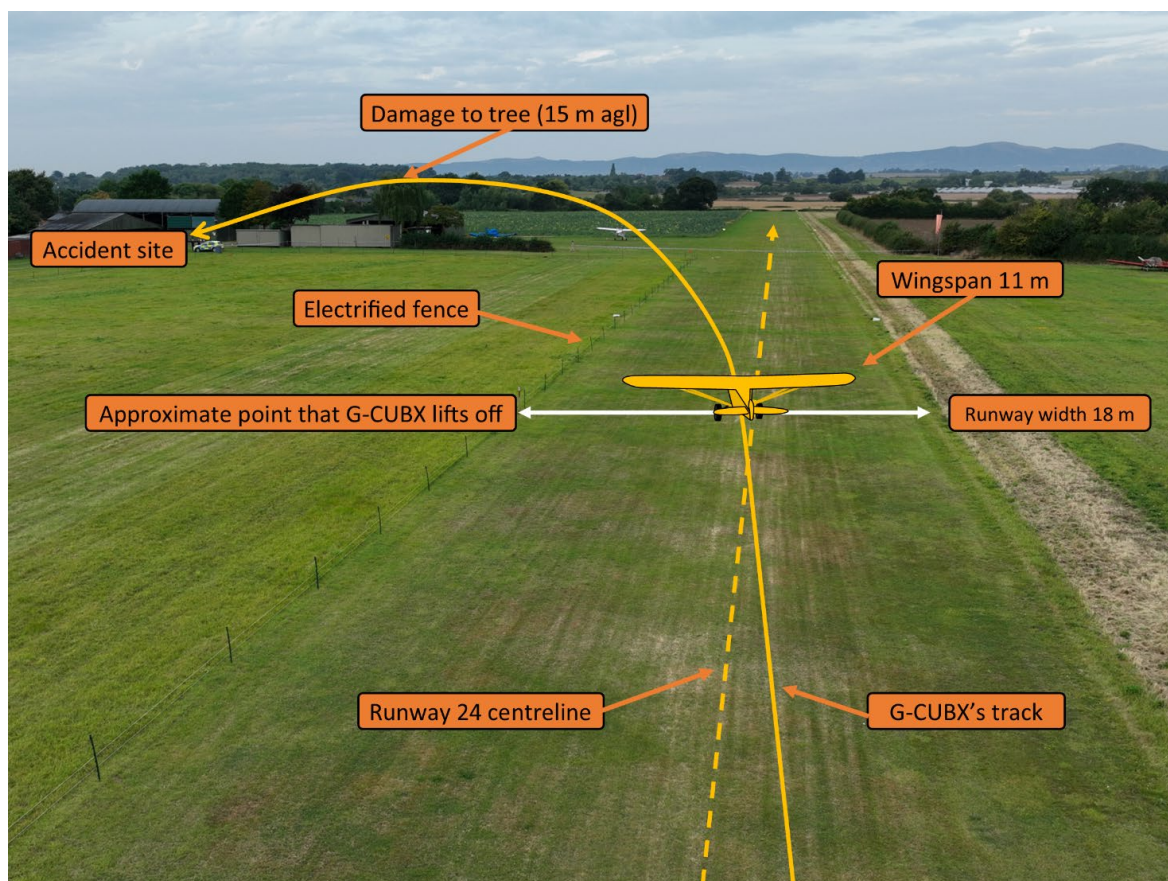
**Figure 11**

The investigation did not find conclusive evidence to explain why the pilot lifted off at 34 kt groundspeed or for the steep climb and apparent loss of effective control. The investigation considered the aircraft's ground roll track converging with the electrified fence bordering the southern edge of the runway (Figure 11) could have been a contributory factor if the pilot decided to lift off earlier than perhaps he originally intended.

G-CUBX's approximate ground track and flightpath (aircraft drawn to scale)

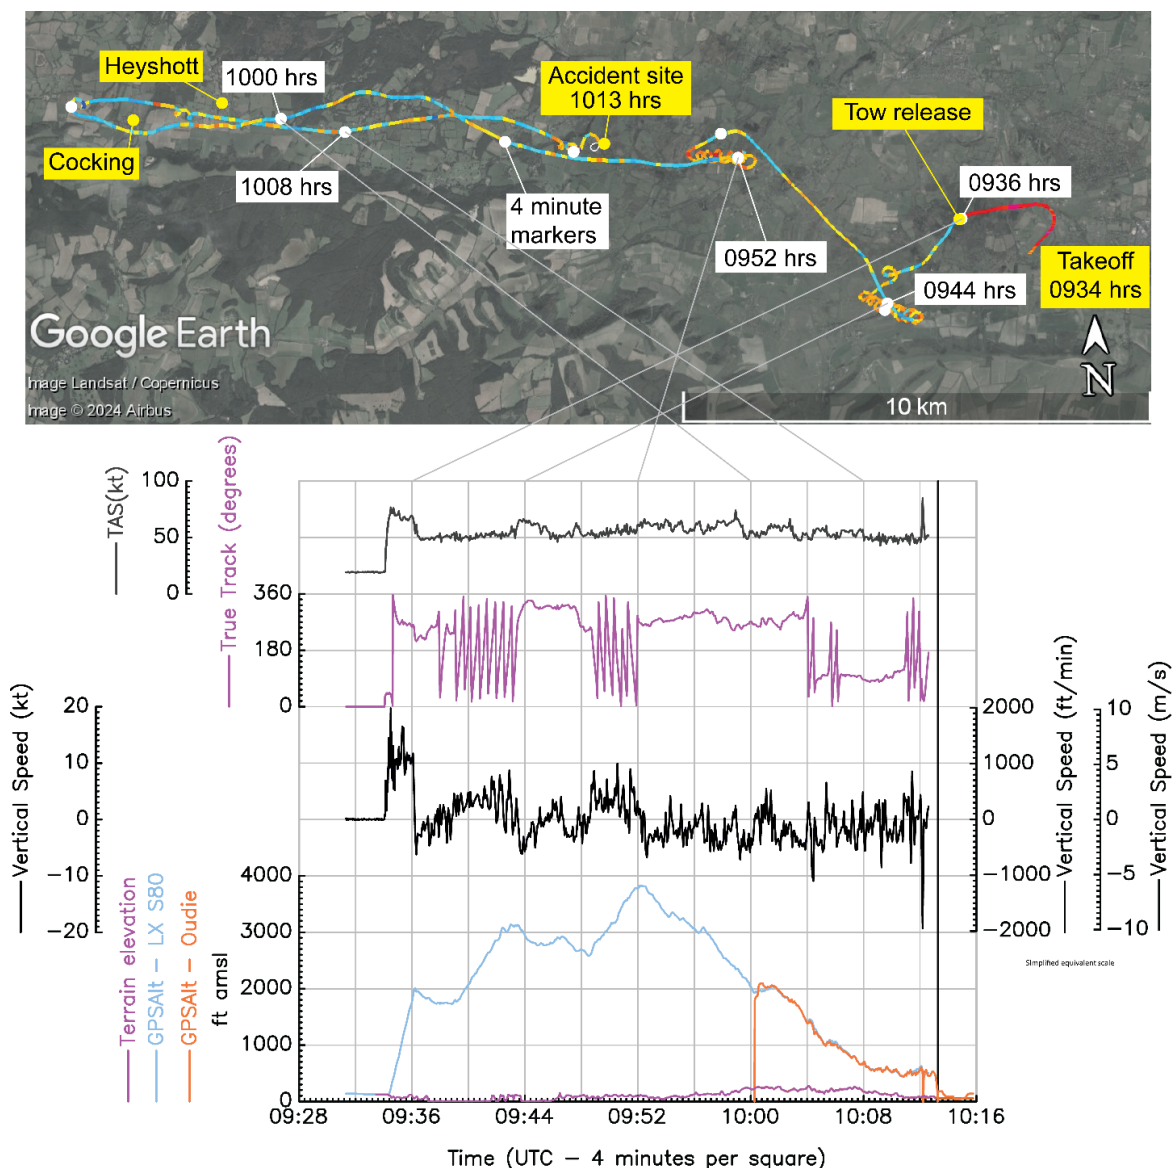
**Figure 1**

Flightpath of G-CFHG (colour coded to show climb and descent rate) and overview data plot

The top half of Figure 1 shows the flightpath of G-CFHG, coloured<sup>3</sup> to indicate the areas and degree of lift and sink<sup>4</sup> the pilot encountered. The bottom plot shows the various other parameters for the flight. The pilot launched using an aerotow at 0934 hrs. After being released from the aerotow at about 2,000 ft amsl, he then tracked south-west before entering a thermal. The pilot completed eight orbits to stay within the rising airflow, climbing from approximately 1,700 ft amsl to about 3,100 ft amsl. He then tracked north-west for about 4 minutes before entering a second thermal at about 2,600 ft amsl. The aircraft climbed to

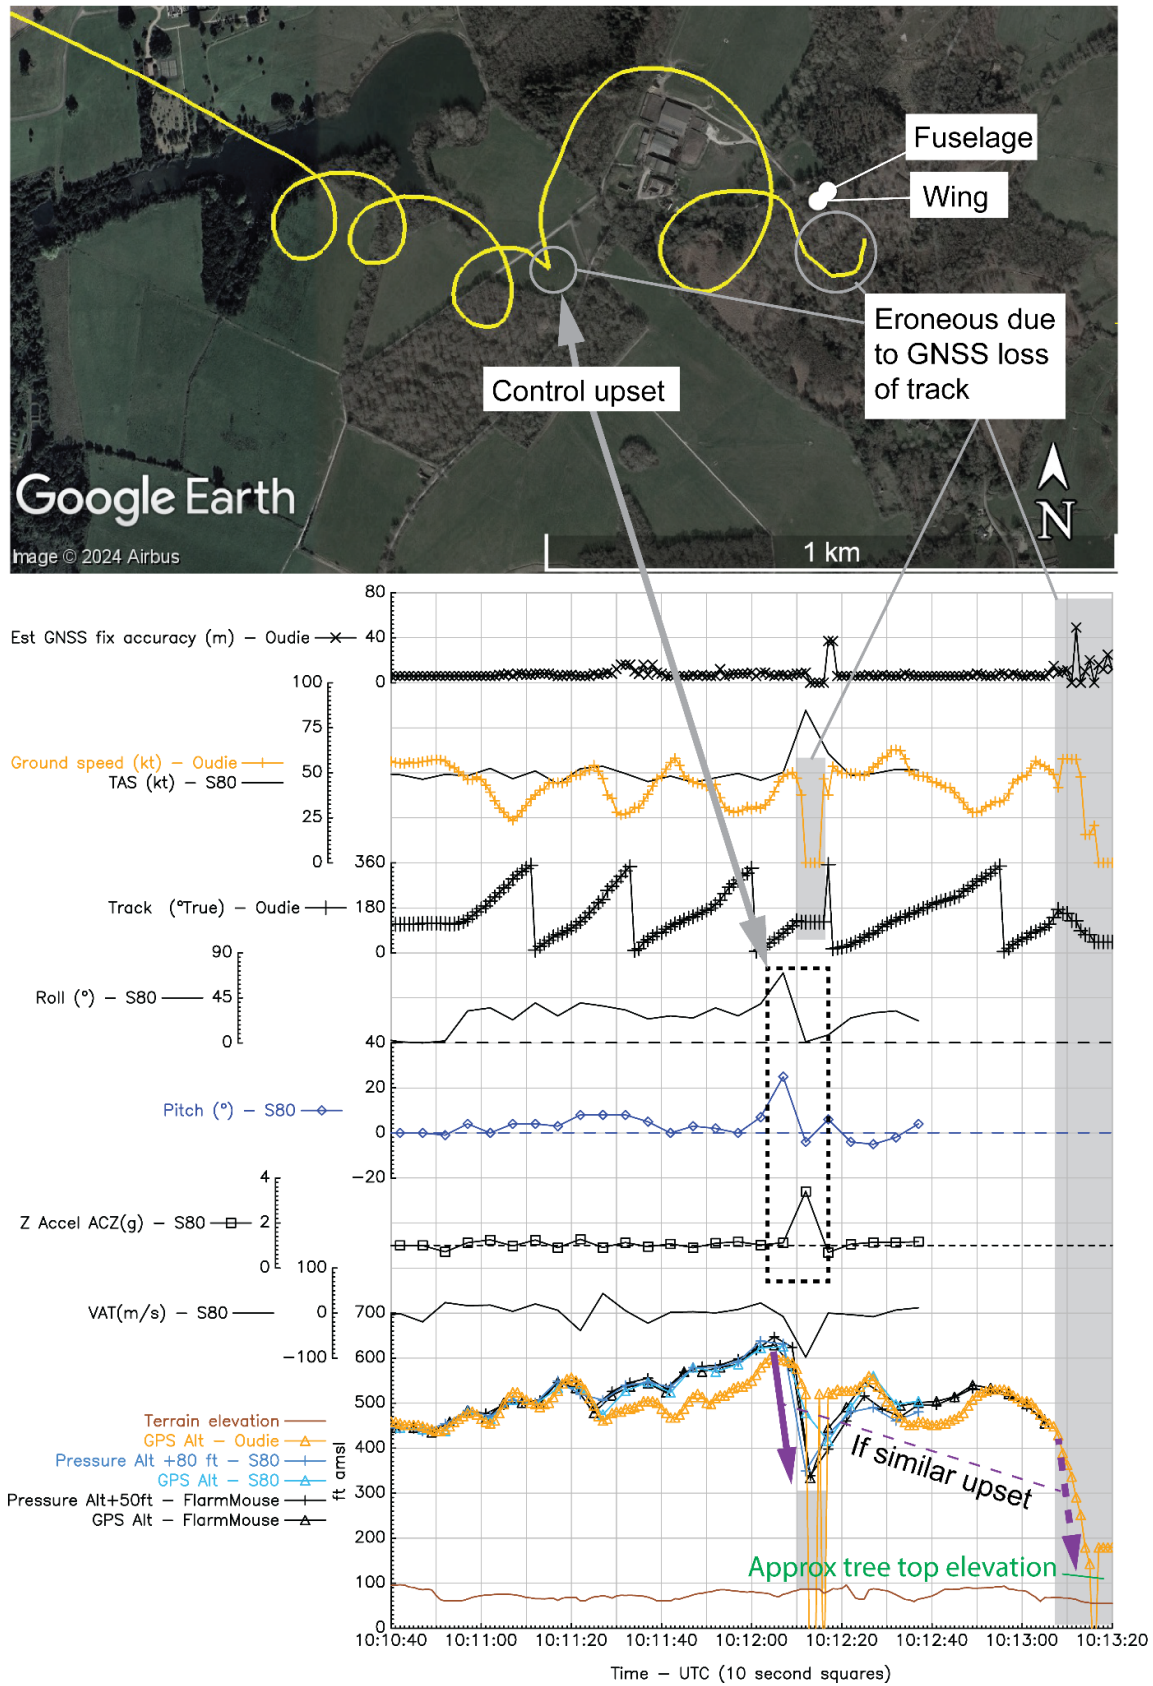
Figure 2

In the final phase of the flight, a sequence of turns was initiated at a height of 400 ft agl. After completing three turns, having gained approximately 200 ft in altitude, the data indicates a dynamic event occurred. Maximum values of 25° pitch and 70° right roll were recorded. However, the pitch and roll parameters were only sampled once every 5 seconds. As such, it was not possible to identify the relative sequence of these parameters nor is it likely that these were the absolute peak values achieved. The pressure altitude parameters recorded a drop of approximately 280 ft in four seconds, though again sample rate limitations indicate it's likely more altitude was lost. The next recorded value of TAS showed an increase from the initial 50 KTAS prior to the event to 85 KTAS. The recorded GNSS data was erratic, indicating the system had lost track of the satellite signals required to accurately calculate its location. This can typically be due to masking of the antenna when the fuselage reaches an extreme attitude. Prior to the dynamic event the glider was in a right orbit, afterwards the flightpath had abruptly changed to the left, which was inconsistent with normal flight manoeuvres. A high normal acceleration was also recorded, likely during an exchange of speed for height during the upset recovery.

The recovery manoeuvre from the event was followed by the glider flying a wide right hand turn that then tightened. There was no recorded pitch or roll data for this final turn but soon after the glider track passed through an easterly heading, the recorded GNSS track became erratic once more. The GNSS fix accuracy parameter, though not always a robust indicator of a problem, started degrading at 1013:07 hrs with the aircraft below 400 ft agl and descending (as recorded by the FlarmMouse pressure altitude). This was followed by anomalous GNSS data, a sign of the system having trouble fixing the aircraft location, again associated with dynamic manoeuvres such as the one experienced a minute earlier.

Flightpath of the end of the flight and associated data plot

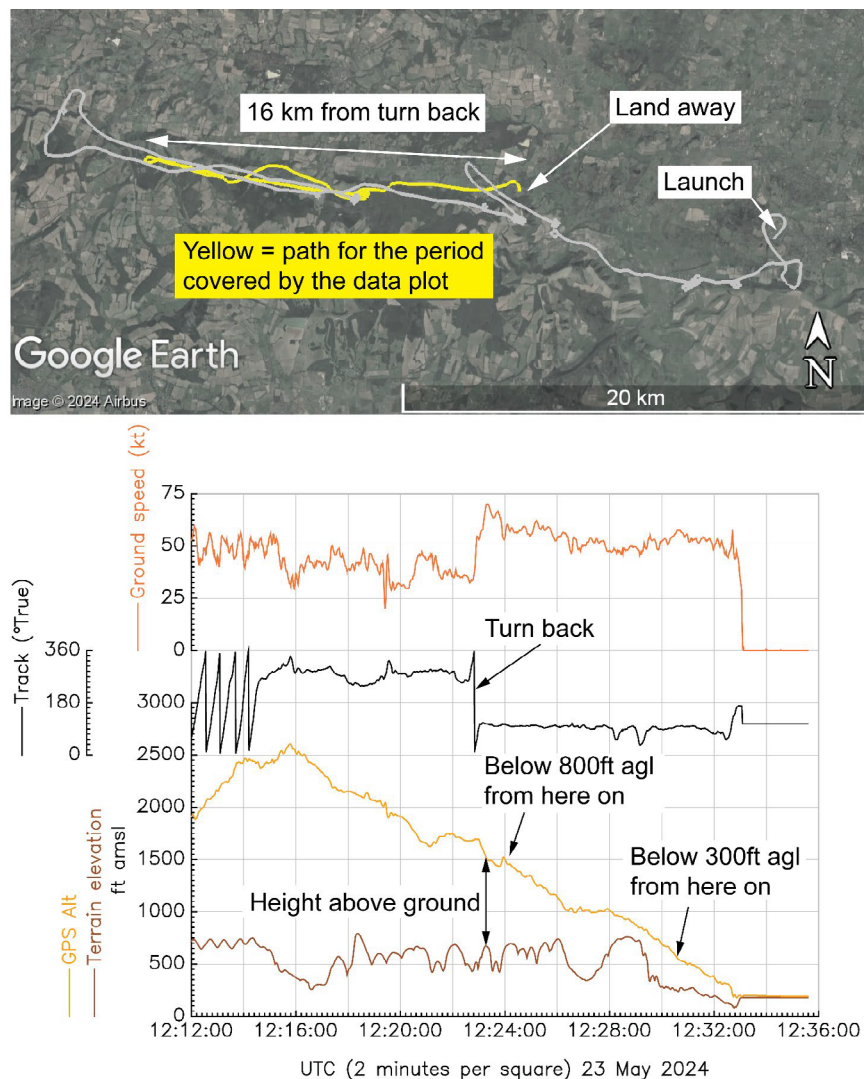
The data recovered for a flight on 23 May 2024, involved a landing away from an airfield. This is shown in Figure 3. The flight profile prior to the landing has similarities to the accident flight profile prior to the upset events. The final phase of the flight from the last time the glider gained height in a thermal is highlighted in yellow. This is the sequence shown in detail in the data plot below.

**Figure 3**  
Previous land away flight (23 May 2024) and associated data plot

The final descent was from a height of more than 2,000 ft agl whilst heading in a westerly direction. At just above 1,000 ft agl, an orbit was flown and then an easterly flightpath back towards the launch site. Descending through approximately 150 ft agl, the glider turned south and landed in a field. The field was approximately 2 km west of the accident site.
