Grounding and subsequent loss of the prawn trawler *Sustain* (UL 45) on Rubha Camas a' Mhaoraich, Loch Broom, Scotland on 16 November 2023

SUMMARY

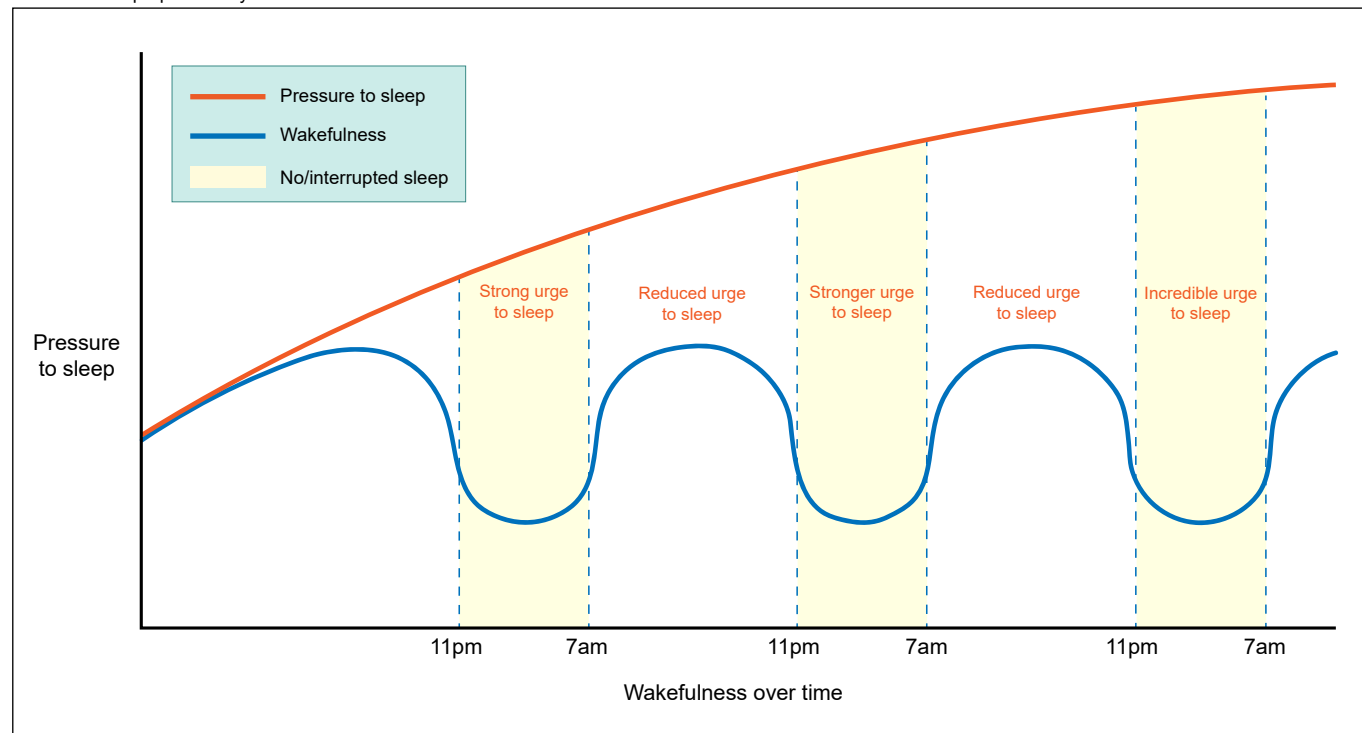
Figure 4: Pressure to sleep versus wakefulness illustration

Two unused opportunities for additional rest during the morning and afternoon tows meant 7 hours of sleep were potentially missed when the skipper decided to carry on working. This was likely due to the body's natural circadian cycle¹⁰ and the skipper being mindful that the crew also needed to rest having started earlier than usual that morning. The circadian cycle produces a peak in alertness towards midday (**Figure 4**), which coincided with the start of the second tow.
