**Accident**

| <b>Aircraft Type and Registration:</b> | Grob G109B, G-CHYB | |
| <b>Date &amp; Time (UTC):</b> | 27 August 2024 at 1545 hrs | |
| <b>Location:</b> | A419 near Aston Down Airfield, Gloucestershire | |

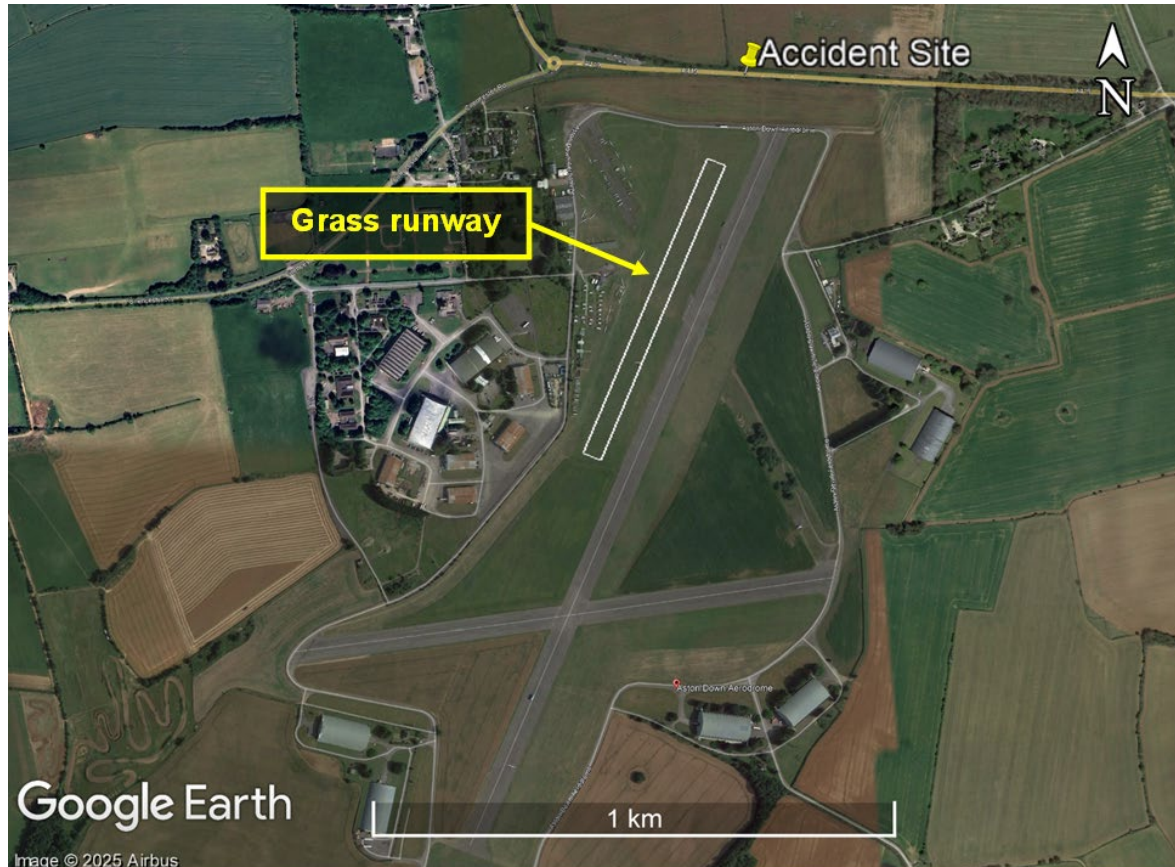
**Figure 1**

The accident occurred during a final approach to the grass runway parallel to and west of tarmac Runway 21 at Aston Down (Figure 1).

Aston Down Airfield

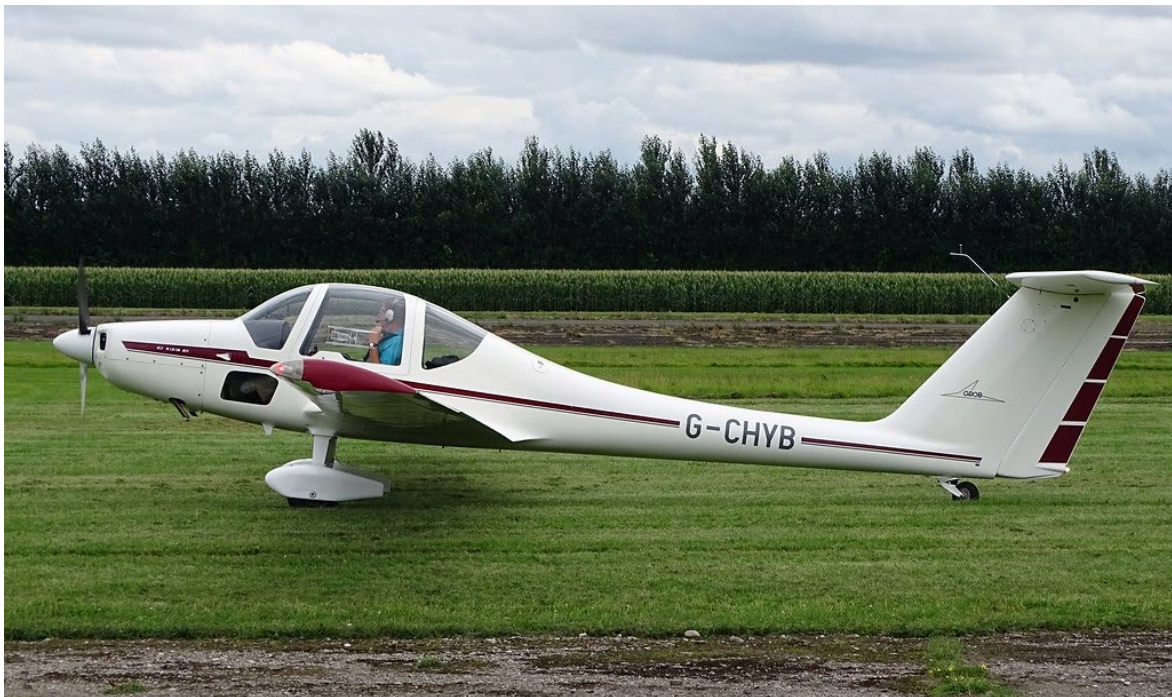
**Figure 4**

The Grob 109B is a 2-seat side-by-side low wing touring motor glider (Figure 4).

Grob 109B
