**Accident**

| <b>Aircraft Type and Registration:</b> | Guimbal Cabri G2, G-FICH | |
| <b>Location:</b> | Leicester Airport | |

**Synopsis**

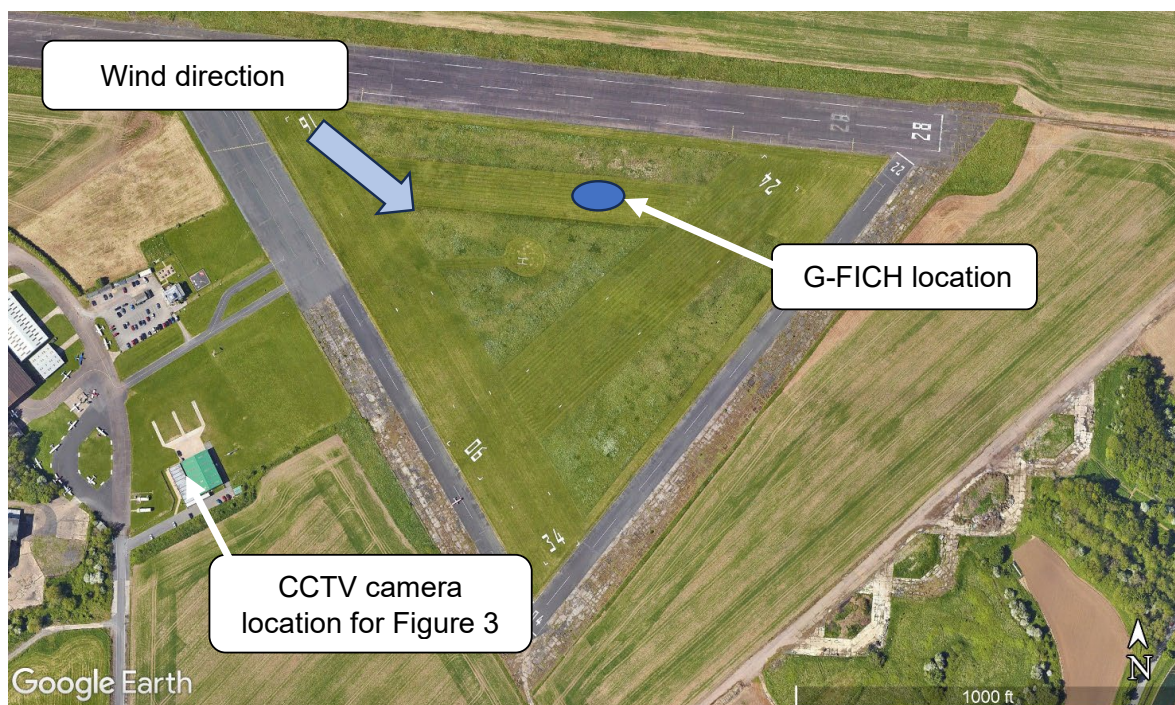
**Figure 2**

CCTV footage of the airport was provided which captured the accident sequence. The helicopter was located to the south of the paved runway (Figure 2).

Leicester Airport with approximate helicopter location and Figure 3 camera location
