AAIB Bulletin

8/2025

Piper PA-23-250	G-BKJW	6-Jul-23	3
-----------------	--------	----------	---

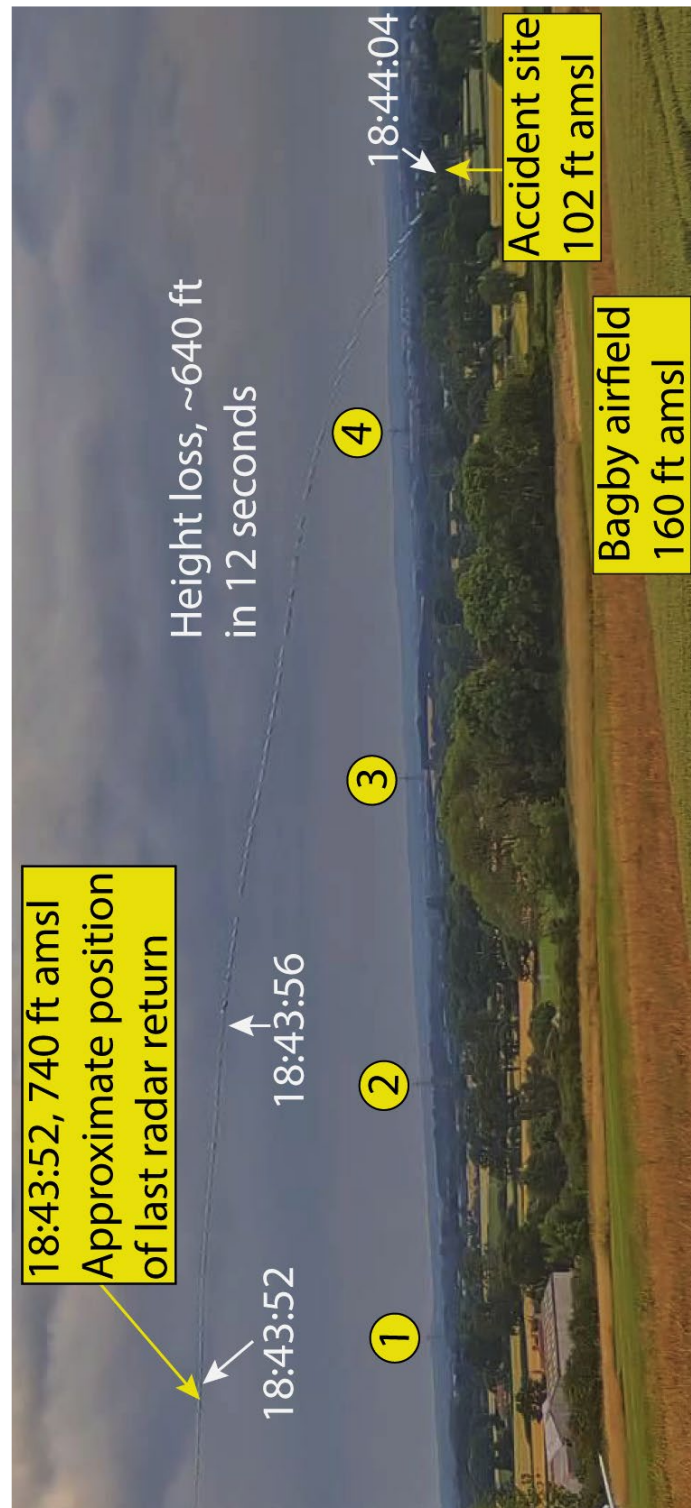
Figure 4

Composite CCTV image of G-BKJW descent into terrain

Several electricity pylons are visible in this image, numbered 1 through 4, and G-BKJW's groundspeed was calculated by timing the passage of the aircraft between these points, using an assumed ground path for G-BKJW between the position of the last radar return and the accident site. These calculations resulted in an estimate for G-BKJW groundspeed of approximately 122 kt, although the associated error in these calculations may be as much as ± 18 kt. With the reported 10 kt wind from the south, G-BKJW's airspeed would have been approximately 112 kt ± 18 kt. A close-up of the aircraft's final descent is shown in Figure 5.

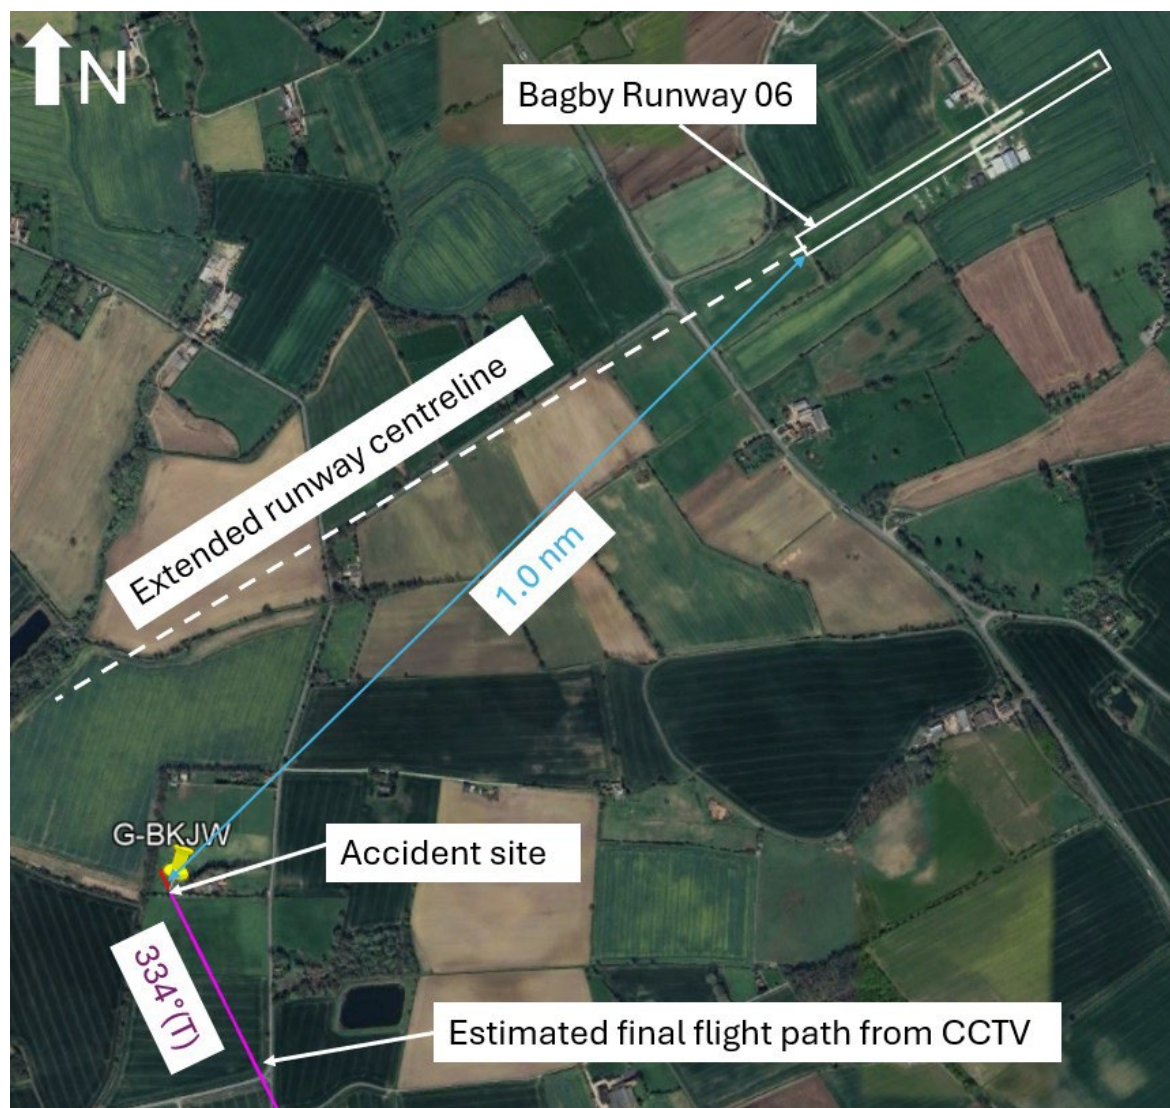
Figure 6

The accident site was located 1.0 nm south-west of the Runway 06 threshold at Bagby airfield (Figure 6). The site revealed that the aircraft had struck trees in a steep nose-down attitude before hitting the ground and catching fire, consistent with the CCTV video. The direction of travel from the trees to the ground and the aircraft fuselage remains was in a line of about $335^\circ(\text{T})$ (Figure 7). There was no indication of aircraft roll or yaw at impact. Both engines had created similar impact craters, and their location indicated a flight path of about 35° to 40° nose-down from tree impact to ground impact. The wreckage spread was about 47 m and the pilot's body was found 34 m beyond the remains of the fuselage. The wreckage was extensively damaged by fire, but the aircraft's tail section was relatively intact (Figure 8). The horizontal stabilator was free to move and its control cables were connected. The stabilator pitch trim drum was found in a nearly full nose-down trim position. The pre-impact flap and landing gear positions could not be determined.

Accident site location relative to runway at Bagby airfield

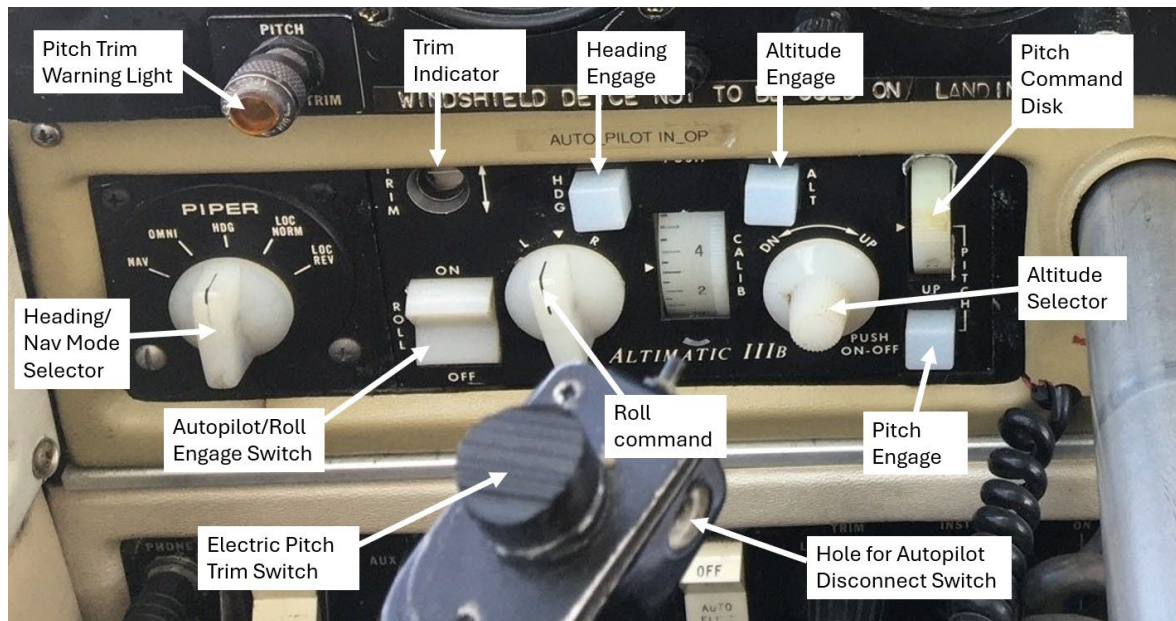
**Figure 12**

The aircraft was equipped with a Piper Altimatic IIIB autopilot system that was placarded inoperative but known to have some functionality. The build record for G-BKJW revealed that this system had been fitted at original manufacture. It was an analogue autopilot system that had three servos to control the ailerons, the stabilator and the pitch trim tab respectively. Its control console was fitted to the lower instrument panel on the pilot's left side (Figures 11 and 12). The autopilot was turned on by pressing the Autopilot/Roll engage switch. This would engage the autopilot in roll mode which could then maintain a selected bank angle or be used to track a heading after pressing the heading engage button. The pitch mode was engaged using a separate Pitch Engage button. Prior to engaging the pitch mode it was important to centre the trim indicator using the Pitch Command Disk. If this was not done the aircraft would pitch up or down upon pitch mode engagement. Once the pitch mode was engaged the Pitch Command Disk could be used to select a desired pitch angle up to 8° nose-up or 6° nose-down, or the Altitude Selector could be used to select a desired altitude. The autopilot was disengaged by either pressing the Autopilot/Roll Engage switch OFF, or by pressing the autopilot disconnect switch on the control yoke; however, the yoke mounted disconnect switch was not fitted on G-BKJW – there was an empty hole for it (Figure 12).

Altimatic IIIB Autopilot Console fitted to G-BKJW

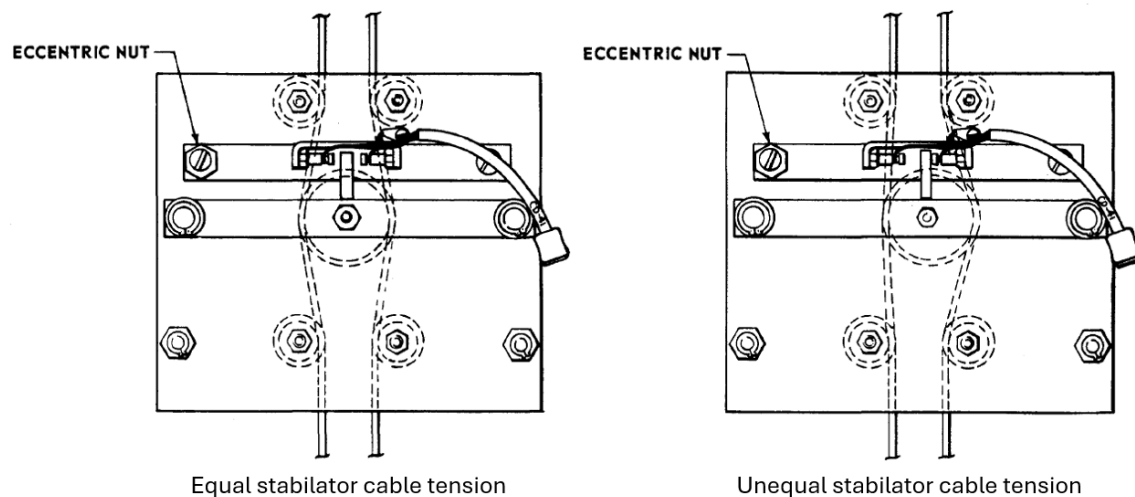
Figure 14
Pitch trim sensor (© Piper Aircraft)

A single fault in the pitch trim sensor, for example the sensor sticking to one side, could cause a pitch trim runaway.

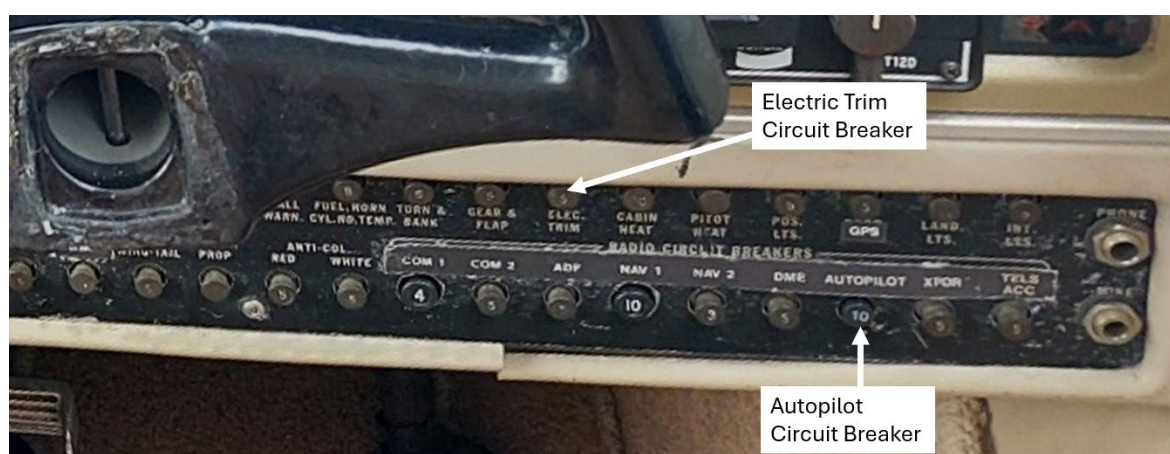
The circuit breaker panel was located on the lower right side of the instrument panel, beneath the right control yoke. Figure 15 shows a pre-accident photo of the circuit breaker panel on G-BKJW, with the location of the electric trim and autopilot circuit breakers highlighted. The maintenance organisation stated that the circuit breakers had been re-labelled during the aircraft's annual inspection with black text on yellow tape to make them clearer, but no photos of this change were available. The circuit breakers automatically open when an overload occurs on the electrical circuit it protects. The circuit breakers can also be manually pulled out to isolate a circuit and manually pushed in to reset it.

Location of electric trim and autopilot circuit breakers (G-BKJW pre-accident photo)

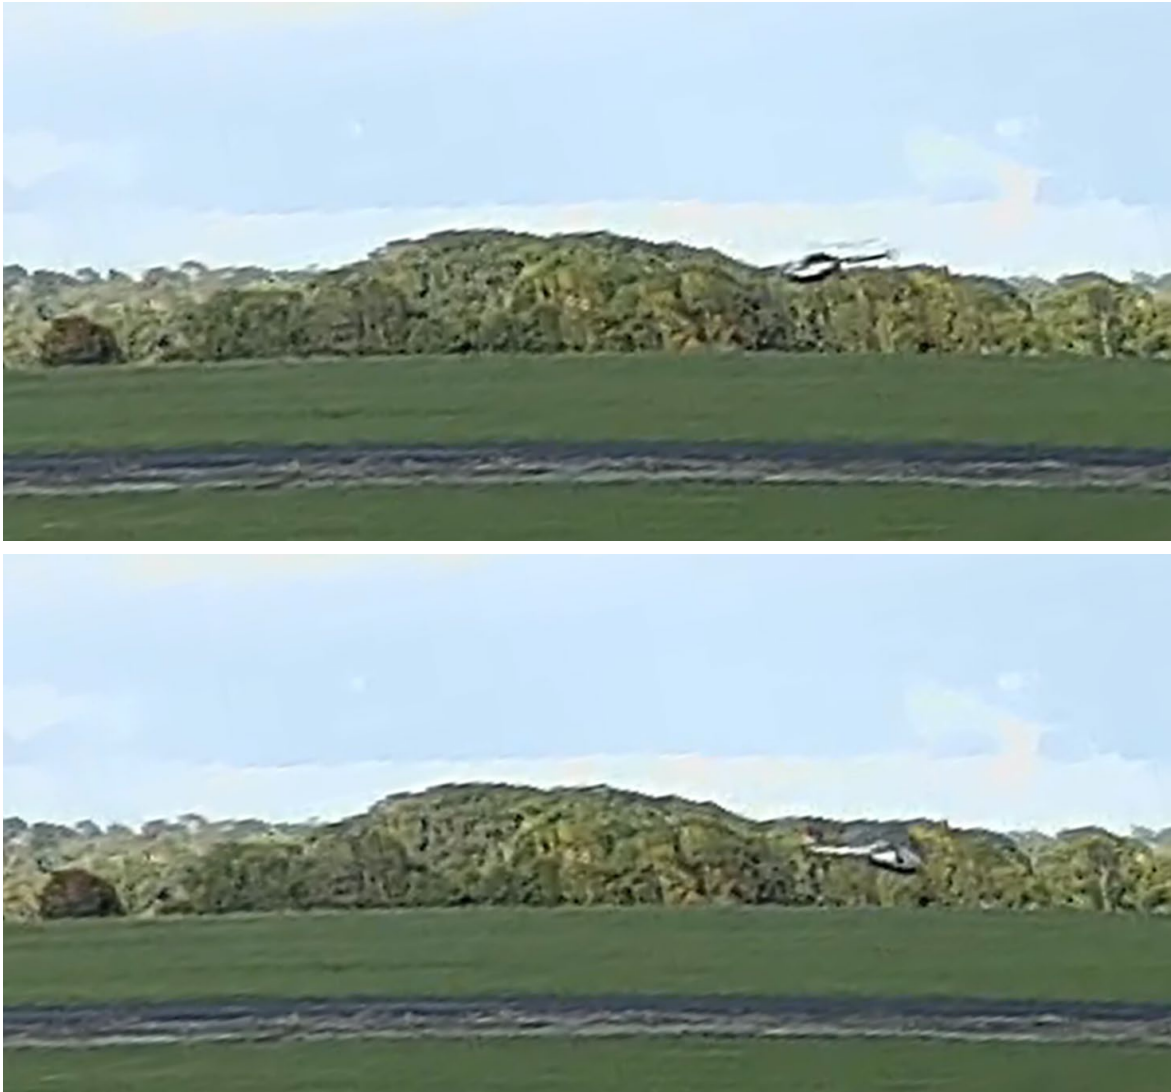
The CCTV showed G-FICH moving forward very slowly as it was brought to a hover approximately into wind. It then yawed rapidly to the left and continued yawing, roughly level in pitch and height for the first rotation. The second rotation saw G-FICH descend closer to the ground, but the helicopter climbed vertically during the third rotation which would likely have been the result of an increase in the collective. The fourth rotation saw G-FICH descend before contact with the ground initially with the rear of the skids and the tail.

Two still images from the CCTV are shown in Figure 3 showing one of the turns to the left prior to striking the ground.

CCTV still images from Leicester Airport

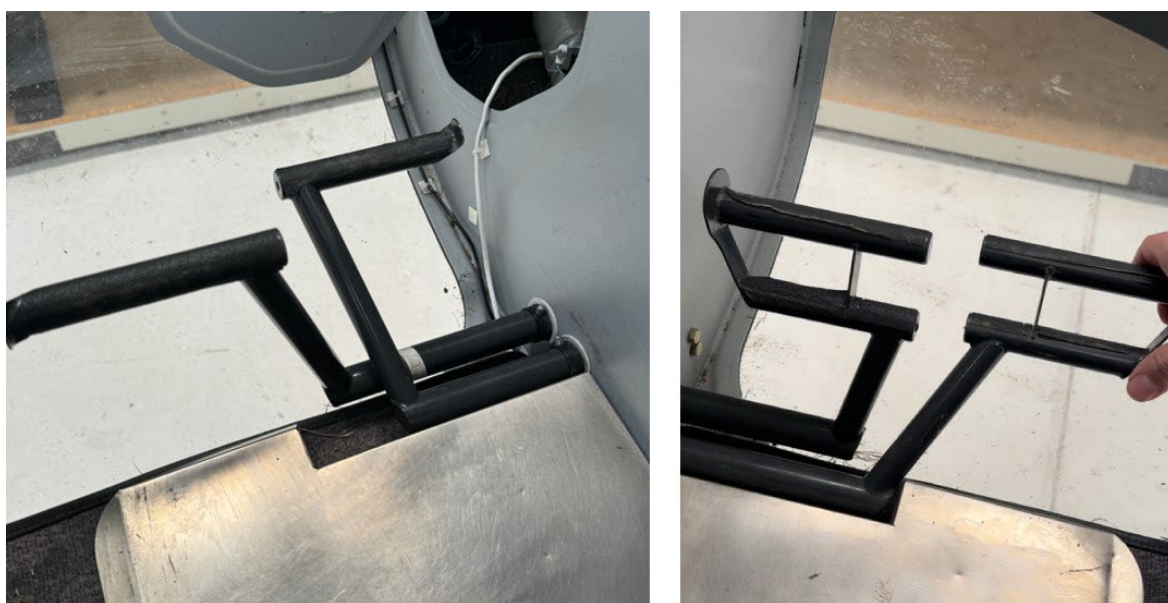
Figure 4

the pedals and seat by 80 mm, by pivoting the top of the pedal aft (Figure 4). The left side had the standard non-adjustable pedals.

The manufacturer initially fitted the helicopter type with non-adjustable pedals on both sides¹, but in 2011 (from Serial Number 1024 onwards) it moved to fitting adjustable pedals on the right side as standard. The adjustable pedals were available for the left side as a factory-fit option or as a more expensive retrofit-option. As a result of the findings of this investigation, the manufacturer plans to install adjustable pedals on the left side as a standard fit on new models.

Left side fixed pedals (left image) and right side adjustable pedals (right image)
on G-FICH
