Report on the investigation of
a serious injury to a passenger on the sea safari rigid
inflatable boat

Lundy Explorer

at Ilfracombe, England

on 7 June 2023

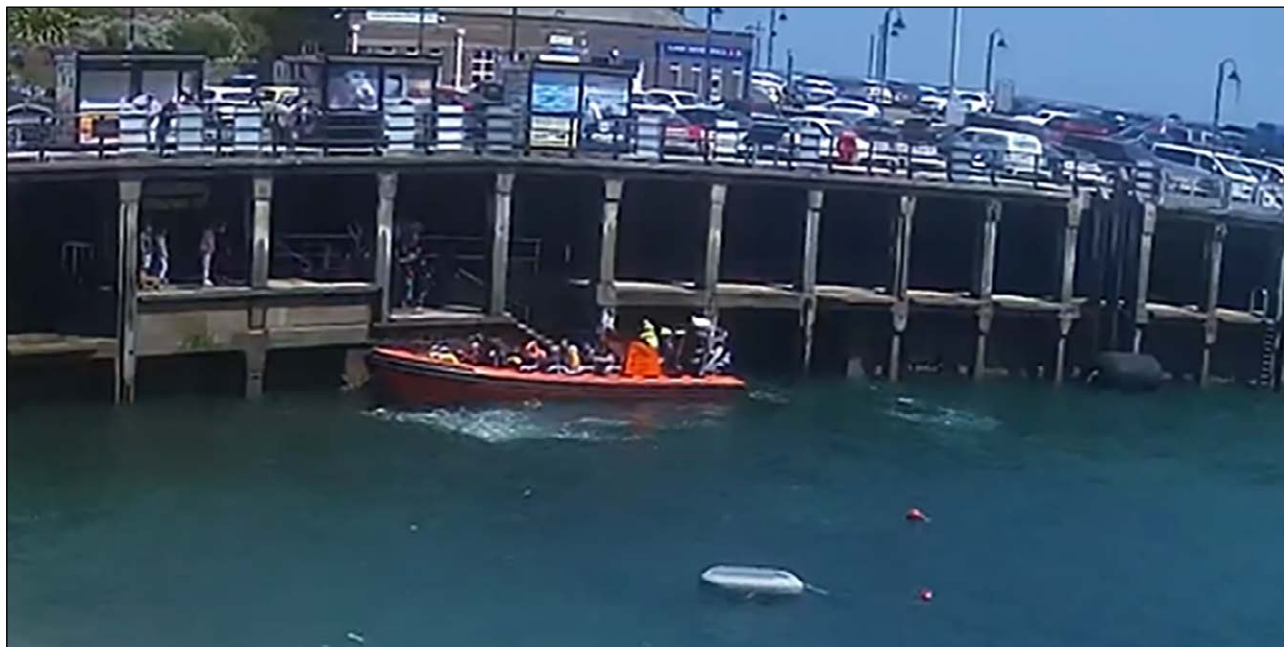
At 1201 on 7 June 2023, the 11m rigid inflatable boat (RIB) *Lundy Explorer* berthed alongside the pier at Ilfracombe Harbour, Devon, England to disembark passengers after a 2-hour trip (**Figure 1**). Waiting at the pier landing stages were the owner of the RIB company and 12 new passengers who had booked a 1-hour trip to see wildlife along the coast.

Figure 1: *Lundy Explorer* at pier landing stages about to disembark passengers

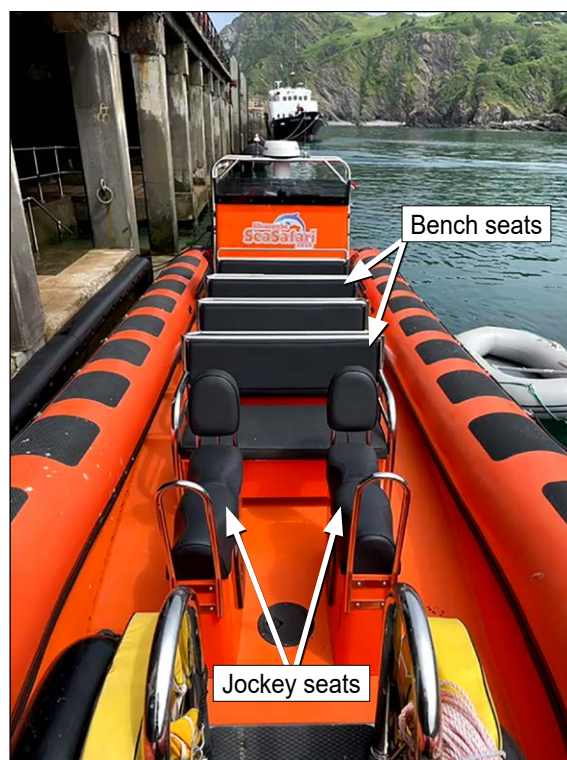
Once the passengers had disembarked, one of the company's owners guided the next group of 12 adult passengers and one dog on board. The first two passengers initially sat on a bench seat but were told by the deckhand to fill the RIB's seats from forward. The passengers went forward and sat together on the port jockey seat. The deckhand advised that they could each sit on a jockey seat so one passenger sat on the port side and the other on the starboard side (**Figure 2**). The remaining passengers sat on the bench seats. Once all were on board, the deckhand gave a safety briefing and instructed the passengers on how to wear the personal flotation devices provided and what actions to take in an emergency. The passengers were also advised to hold on as the conditions would be bumpy in the harbour entrance, but would improve once the RIB was clear of the harbour.

Figure 2: *Lundy Explorer* seating arrangement

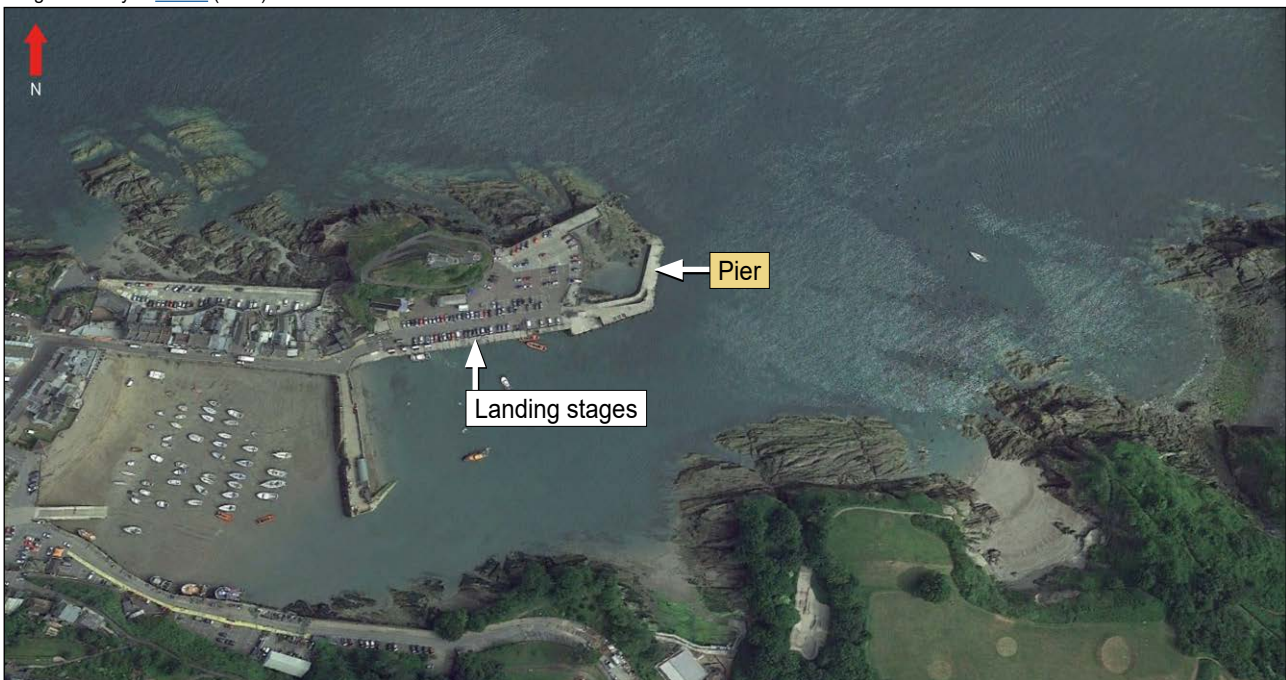
At 1205, *Lundy Explorer* departed and met *Voyager*, another of the company's RIBs that had developed an engine fault minutes earlier and was waiting in the harbour. *Lundy Explorer* went alongside *Voyager* and the two skippers swapped RIBs. At 1209, *Lundy Explorer* headed out of the harbour (**Figure 3**) at about 4 knots (kts).

Figure 3: Ilfracombe Harbour

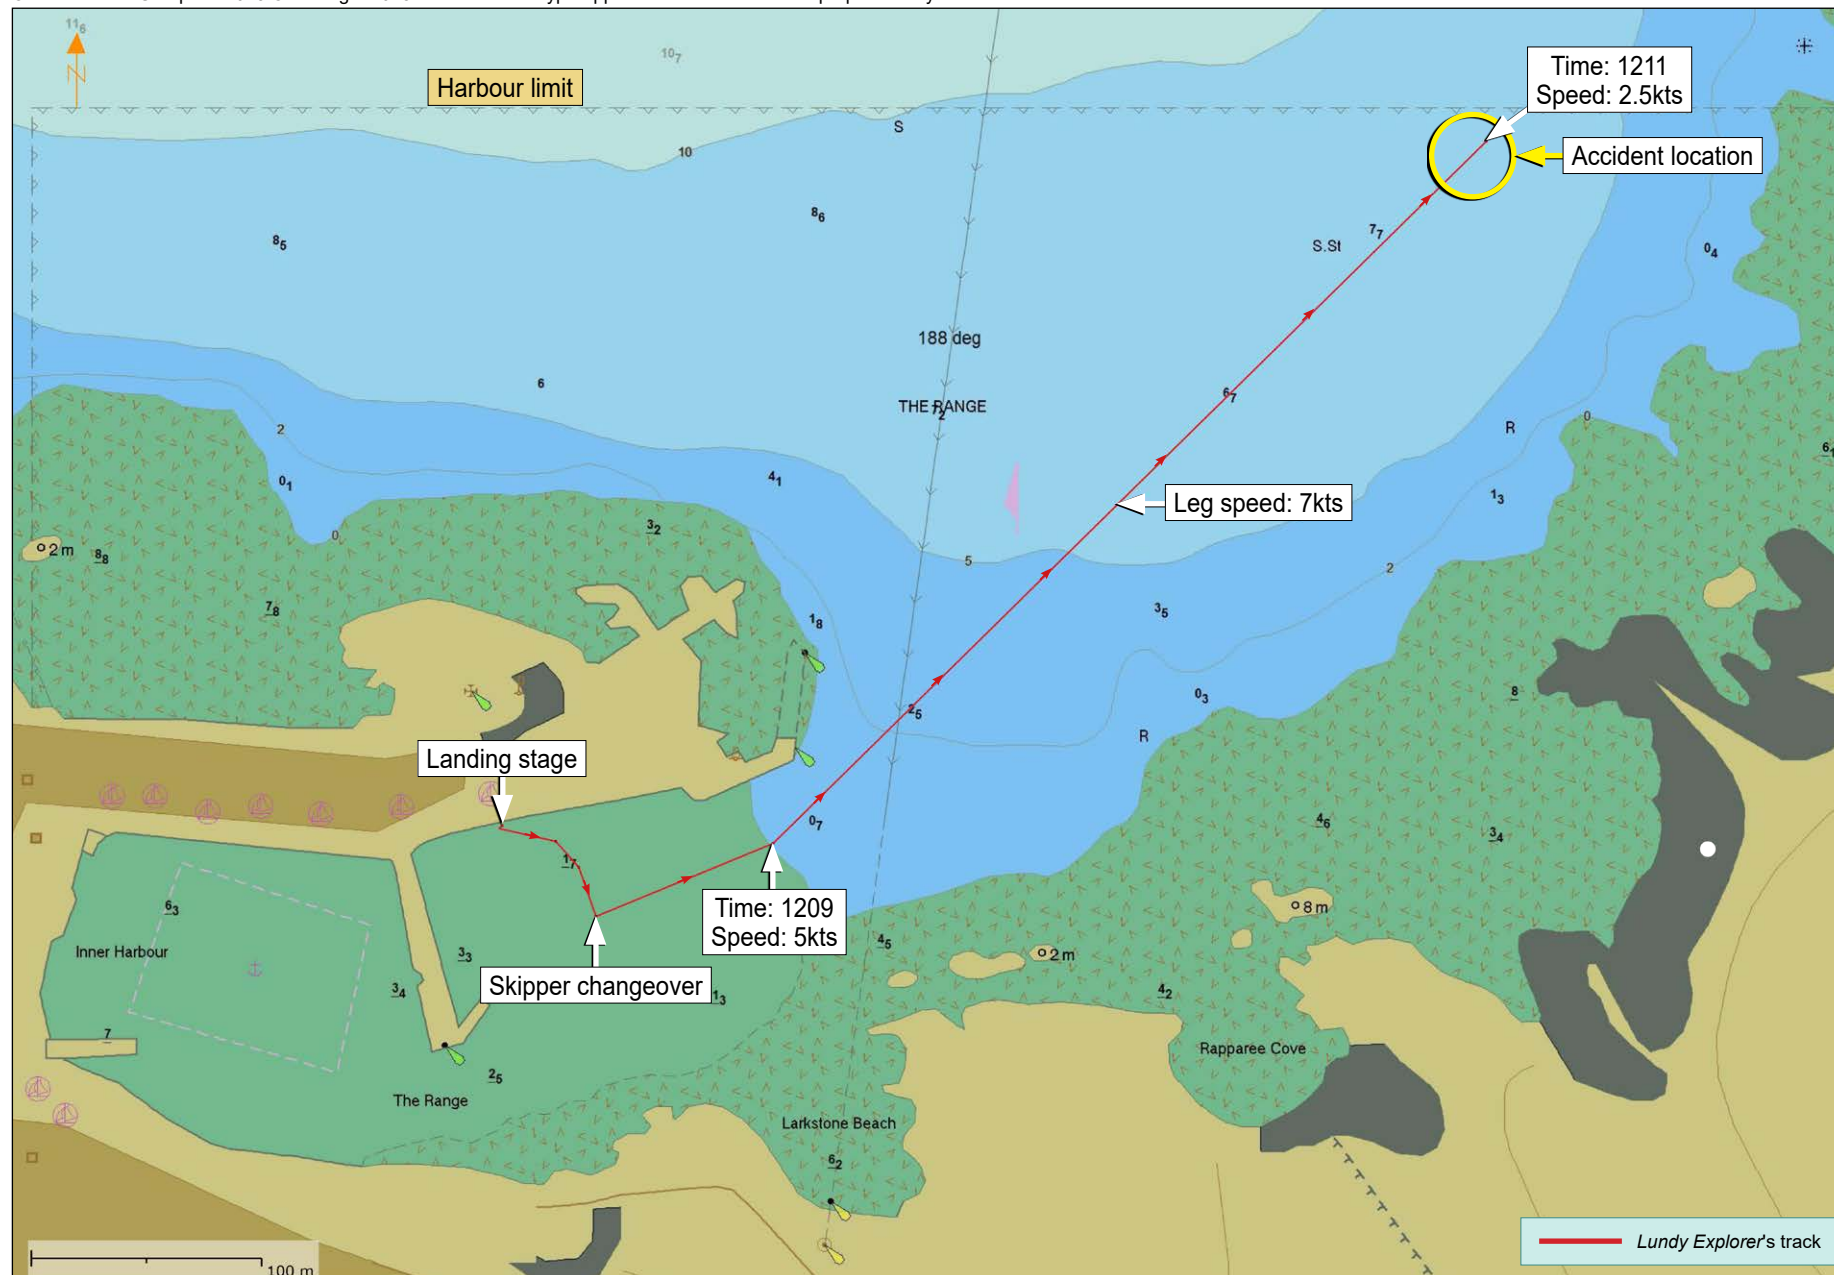
The heights of the waves increased, and the RIB's pitching worsened as *Lundy Explorer* headed north-east (**Figure 5**). The skipper, who was surprised at the height of the waves, adjusted the RIB's speed to minimise pitching and attempt to keep the passengers dry. Some of the passengers became anxious as *Lundy Explorer* pitched more intensely. Anticipating calmer waters beyond the harbour, the skipper shouted that the passengers should make it known if they wanted to go faster.

Figure 5: Lundy Explorer's position and general track rounding the pier to the accident location

Lundy Explorer's on board equipment recorded that the RIB was making an average speed over the ground of approximately 7kts between 1209 and 1211, just before the accident (see **Figure 5**).
