Fatal man overboard from the fishing vessel *Kingfisher* (DH 110) approximately 30 nautical miles east-north-east of Wick, Scotland on 12 July 2024

SUMMARY

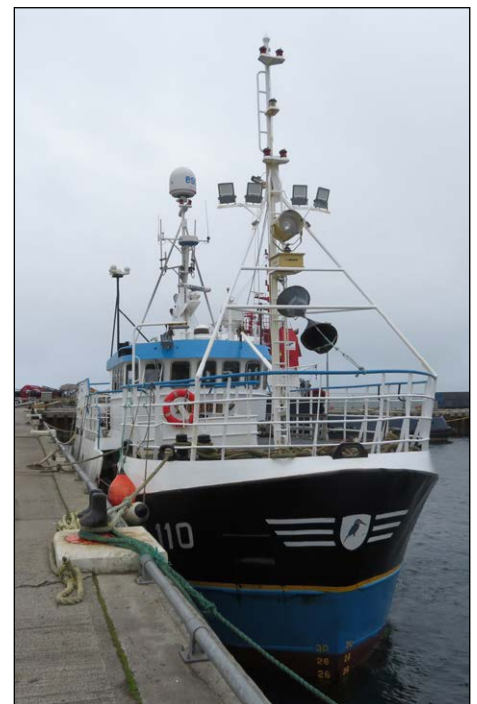
Figure 1: *Kingfisher*

On the afternoon of 12 July 2024, the crew of the UK registered fishing vessel *Kingfisher* (**Figure 1**) were manually shooting a string of creels when a deckhand became attached to a creel's leg rope and was pulled overboard. The deckhand's personal flotation device automatically inflated but he was pulled underwater by the sinking creels. Using the hauling winch, *Kingfisher*'s crew retrieved the back rope and recovered the now submerged deckhand on board. Despite the efforts of the vessel's crew, rescue services and crew members from a nearby vessel, the deckhand could not be revived.
