Report on the investigation of
the fire and subsequent loss of power on board the
Finland registered roll-on/roll-off cargo ship

Finnmaster

at King George Dock, Hull, England

REPORT NO 13/2025

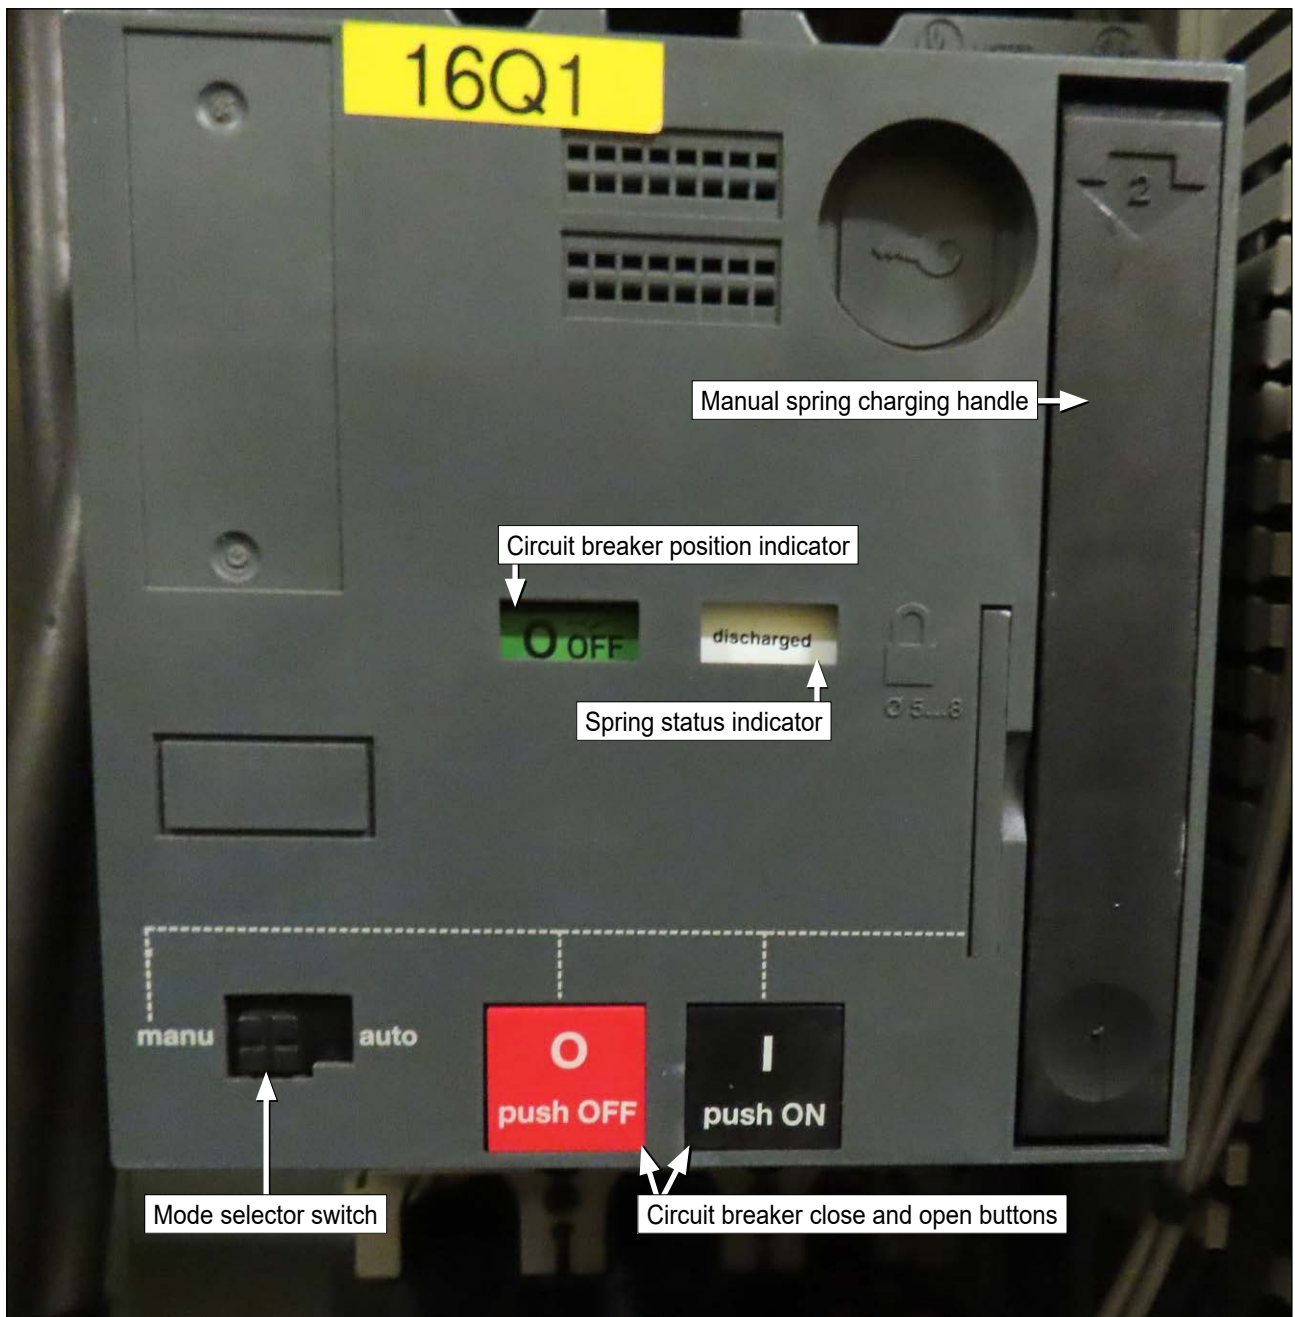
Figure 5: Emergency diesel generator circuit breaker motor mechanism front panel

On arrival at the emergency generator room the 2/E found that the EDG was running but its circuit breaker had not closed to connect the generator to the emergency switchboard. The 2/E tried to close the circuit breaker manually by using the push button on its front panel, but it did not operate. The EDG cooling water temperature was high and the cooling fan was not operating so the 2/E stopped the engine manually and left to inform the C/E of the problem with the circuit breaker.

The circuit breaker motor module allowed either automatic or manual operation of the EDG circuit breaker using a circuit breaker mode selector on the front of the motor module cover. In manual mode it was possible to compress a charging spring in the motor module using a ratchet lever and then open or close the circuit breaker using push buttons on the front of the unit. During the emergency on *Finnmaster* the mode selector switch was set to automatic. In later attempts to close the circuit breaker, the crew set the mode selector switch to manual (**Figure 5**). In automatic mode, the motor module charging spring was compressed by the action of a 220VAC motor acting through a gear mechanism in the unit. The design criteria for the charging motor limited its operation to a maximum of four operations per minute.

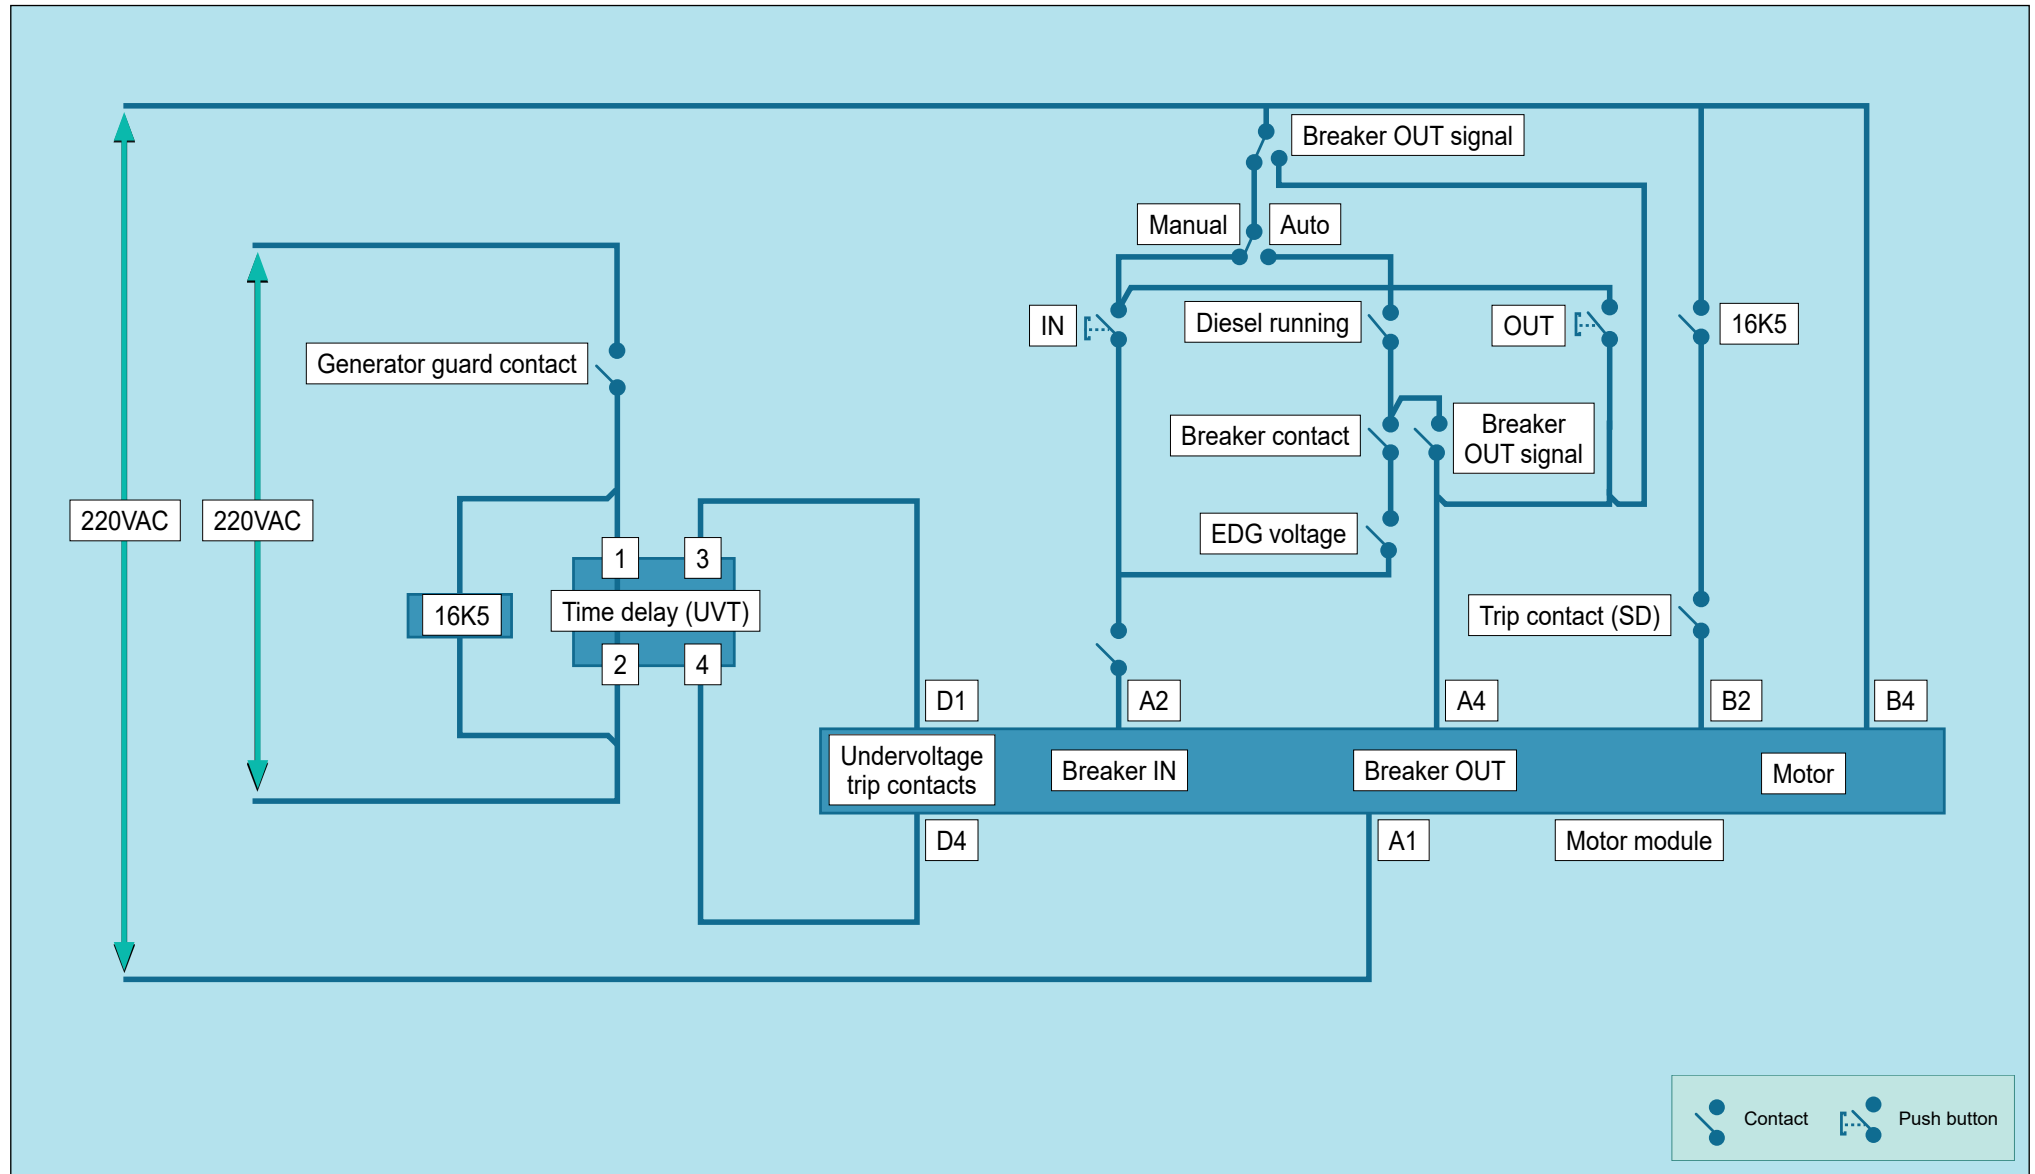
Figure 6: Emergency diesel generator circuit breaker motor mechanism control circuit

The EDG circuit breaker motor module control circuit diagram is shown in **Figure 6**. An undervoltage time delay unit (UVT) was installed to delay the opening of the circuit breaker¹⁰ and prevent nuisance tripping in the event of a transient voltage drop. A loss of power to the undervoltage trip contacts on the motor module would cause the circuit breaker to open.

⁷² Labelled as *Trip contact (SD)* in the **Figure 6** circuit diagram.

The control circuit schematic showed that when the motor mechanism was in auto mode, auto-rearming of the motor mechanism is selected, and the SD contact should be wired to close the rearming order. The NS400 was received with no SD contact to ensure this function. We cannot confirm if the contact was present or not.

1. An issue with the supply to the UVR coil is created due to UVR time delay connector soldering cracks. With no supply to the UVR coil, the switch then opens. Even though supply is lost to the UVR coil, relay 16K5 remains energised.

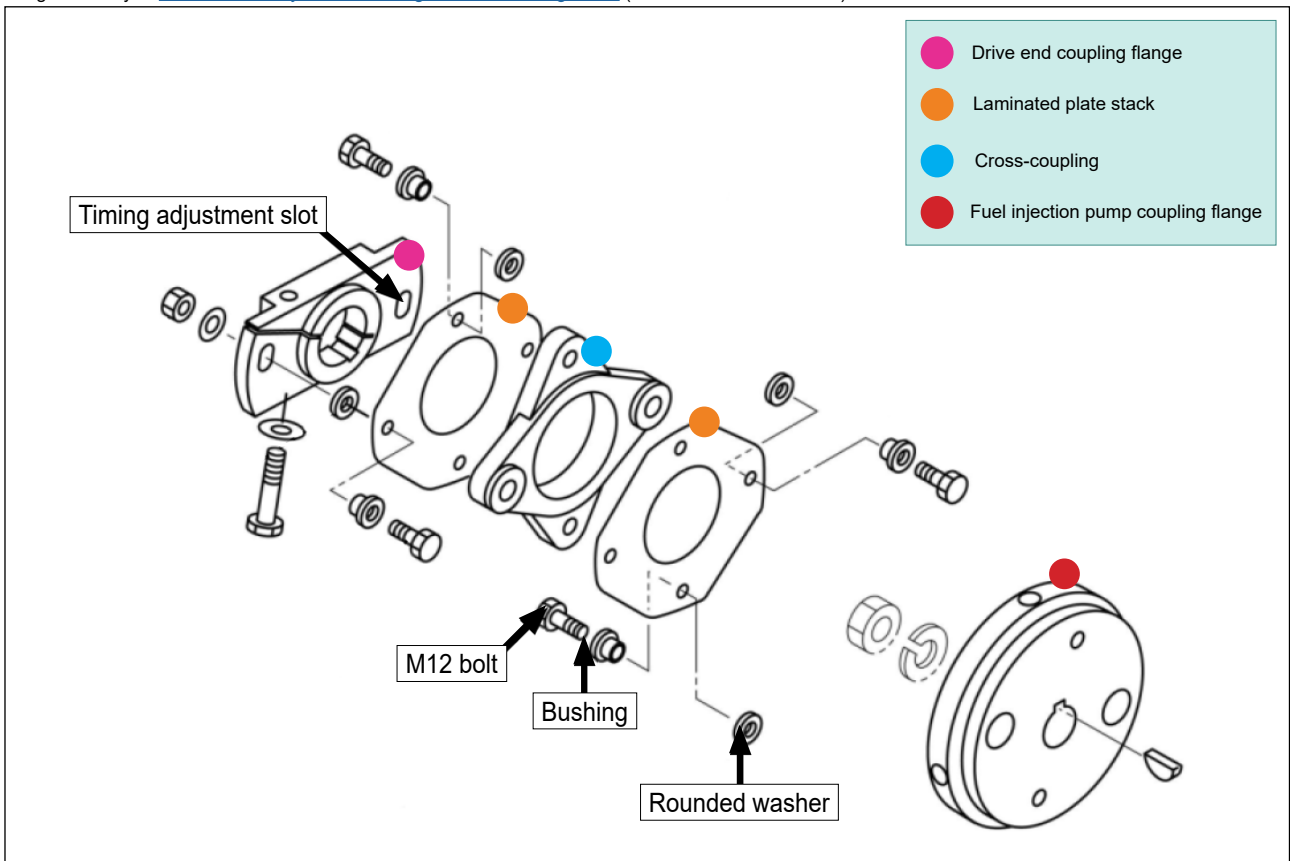
Figure 8: Fuel injection pump coupling

After the failure the rounded washers remained in place where the bolts passed through the laminated plates. The washers were oriented in line with the servicing instructions.

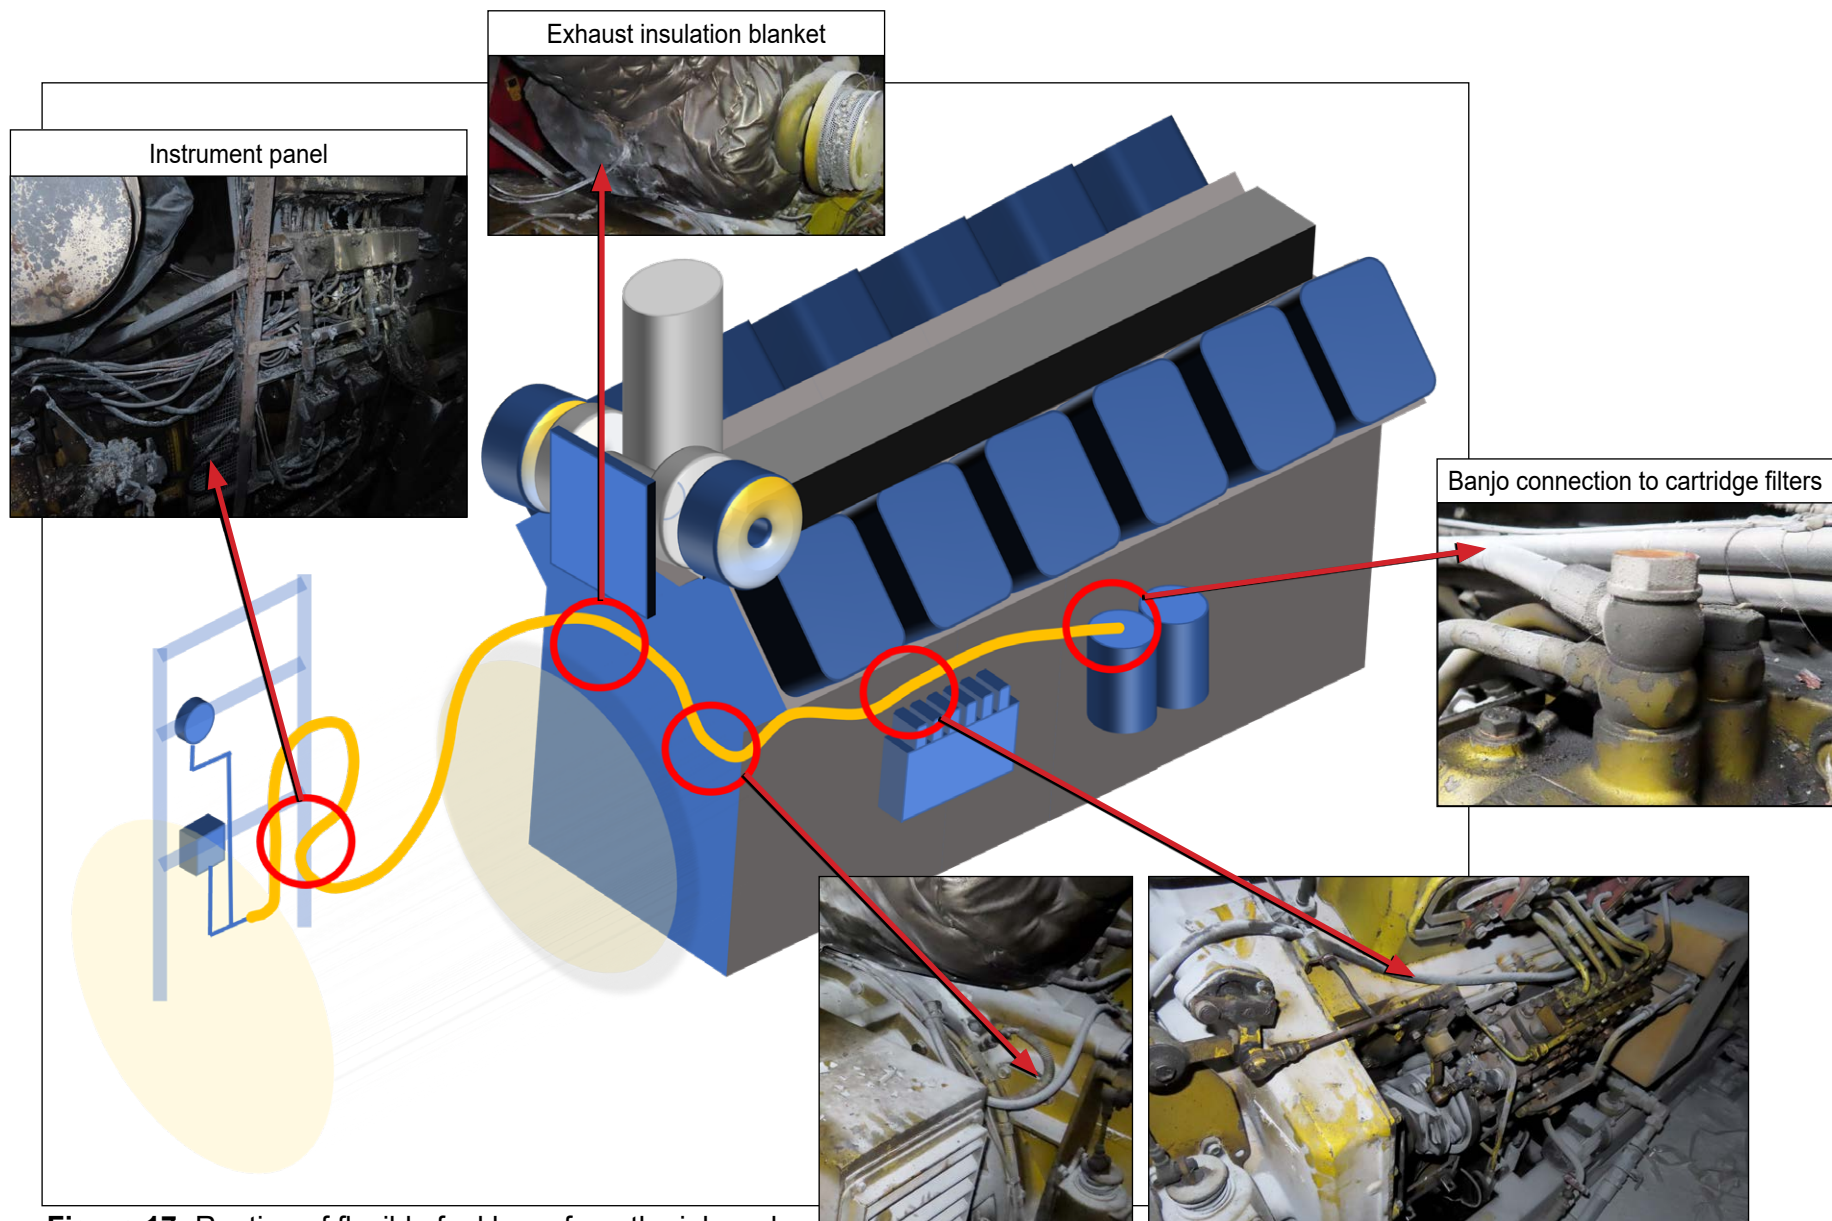
Figure 17: Routing of flexible fuel hose from the inboard cartridge filters to the AE2 local instrument panel

The 3.6m flexible fuel hose installed on AE2 from the inboard fuel cartridge filters was routed aft, over the top of the fuel injection pump and across the flywheel cover of the engine to the local instrument panel. The flexible hose passed below the exhaust insulation blankets fixed over the insulated box structure that covered the exhaust system at the aft end of the engine (**Figure 17**). The flexible hose was looped across the back of the frame around the local instrument panel and connected to a steel tee piece at the bottom of the frame. Steel pipes led from the tee piece connection and on through separate isolation valves to the pressure switch and pressure gauge. Plastic cable ties secured the length of the flexible fuel hose. The flexible hose passed over the flywheel cover at 1.08m above the level of the bottom of the daily service tank.

The rules also required means to be provided to *isolate flexible hoses used in systems for fuel oil*. The only valve in the instrumentation line was at the local instrument panel and served only to isolate the pressure gauge and pressure switch.

The banjo connection at the fuel cartridge filter outlet was an open connection without any means of closure. The flexible fuel hose remained under pressure at all times unless the engine in question was isolated as a whole from the main fuel supply.

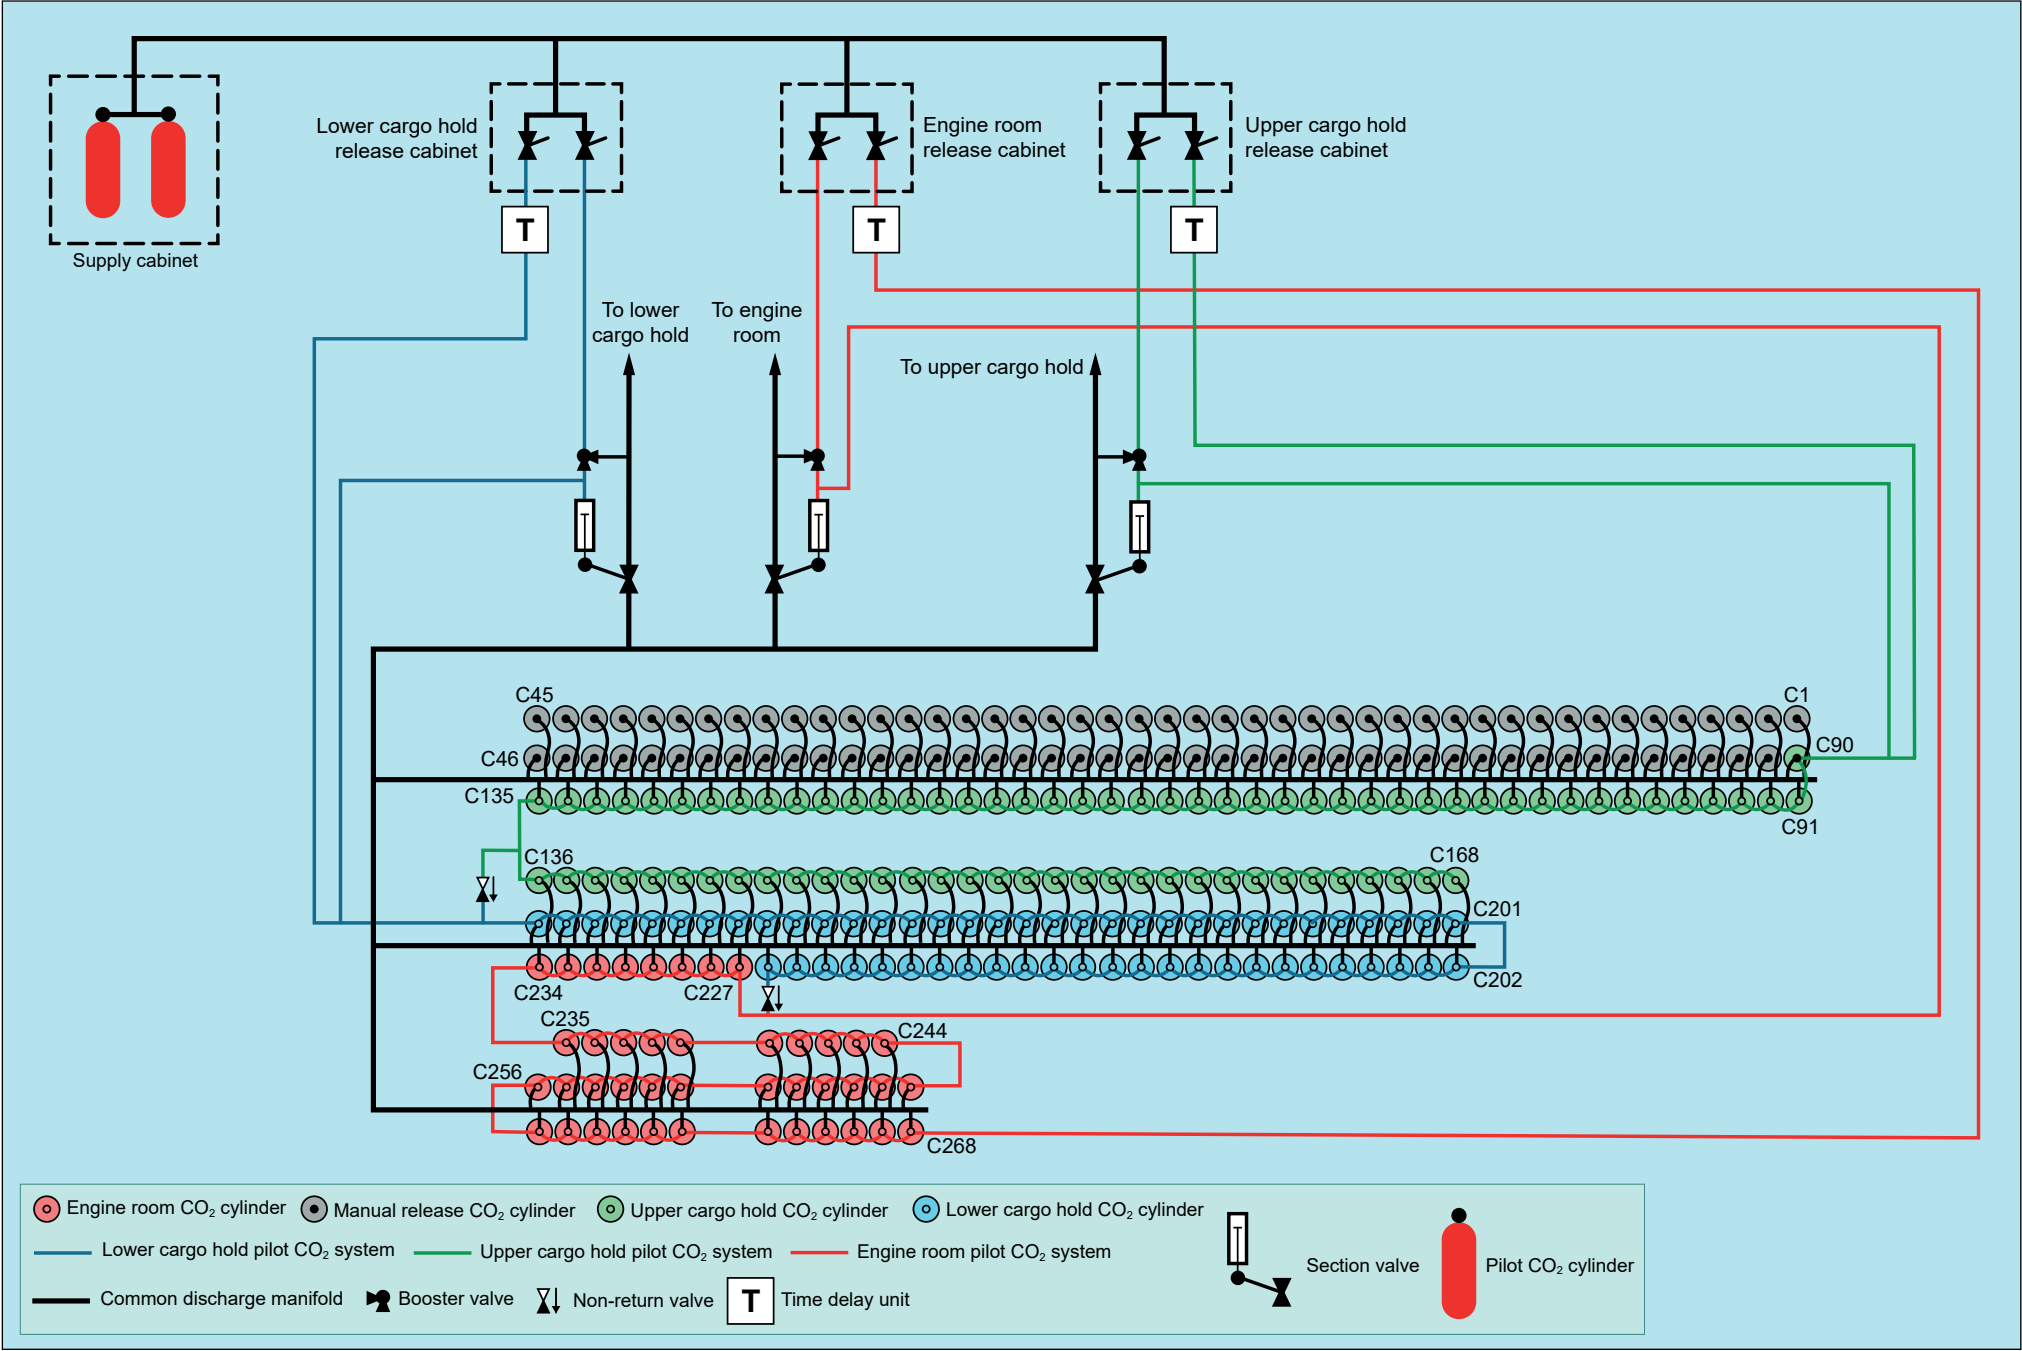
Figure 19: Finnmaster CO₂ system schematic drawing

The sequence that the C/E followed to activate the CO₂ system matched the operating instructions for system. After the time delay unit in the system activated, CO₂ was admitted to the pilot system connected to the series of flexible hose assemblies at cylinder C268 in the CO₂ room (see **Figure 19**). The system operated as intended up until this point in the activation sequence.

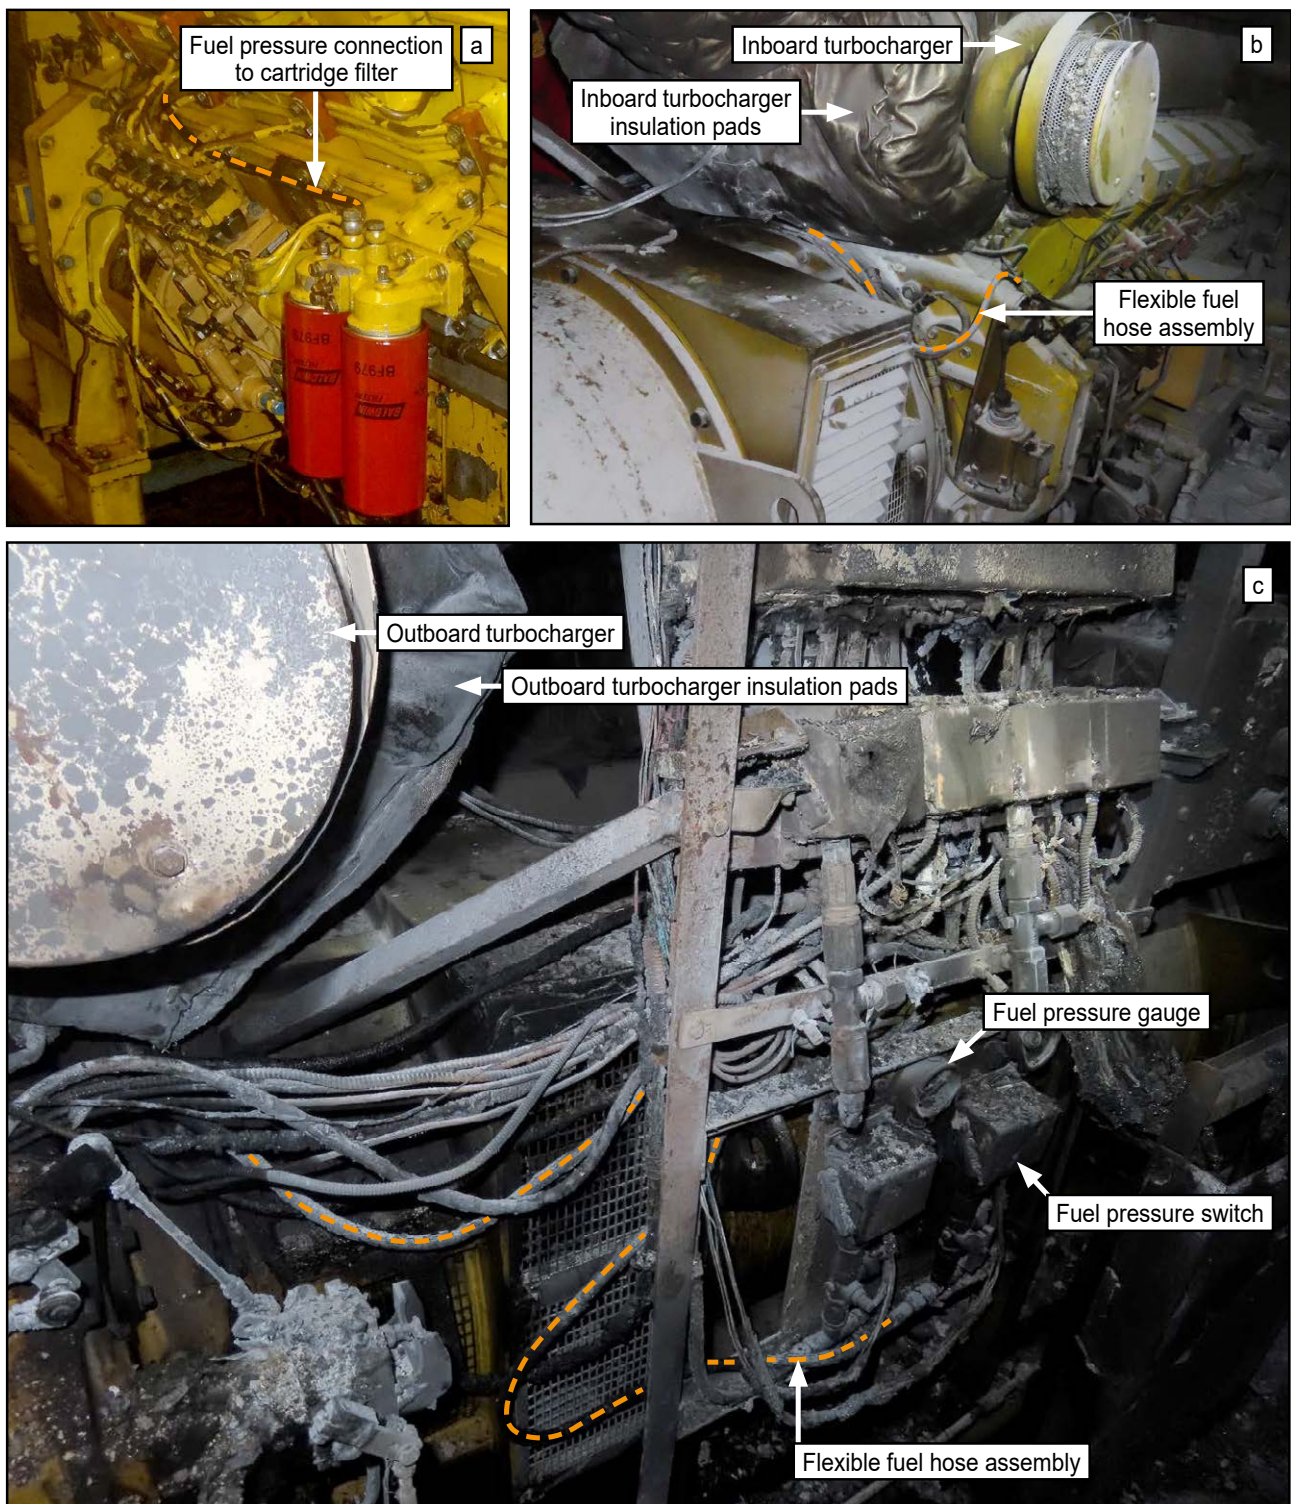
Figure 3: Small-bore flexible fuel hose assembly on AE2, as indicated by dashed orange line

The IMO guidance on flexible hose installations, including the limitation of length, were incorporated into the rules of the two classification societies that provided oversight of *Finnmaster* during the period that the flexible hoses were in place on the vessel.
