Report on the investigation of  
the fire and subsequent loss of power on board the  
Finland registered roll-on/roll-off cargo ship

***Finnmaster***

at King George Dock, Hull, England

REPORT NO 13/2025

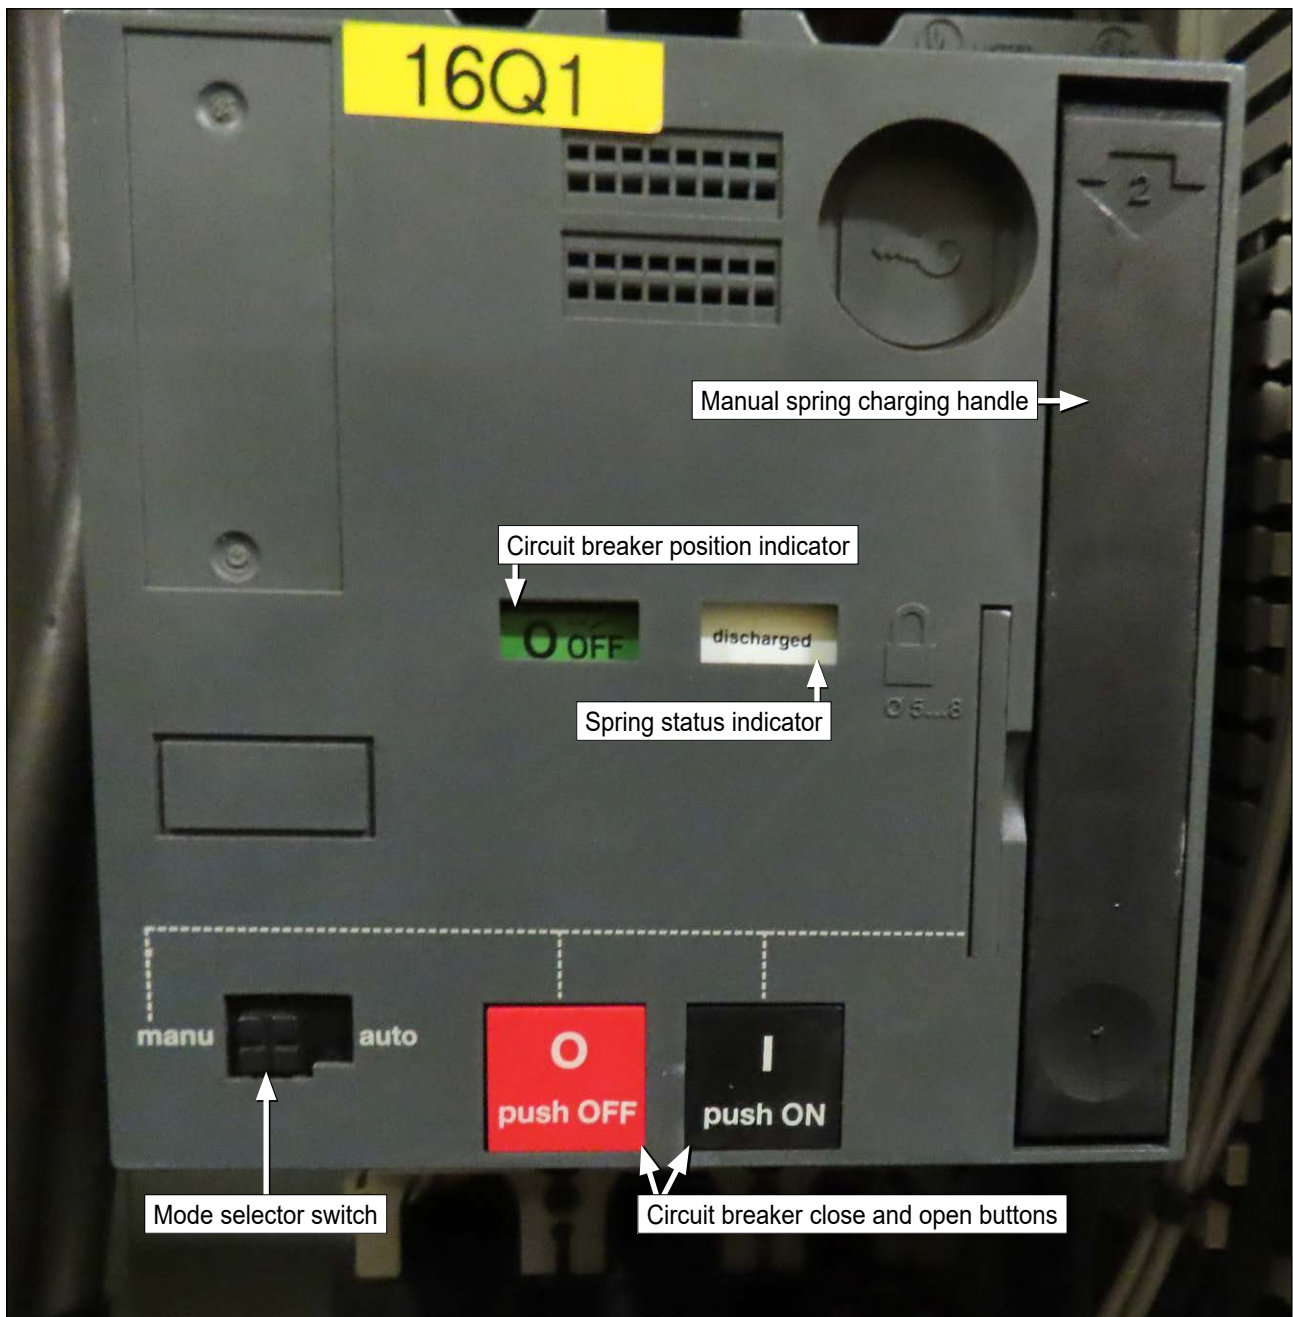
**Figure 5:** Emergency diesel generator circuit breaker motor mechanism front panel

On arrival at the emergency generator room the 2/E found that the EDG was running but its circuit breaker had not closed to connect the generator to the emergency switchboard. The 2/E tried to close the circuit breaker manually by using the push button on its front panel, but it did not operate. The EDG cooling water temperature was high and the cooling fan was not operating so the 2/E stopped the engine manually and left to inform the C/E of the problem with the circuit breaker.

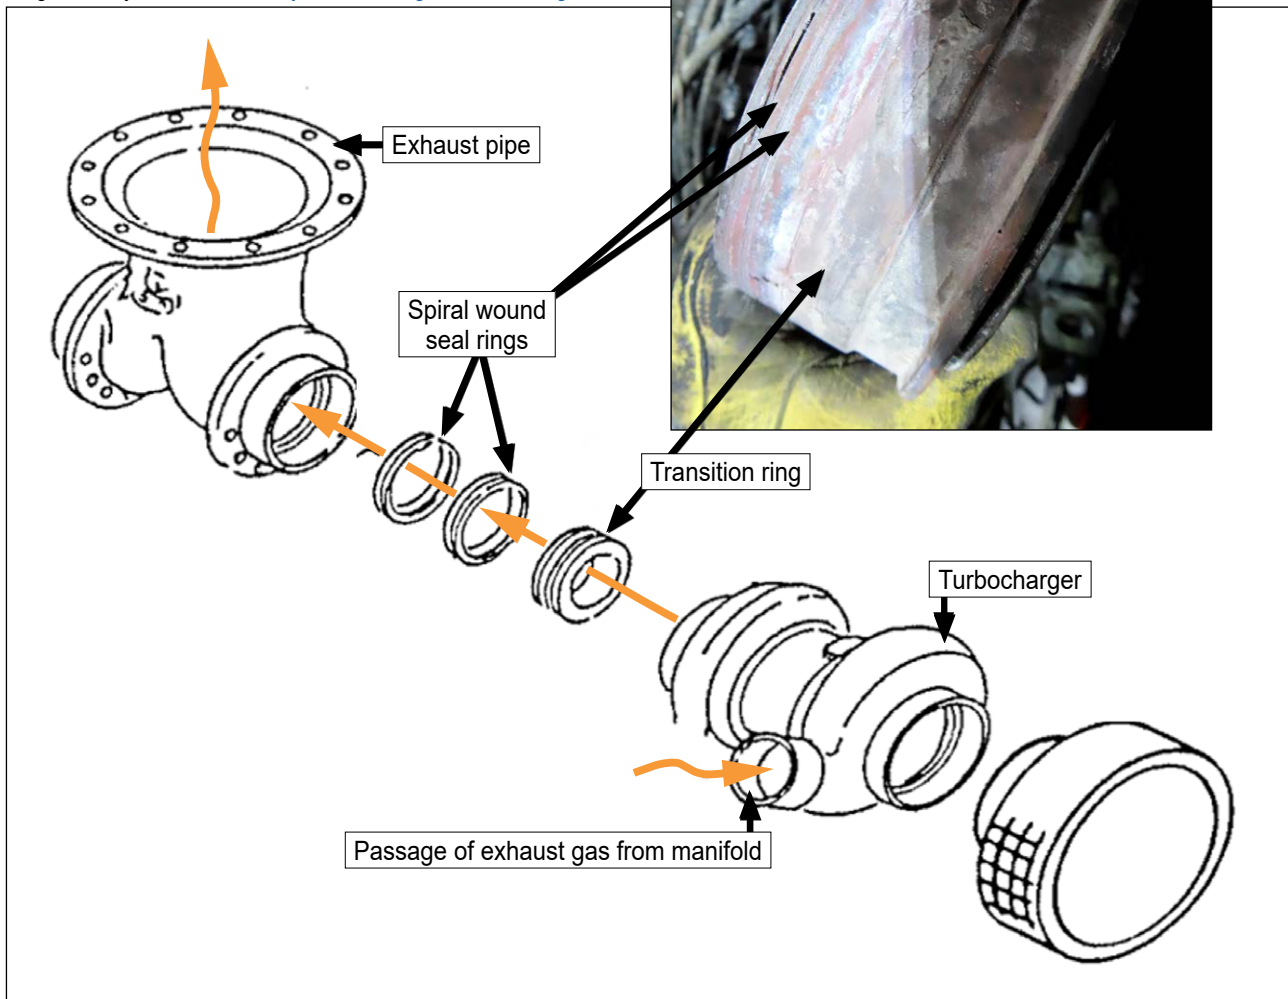
**Figure 13: AE2 exhaust system**

The exhaust system on each of the auxiliary engines was installed within an insulated box structure to prevent contact of the flammable liquids with the very high temperature surfaces of the turbocharger turbine casings and central exhaust pipe (**Figure 14**). A transverse oil supply pipe for the turbocharger bearings ran along the lowest point of the insulated box structure. Behind this pipe there was a gap of approximately 25mm between the lowermost panel of the box structure and the engine frame.

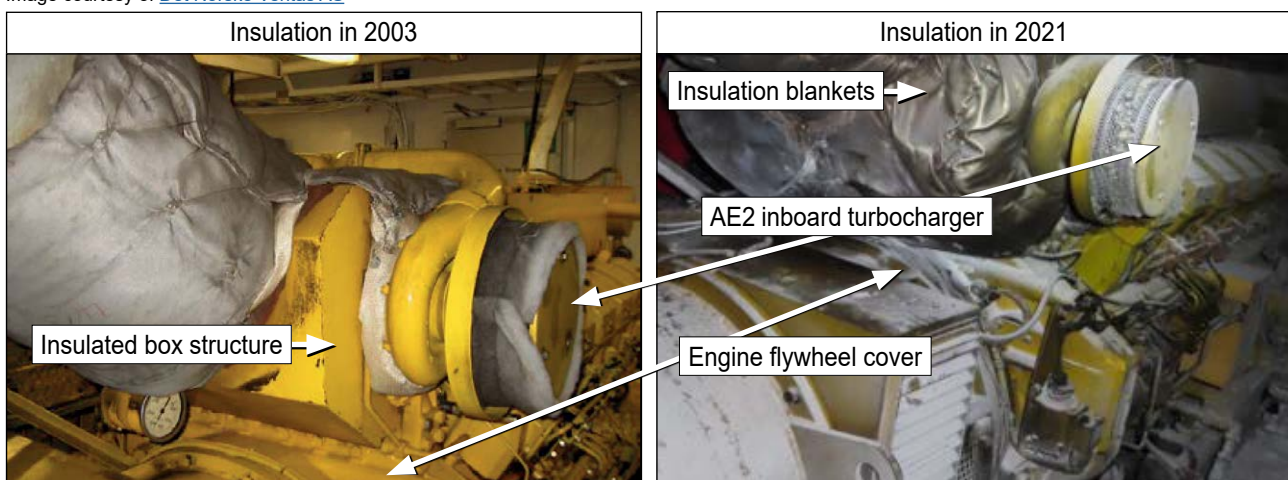
**Figure 14: AE2 exhaust insulation**

In April 2003, a survey by a DNV surveyor verified that the installation on AE2 met the requirements for the protection of the high temperature surfaces.

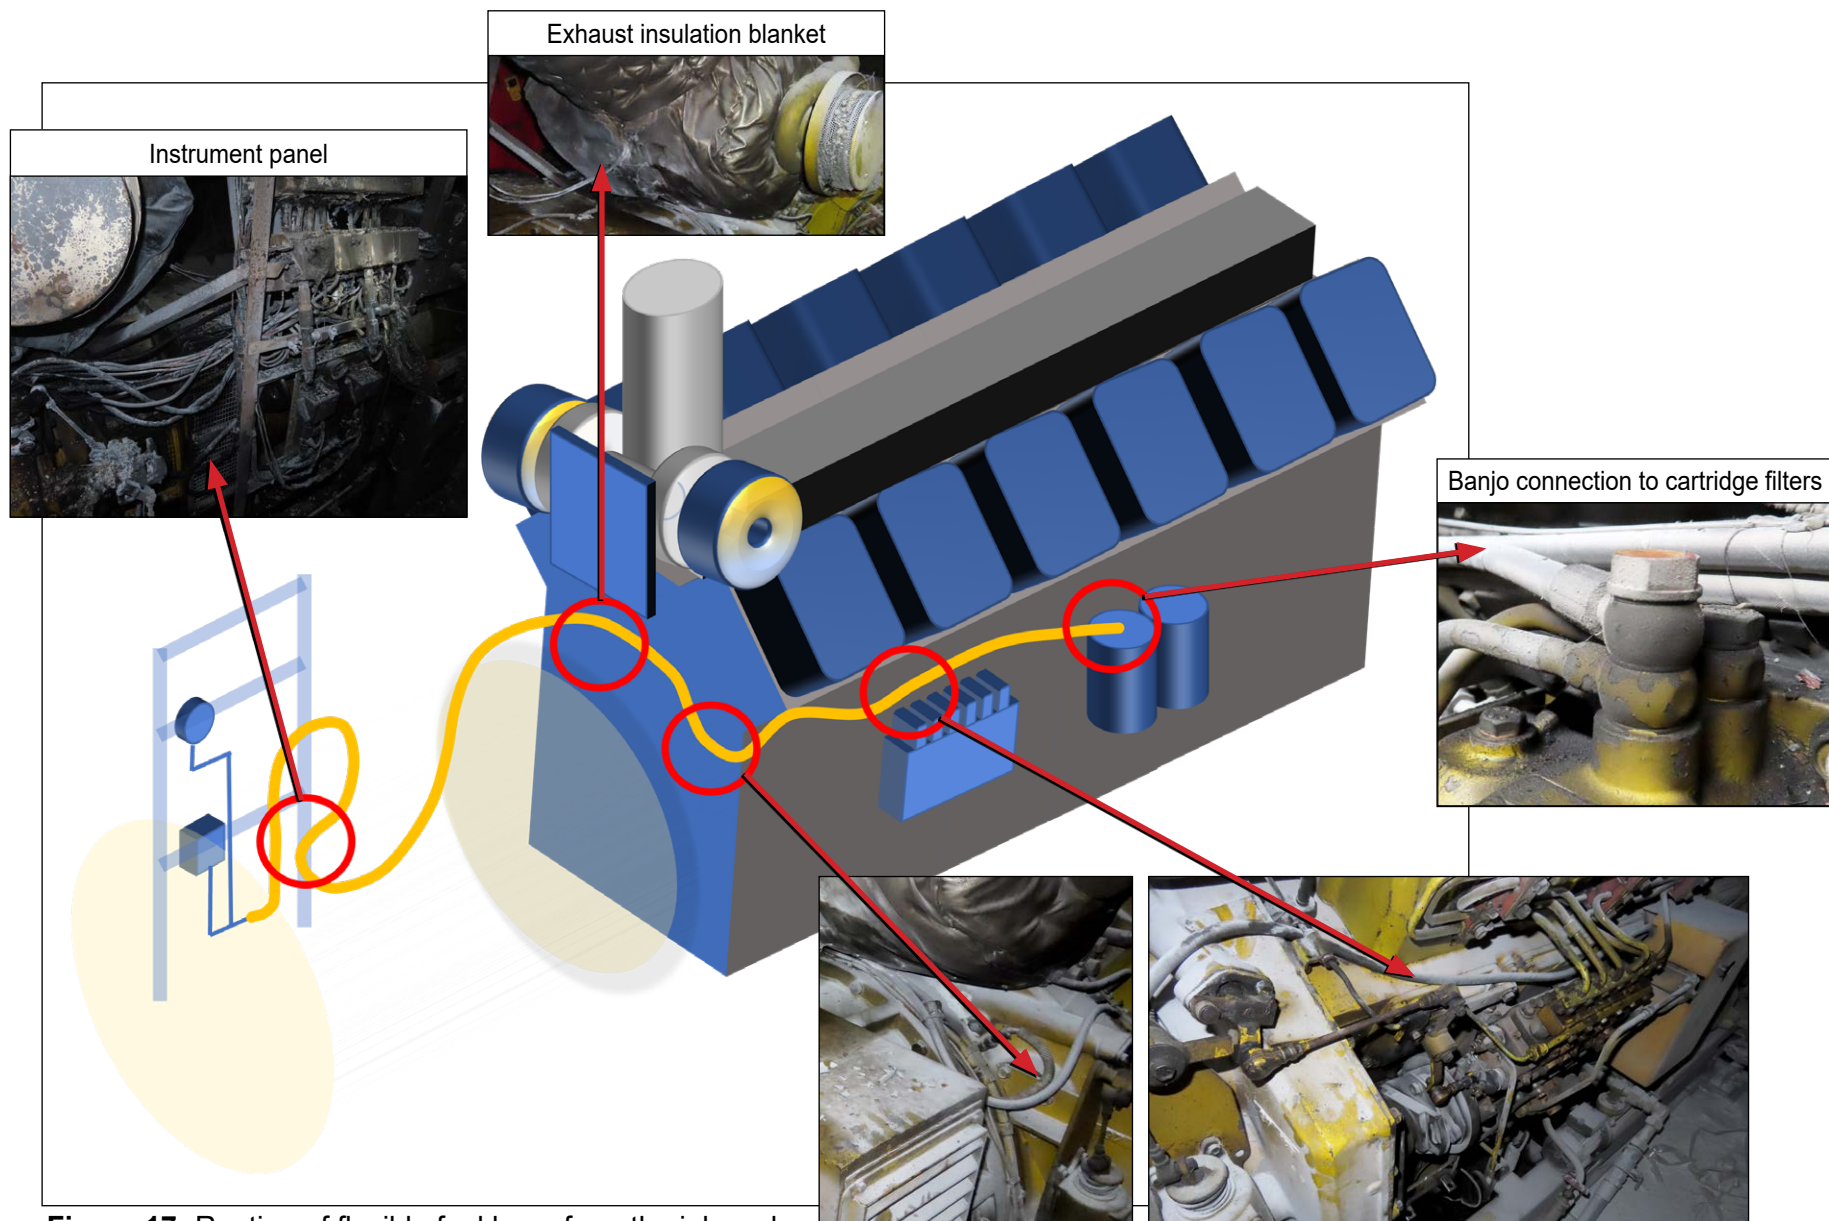
**Figure 17:** Routing of flexible fuel hose from the inboard cartridge filters to the AE2 local instrument panel

The banjo connection at the fuel cartridge filter outlet was an open connection without any means of closure. The flexible fuel hose remained under pressure at all times unless the engine in question was isolated as a whole from the main fuel supply.

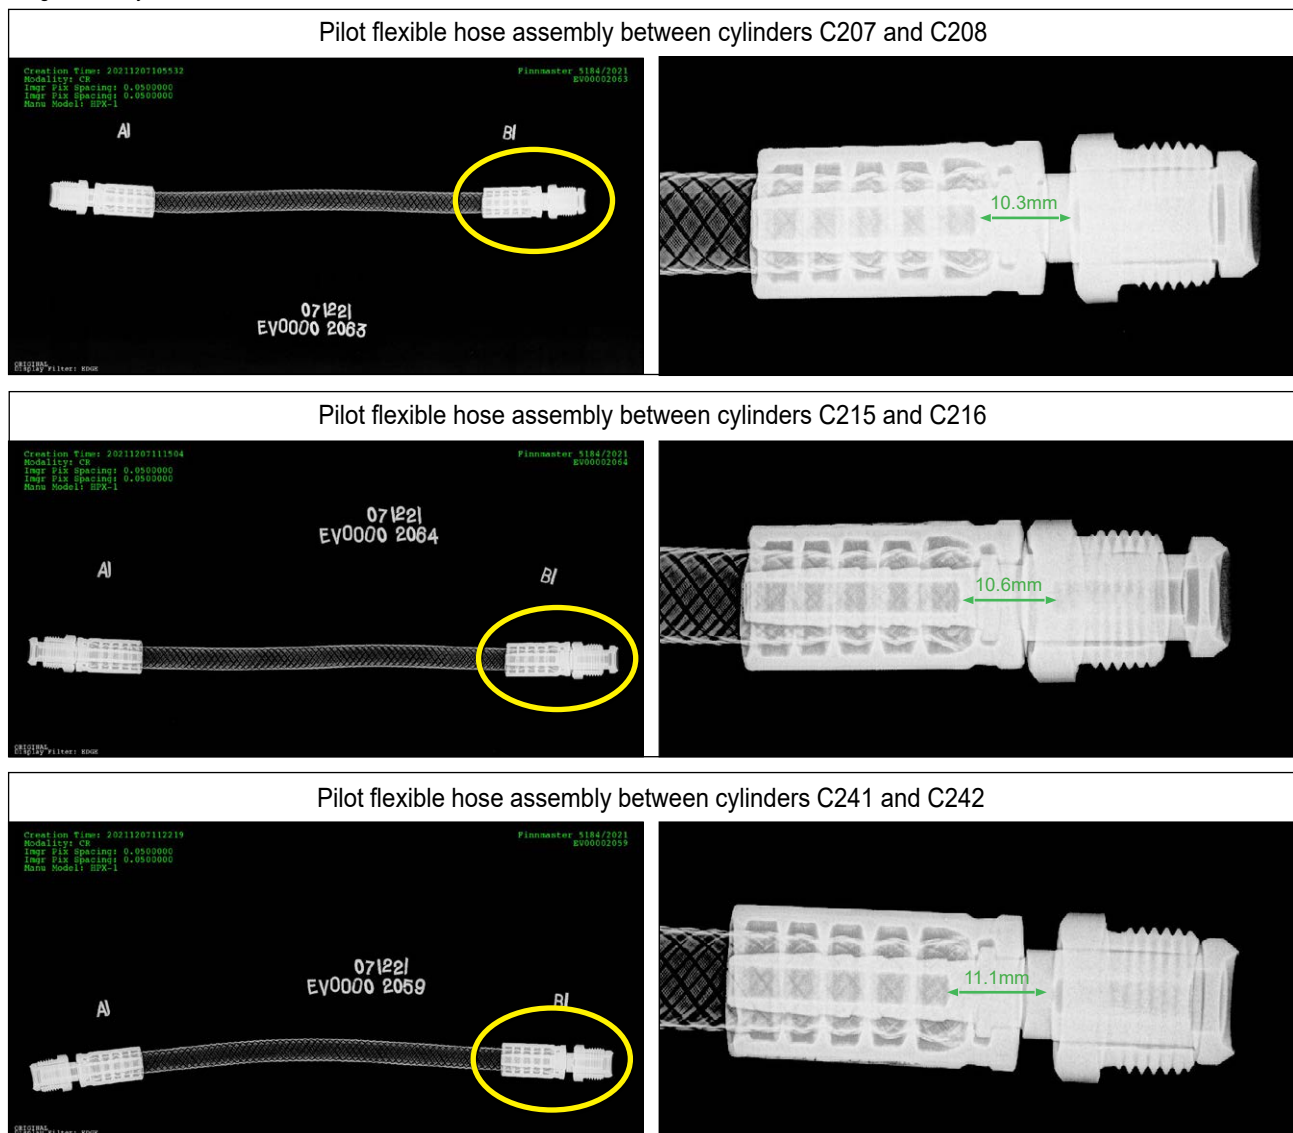
**Figure 24:** Pilot flexible hose assembly radiographic images

The three blocked flexible pilot hose assemblies were removed from *Finnmaster* and subjected to radiographic examination, which indicated blockage at the end couplings (**Figure 24**).

The flexible hose assembly from between cylinders C241 and C242 in the AER's pilot hose system was subsequently sectioned to fully investigate the blockage identified in the radiographs. The section revealed that the 4mm bore through the pilot hose coupling had not been fully drilled during manufacture, preventing the passage of gas through the flexible hose assembly (**Figure 25**).

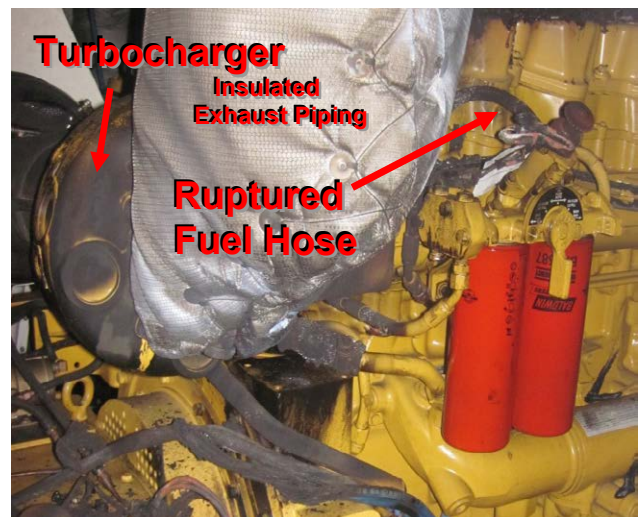
During the post-casualty inspection of the engine room, the source of the fuel leak was identified to be a rupture on a flexible fuel hose connected to the fuel filter assembly. Additionally, it was noted that the fuel filter assembly and its components were installed in relatively close proximity to the turbocharger on the inboard side of the engine. Although components of the turbochargers may be insulated, temperatures on some surfaces typically exceed the fuel's ignition point. In this instance, the heat radiating from the turbo charger components was very high and likely led to the degradation of the flexible rubberized hoses nearby. However, the installation was confirmed to be in accordance with an accepted location on the manufacturer's marine engine manual.

Following the casualty, the owner/operator of the vessel enacted fleet-wide changes and relocated the fuel filter assemblies away from the turbochargers on the outboard side of the engines in the vicinity of the fuel pumps.

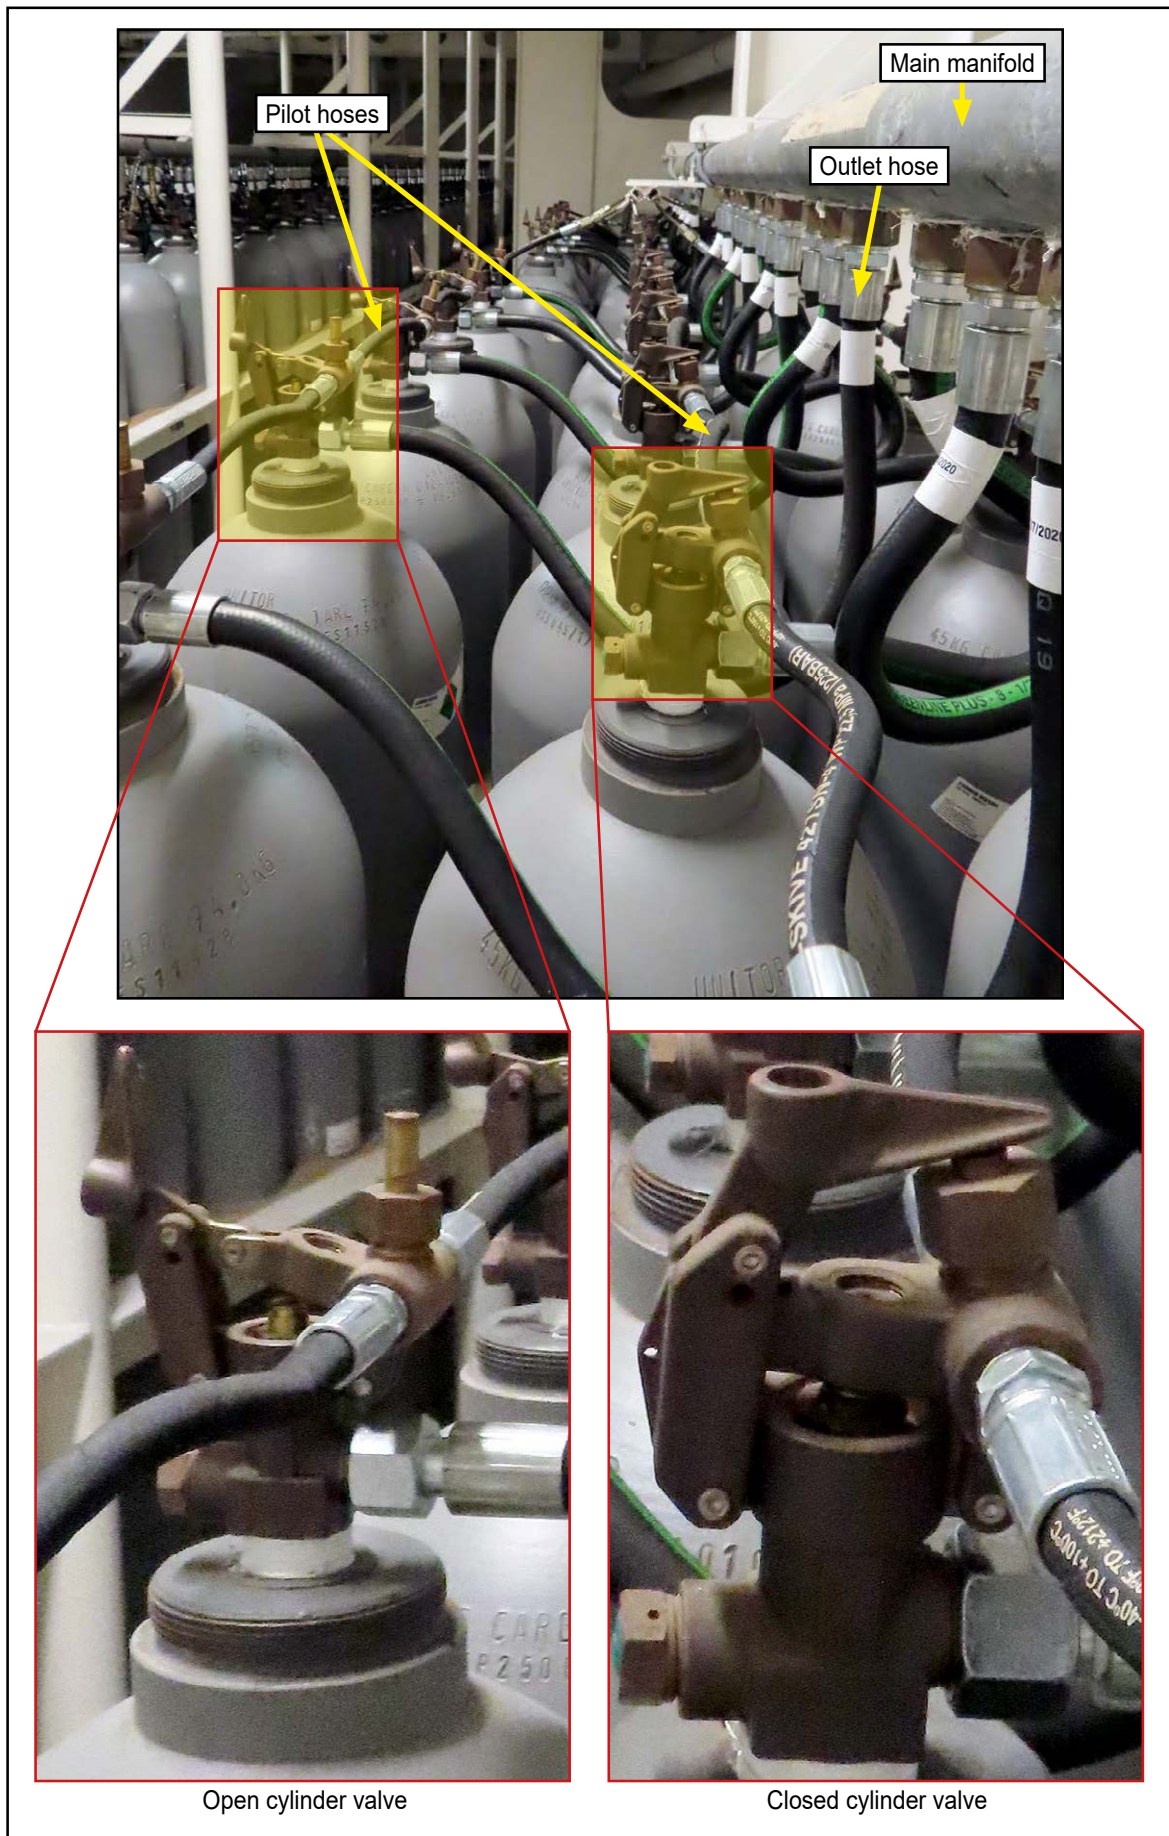
**Figure 1:** Part of the *Finnmaster* CO<sub>2</sub> fire extinguishing system post-accident

The initial MAIB investigation identified that one of the auxiliary engine room's CO<sub>2</sub> system pilot hoses was completely blocked. Subsequent examination and testing of *Finnmaster*'s fixed fire extinguishing systems identified two other hoses on the cargo hold pilot line system that were blocked. Radiographic images taken of the blocked hoses (**Figures 2 and 3**) showed that the pilot hose couplings had not been fully bored through during the manufacturing process. The testing process also identified several coupling leaks in the pilot lines.
