# Rail Accident Report

## **Collision between passenger trains at Salisbury Tunnel Junction, Wiltshire 31 October 2021**

Report 12/2023  
October 2023

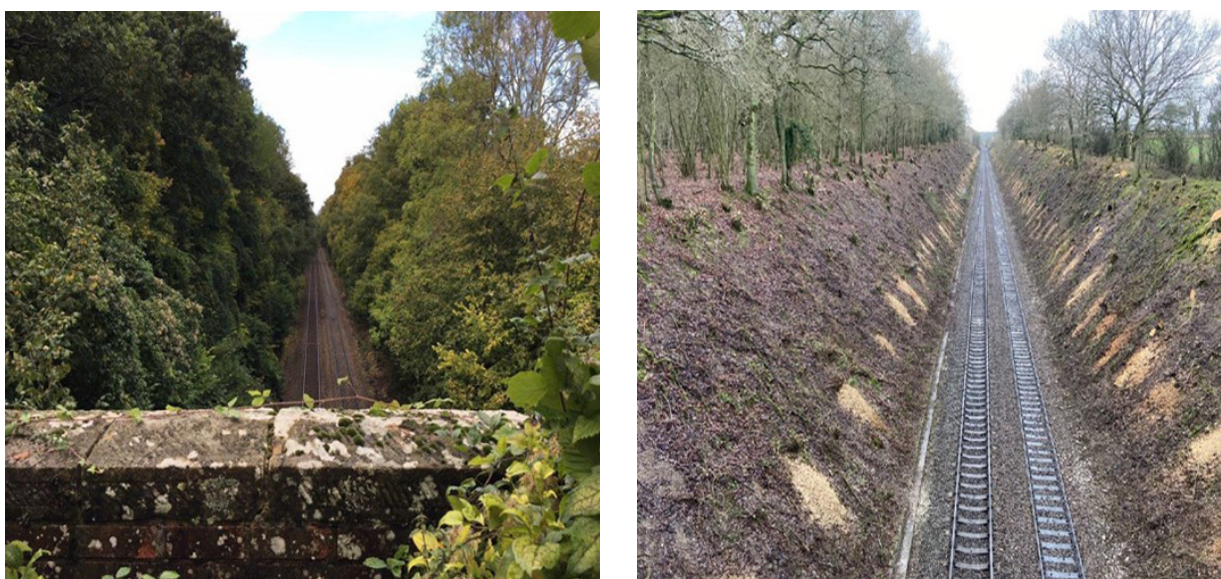
Figure 28: The main lines between Overton and Whitchurch looking towards Salisbury showing the condition of the vegetation before (taken in summer) and after (taken in winter) vegetation work was completed in 2019/20.

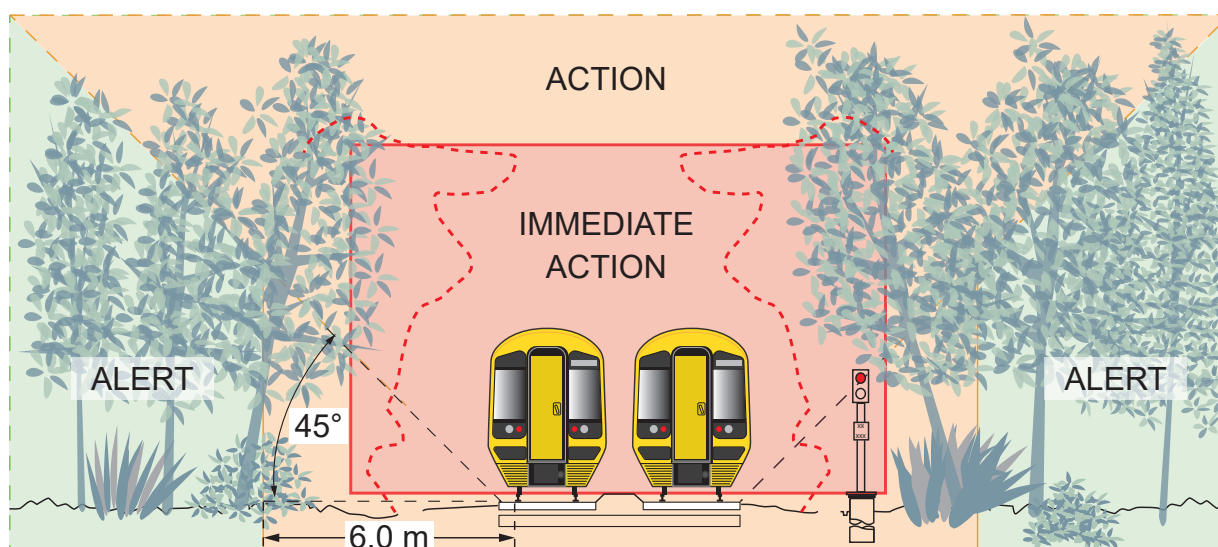
Figure 31: RAIB diagram showing the action zones from Network Rail standard NR/L2/OTK/5201, train profiles similar to class 159 trains, and tree growth as found on certain sections of the main lines between signals SY29R and SY31 (red dotted line).

148 Furthermore, an examination of the section of line from signal SY29R to beyond signal SY31 after the accident (paragraph 130) showed there were areas of medium to heavy railhead contamination which would have resulted in low levels of wheel/rail adhesion, even on sections that had low scores in the 2021 risk assessment. The amount and condition of the vegetation and trees were also seen to be non-compliant with the wider requirements of NR/L2/OTK/5201 (figure 31).

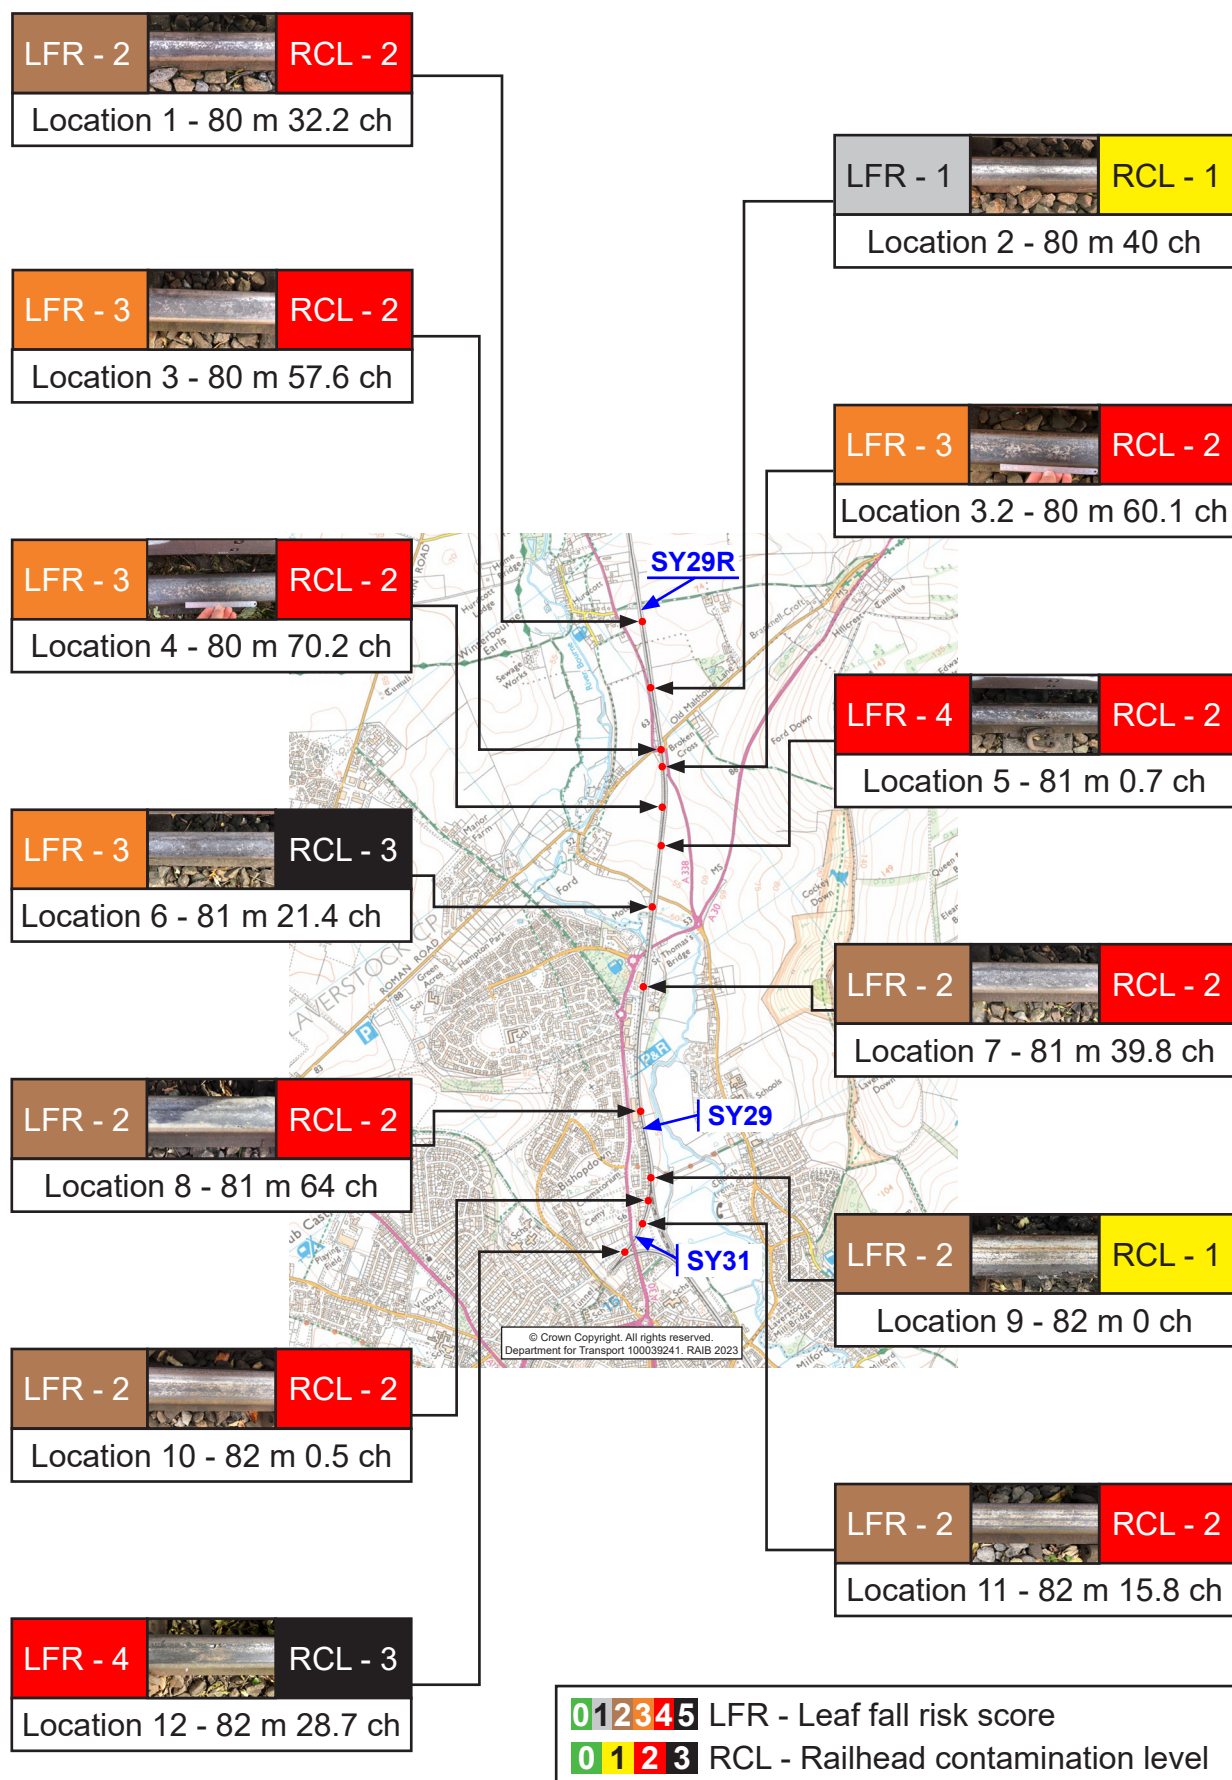
223 Documentary and witness evidence shows that before the accident Network Rail's Wessex route had not correctly identified sections of track as HRLA sites. This was probably because the information (figure 40) that the SDS was provided with and which they were using to identify such locations was inaccurate. These inaccuracies arose because the process employed to inspect and risk assess locations, and the subsequent dissemination of the information gathered, was ineffective (paragraph 136).

Figure 40: Braking locations for train 1L53 with predicted leaf fall risk scores (0 to 5) from the leaf fall assessment completed in June 2021 and corresponding physical railhead contamination level found on site (0 to 3) on 31 October 2021.

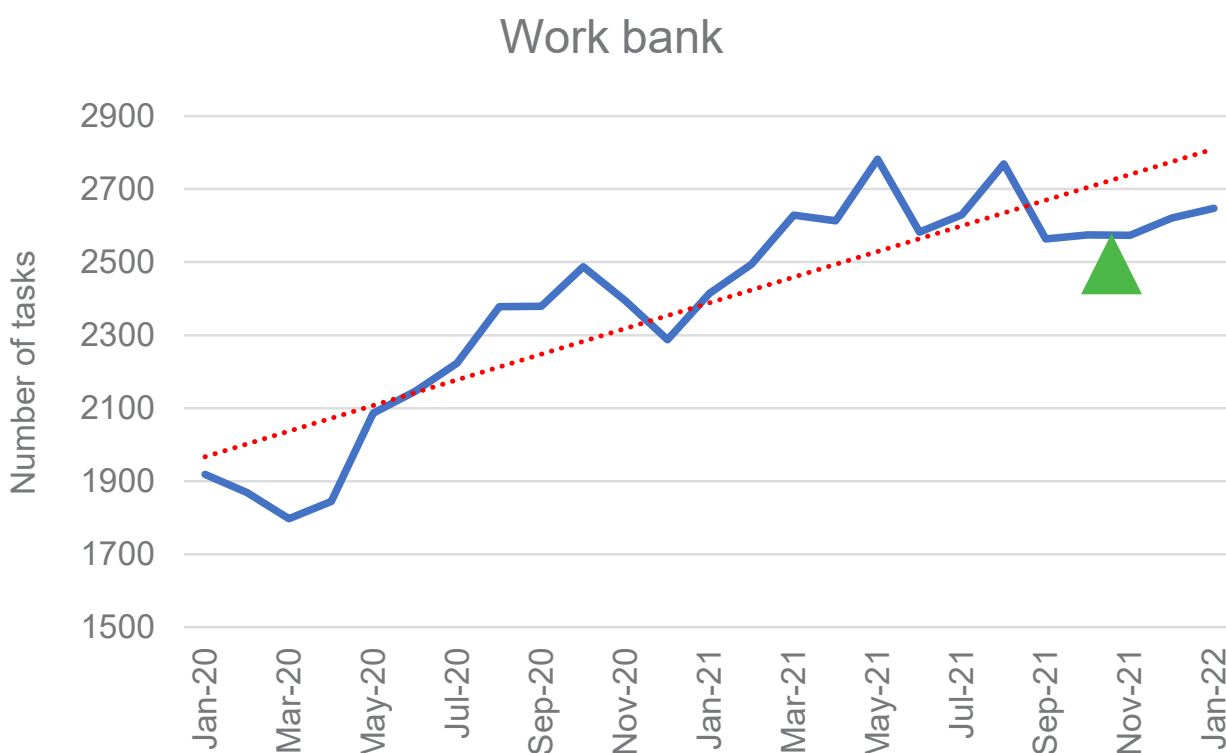
- 227 Despite this report, MDU off track staff reported that its increasing workload combined with a shortage of resources between May and August 2021 (figure 41) meant that it could not address the existing work bank and that the MDU was 'fighting' in response to arising incidents. Additionally, witness evidence is that there was also a perceived problem with the availability of contractors. Consequently, the MDU did not have the time or resources to prioritise and plan the vegetation assessment and management work.

Figure 41: Ellipse work bank (number of tasks) levels (blue solid line) and mean average level (red dotted line) between January 2020 and January 2022 (green triangle shows accident date).
