AAIB Bulletin

10/2025

Published: 9 October 2025.

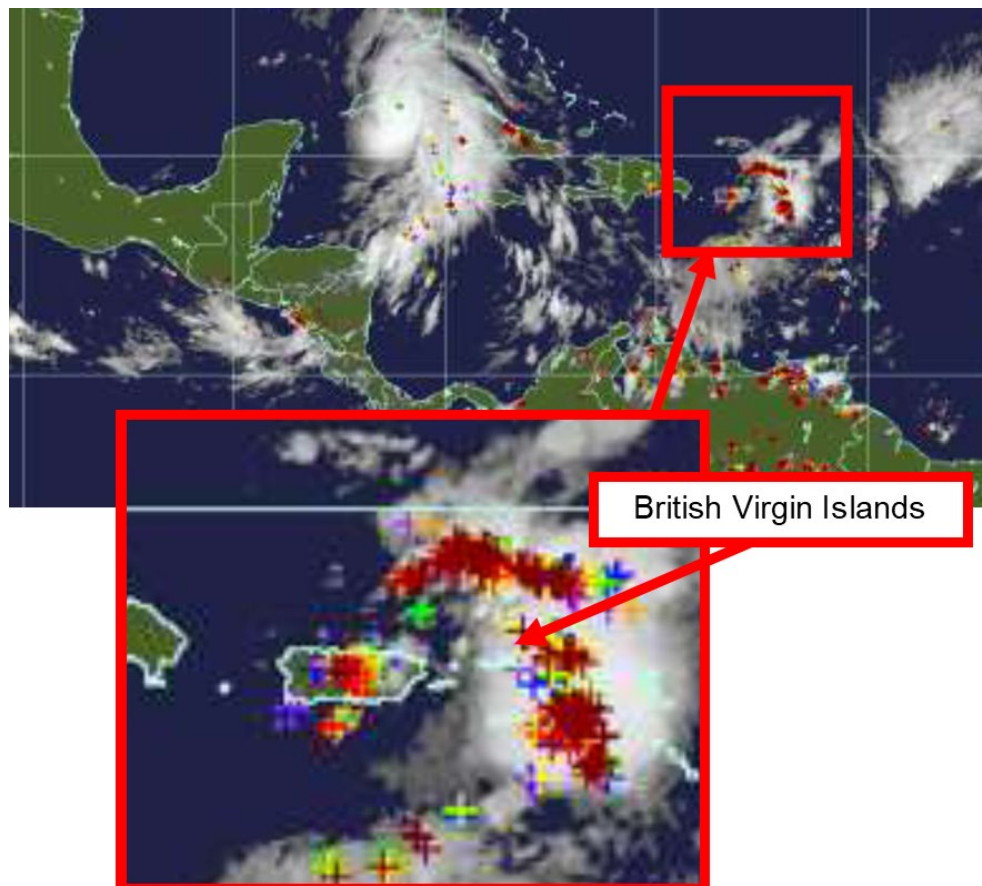
- The TUPJ TAF included a risk of thunderstorms from 1800 hrs UTC, with an associated forecast reduction in visibility and cloud bases.
- The reported intensity of the rainfall at the airfield along with the number of lightning strikes recorded on the weather radar imagery at Figure 5 indicated an active CB cell was over or close to the territory at the time of the serious incident.
- There was no indication of any significant wind shear in association with the thunderstorms, but the Met Office did not have access to the full record of wind speed or direction.

Weather radar image at 1900 hrs Z on 6 November 2024 (crosses indicate lightning strikes)
