**Accident**

| <b>Aircraft Type and Registration:</b> | 1) Discus B, G-DJMD<br>2) Standard Cirrus, G-DCTB |
| <b>Date &amp; Time (UTC):</b> | 25 May 2024 at 1400 hrs |
| <b>Location:</b> | Hinton-in-the-Hedges Airfield, Northamptonshire |

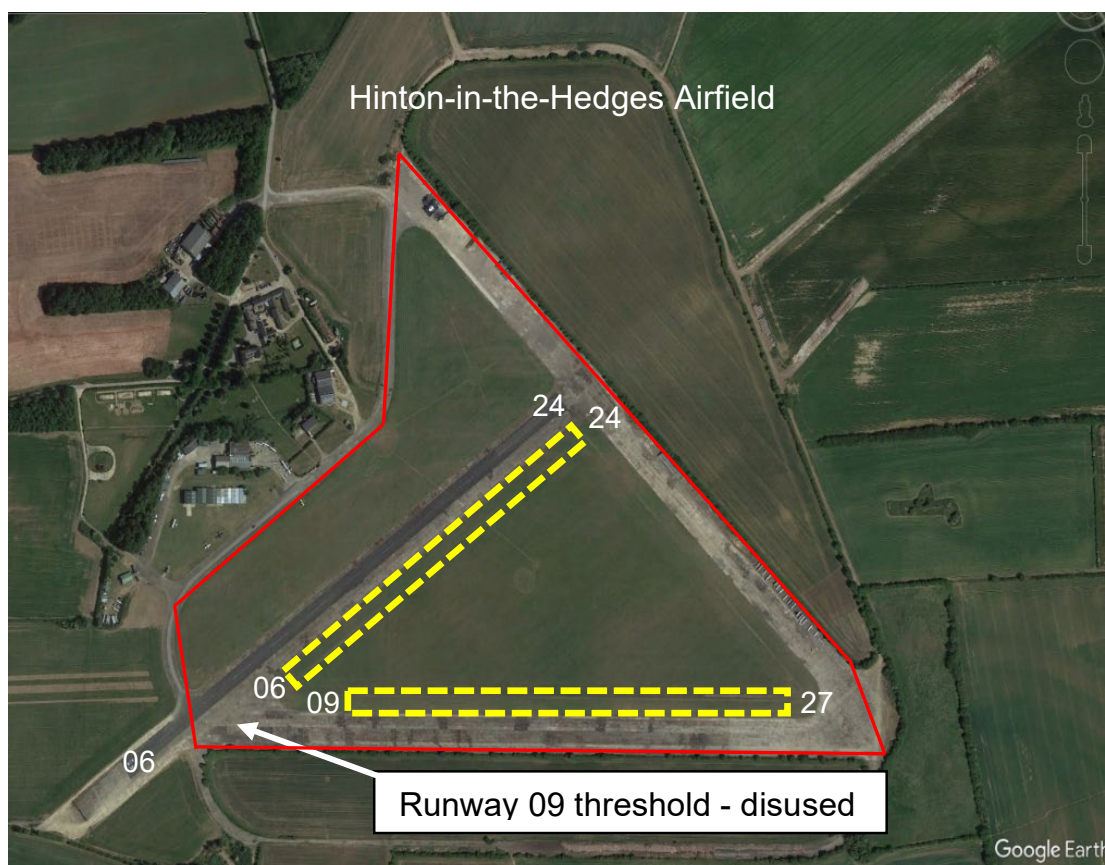
**Figure 1**

Hinton-in-the-Hedges runway layout and parachute landing area (bounded in red)

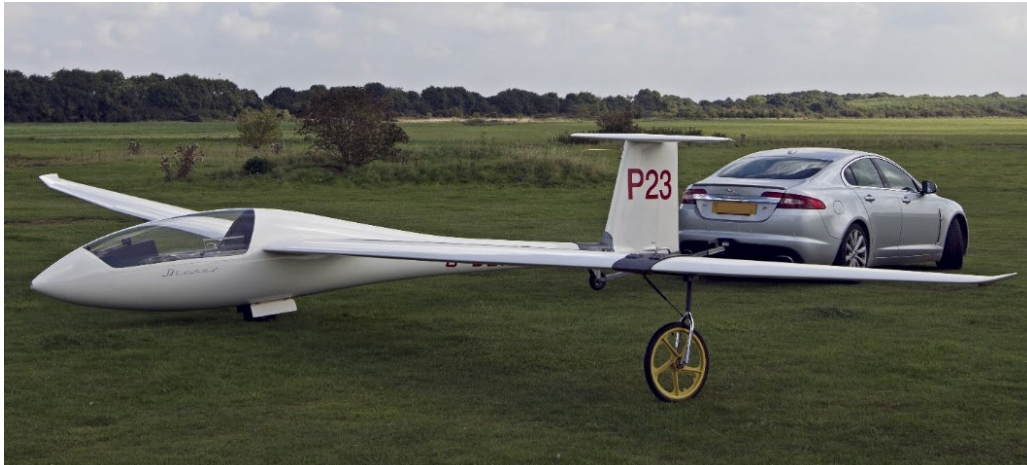
**Figure 4**

G-DJMD was manufactured in 1988, had 2,254 hours at its last inspection, and held a valid Airworthiness Review Certificate (ARC). Its paintwork was white and it displayed the competition number P23 (Figure 4).

G-DJMD (image used with permission)

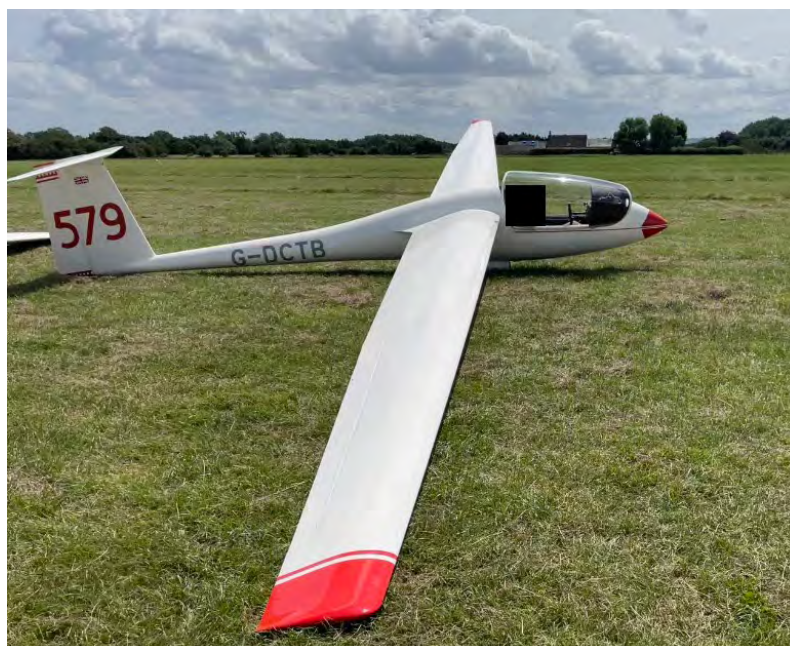
**Figure 5**

G-DCTB was manufactured in 1972, had 3,128 hours at its last inspection, and held a valid ARC. It had red paintwork on the nose cone, wing tips, and the bottom and top of the rudder. G-DCTB displayed the competition number 579 (Figure 5).

G-DCTB (image used with permission)

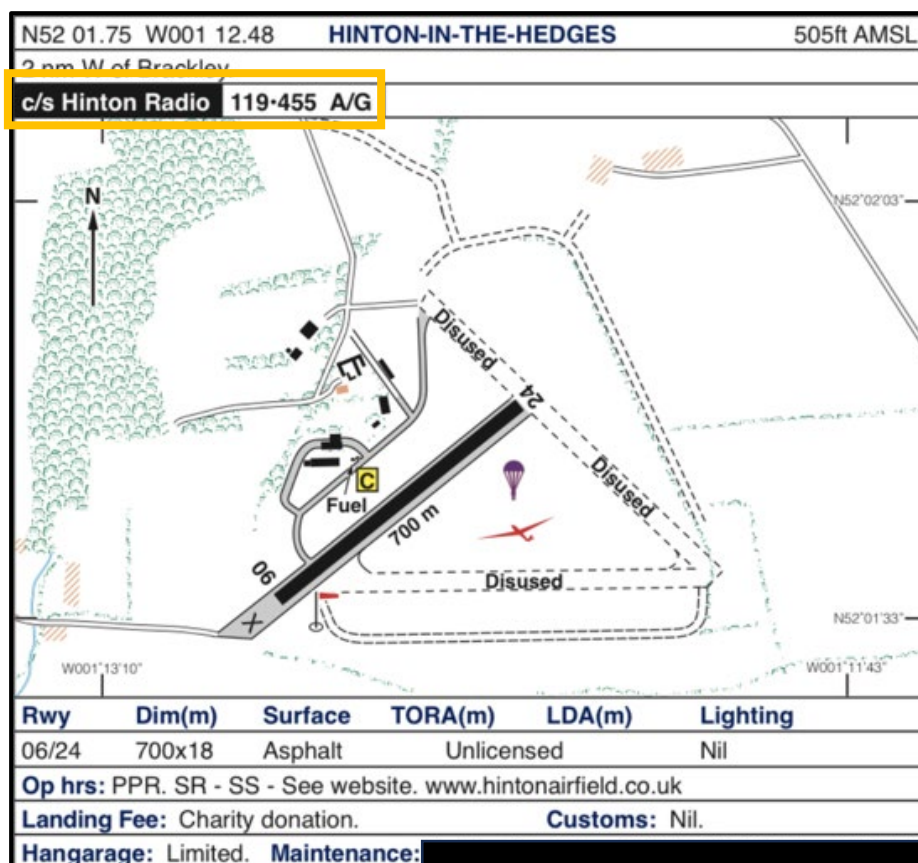
**Figure 8**

Hinton-in-the-Hedges is an unlicensed airfield located approximately 4 km west of Brackley, Northamptonshire, at an elevation of 505 ft amsl (Figure 8). It is owned and operated by a private company.

Hinton-in-the Hedges Airfield (© Pooleys, 2023)

The skydiving operator used a radio base station to communicate with their drop aircraft, while the gliding club used handheld radios to coordinate gliding activities. All radios operated on the frequency 119.455 MHz. Hinton airfield users routinely used the callsign 'Hinton Traffic' for radio calls, although the approved callsign suffix for an AGCS is 'Radio'. The entry in Pooleys Flight Guide for Hinton airfield had been annotated with the callsign '*Hinton Radio*' (Figure 8) since 1993.
