# Rail Accident Report

Pedestrian struck by a train at Bourneview footpath crossing, London Borough of Croydon, 23 January 2025

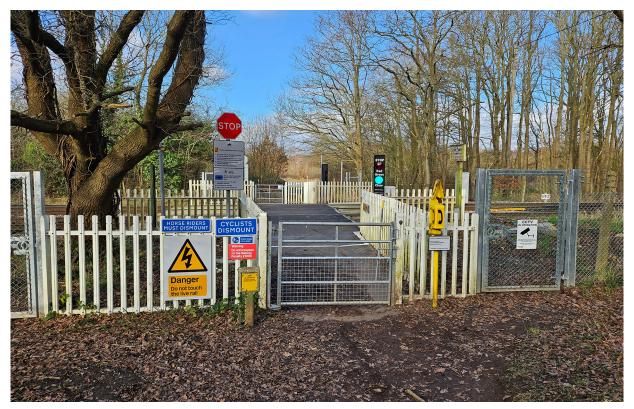
73 Following the May 2023 NRA and an analysis of level crossing risk across the Southern region, Network Rail's level crossing management, including the ORA and regional level crossing manager met in late 2023 and recommended that Bourneview footpath crossing should be upgraded by fitting MSLs (figure 9, typical installation example). This was due to the high number of reported incidents at Bourneview, rather than a strict adherence to the cost-benefit analysis, which showed a relatively weak case for this level of safety investment at this crossing.

Figure 9: Lady Howard crossing in Surrey, fitted with MSLs and audible warnings.

74 In December 2023, the recommendation to fit MSLs at Bourneview received financial approval. The work was programmed for March 2026, as part of a rolling contract of crossing upgrades with Network Rail's contractor, ordered according to risk and geographical location.

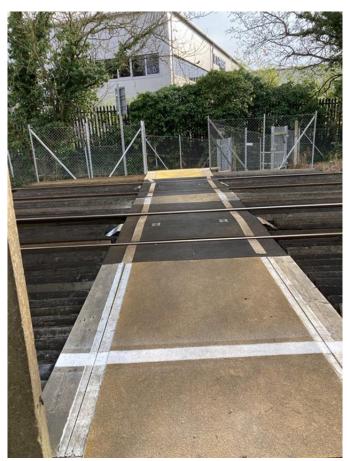
- 79 Network Rail standard NR/L2/XNG/30020 Module R03, 'Requirements for station, footpath, bridleway and user-worked level crossings', issue 1 dated June 2022, requires that, where the user is required to stop, look and listen to cross a railway, the surface between decision points should be coloured yellow (figure 10), where the type of crossing surface makes this reasonably practical.

Figure 10: The crossing at Synehurst in Hampshire, with white lines and yellow surface.

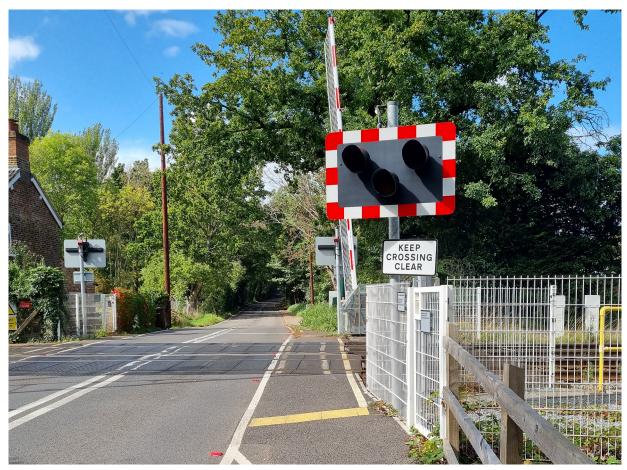
- 83 The footways on other types of level crossing, such as those with half and full barriers (figure 11), and those on tramways (figure 12), are marked by a distinct type of tactile paving. This gives a sensory cue to users who are distracted, or cannot see, that they are approaching an area where a different level of vigilance is required.

Figure 11: A full barrier crossing, with tactile paving before the barriers.

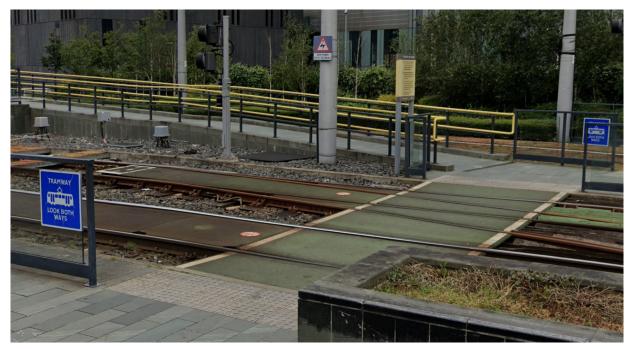
Figure 12: A crossing on Manchester Metrolink, with tactile paving, low signage and distinct colours (courtesy of Google).
