# ***AAIB Bulletin***

# ***11/2025***

| Boeing 737-8K5 | G-TAWB | 16-Dec-24 | 3 |

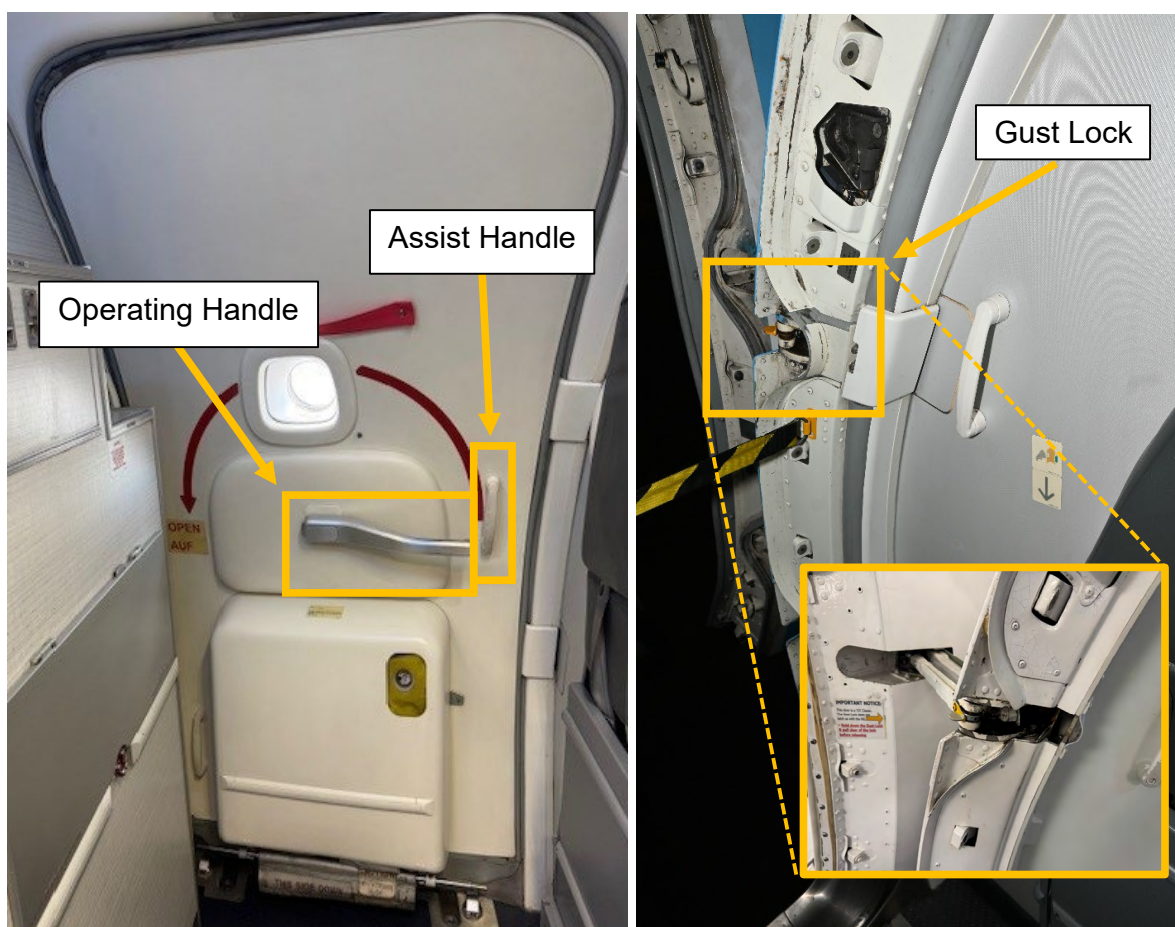
**Figure 1**

The B737 is fitted with two passenger entry doors and two service doors all of which have the same mechanism for opening and closing. The doors open towards the nose of the aircraft and are fitted with a gust lock to secure the door in the open position. The gust lock on G-TAWB must be depressed to release the door so that it can be closed. On the inside of the door there is an assist handle on the right side as well as a large operating handle. The door is fitted with a viewing window, red warning strap to alert anyone outside the aircraft when the door is armed and an escape slide and its associated equipment. Figure 1 shows the door of G-TAWB from the inside of the aircraft with the door equipment used for closure labelled.

Inside view of front left passenger G-TAWB door closed (left) and open (right)

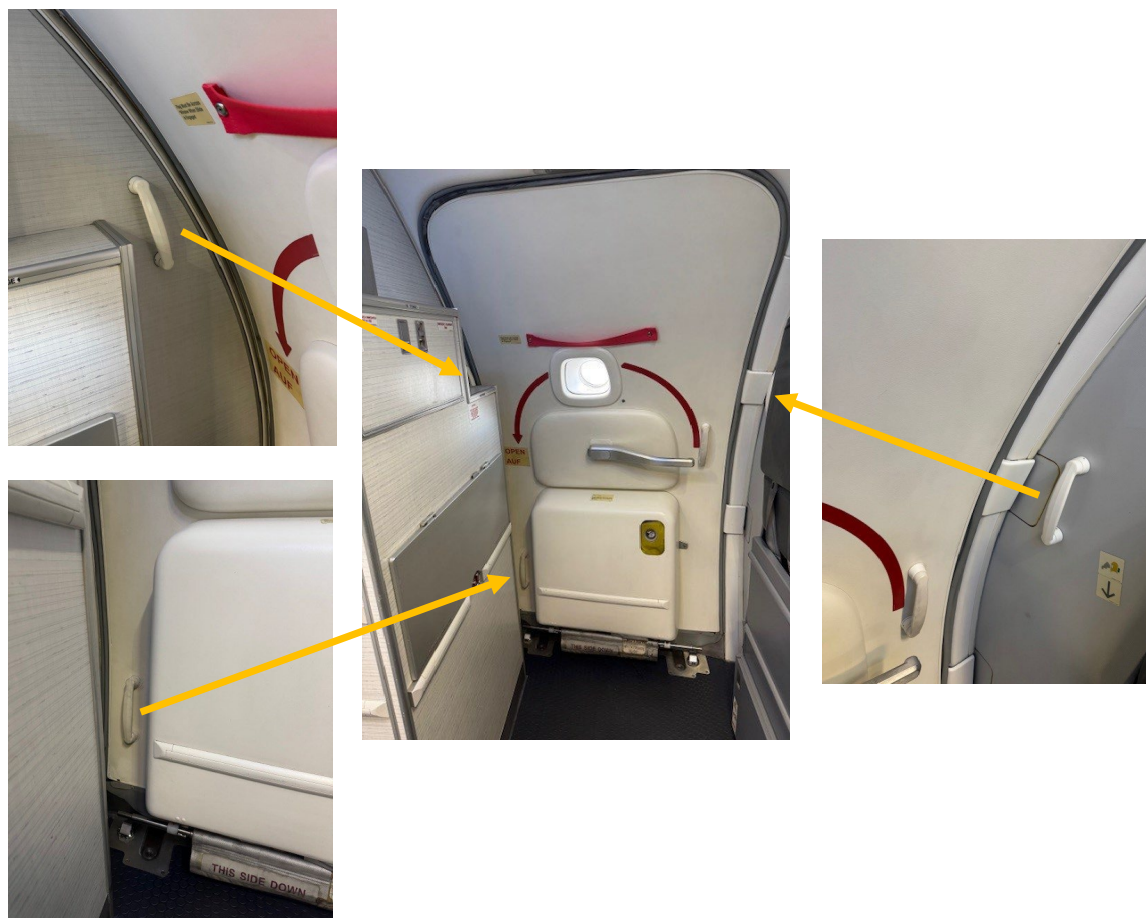
**Figure 2**

The aircraft door and surrounds are also equipped with a number of safety handles to assist with door operation. These handles are fitted on the left and right of the door in the cabin as well as a lower handle on the door itself to assist with operation from aircraft airstairs if they are fitted. These handles are shown in Figure 2.

Additional handles fitted the left, right and bottom of the door to assist with operation

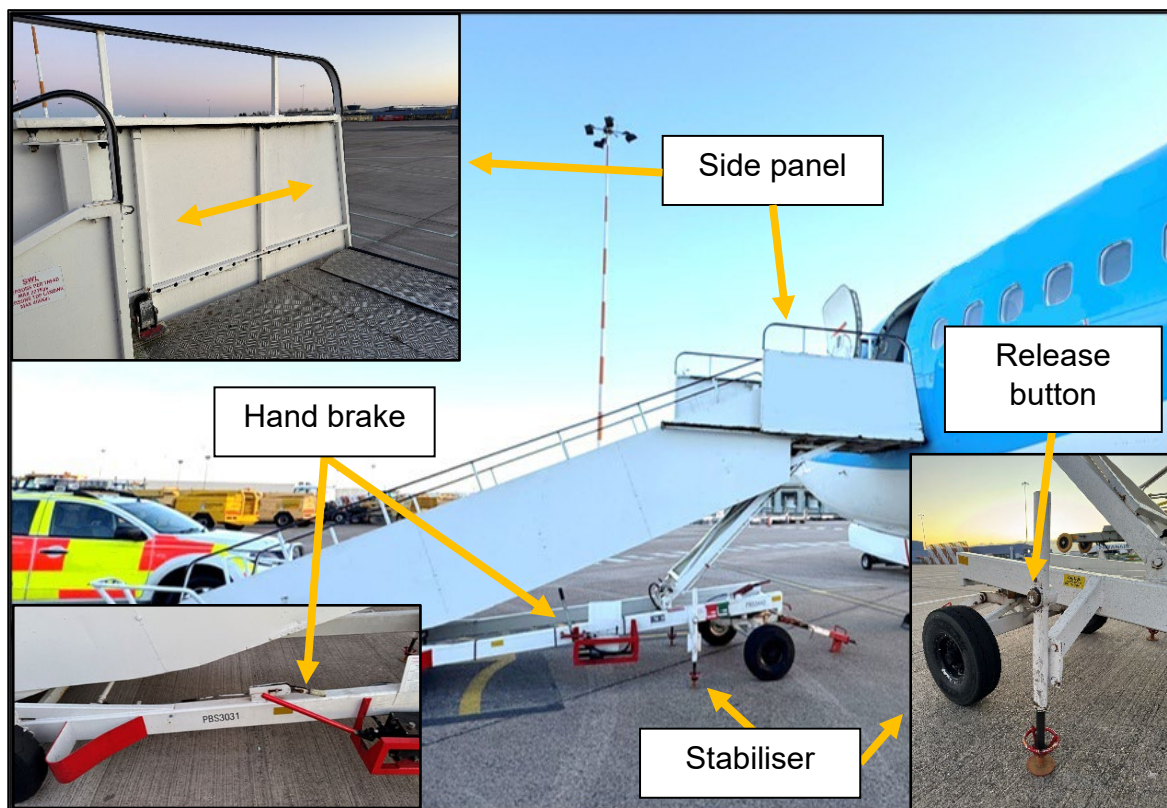
**Figure 3**

The ground handling company had several different types of steps available at East Midlands suitable for use with the front and rear doors of a B737. The main differences between the types are related to the safety barriers and available power sources. The steps positioned at the front of G-TAWB were the most basic available and were a set of Skway Towable Passenger Stairs (Figure 3).

Features of Skyway Towable Passenger Stairs

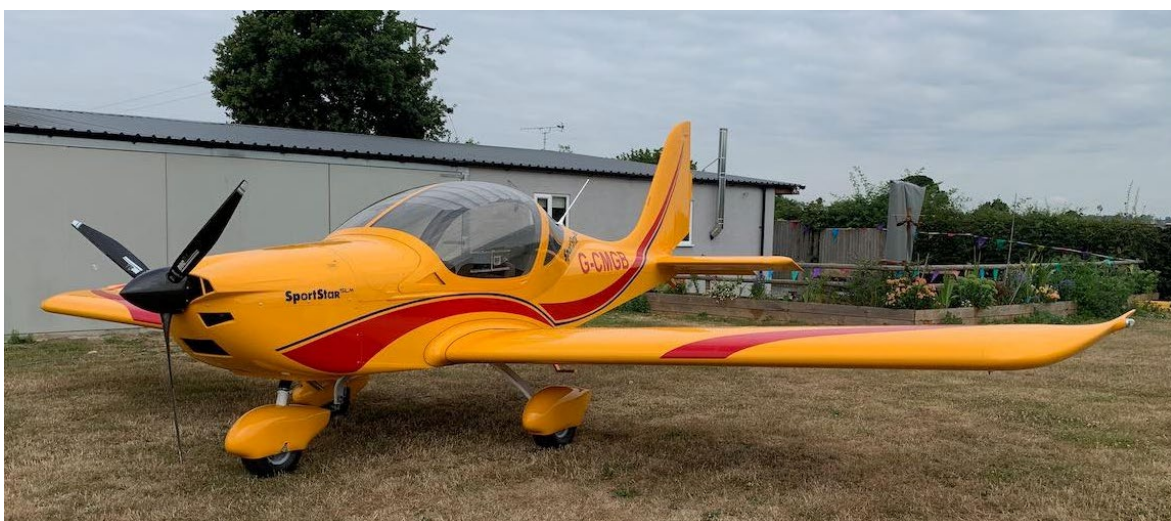
**Figure 4**

The Evektor Sportstar SLM is a two-seat microlight designed in the Czech Republic (Figure 4).

G-CMGB (image used with permission)

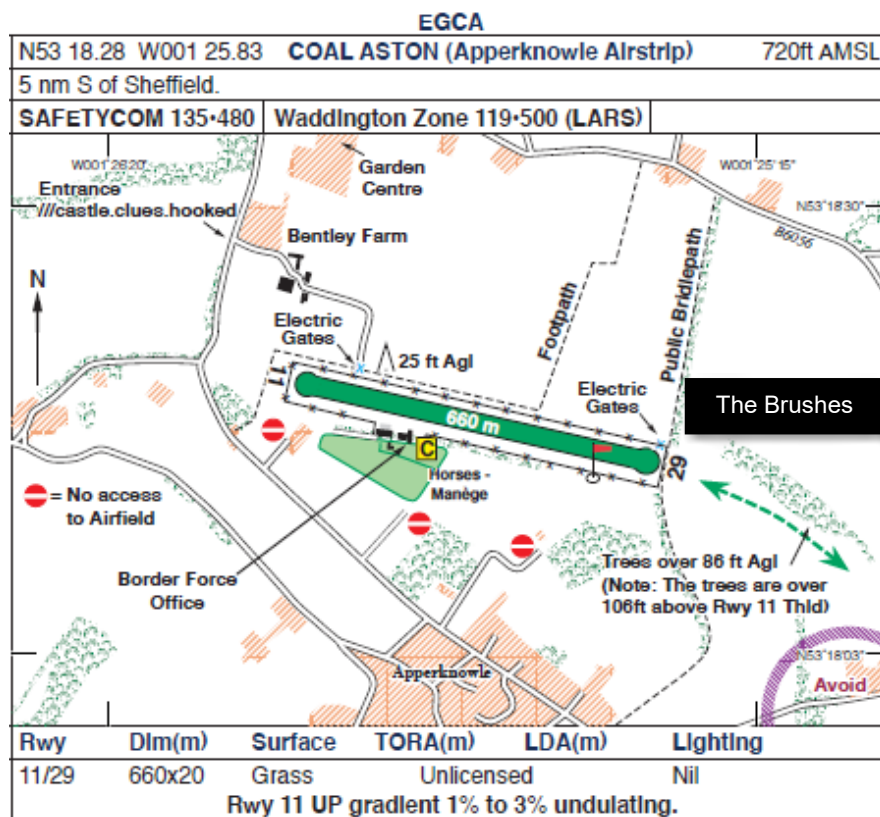
**Figure 5**  
Coal Aston Airfield

Coal Aston is a privately owned and unlicensed airfield located nine km south of Sheffield at an elevation of 720 ft amsl (Figure 5). Beyond the threshold of Runway 29 there is a copse of trees, The Brushes, that are 106 ft agl, measured at the threshold of Runway 11 (Figure 6), and 600 m from the airfield office (Border Force Office).

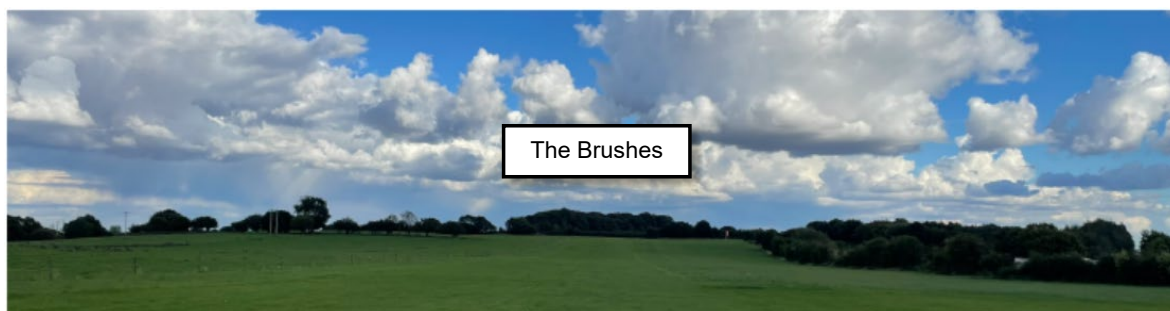
**Figure 6**

Coal Aston Airfield looking along Runway 11 towards The Brushes

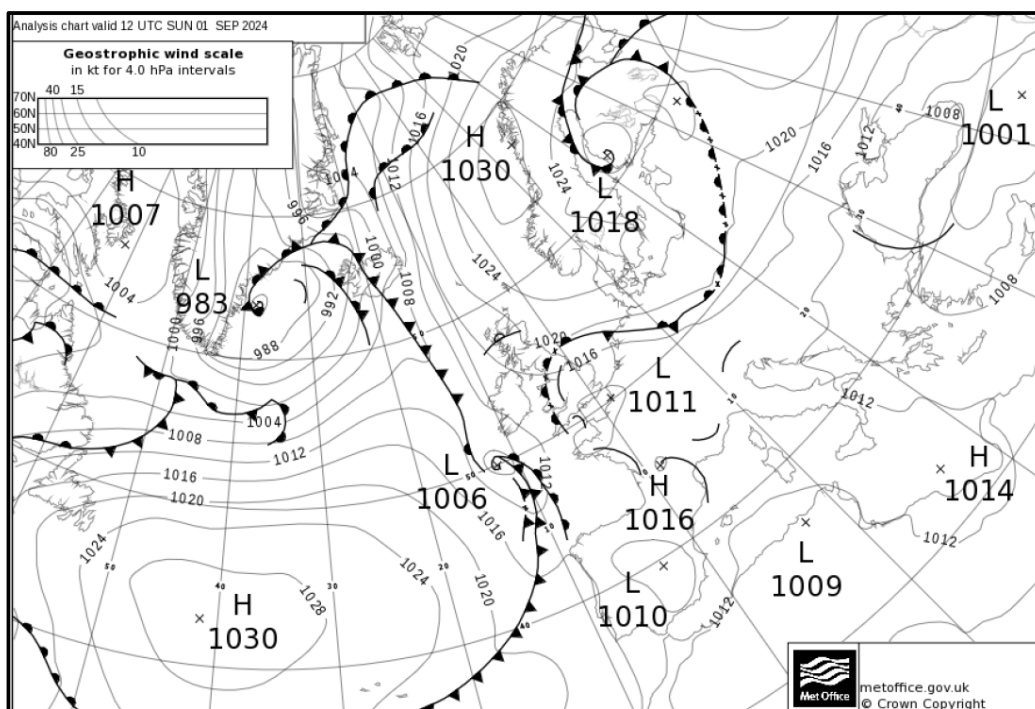
**Figure 7**

The Surface Analysis Chart published by the Met Office, valid for 1200 hrs on Sunday 1 September 2024 (Figure 7), showed an area of low pressure over northern France with a light easterly airflow across the planned route. There was a weakening warm frontal system heading north, slowly clearing the area of Coal Aston.

Surface Analysis Chart valid 1200 hrs Sunday 01 September 2024

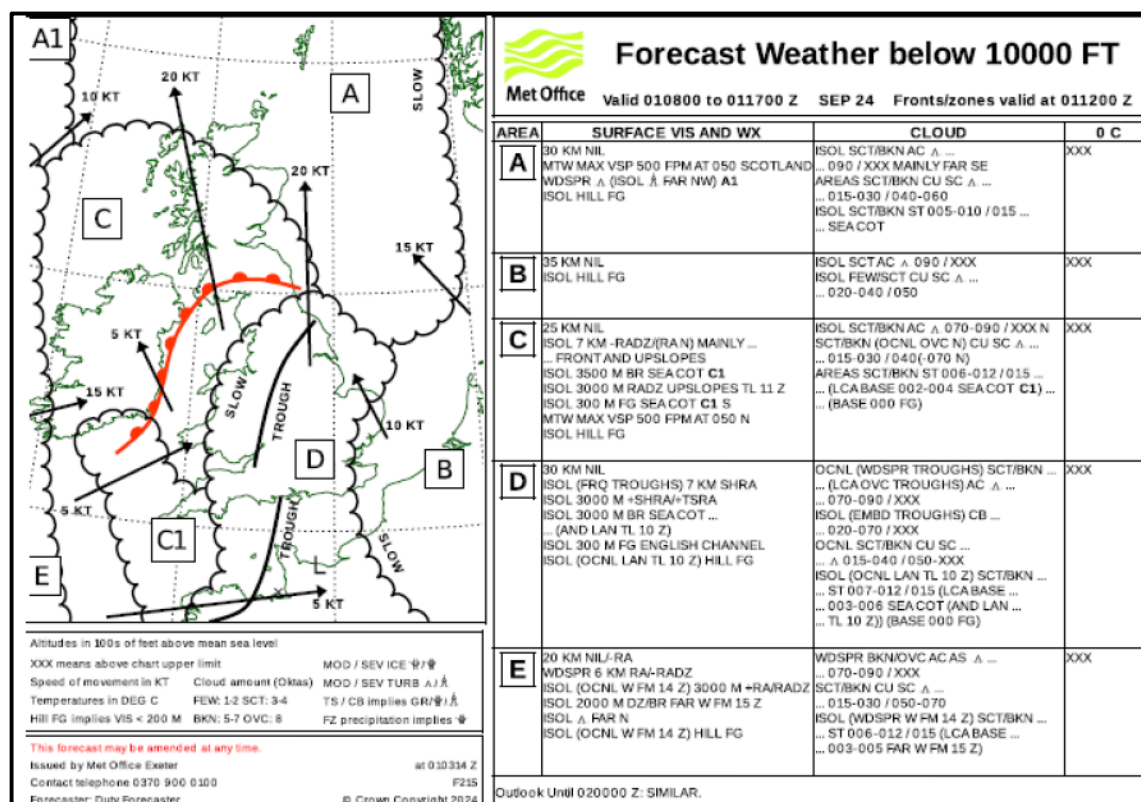
Figure 8

The Met Office published a Low Level Significant Weather Chart (Form 215 – Figure 8) at 0314 hrs on Sunday 1 September 2024 (valid for 0800 to 1700 hrs). The flight was planned to be conducted within Area D.

F215 Low Level Significant Weather Chart for 0800 to 1700 hrs 1 September 2024
