## Abbreviated Vibration Monitoring Report

Monitoring Period: 29 September 2025 to 02 November 2025

| <b>Project:</b> | Grenfell Tower |
| <b>Document Ref:</b> | EEMC-VMR-201/102 – Grenfell Tower Rev 02 |

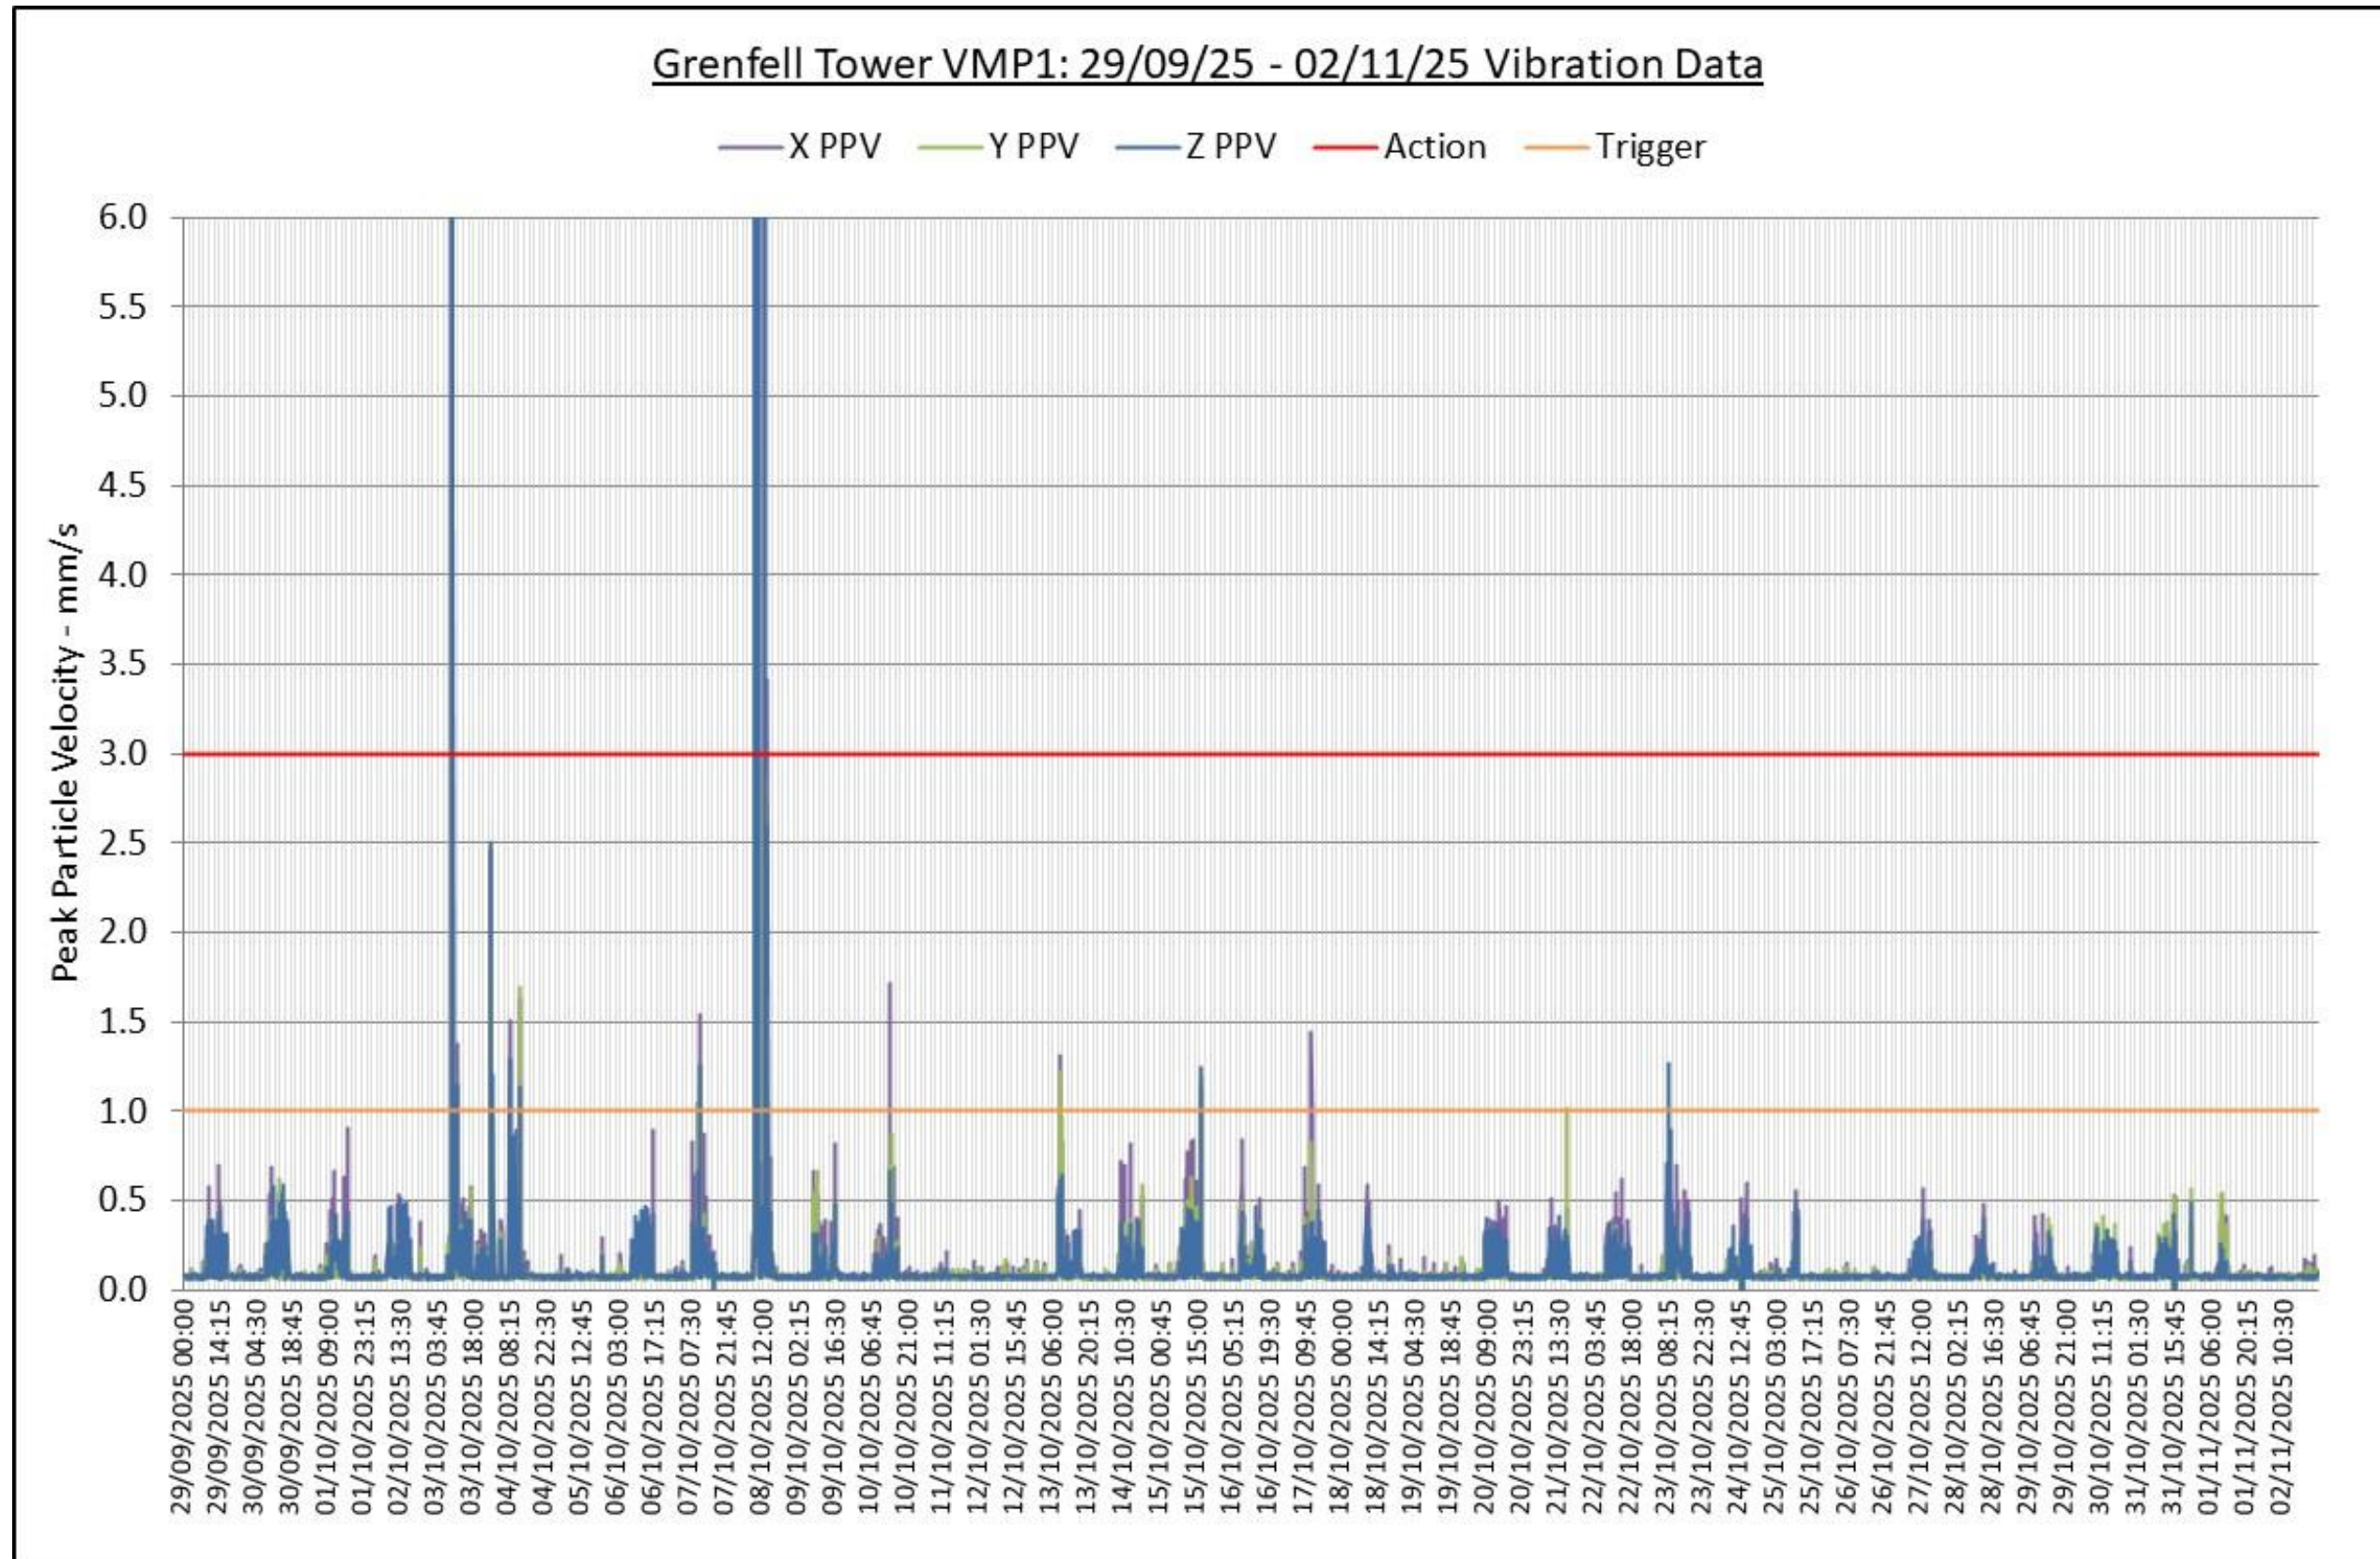
### At VMP1:

- There were **seven (7) exceedances** of the **Red Action level 3.0mm/s** and **twenty-six (26) further exceedances** of the **Amber Trigger Level 1.0mm/s** during working hours in this reporting period including three (3) exceedances that occur outside of working hours.

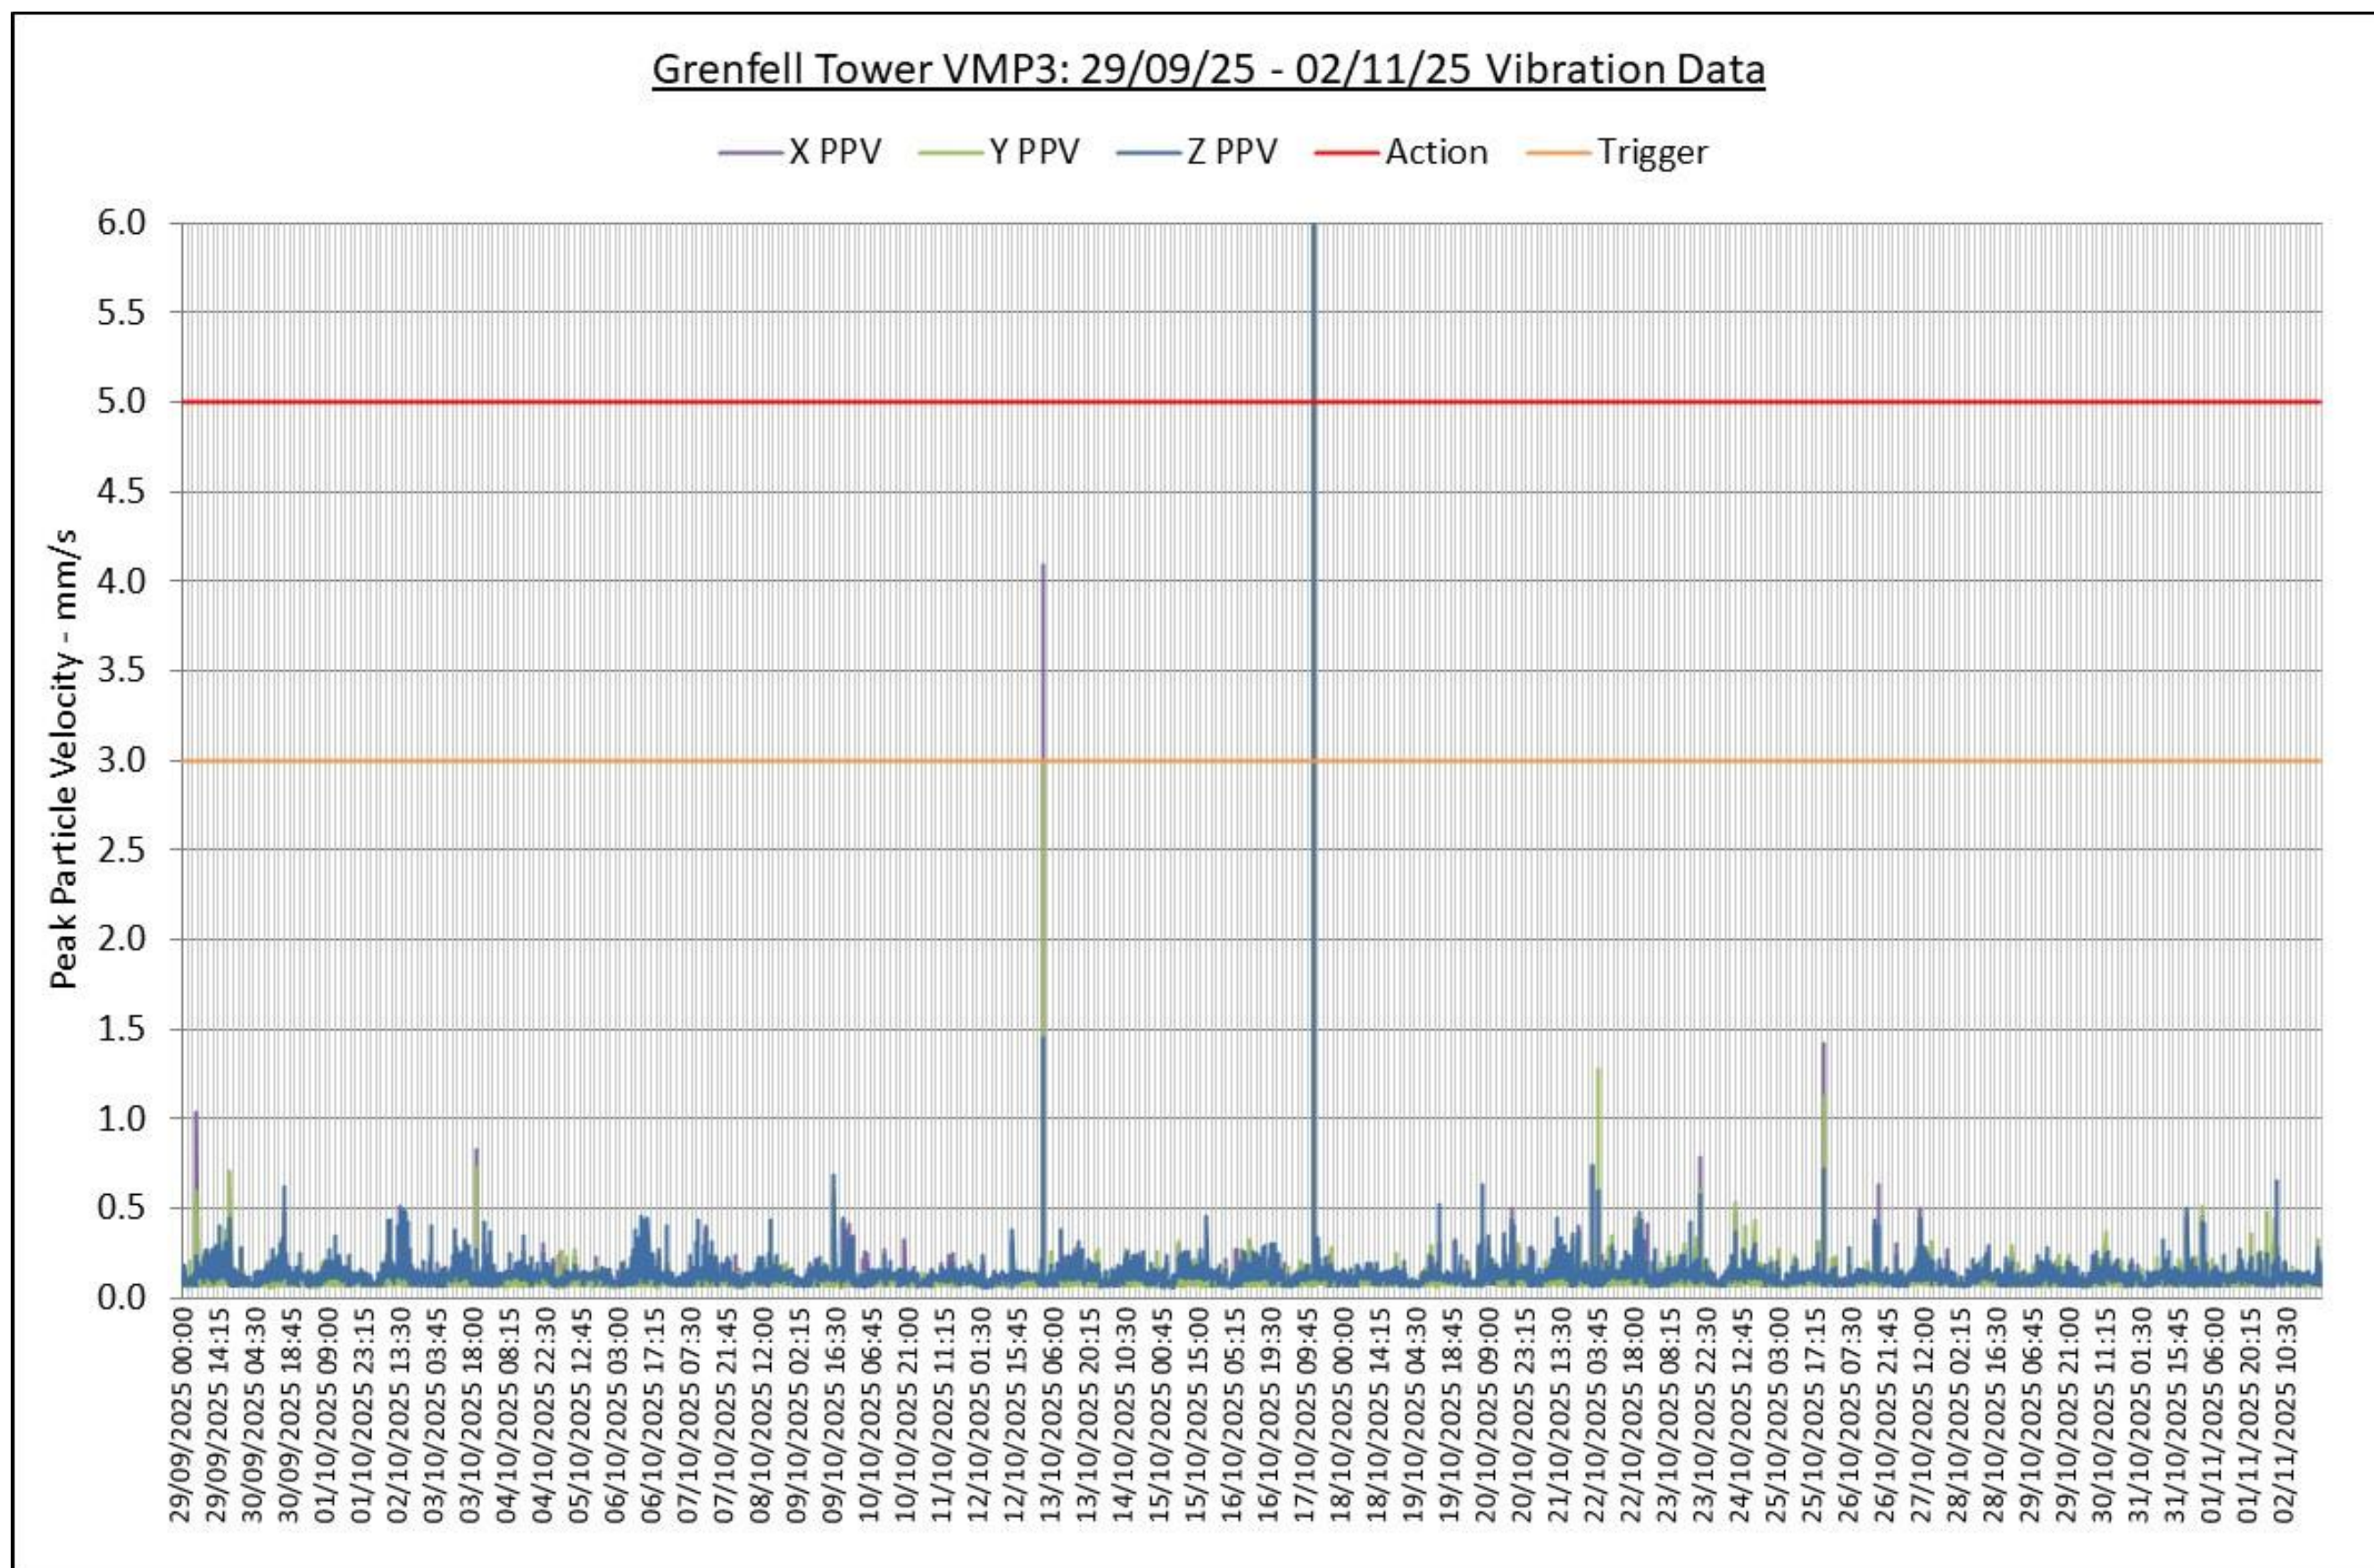
### At VMP3:

- There were **two (2) exceedances** of the **Red Action Level 5.0mm/s**, and **no exceedances** of the **Amber Trigger level** in this reporting period. However, there was one (1) exceedance of the Amber Trigger Level outside of typical site working hours.

| VMP3 | 17/10/2025 12:20 | 41.92 | | Exceedances caused during routine maintenance of the monitor. | |
| | 17/10/2025 12:25 | 17.18 | | | |
