Rail Accident Report

Fatal accident at Stratford London Underground station 26 December 2023

Report 01/2025
January 2025

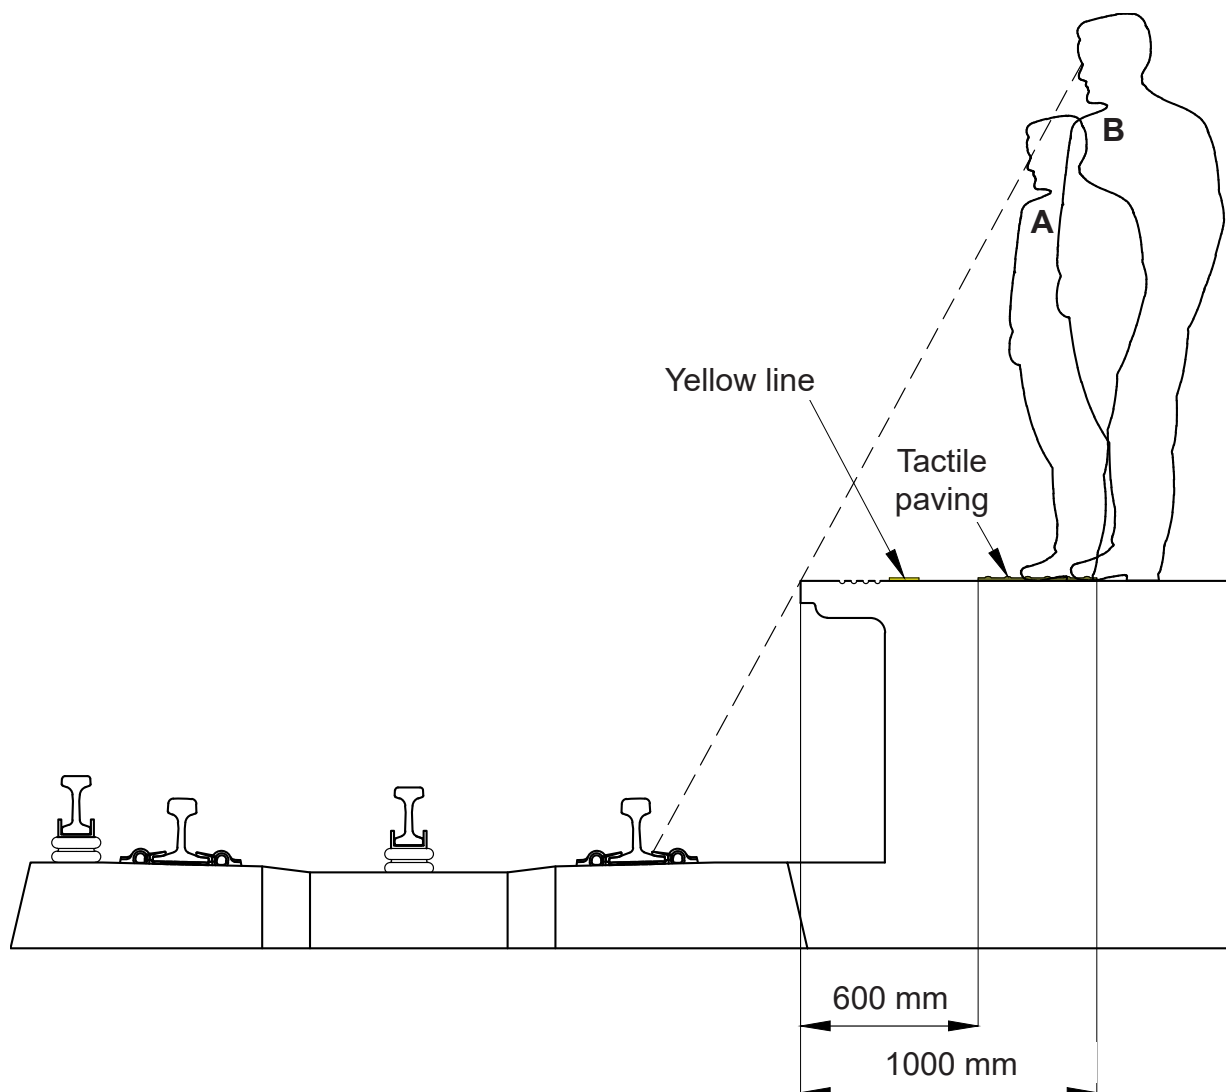
- 61 RAIB undertook a reconstruction to understand how visible the passenger on the track would have been to people on platform 13. Due to the location and orientation of the passenger, a person standing on the platform would need to be standing at, or near to, the platform edge to be able to see the passenger. The reconstruction showed that the distance from the platform edge that someone would be required to stand to see the closest running rail ranged from around 0.8 metres for someone who is 5 feet (1.52 metres) tall to 0.95 metres for someone who is 6 feet (1.83 metres) tall (figure 6).

Figure 6: Diagram showing sighting angles and distances of a 5ft (1.52 m) person (A), and a 6ft (1.83 m) person (B).

- 67 Station CCTV footage shows that TO2 entered platform 13 at 14:50 around 5 minutes after the passenger fell onto the track. On entering the platform, TO2 saw the passenger's bag and applied the standard TfL procedure for dealing with unattended property (paragraph 37). CCTV footage shows that TO2 did not look towards the track while doing this. As the bag was located around 1.5 metres from the platform edge, TO2 would not have been able to see the passenger even if they had looked towards the track at this point (paragraph 61 and figure 6). TO2 later stated that they were unaware of the passenger.
