Accident

Aircraft Type and Registration:	Spitfire Mk 26B, G-ENAA	
No & Type of Engines:	1 Isuzu V6 piston engine	
Year of Manufacture:	2013 (Serial no: LAA 324-15097)	
Date & Time (UTC):	28 July 2024 at 1258 hrs	
Location:	Enstone Airfield, West Oxfordshire	
Type of Flight:	Private	
Persons on Board:	Crew - 1	Passengers - None
Injuries:	Crew - 1 (Fatal)	Passengers - N/A
Nature of Damage:	Aircraft destroyed	
Commander's Licence:	Airline Transport Pilot's Licence	
Commander's Age:	71 years	
Commander's Flying Experience:	21,740 hours (of which 19 were on type) Last 90 days - 2 hours Last 28 days - 1 hours	
Information Source:	AAIB Field Investigation

Synopsis

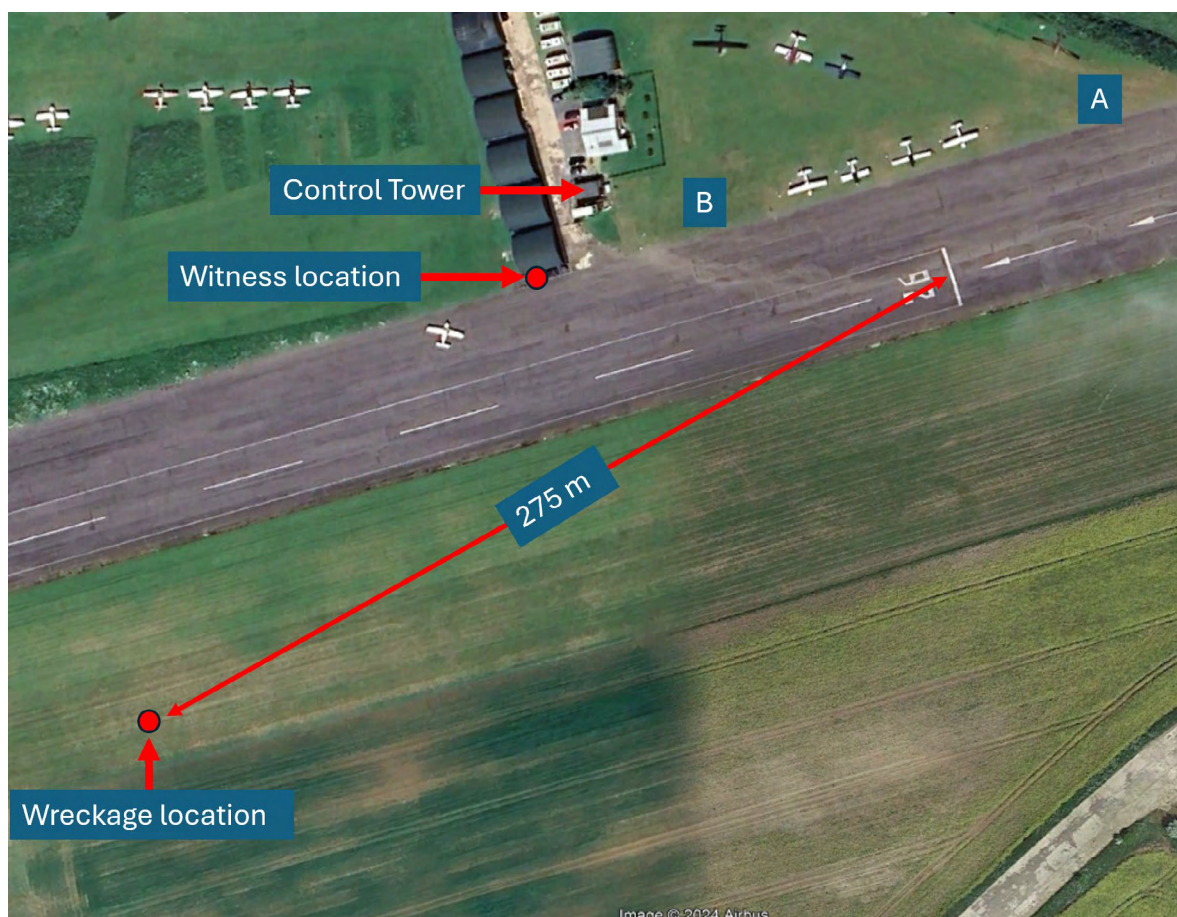
Figure 2

The aircraft came to rest at the southern edge of the south side grass Runway 26, approximately 45 m from the edge of tarmac Runway 26. The ground marks showed that the left wingtip struck the ground first, followed by the propeller and engine. Distinct propeller strikes on the ground indicated propeller rotation at the time of impact. The impact sequence was dynamic, with the right wing then striking the ground before the aircraft came to rest inverted. An intense post-crash fire, centred on the cockpit, caused extensive damage to the central part of the aircraft and engine bay.

Relative position of control tower, taxi points A and B, witness and wreckage

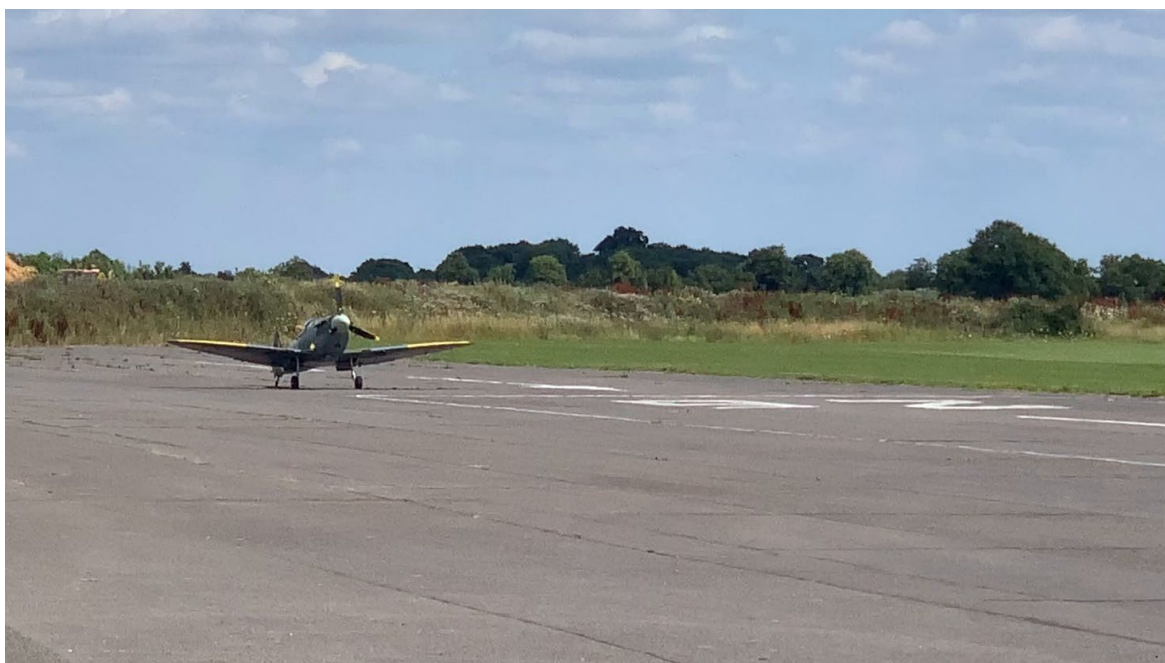
Figure 3

The aircraft commenced taxiing towards Runway 26 at 1251:25 hrs from its parked position adjacent to the control tower. It taxied along the grass parking area to taxi point A, where it stopped short of the runway. The aircraft then remained stationary, consistent with pre-takeoff checks being performed, before the pilot transmitted at 1256:37 hrs that he was ready for departure. The flaps could be seen to be deployed but it was not possible at this point in the recordings to confirm their position. The radio operator advised that the surface wind was from 220° at 5 kt, which the pilot acknowledged; no further radio transmissions were received from the pilot. The wind direction and speed were consistent with the recorded footage of the airfield's windsock captured by the CCTV and witness video recordings. The aircraft then taxied to the runway where it was aligned to the right of the runway's centre line (Figure 3). At 1257:23 hrs the pilot commenced the takeoff run and the aircraft started to accelerate.

Aircraft at start of takeoff run

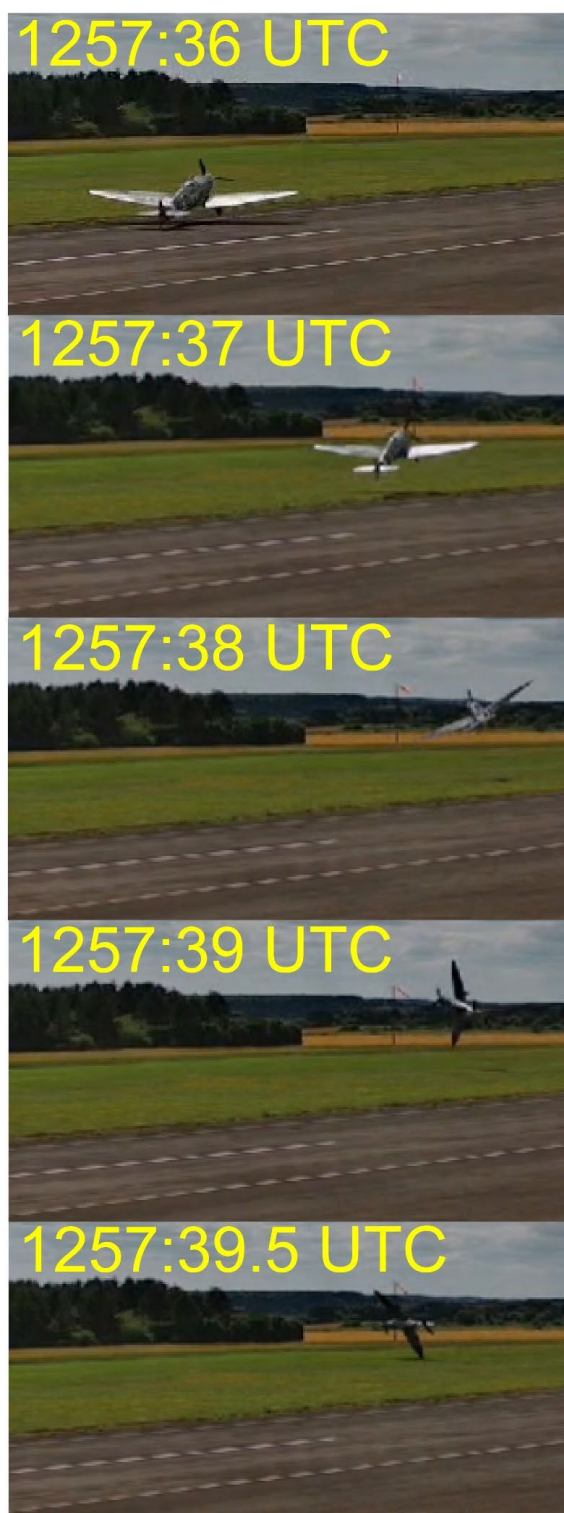
Figure 11
CCTV image sequence

The aircraft's ailerons were then observed to move to a right roll position (left aileron surface down / right aileron surface up) (Figure 10) but the aircraft continued rolling left. The footage of the aircraft captured by the witness ended shortly after this point but the continuing flight path of the aircraft was recorded by one of the CCTV cameras (Figure 11). When the aircraft's bank angle reached about 30°, its pitch attitude briefly stabilised at about 15° nose-up but as the bank angle reached about 40° the roll rate increased quickly to about 70°/s. The aircraft's nose started to drop and the aircraft descended, with the bank angle reaching about 120° before the aircraft struck the ground, left wingtip first, at 1257:40 hrs.

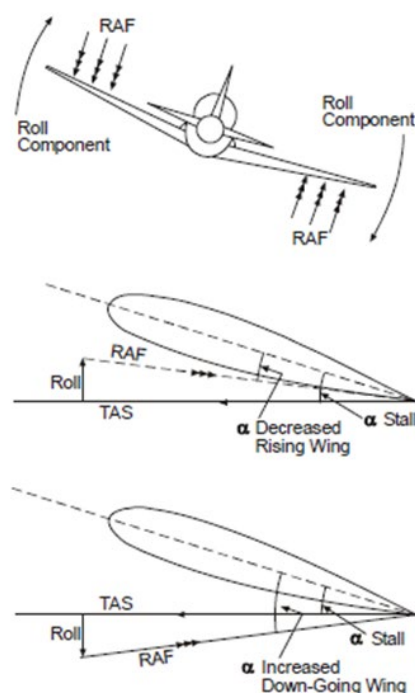
**Figure 14**

Change of angle of attack with roll

As an aircraft rolls, the angle of attack on the down going wing is increased. The lift produced by a wing will increase with angle of attack up until the point of a stall. If angle of attack continues to increase beyond the stalling angle then the coefficient of lift (C_L) on the wing will decrease and so exacerbate the roll. Deflecting ailerons downward increases the angle of attack of a wing, so any attempt to use them in the usual sense post stall will increase rather than correct any roll. As angle of attack increases, the coefficient of drag (C_D) produced by a wing also increases. So, if an aircraft rolls left post stall, the lift from the left wing will continue to reduce while the drag increases. The result of these two effects is the roll will increase, and the aircraft will yaw to the left. These effects are illustrated in Figure 15.

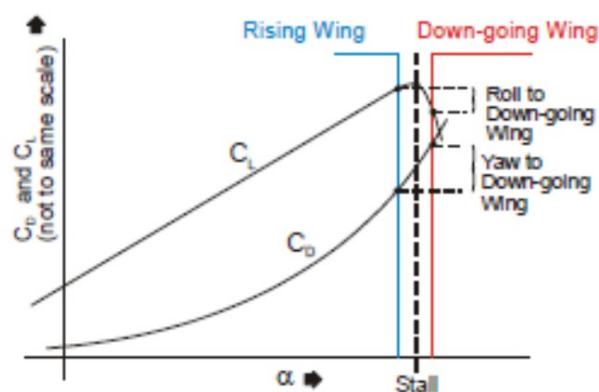
**Figure 15**

Variation of lift and drag with angle of attack
