AAIB Bulletin

12/2025

Aircraft Type and Registration:	Cessna T210M, N761JU	
No & Type of Engines:	1 Continental TSIO-520-R piston engine	
Year of Manufacture:	1977 (Serial no: 21062300)	
Date & Time (UTC):	11 April 2024 at 1609 hrs	
Location:	Leeds East Airport	
Type of Flight:	Private	
Persons on Board:	Crew - 1	Passengers - 1
Injuries:	Crew - 1 (Minor)	Passengers - 1 (Fatal)
Nature of Damage:	Propeller and nose landing gear damaged. Structural damage from becoming inverted. Aircraft damaged beyond repair	
Commander's Licence:	UK Private Pilot's Licence (Aeroplanes) and FAA Private's Pilot's Licence (Foreign Based)	
Commander's Age:	79 years	
Commander's Flying Experience:	1,378 hours (of which 62 were on type) Last 90 days - 10 hours Last 28 days - 5 hours	
Information Source:	AAIB Field Investigation

An undetected pitch trim setting resulted in the pilot attempting to takeoff with close to full NOSE DOWN elevator trim. The pilot rejected the takeoff, whereupon the aircraft briefly became airborne, but the pilot was unable to effectively control the aircraft in pitch. The aircraft bounced several times causing the aircraft's nosewheel to fail and the aircraft to slew off the r

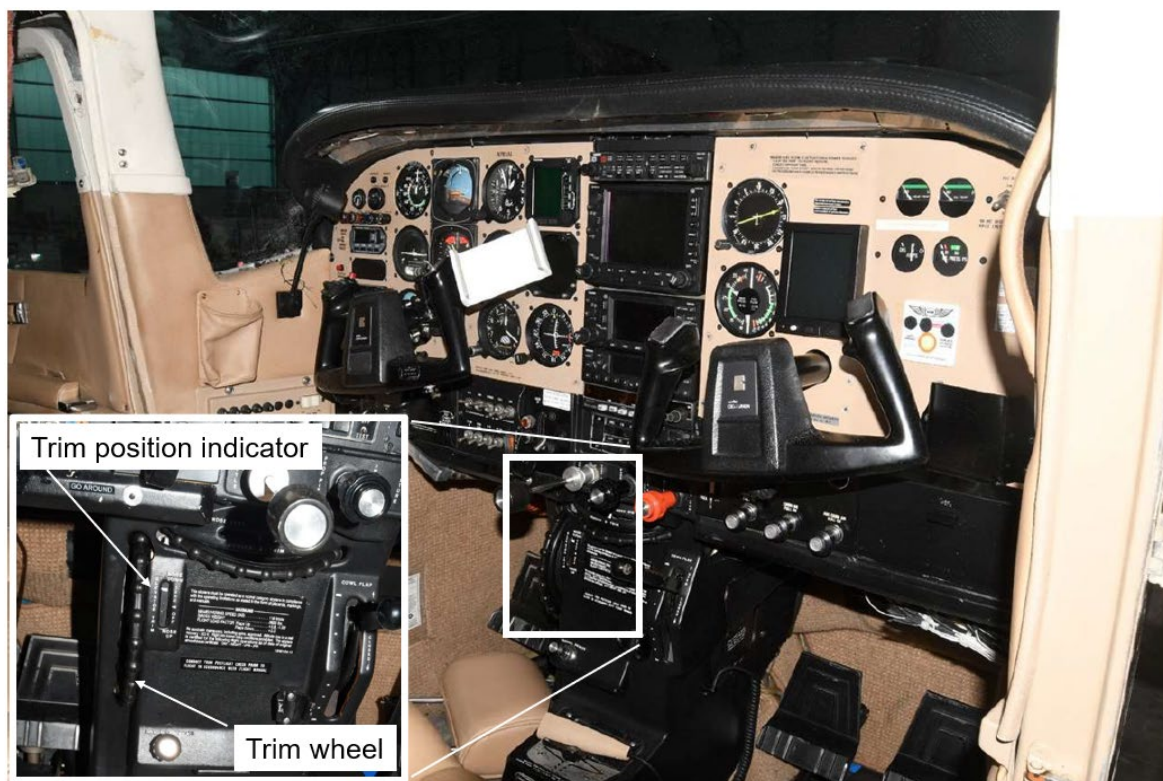
Figure 7

N761JU was a Cessna T210M which is a high wing, six seat GA aircraft with a turbo-charged Continental TSIO-520-R piston engine and a variable pitch three bladed propeller. It is fitted with conventional flying surfaces which are operated via steel cables and pulleys. The aircraft is trimmed in pitch by a trim tab fitted to the right elevator and is moved by a pitch trim wheel operating a series of cables. The trim wheel is a black hard moulded plastic wheel, with 24 evenly spaced tactile bumps spaced equally around the circumference. A trim position indicator is positioned adjacent to the trim wheel (Figure 7) in the cockpit on the centre pedestal. It is labelled NOSE UP, NOSE DOWN and TAKE OFF.

The full NOSE UP, full NOSE DOWN and TAKE OFF trim tab deflections were measured relative to the neutral position on the elevator. The TAKE OFF position corresponded to a 4° upwards trim tab deflection, with NOSE DOWN corresponding to a 24° upwards deflection. Full NOSE UP deflection corresponded to the trim tab deflecting 10° down relative to the elevator surface. From the neutral position the trim wheel turns two full revolutions to NOSE UP and one and half revolutions to NOSE DOWN.

Location of the aircraft's elevator trim wheel and position indicator

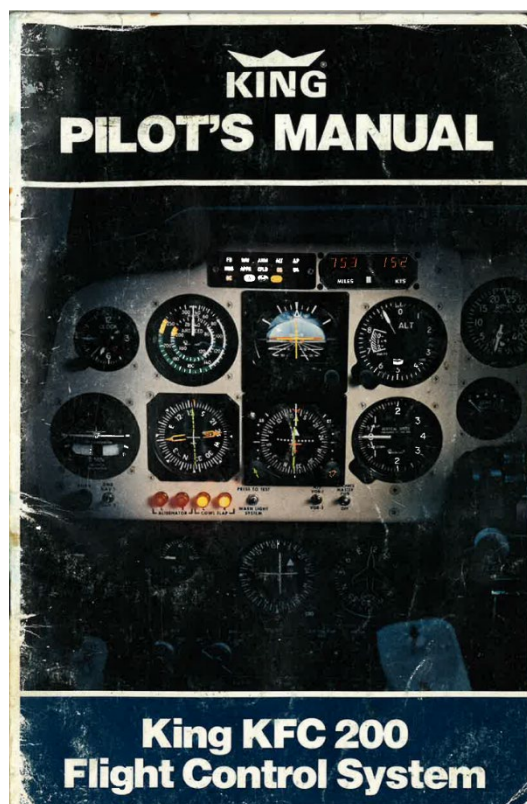
Figure 8

Despite mention of the supplement in the STC, the supplements section of the POH did not include reference to, or guidance for, the installed KFC 200 autopilot system. Nonetheless, filed in the POH binder was a standalone '*Pilot's Manual*' for the '*King KFC 200 Flight Control System*' published by the King Radio Corporation (Figure 8). This manual did not contain a publication date or version number.

King Pilot's Manual for the KFC 200 Flight Control System

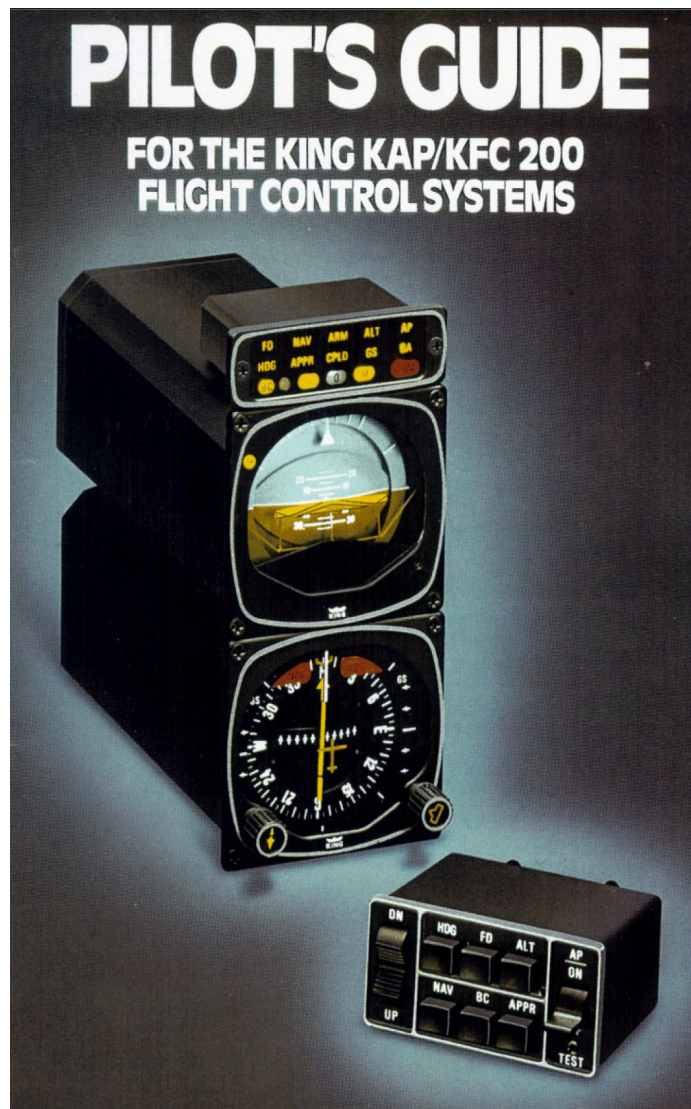
Figure 9

The investigation found a more comprehensive version of a manual on the manufacturer's website² (Figure 9). This document was also undated but contained additional information not included in the version found in the aircraft POH binder.

Expanded version of the King Pilot's Guide for the KAP/KFC 200 flight control systems

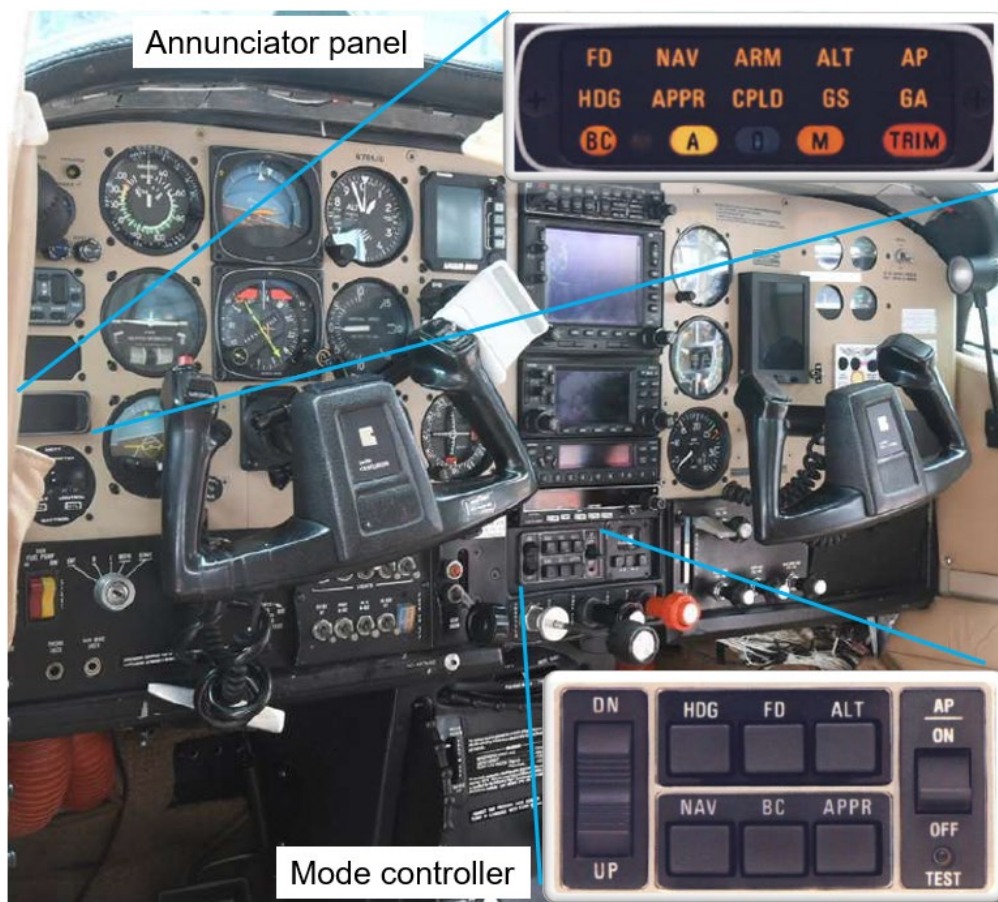
Figure 10

The primary autopilot interface is the mode controller situated in the lower centre of the instrument panel (Figure 10). Through this panel the different modes can be selected via push button switches, and the autopilot is engaged with a solenoid-held ON/OFF switch. This switch will return to OFF when power is removed by switching off either the aircraft or the avionics master switch. In the lower right corner of the controller is a pre-flight test switch.

Autopilot mode controller and annunciator panel

Fitted to the left side of the aircraft instrument panel is the autopilot annunciator panel (Figure 10) which displays to the pilot which modes have been selected and incorporates a TRIM failure warning light in the lower right corner. This warning light will illuminate when an auto-trim failure occurs or when the trim circuit breaker is pulled. During the pre-flight checks detailed in the King manuals, when the TEST button is pressed on the mode controller the TRIM warning light will flash at least four times to indicate proper operation of the auto-trim monitoring system.

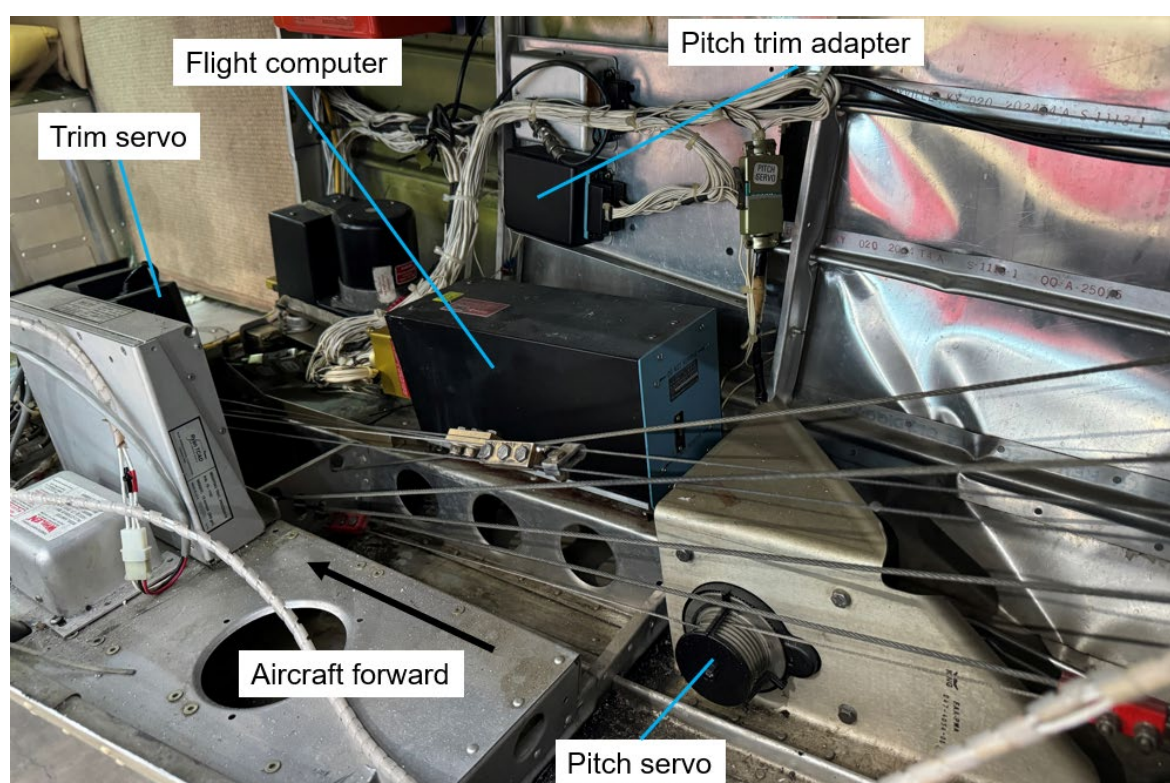
Figure 11

The physical installation of the autopilot consists of multiple electrical and electromechanical components, most of which are in the aft fuselage behind the passenger cabin (Figure 11).

Location of some of the autopilot components

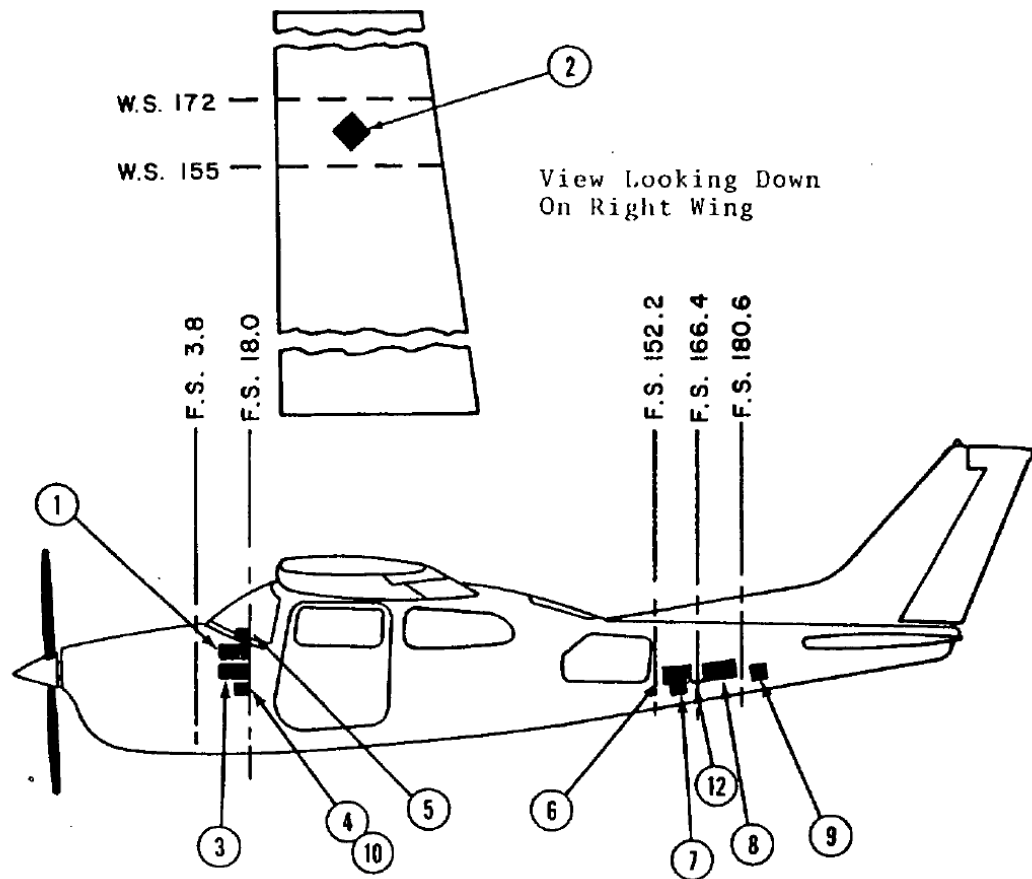
Figure 17

A survey of the aircraft revealed that the autopilot components installed were not in accordance with the STC for the Cessna T210M. Appendix 1 shows the components of the autopilot as referenced in the STC and what was found installed on the aircraft. No records were found to certify these variations and therefore it was assumed that this was the system installed in 1978 and had been operated in this configuration ever since.

Location of autopilot components (refer to Table 1)

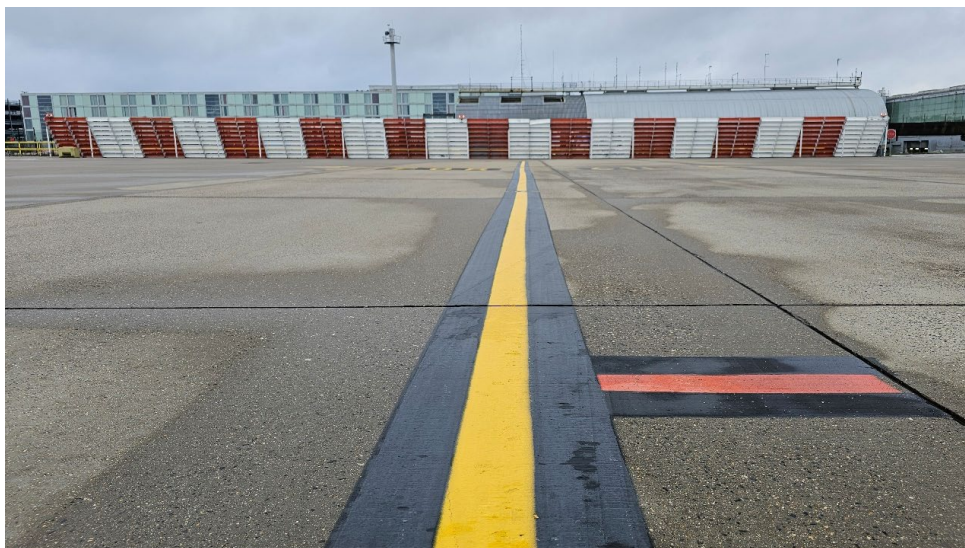
Figure 4

TRPs were introduced at Stansted in 2020. A TRP consisted of a 0.5 m red line, painted on one side of the taxiway line (Figure 4). They are used for Code C³ aircraft or smaller⁴. The TRP on Taxiway Delta is between Stands 61L and 61R. There is a 14.97 m clearance behind a B737-800 and the blast fence when its nosewheel is on the TRP.

Image of the TRP and blast fence around the time of the accident
