Report on the investigation of
the capsized and foundering of the prawn trawler

Odyssey (FR 70)

REPORT NO 17/2025

DECEMBER 2025

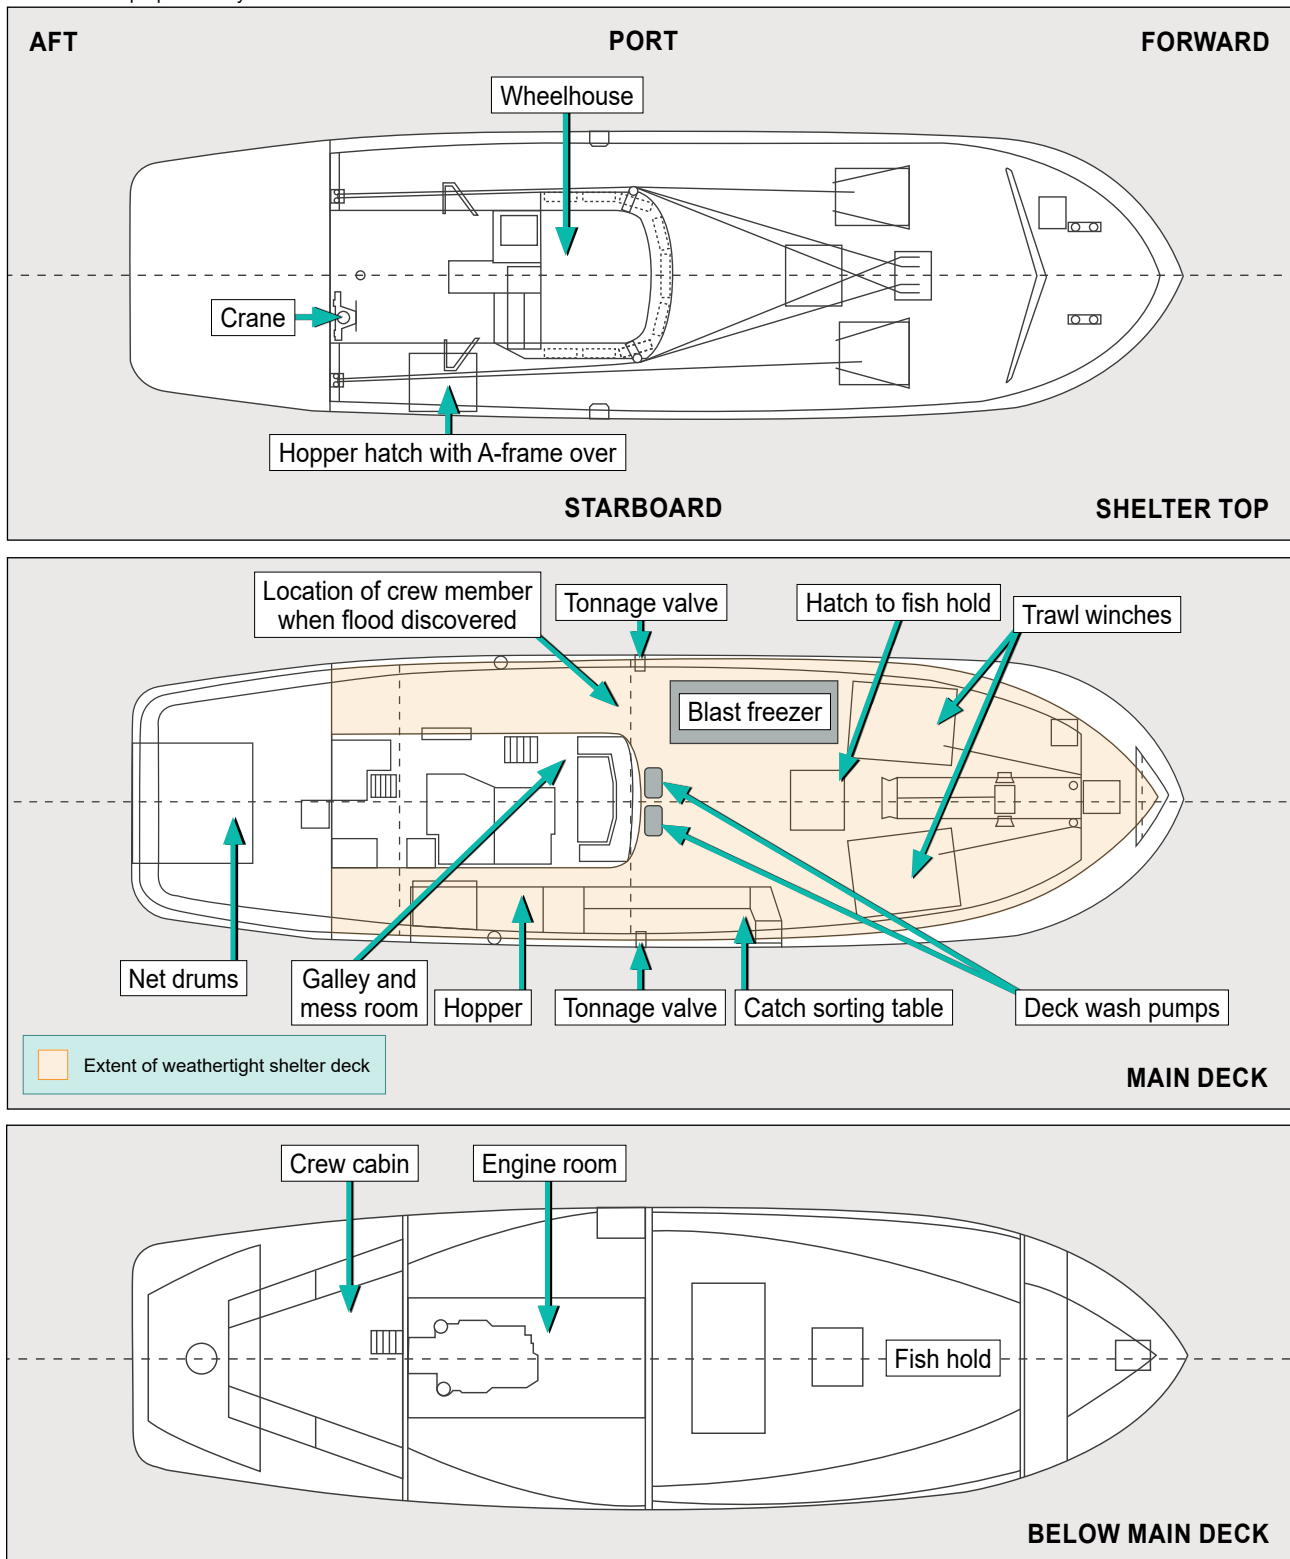
Figure 3: Vessel layout

Once the crew had finished sorting the catch in the weathertight shelter deck area, two deckhands would supervise the recovery of the trawl wires onto the winches. They would then go onto the shelter top and aft deck to assist with net recovery and to empty the catch into the hopper (**Figure 3**). The shelter deck would be left unattended for about 40 minutes during this operation.
