Rail Accident Report

Buffer stop collision at London Bridge station 13 December 2024

Report 09/2025
December 2025

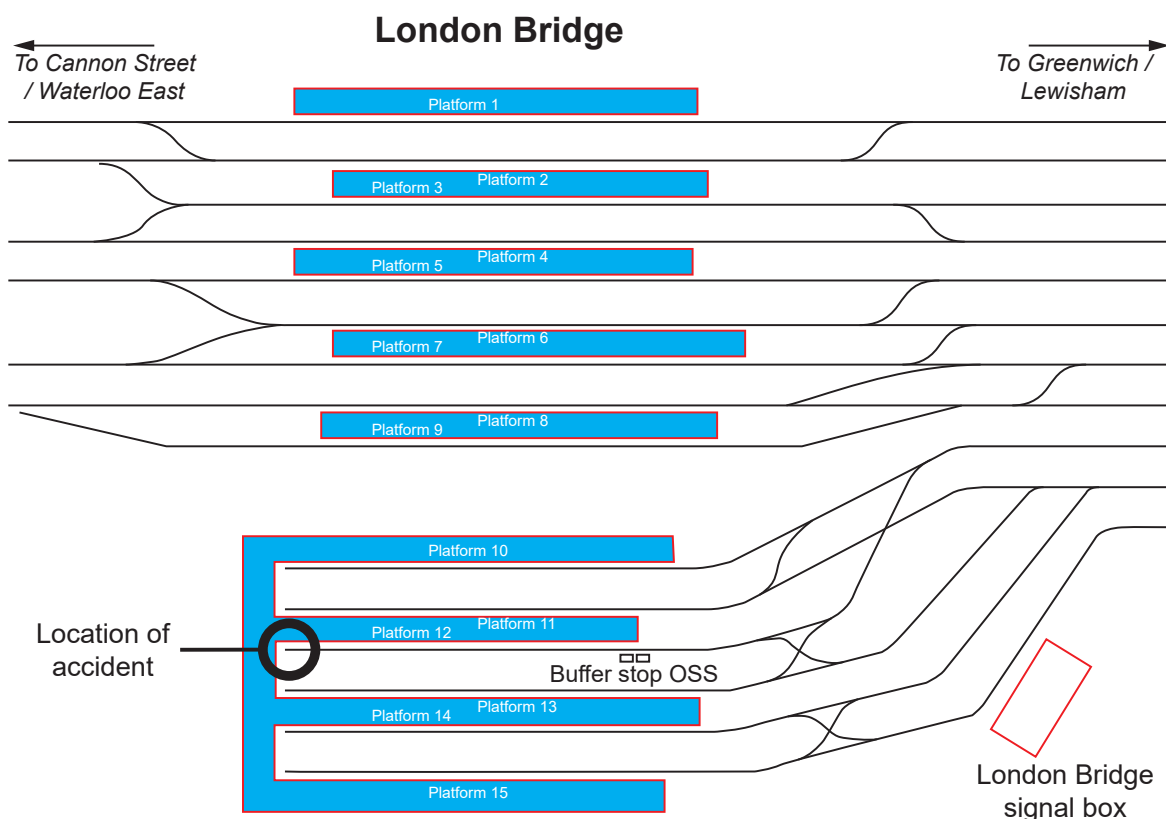
Figure 3: Simplified diagram of London Bridge station platform layout, showing platforms 1 to 15, highlighting the area of the buffer stops in platform 12, where the accident occurred.
