Rail Accident Report

Derailment of a freight train at Audenshaw, Greater Manchester 6 September 2024

Report 10/2025
December 2025

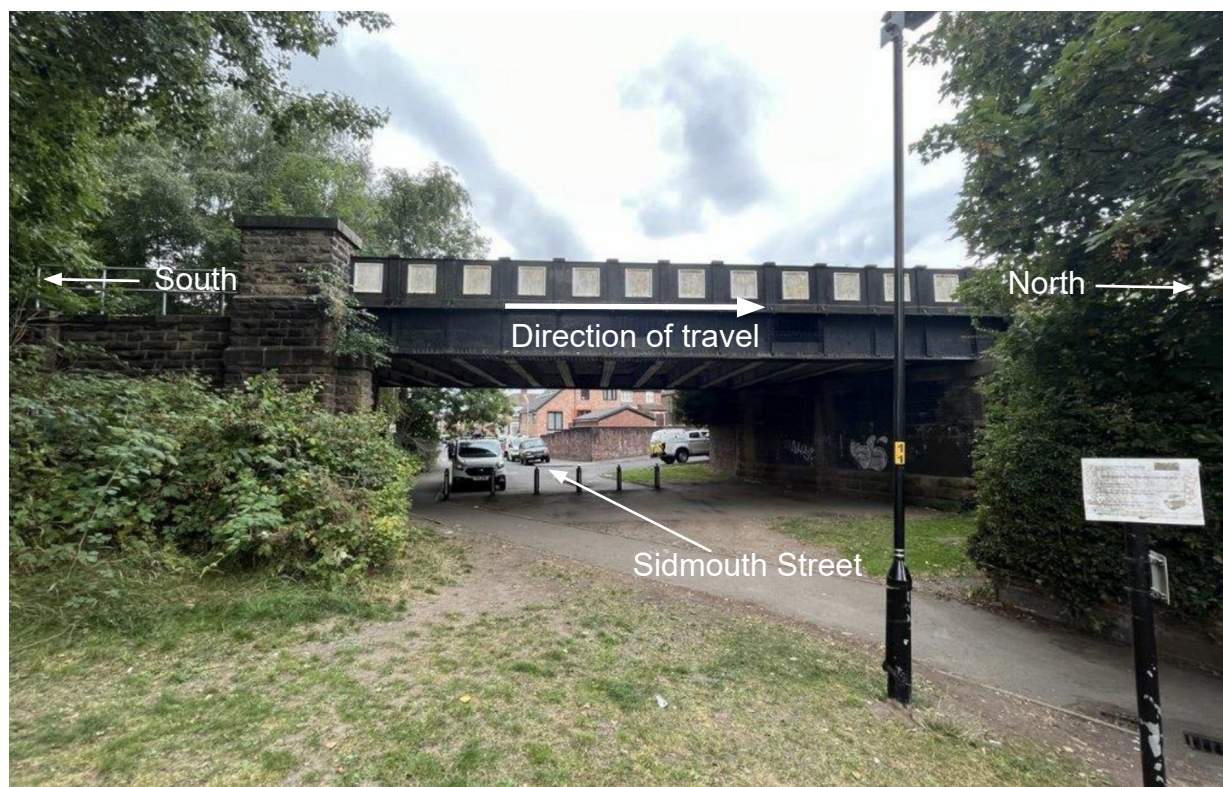
- 9 The derailment happened on a bridge, known as bridge 3, which carries a double track non-electrified railway over Sidmouth Street in Audenshaw. Sidmouth Street is a footpath at this location, closed to road traffic just before it passes under the bridge (figure 3). The tracks on both lines over the bridge are carried by a longitudinal bearer system (LBS).
- 10 Bridge 3 is located on the railway line between Denton Junction and Ashton Moss North Junction (4 miles 1083 yards to 4 miles 1105 yards, with a zero reference at Heaton Norris Junction, north of Stockport). The Network Rail reference for this section of line is DJO1, so Network Rail refers to the bridge as bridge DJO1/3.

Figure 3: The bridge from Sidmouth Street level (courtesy of Network Rail with RAIB annotations).

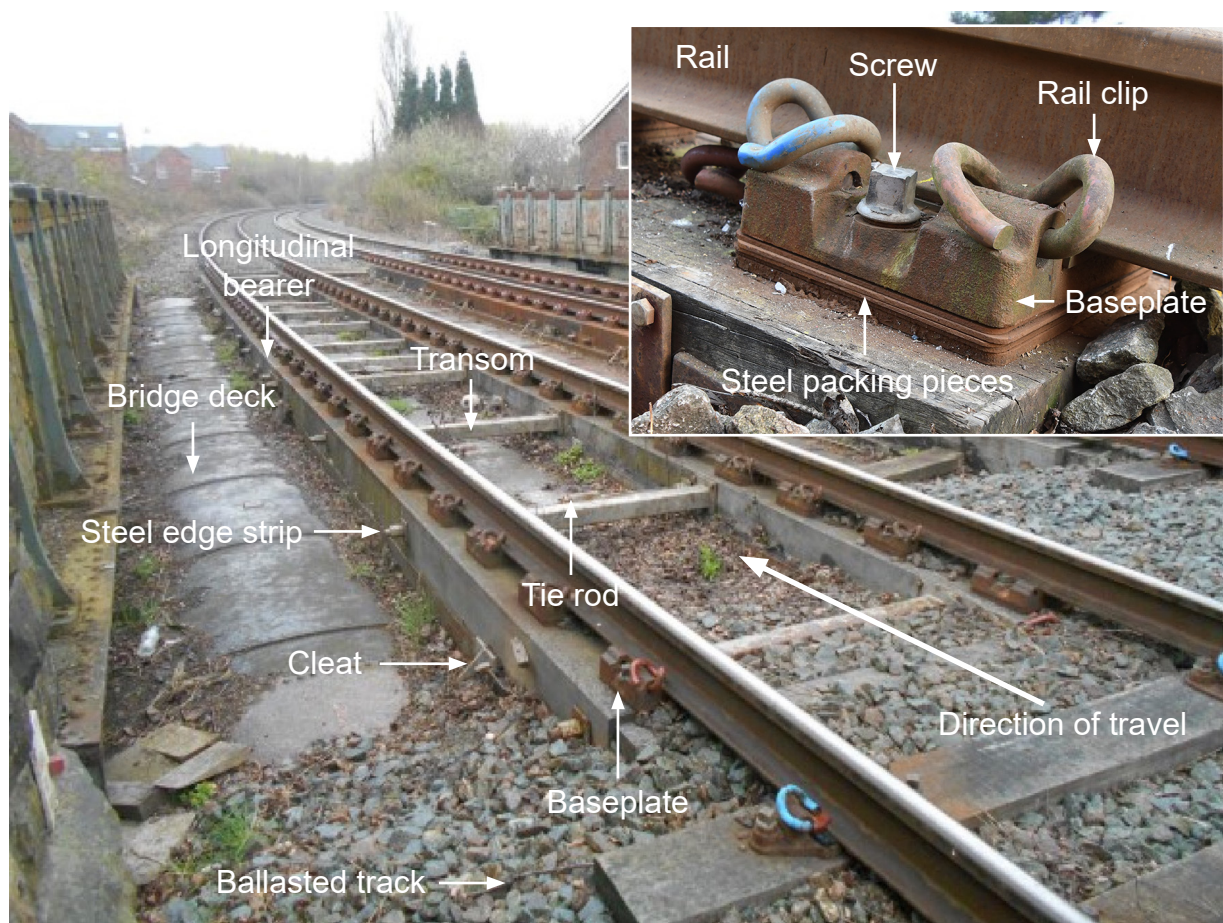
- 23 The main components of the LBS before the derailment are shown in figure 6. The LBS on the down line of bridge 3 comprised three longitudinal bearers (sometimes known as waybeams or wheel-timbers) running along the bridge under each rail, made from a hardwood timber known as Greenheart. The bearers of the south end section of the down line (which was at the point of derailment) were 6.5 m long, 280 mm deep and 410 mm wide.

- 24 The rails were seated on PAN M6 baseplates and held down by Pandrol PR401A/P402A rail clips. The baseplates were attached to the bearers using two LSA chair screws (referred to in the remainder of this report as 'screws') per plate, each fitted within a polymeric ferrule in the bossed hole of the baseplate. LSA screws are approximately 205 mm long, measured from under the head. They have a plain shank about 57 mm long, before a transition into the threaded part of the fastener. The markings on the heads of the screws recovered from site indicated that they were manufactured in 2021 and were of the normal grade of steel. Between the baseplates and the bearers over the full length of the LBS were varying thicknesses of steel packing pieces. These were used to achieve the track's designed cross-level (cant) of between 30 and 40 mm.

Figure 6: The main components of the LBS of the Down Crowthorne line on bridge 3 (courtesy of Network Rail with RAIB annotations).

- 61 Both the transoms and the tie rods between the left and right bearers were examined (figure 6). Although there was evidence of the retraction of some coach screws holding the transoms to the bearer's sides, there were no signs of significant gauge widening of the track related to the bearers spreading apart. All the threaded fastening components on the tie rods had been secured by welds, and apart from at one location, the welds were all intact. This, and the retraction of some of the transom coach screws, some of which were impacted by the wagons' wheels, is thought likely to have occurred as a result of the derailment.

- 121 The baseplates fitted to the LBS on the down line were of the PAN M6 type, which have only two screws per baseplate (figure 6). More common types of baseplates used on timber sleepers and bearers across the network (for example, the NRS2 baseplate) use three or four screws. At a basic engineering level, each screw in the baseplate assembly fitted to the down line will be subjected to a higher level of stress than one fitted in a three or four screw baseplate assembly under the same track loading conditions.

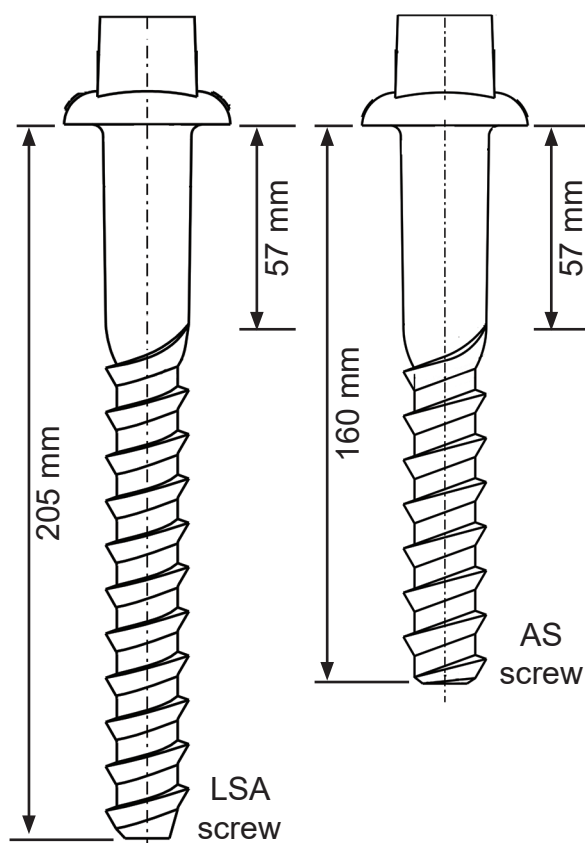
- 125 The screws fitted to the LBS at the time of the accident were of the LSA type. The more common type used across the network is known as an AS screw (figure 29). The LSA screws are longer than the AS type by around 45 mm, although the shanks (the plain, unthreaded portion under the head) are of an equal length. LSA screws are manufactured from both normal and high tensile grades of steel. Examinations of the markings on the head, and metallurgical testing, showed that those fitted to the LBS were of the normal grade.

Figure 29: LSA and AS screw comparison
(courtesy of Network Rail with RAIB annotations).

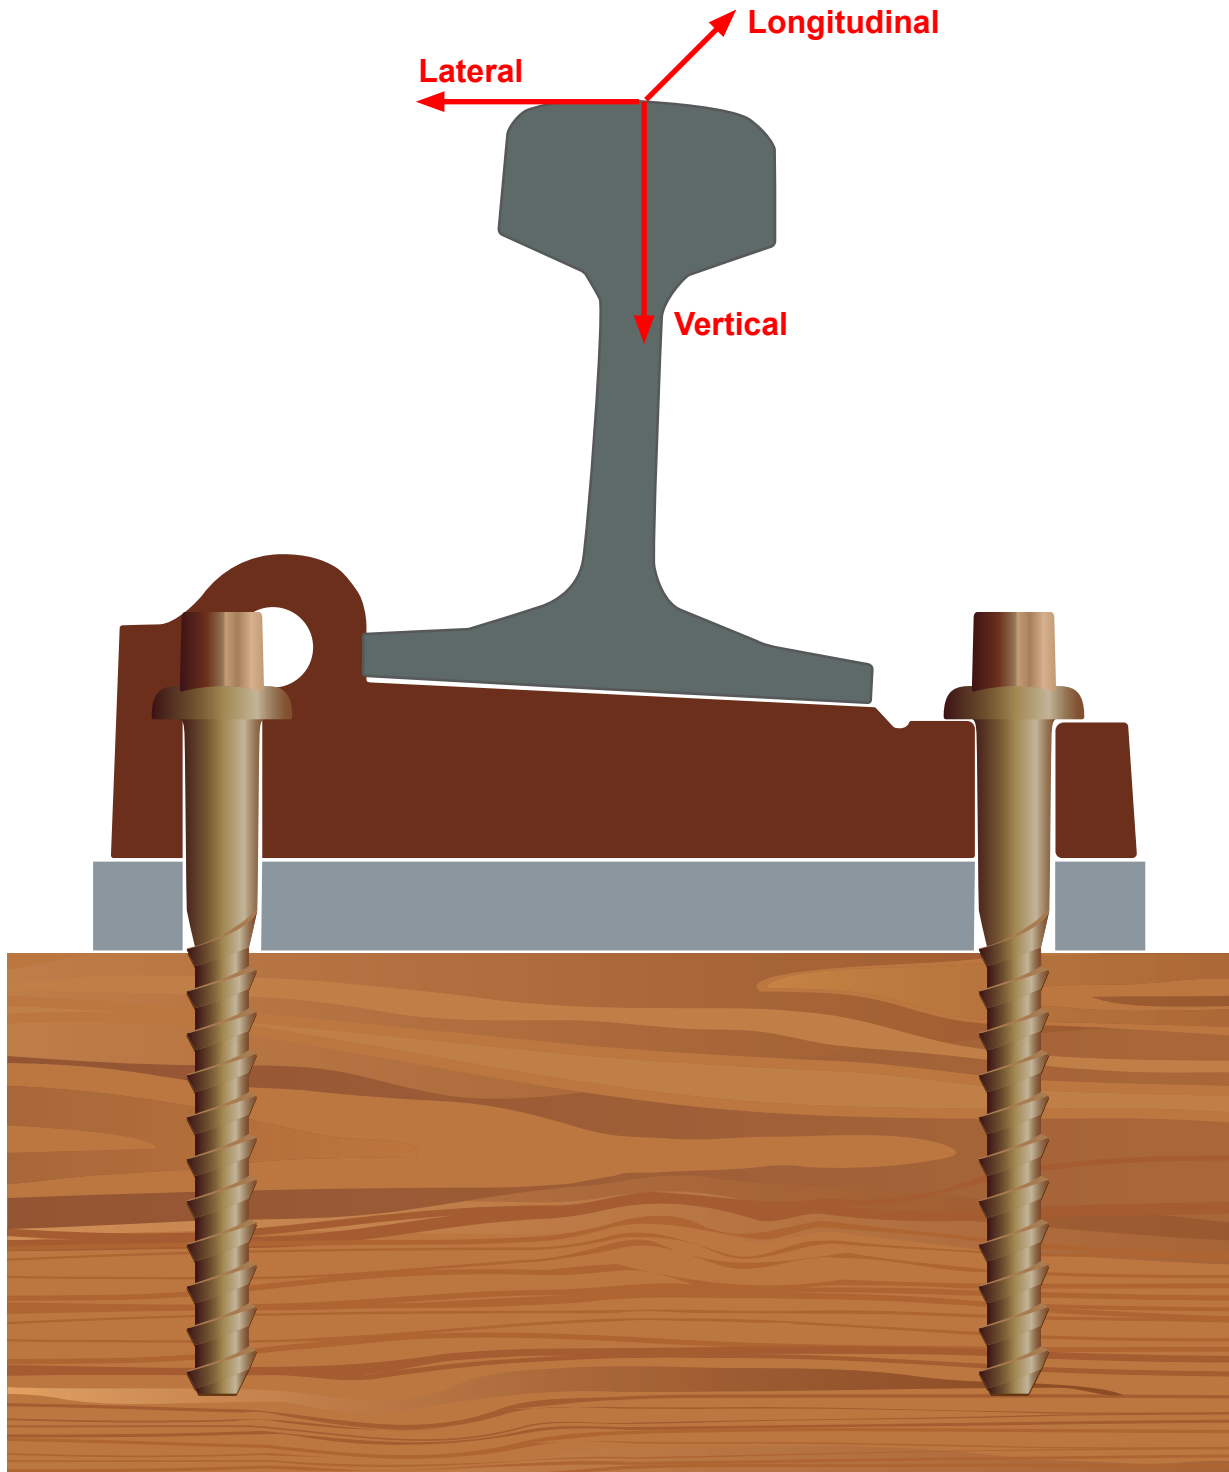
- 128 RAIB's assessment of the effect on the fatigue performance of the screws from the repeated dynamic forces applied by passing wheels on the top of the rail considered the forces in three directions (figure 30). These were:

Figure 30: The effect of the forces applied by passing wheels on the top of the rail in three directions.

- 130 When the lateral forces on the rail were considered, it was found that these significantly loaded the screws, in both axial and shear directions (figure 30). The axial force is unlikely to create bending stresses in the screws, as witnessed in the failed screws (paragraph 64), whereas the shear force will. In the assessment, the shear force was applied to the screw at a plane level with the underside of the baseplate. This shear force leads to increasing bending stresses in the screw along its length up to the point where the threaded part of the screw is firmly embedded in the bearer.

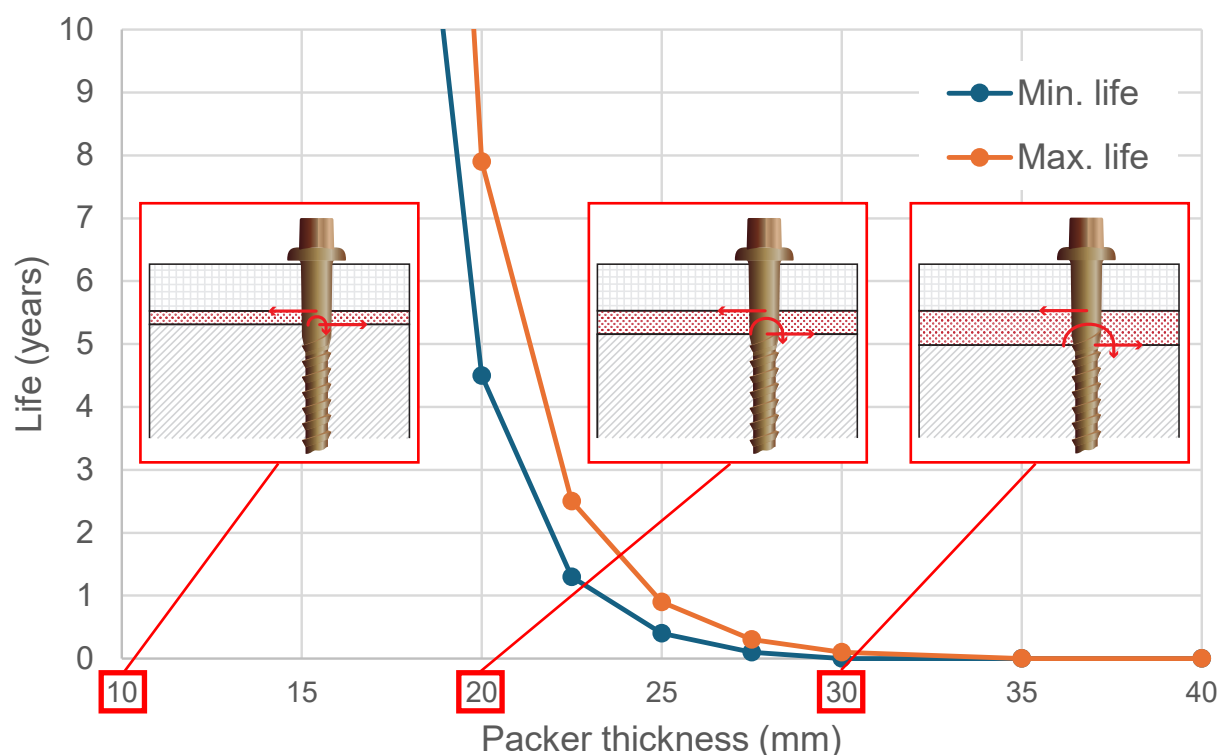
- 134 The main finding was that the expected life is strongly dependent on the thickness of packing pieces under the baseplate. The effect of the total thickness of the baseplate packing pieces and how this affects the fatigue failure of the screw is illustrated in figure 31. This shows that, as the thickness of the steel packing pieces increases, the point at which the lateral force acts on the screw moves from the larger diameter shank to the smaller diameter threaded section. All the broken screws examined afterwards were found to have broken through their threaded section, just below the upper surface of the bearer (paragraph 63).

Figure 31: The effect of the steel packing thickness on the fatigue failure of the screws.

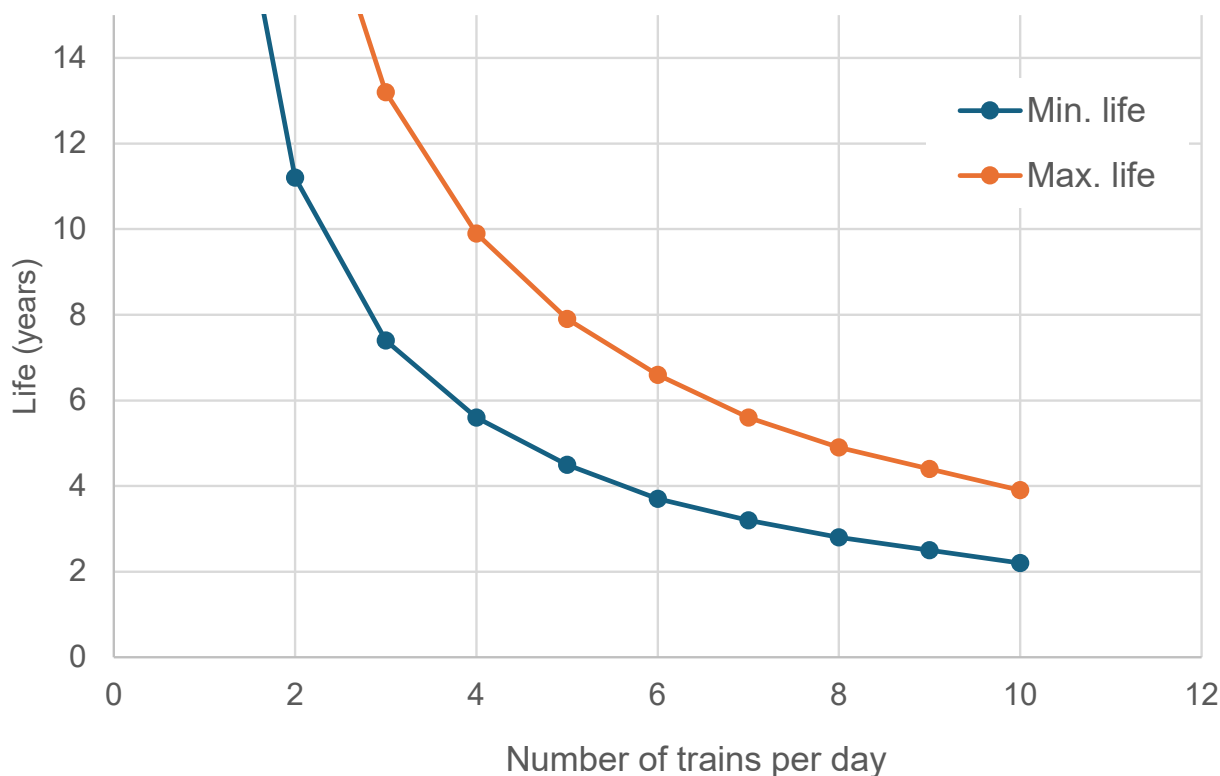
138 The screw fatigue sensitivity analysis also considered the increase in freight traffic passing over the LBS (figure 32). As the fatigue failure of a screw is related to the number of cycles it is subjected to, increasing or decreasing the number of trains changes the rate of crack propagation, and therefore the duration over which a screw would suffer fatigue crack growth before eventual failure.

Figure 32: Graph showing how the number of trains affects the time before a screw would fail due to fatigue.

- 139 With a single daily train, the assessment showed that a screw of normal grade material was predicted to fail in fatigue after around 20 to 40 years. This decreased to about 7 to 14 years for three trains daily and to about 2 to 4 years for 10 trains daily. Screws of the high tensile grade performed better but followed a similar pattern.
