Serious Incident

Aircraft Type and Registration:	Airbus A320-251N, G-UZEF	
No & Type of Engines:	2 CFM International Sa LEAP-1A26 turbofan engines	
Year of Manufacture:	2025 (Serial no: 12383)	
Date & Time (UTC):	20 April 2025 at 0547 hrs	
Location:	South-western UK Airspace	
Type of Flight:	Commercial Air Transport (Passenger)	
Persons on Board:	Crew - 6	Passengers - 177
Injuries:	Crew - None	Passengers - None
Nature of Damage:	None	
Commander's Licence:	Airline Transport Pilot's Licence	
Commander's Age:	53 years	
Commander's Flying Experience:	15,100 hours (of which 9,100 were on type) Last 90 days - 115 hours Last 28 days - 45 hours	
Information Source:	Aircraft Accident Report Form submitted by the pilot and enquiries by the AAIB

Synopsis

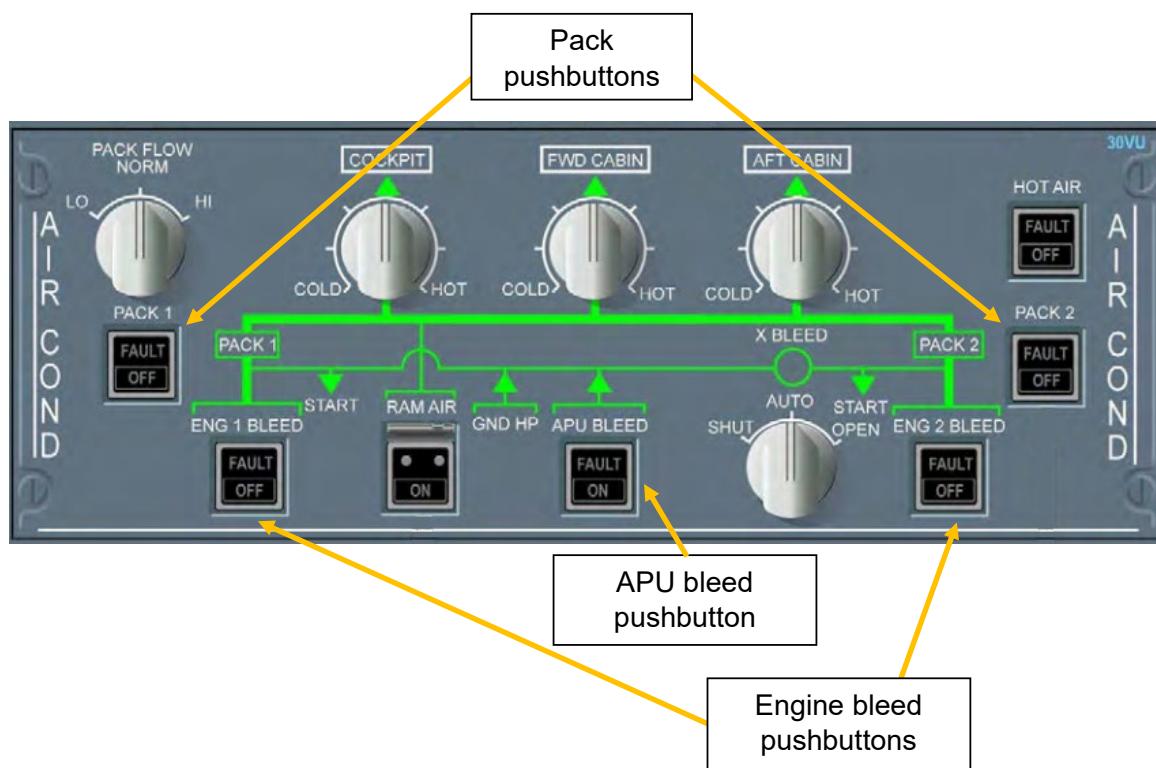
Air for pressurisation and air conditioning is supplied by two air conditioning packs. The packs receive bleed air from the engines or the auxiliary power unit (APU). Bleed air sources and packs are switched on and off using individual pushbuttons on the air condition systems panel on the overhead panel (Figure 3). The air flow into each pack is regulated by a pack control valve.

Figure 3
Air conditioning controls on the overhead panel ©Airbus

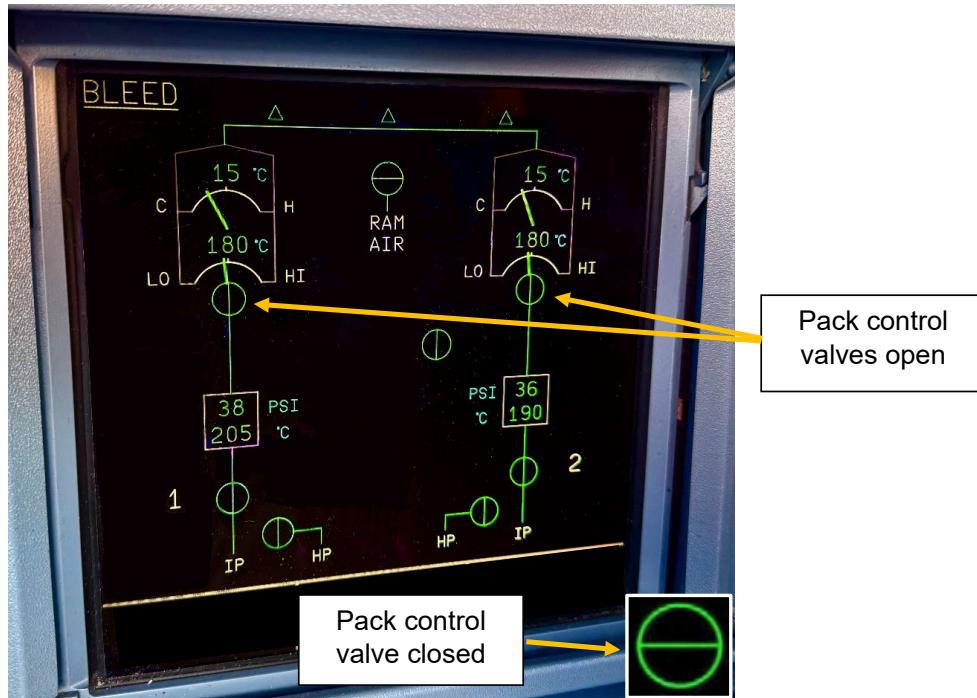
Figure 4

Bleed ECAM systems page with inset showing how closed valve would be displayed
©A320 Guide

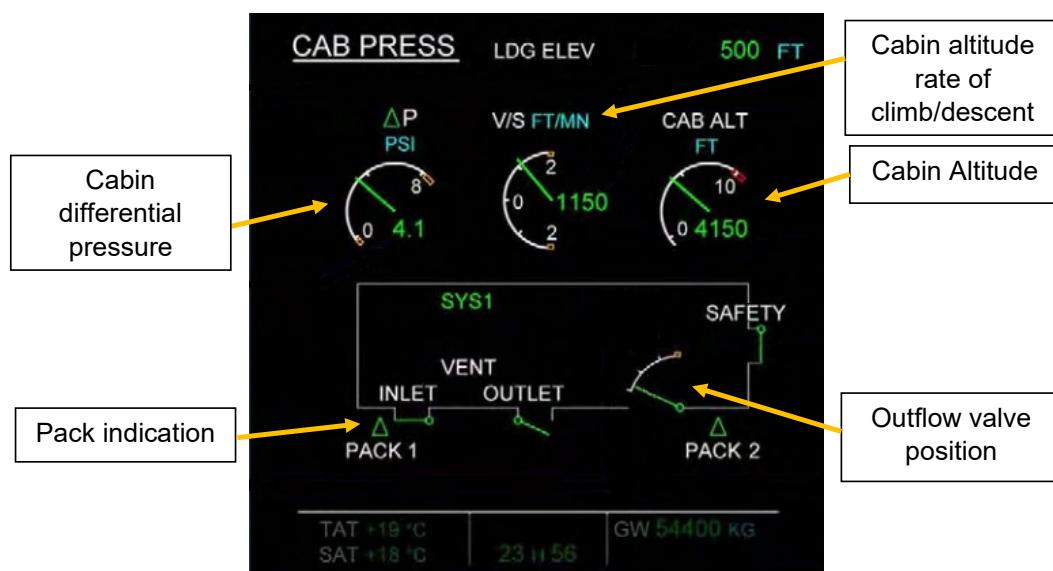
Figure 5

The cabin pressure page shows the position of the outflow valve, cabin altitude, differential pressure, and rate of cabin altitude climb or descent (Figure 5). There are two pack indications which are small triangles above the related pack label. These triangles are normally green with the pack label in white. Both become amber when the pack flow control valve is closed with the associated engine running.

Cabin Pressure ECAM system page ©Airbus
