AAIB Bulletin

1/2026

Published: 8 January 2026.

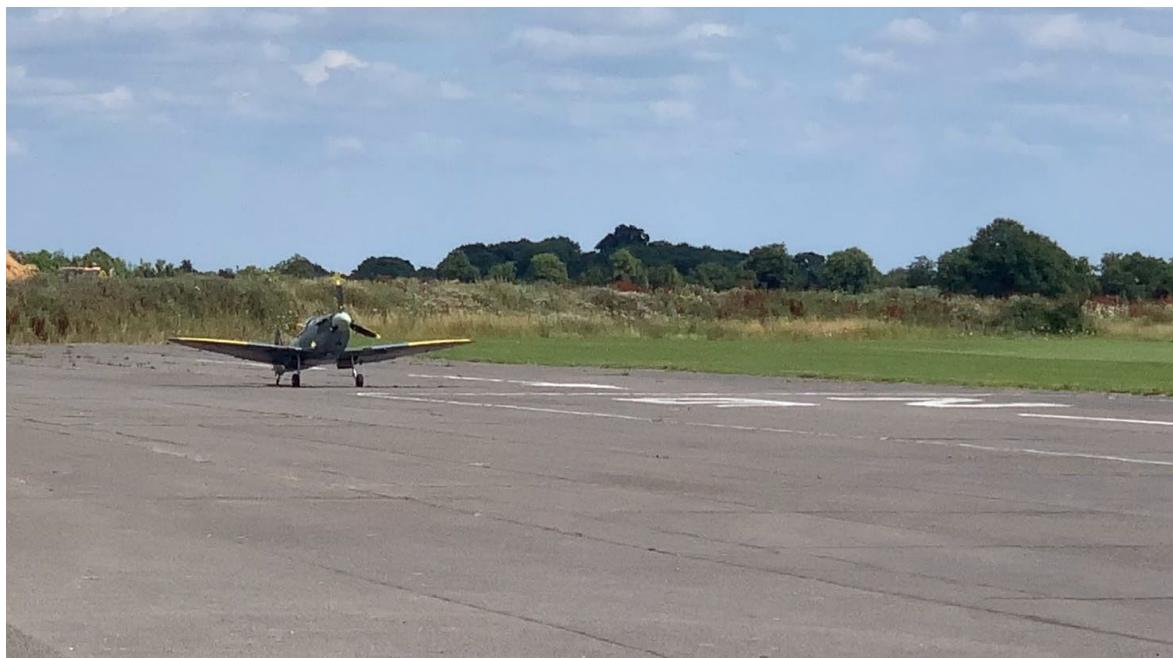
The aircraft commenced taxiing towards Runway 26 at 1251:25 hrs from its parked position adjacent to the control tower. It taxied along the grass parking area to taxi point A, where it stopped short of the runway. The aircraft then remained stationary, consistent with pre-takeoff checks being performed, before the pilot transmitted at 1256:37 hrs that he was ready for departure. The flaps could be seen to be deployed but it was not possible at this point in the recordings to confirm their position. The radio operator advised that the surface wind was from 220° at 5 kt, which the pilot acknowledged; no further radio transmissions were received from the pilot. The wind direction and speed were consistent with the recorded footage of the airfield's windsock captured by the CCTV and witness video recordings. The aircraft then taxied to the runway where it was aligned to the right of the runway's centre line (Figure 3). At 1257:23 hrs the pilot commenced the takeoff run and the aircraft started to accelerate.

Figure 3
Aircraft at start of takeoff run

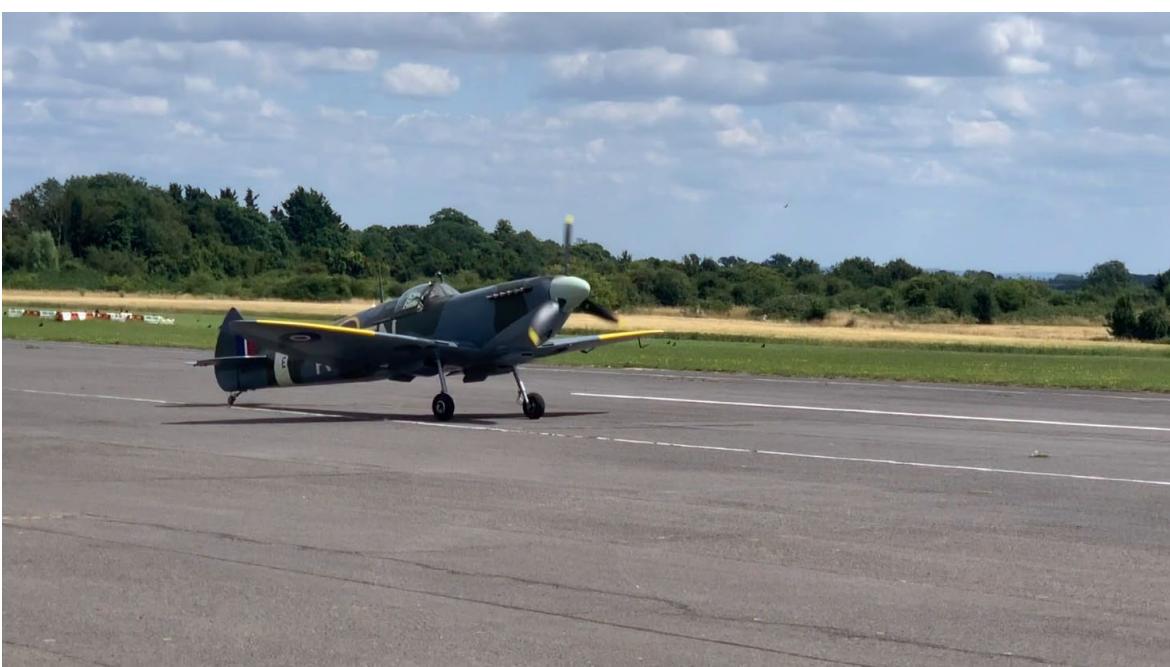
Figure 5
Tail wheel touches back down

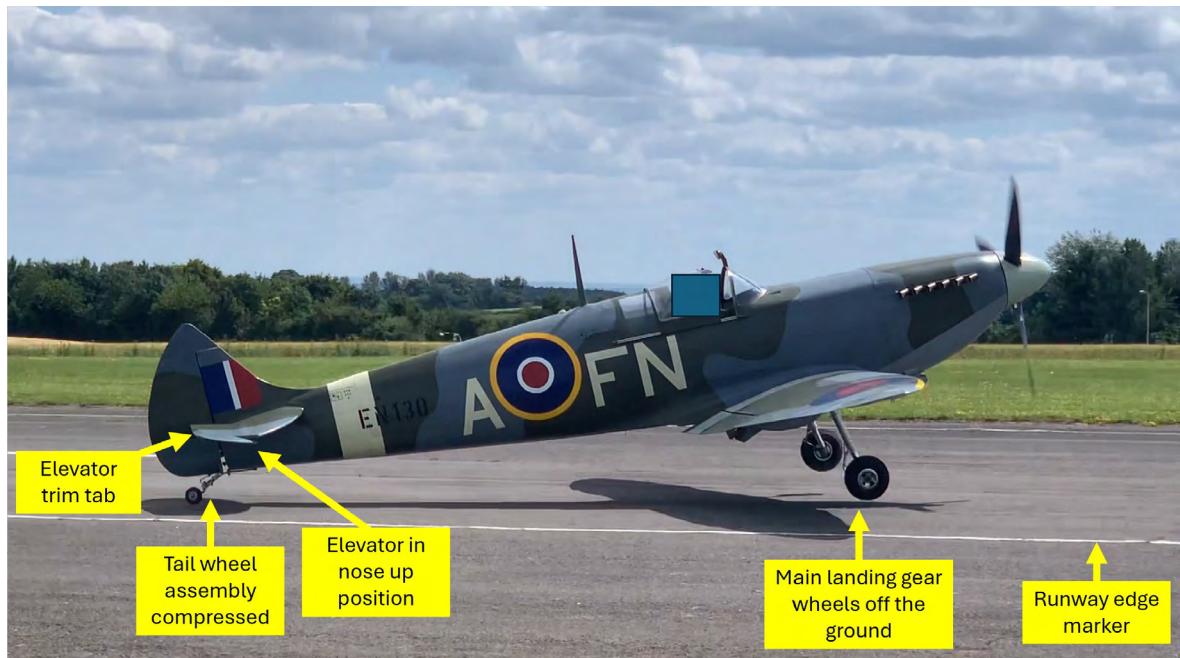
When the aircraft's airspeed reached approximately 45 kt, the tail of the aircraft lifted to an almost horizontal attitude (Figure 4), which coincided with a brief left rudder input, and the aircraft yawed to the left. The elevator could then be observed to move to a pitch up (control surface up) position, which was near to its full travel position, and the tail of the aircraft quickly lowered back towards the runway (Figure 5). The elevator remained in a pitch-up position, whilst the tailwheel tyre bounced on and off the runway surface several times. The aircraft's weight then settled on the tail wheel, which was almost coincident with the main landing gear tyres leaving the runway surface (Figure 6).

Figure 6
Aircraft attitude as it passed the witness position

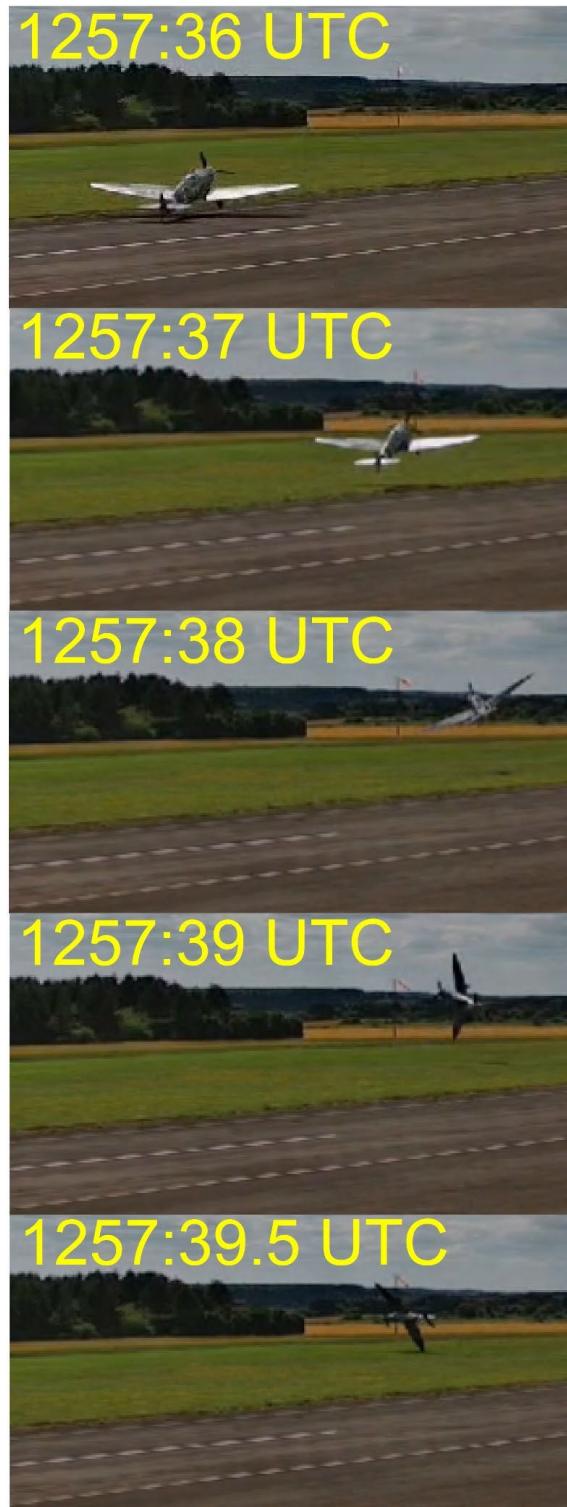
Figure 11
CCTV image sequence

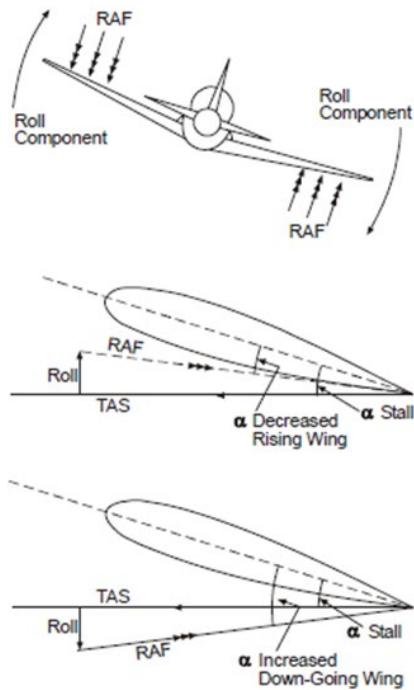
When an aircraft rolls, the relative airflow (RAF) over each wing is formed from components of forward speed and roll as shown in Figure 14.

Figure 14
Change of angle of attack with roll

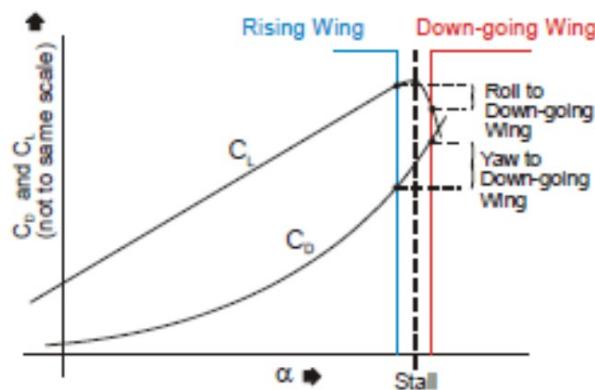
As an aircraft rolls, the angle of attack on the down going wing is increased. The lift produced by a wing will increase with angle of attack up until the point of a stall. If angle of attack continues to increase beyond the stalling angle then the coefficient of lift (C_L) on the wing will decrease and so exacerbate the roll. Deflecting ailerons downward increases the angle of attack of a wing, so any attempt to use them in the usual sense post stall will increase rather than correct any roll. As angle of attack increases, the coefficient of drag (C_D) produced by a wing also increases. So, if an aircraft rolls left post stall, the lift from the left wing will continue to reduce while the drag increases. The result of these two effects is the roll will increase, and the aircraft will yaw to the left. These effects are illustrated in Figure 15.

Figure 15
Variation of lift and drag with angle of attack

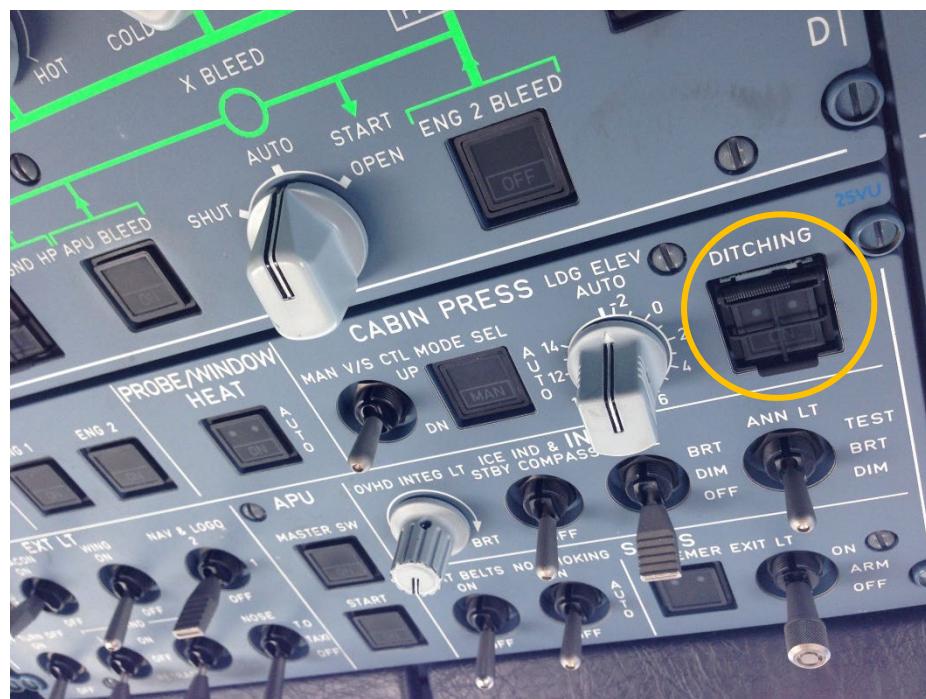
Figure 1

The commander used the relevant checklist in the Quick Reference Handbook (QRH), which was available to both crew members on their electronic tablet devices, to configure the aircraft. The de-icing crew arrived and performed a tactile check, reporting to the commander there was no longer any requirement to de-ice. Therefore, the flight crew began to reinstate the configuration of the aircraft referencing the checklist but, in doing so, omitted to return the ditching pushbutton to OFF (Figure 1).

Ditching pushbutton, situated on the right side of the overhead panel ©A320 Guide

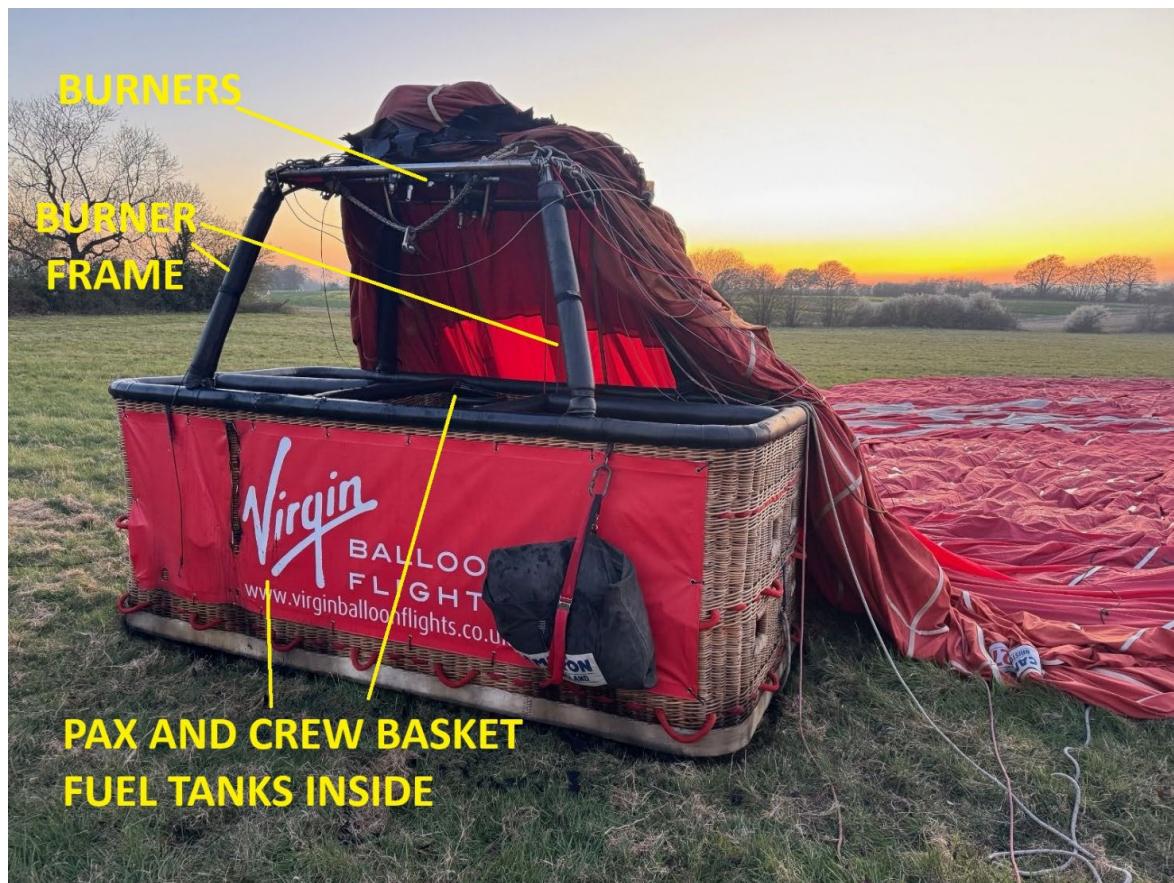
The balloon basket touched down and dragged a few feet. As the envelope began to deflate, the balloon hit the second set of wires, which were heard to break. The pilot turned off the fuel cylinders and the mouth of the balloon envelope descended over the burners (Figure 4). The pilot was uncertain where the wires had fallen and, being concerned about any threat of electrocution from the metal frame holding the burners, he elected not to extinguish the pilot flames.

Figure 4
General arrangement of basket
