Report on the investigation of
the fatal injury to a deckhand following a chain failure
on the scallop dredger

Honeybourne III (PD905)

16 nautical miles south of Newhaven, England
on 6 October 2023

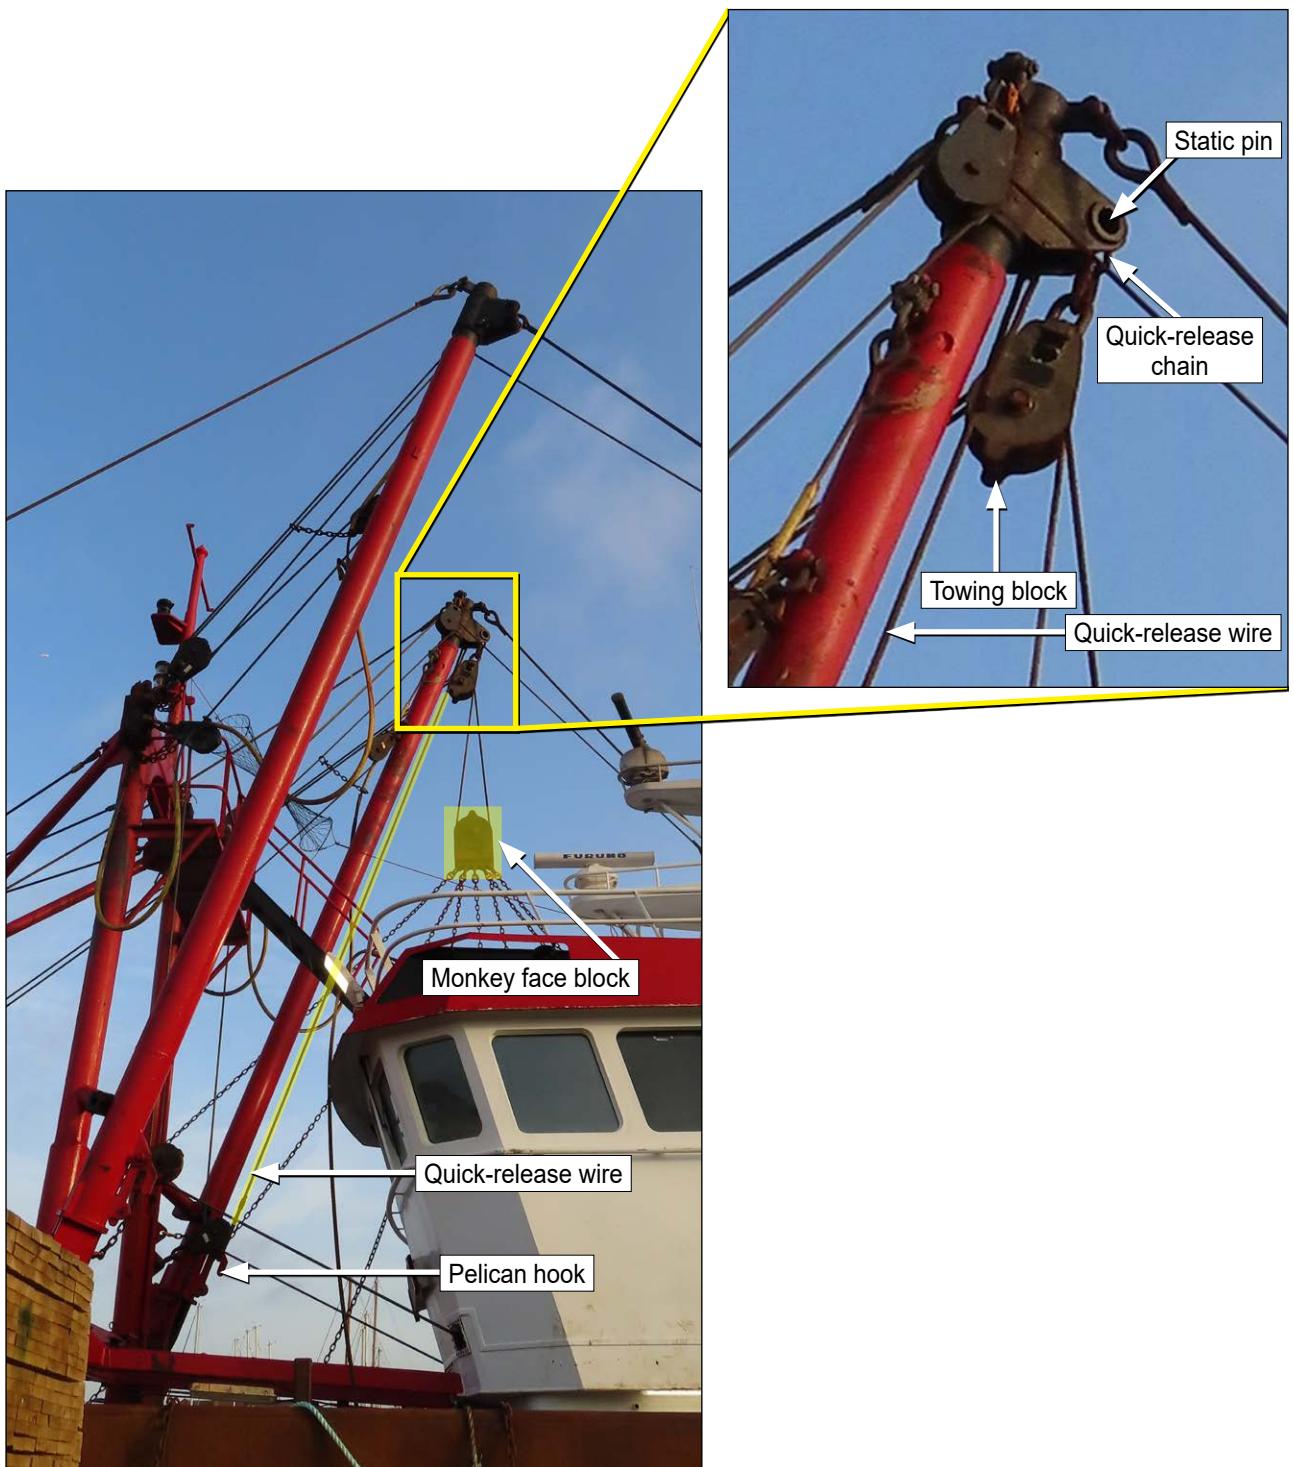
Figure 5: Dredging gear quick-release assembly
(starboard side highlighted)

The chain that failed formed part of a quick-release assembly designed to enable the crew to release the towing point from the derrick head should the dredging gear snag on the seabed and endanger the stability of the vessel. The chain failed where it passed over a static steel pin at the top of the derrick.

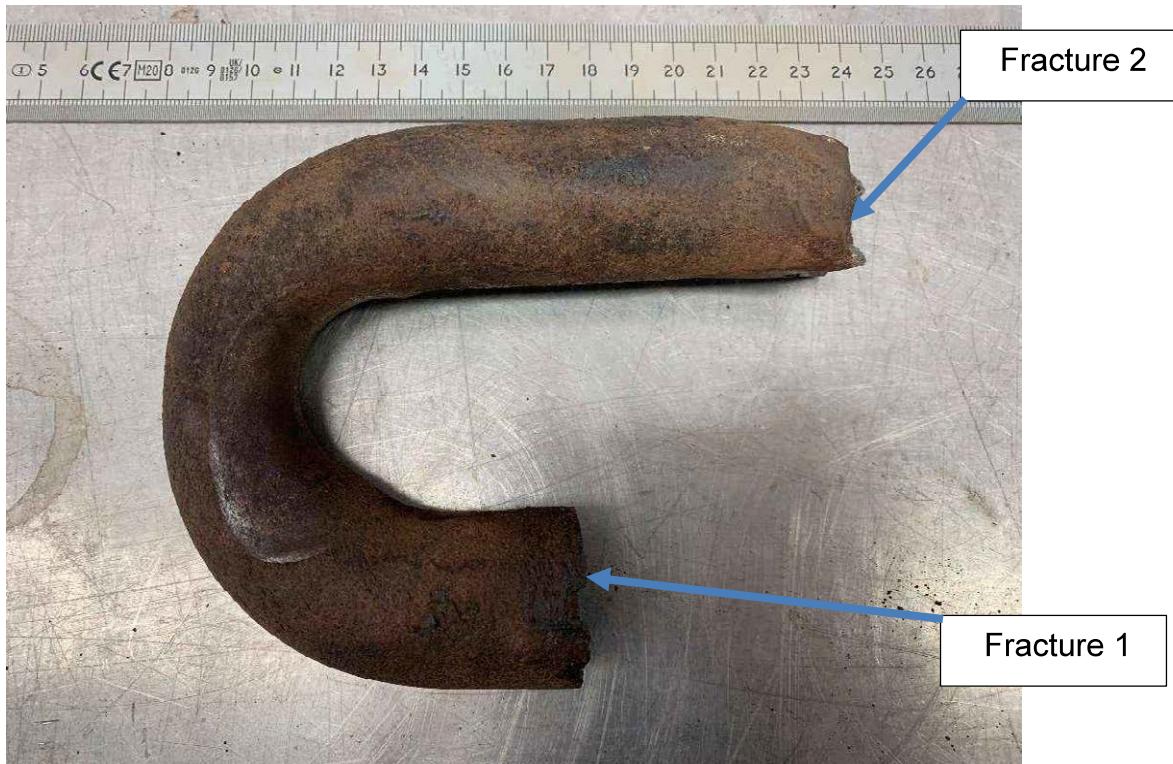
Figure 3: Partial chain link, sample 23307 (image 20240625_085251957_iOS)

The two fracture surfaces were distinctly different in appearance. Figure 3 Fracture 1 had a flat, faceted fracture face with a raised ridge around most of the circumference. This was consistent with a brittle fracture and its associated shear lip. In addition,

there were small areas of discolouration on the fracture face which were investigated as part of the fractography examination (see Figure 4).

Figure 3 Fracture 2 was jagged in appearance with evidence of wear on the inside of the chain link, notable due to the local flattening of the surface adjacent to the fracture. The area of the fracture next to this local flattening has two parallel fissures which may be associated with the wear in this area.

There was also a distinct region of necking which is associated with a ductile fracture as the material yielded before fracture. The fracture face showed areas of corrosion as well as areas of “clean” fracture face (see Figure 5).

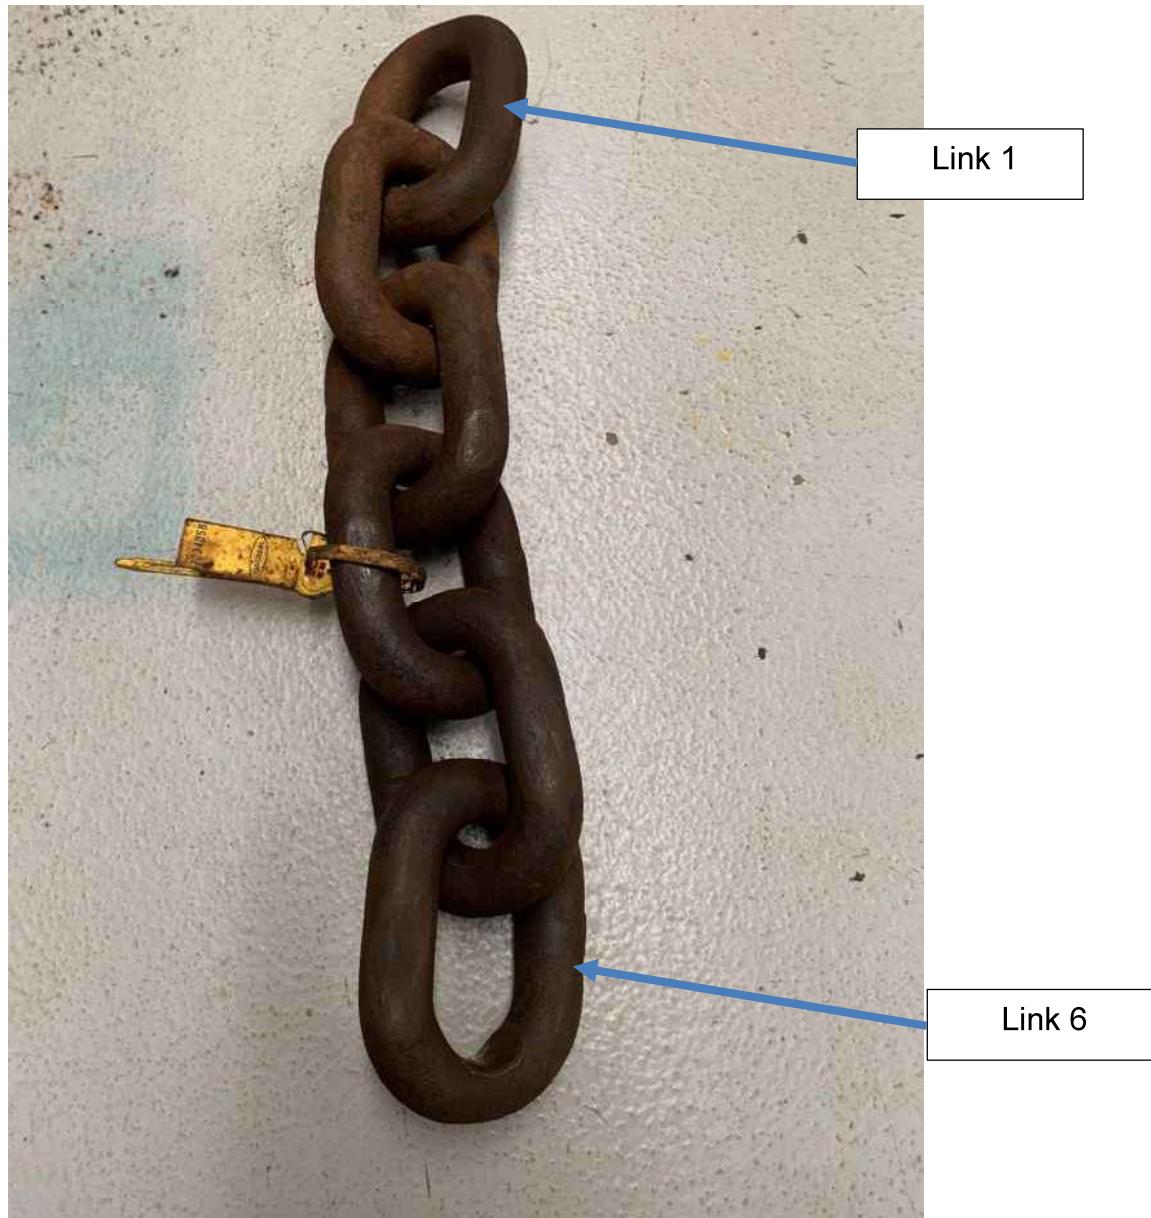
Figure 6: Port quick release chain, sample 23309 (image 20240618_132420371_iOS)

The port quick release chain was given the sample number 23309. Comprising 6 links of 32mm short-link chain (Figure 6). For the purposes of the examination the links were numbered 1 to 6, starting at the link attached to the soft eye steel cable.

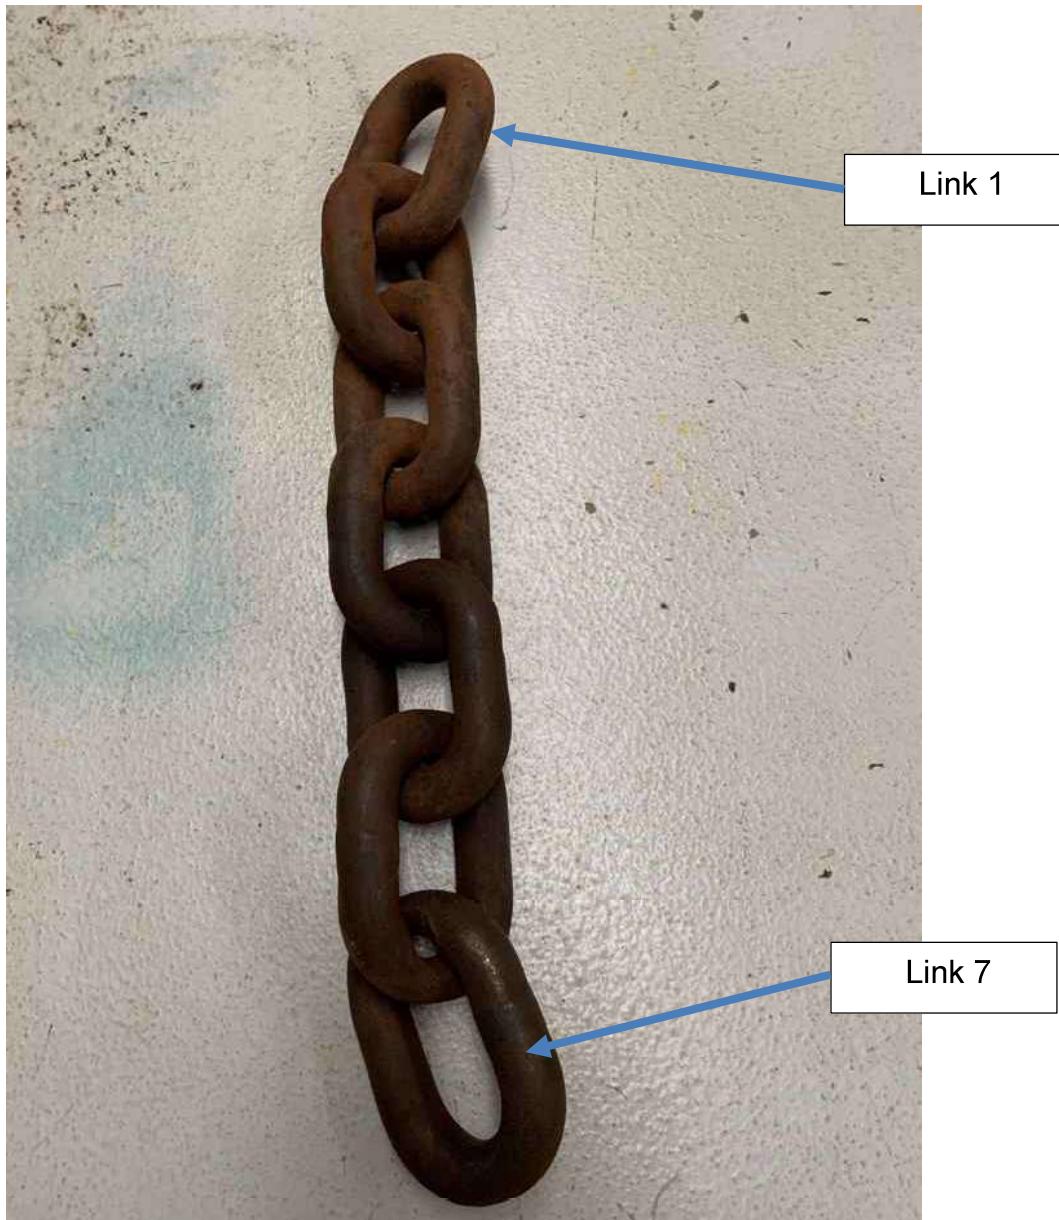
Figure 10: Starboard quick release chain, sample 23310 (image 20240618_132243103_iOS)

The starboard quick release chain was given the sample number 23310. Comprising 7 links of 32 mm short-link chain Figure 10. For the purposes of the examination the links were numbered 1 to 7 starting at the link attached to the soft eye steel cable.

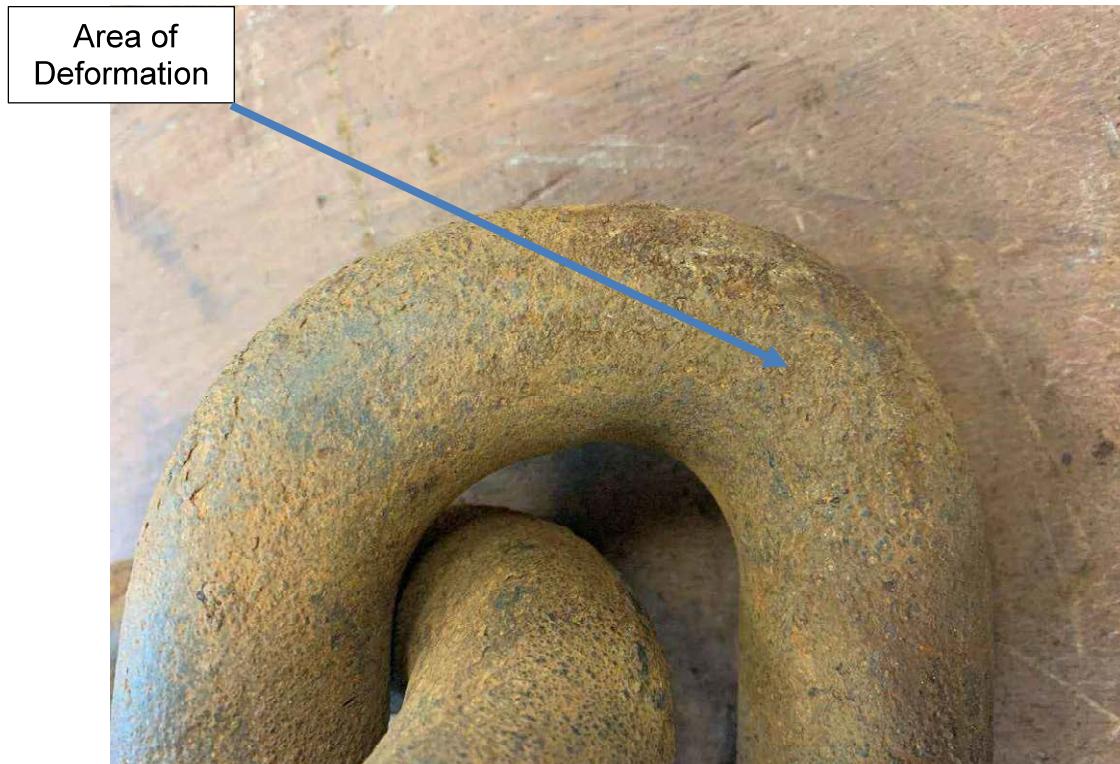
Link 2 showed no wear, however there appeared to be some slight deformation at the crown on one end taking the link out of ovality. This can be seen in Figure 11. This may be as a result of a manufacturing issue or deformed through use.

Figure 11: Deformation on link 2 sample 23310 (image 20240620_151007950_iOS rotated)

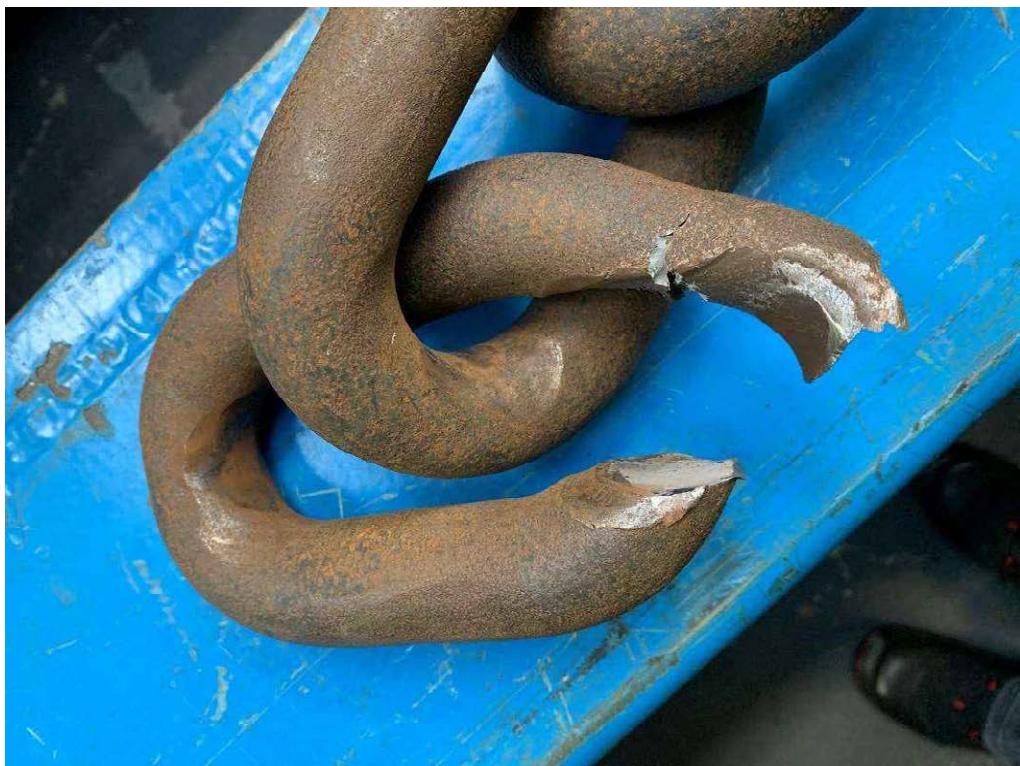
Figure 36: Sample 23310 post MBL test showing the fractured link (20241017_095314490_iOS)

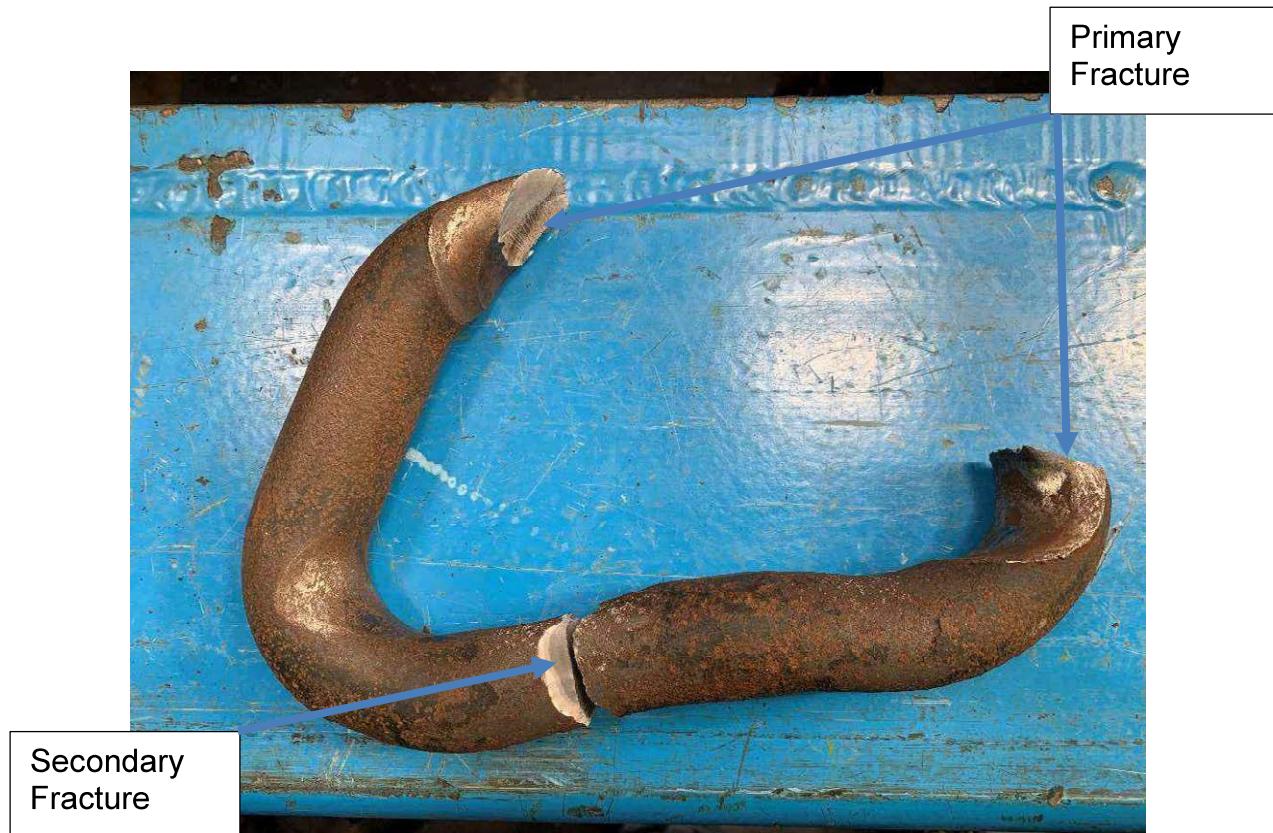
Figure 37: Samples 23544 & 23545 from 23309 post MBL test showing the fractured link
(20241017_104856329_iOS)

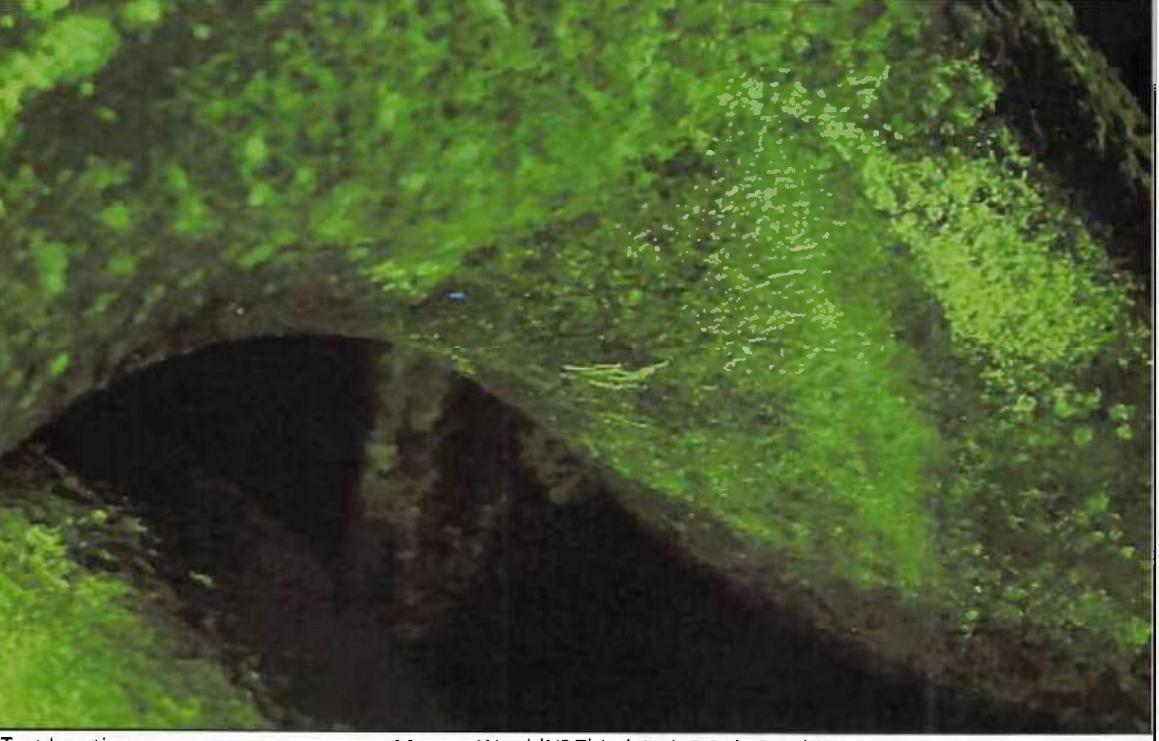
Client: Health & Safety Executive Harpur Hill Buxton Derbyshire SK17 9JN	Report No: 158645.1										
	Date of Test: 15.07.2024										
	Job No: -										
	Order No: 43070026083										
Component / Identification. 2 Sets of Chain links 32mm Grade 8 short link chains 6 Link Chain Serial No: 23309 7 Link Chain Serial No: 23310											
Test Details & Results: Chain Link, crack indication noted, wear noted on the internal radius, several stress cracks noted.

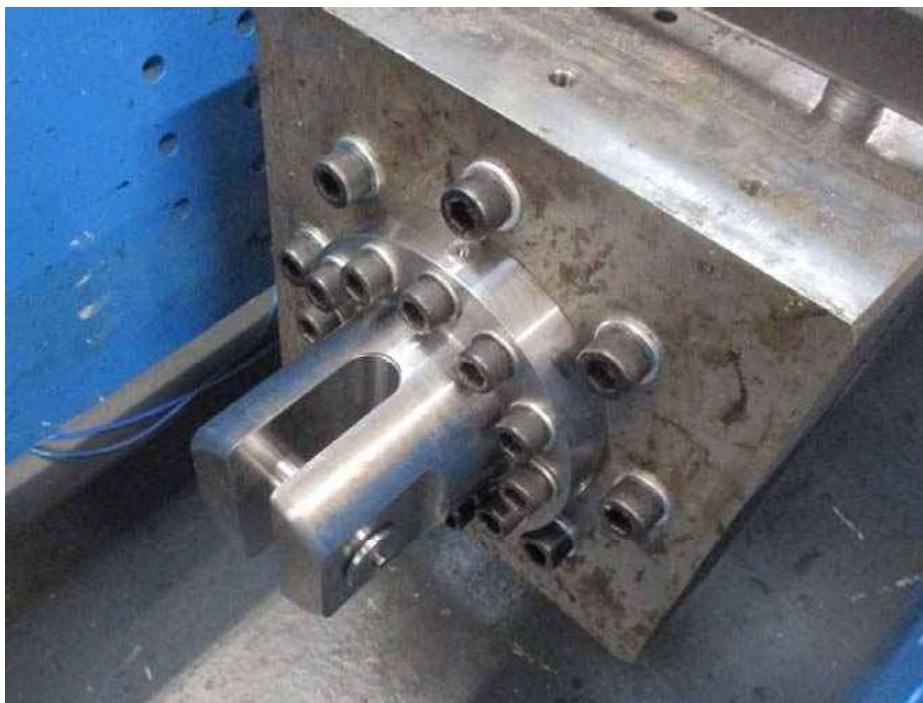
Figure 3.2: Ø32 mm chain fittings used for the first test.

Figure 3.2 shows a typical fitting which was used in the first test to fix the ends of the chain sample to the test machine. Although the test was successful in that the chain sample broke clear of the fittings, the pins bruised and bent slightly meaning that they could not be removed from the clevises. Testing was suspended whilst new fittings were designed and manufactured, Figure 3.3.

As mentioned earlier, the performance of the first set of chain fittings was not satisfactory. Although the chain sample failed clear of the fitting pins (giving confidence that the measured failure load was unaffected by the fittings) it was impossible to remove one of the pins to exchange samples for subsequent tests.

Testing was suspended whilst new fittings were designed and manufactured. The **HSE** left a second new chain sample with **TTI Testing** for use in the design and testing of the new fittings. After measurements of the links, it was determined that the fitting pin diameter could be increased. In addition, the pins were manufactured from a higher grade and heat treated steel.

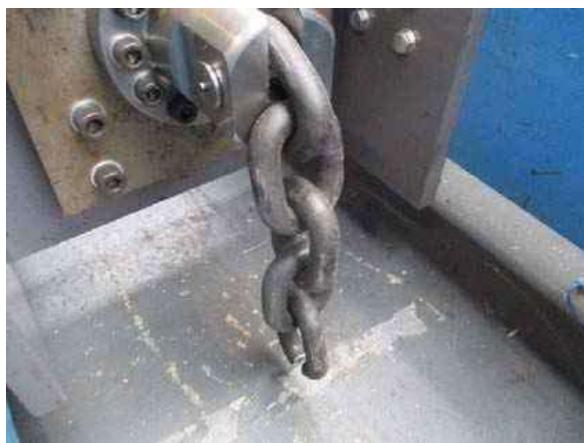
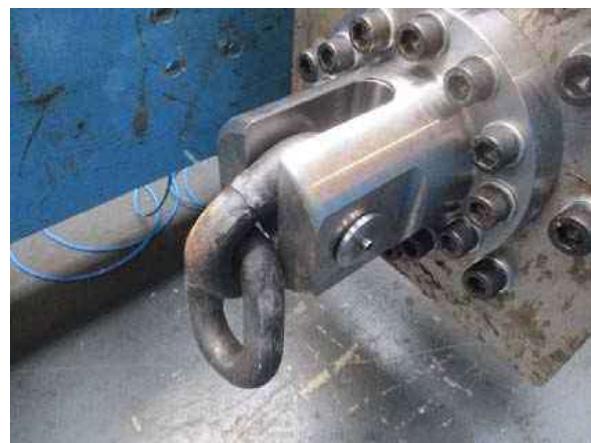
Figure 6.1: Failure of the sample 22384 at 2nd – 3rd link-link interface.

Test 1 was conducted on a sample of as new chain, seven links long. Under a load of 2 kN, L_n was measured at 669 mm. The sample supported a load of **1,020.50 kN**, before failure at the link-link interface of the second and third links from the main actuator end of the sample, Figure 6.1.

It is noted that the measured breaking load and elongation at failure for this sample are both well below the specification in BS EN 818 of 1290 kN [1, Table 5] and 20% [1, §5.4.2].

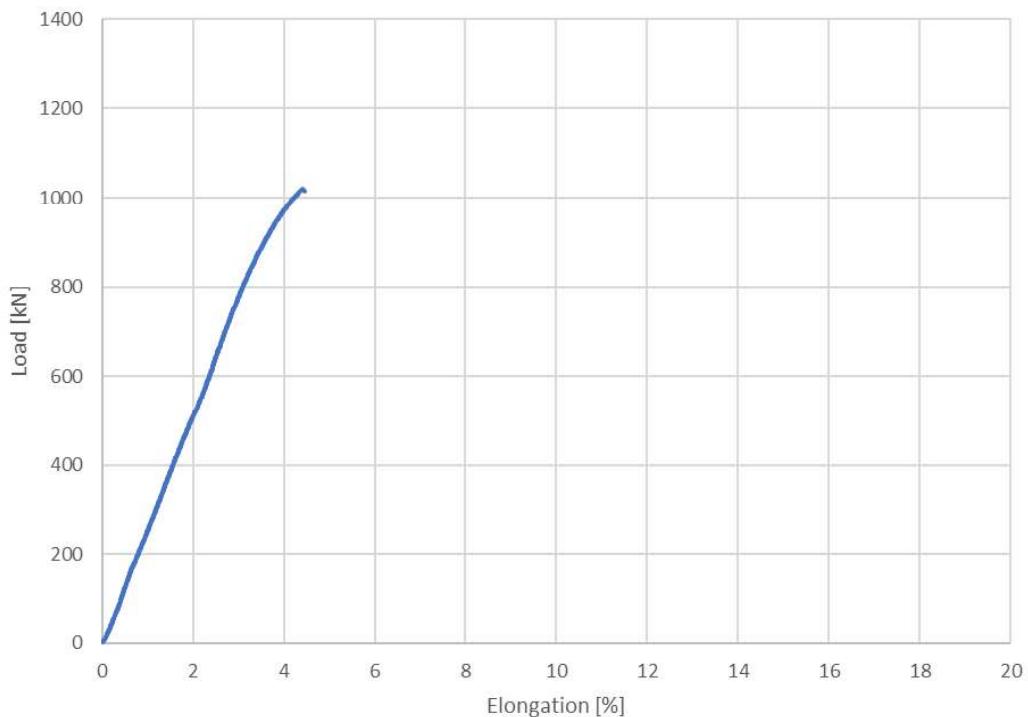
Figure 6.2: Load-elongation relationship for sample 22384 based on recorded data.

Figure 6.2 shows the load-elongation relationship which is based on the L_n measured at 2 kN and data recorded during the test. It is noted that there would be an effect on the measured stroke caused by the bending of the pins which was seen during testing. This effect has not been allowed for in the relationship presented in Figure 6.2, but may be of the order of 10%.

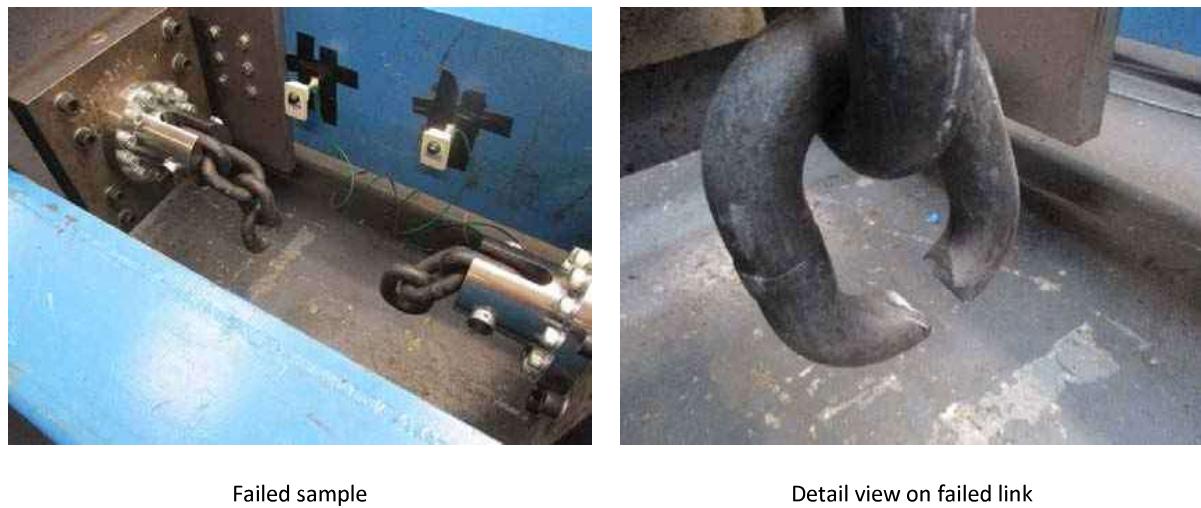
Figure 6.5: Failure of the sample 22385 at 3rd – 4th link-link interface.

Under a load of 2 kN, L_n was measured at 669 mm. The sample supported a load of **1,044.16 kN**, before failure at the link-link interface of the third and fourth links from the main actuator end of the sample, Figure 6.5.

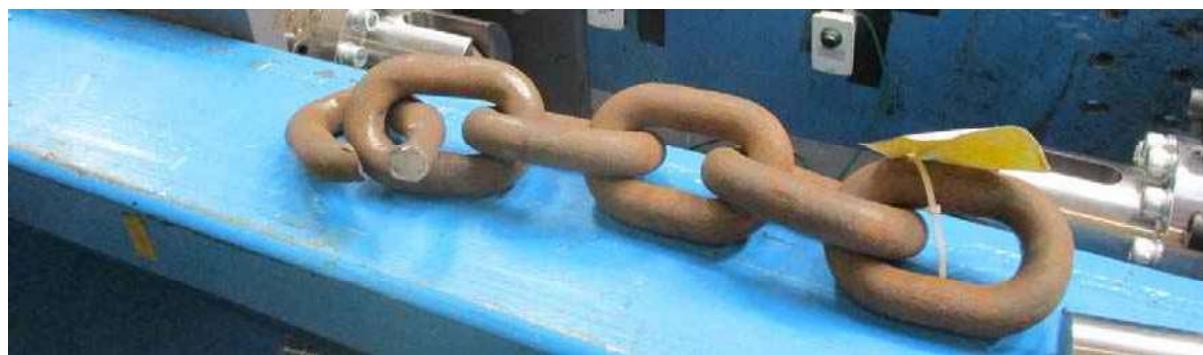
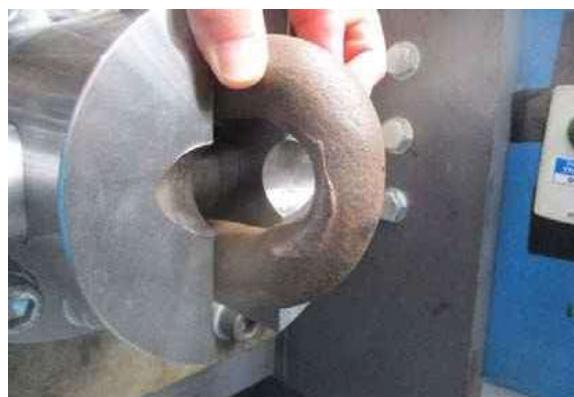
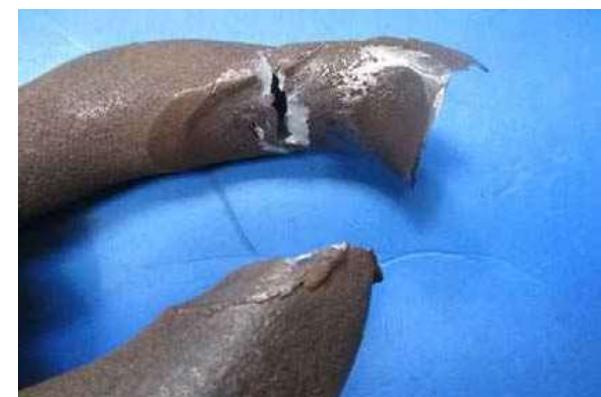
Figure 6.7: Views on the failure of the sample 23310 at 1st and 2nd link-link interface from the static end of the machine.

Under a load of 2 kN, L_n was measured at 696 mm. The sample supported a load of **1,055.02 kN**, before failure of the second link at the link-link interface of the first and second links at the static end of the sample, Figure 6.7. Figure 6.8 shows the load-elongation relationship which is based on the L_n measured at 2 kN and data recorded during the test.

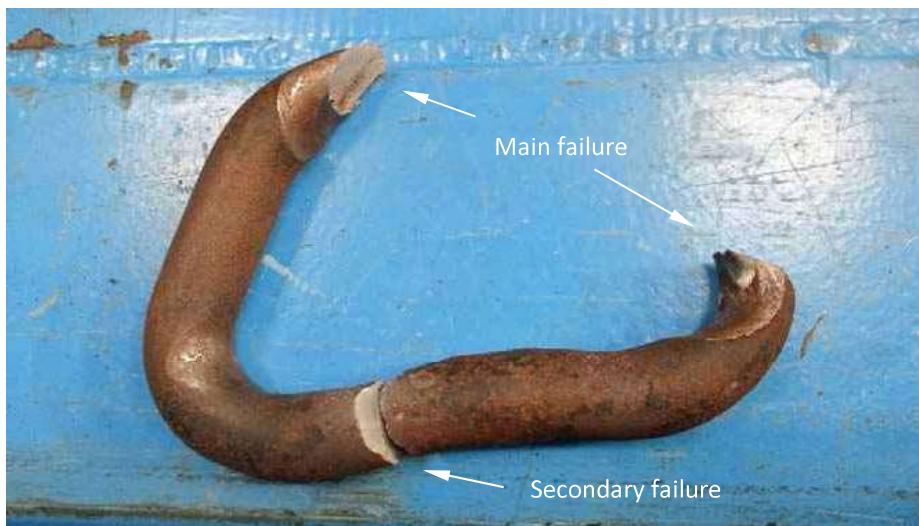
Figure 6.9: Failed link after testing of sample 23309 (Test 4).

Under a load of 2 kN, L_n was measured at 582 mm. The sample supported a load of **1,166.19 kN**, before main failure of the first link at the link-link interface of the first and second links at the static end of the sample, Figure 6.9. As the test machine pulled the sample apart a secondary failure occurred on the same link. Figure 6.10 shows the load-elongation relationship which is based on the L_n measured at 2 kN and data recorded during the test.

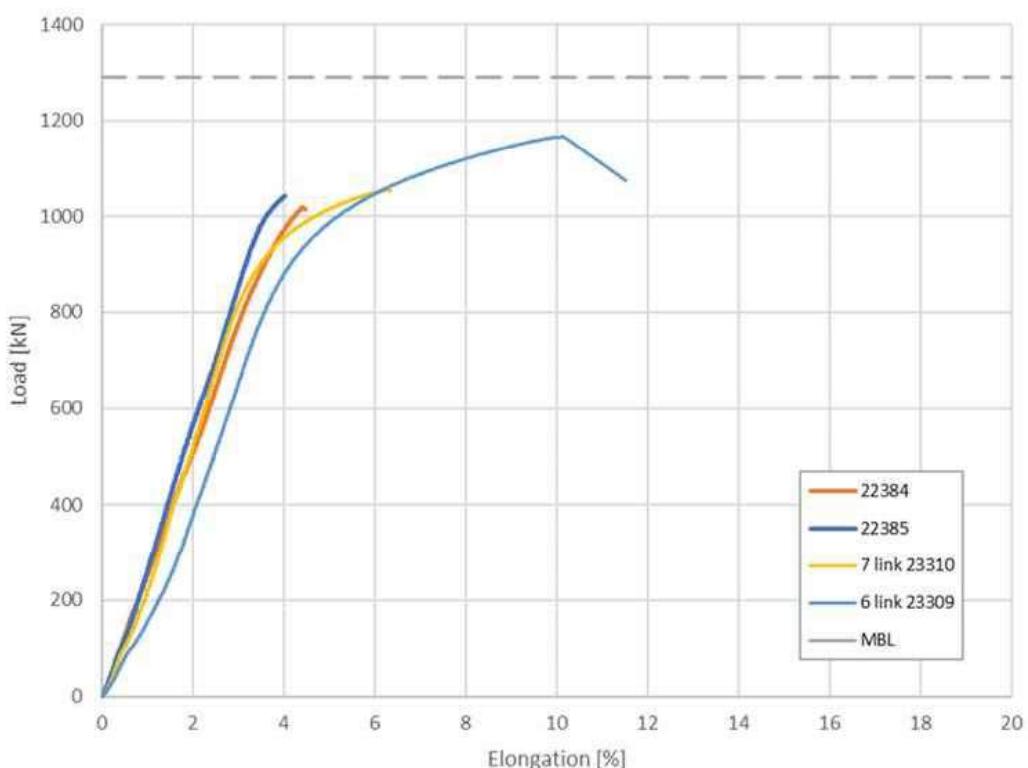
Figure 7.1: Load-elongation relationships based on measured L_n and the recorded load-stroke data from each test.

Table 7.1 summarises the results from the four tests. For ease of comparison, the load-elongation relationships for the four tests are presented in Figure 7.1. As mentioned above, the elongation of sample 22384 has probably been influenced by the deflection of the pins.

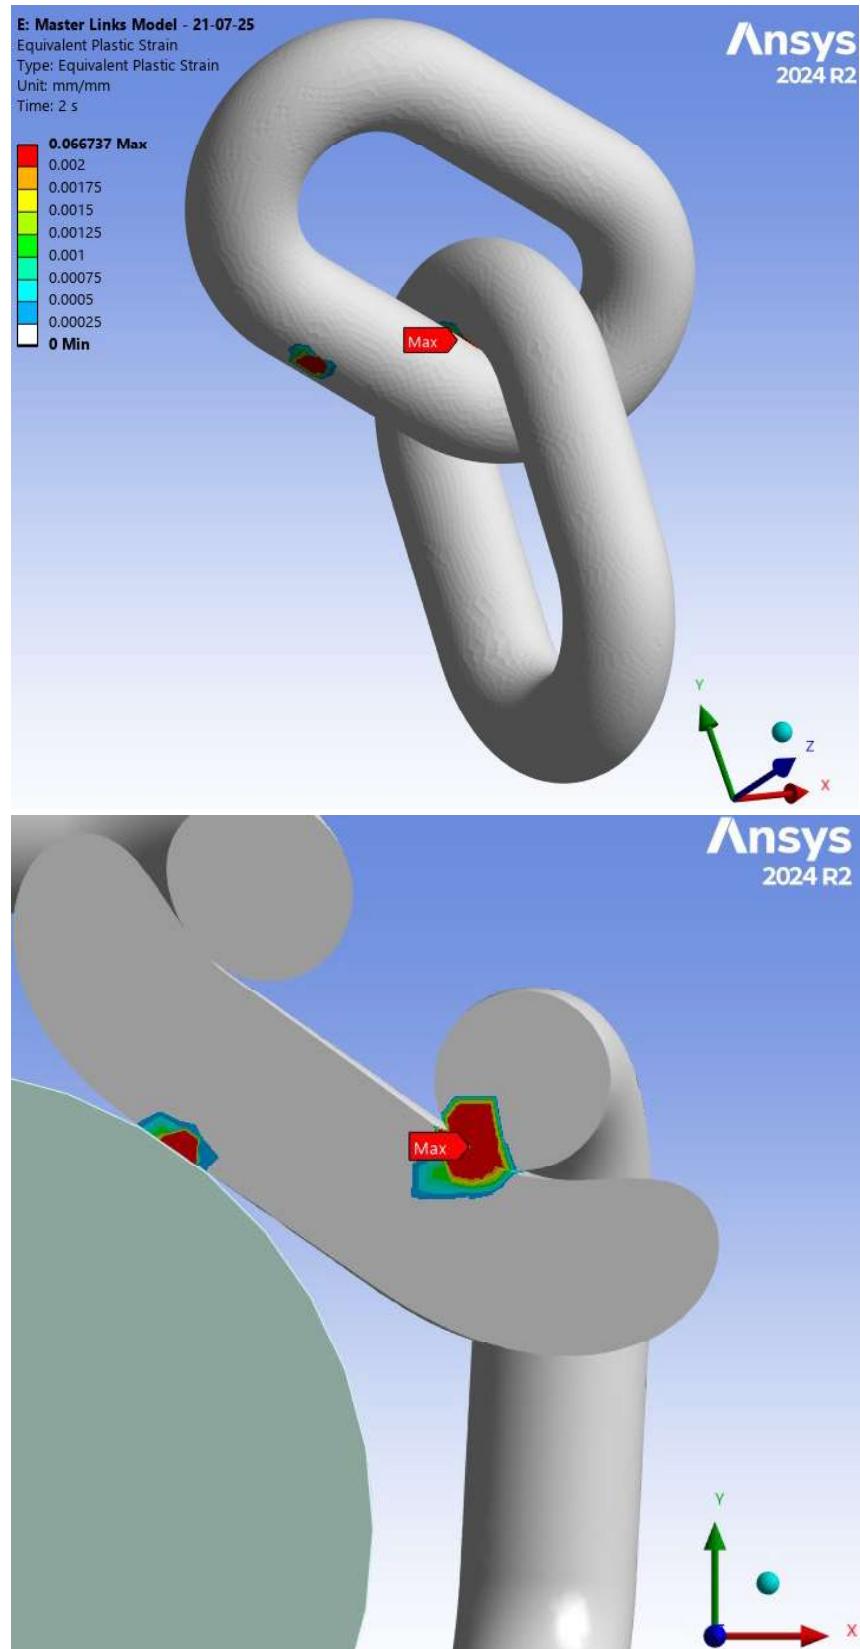
Figure 12 - Equivalent Plastic Strain on Links 1 & 2 - LC1

The maximum equivalent stress is shown in Figure 11 and is 586 MPa on Link 2. Although the von-Mises stress does not exceed the material yield strength of the link, there is high compressive stress and therefore some plastic strain is also present (Figure 12). In Hertzian contact models in ANSYS, localized plastic strain can appear even if the reported equivalent von Mises stress is below the defined yield stress. ANSYS often averages stress values across nodes or elements when displaying results. As a result, a stress peak slightly above yield may be averaged down to below yield in the output, while still causing plastic strain in localized regions. This is common near contact zones where the mesh is fine and stress gradients are steep, as found in this study.

The equivalent plastic strain is shown in Figure 12 on links 1 and 2, with a sectional view through the maximum strain location. The maximum plastic strain is 6.7% and the colour bar is clipped at 0.2% proof strength for visual clarity.

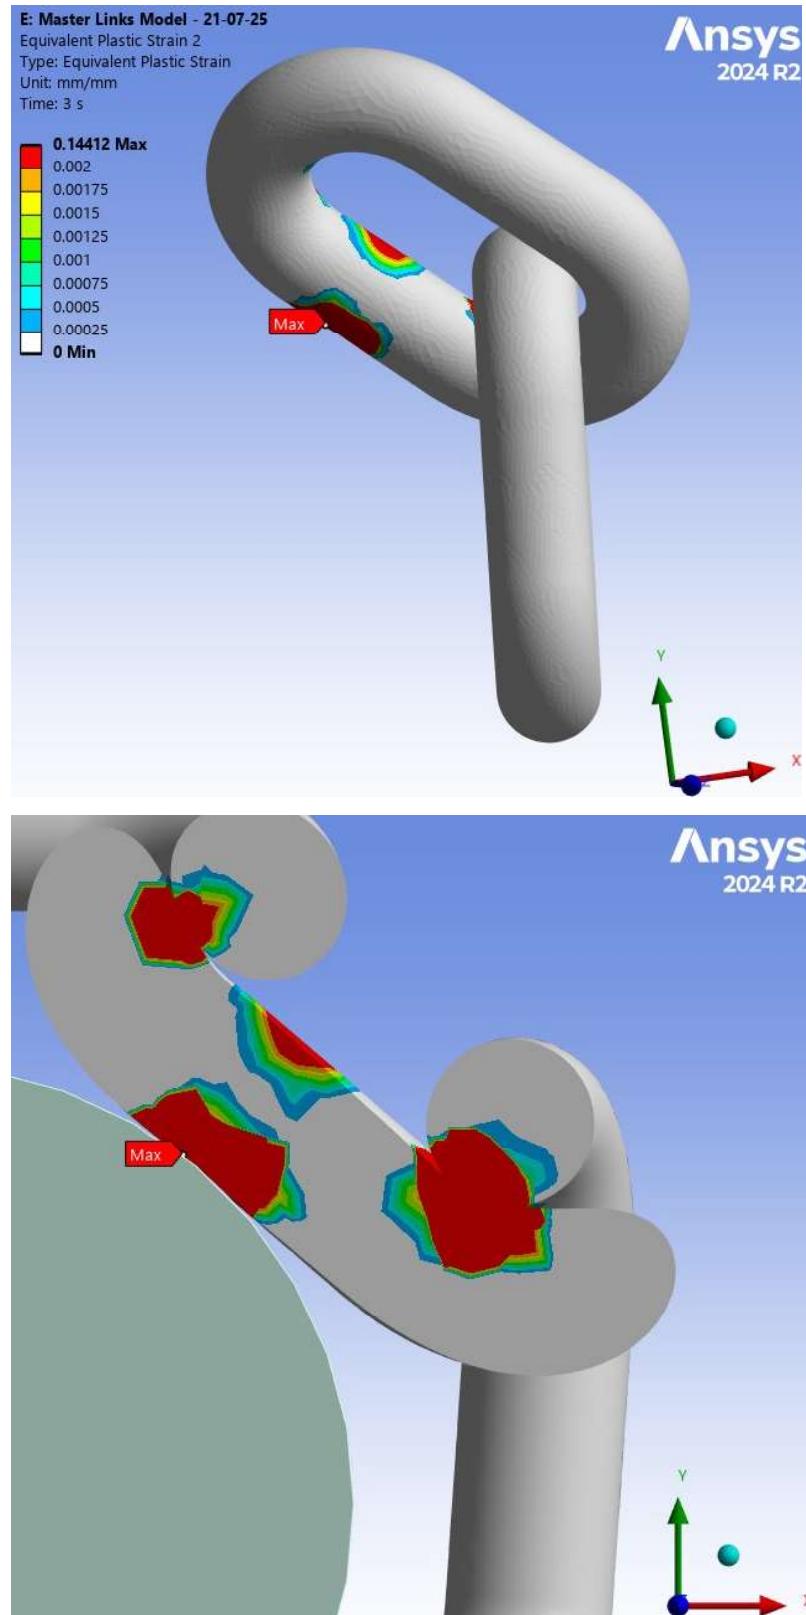
Figure 16 - Equivalent Plastic Strain on Links 1 & 2 - LC2

The maximum equivalent stress is shown in Figure 15 and is 680 MPa on Link 2. This exceeds the material yield strength of the link and therefore the plastic strain is also considered in Figure 16.

The equivalent plastic strain is shown in Figure 16 on links 1 and 2, with a sectional view through the maximum strain location. The maximum plastic strain is 14.4 % and the colour bar is clipped at 0.2% proof strength for visual clarity.

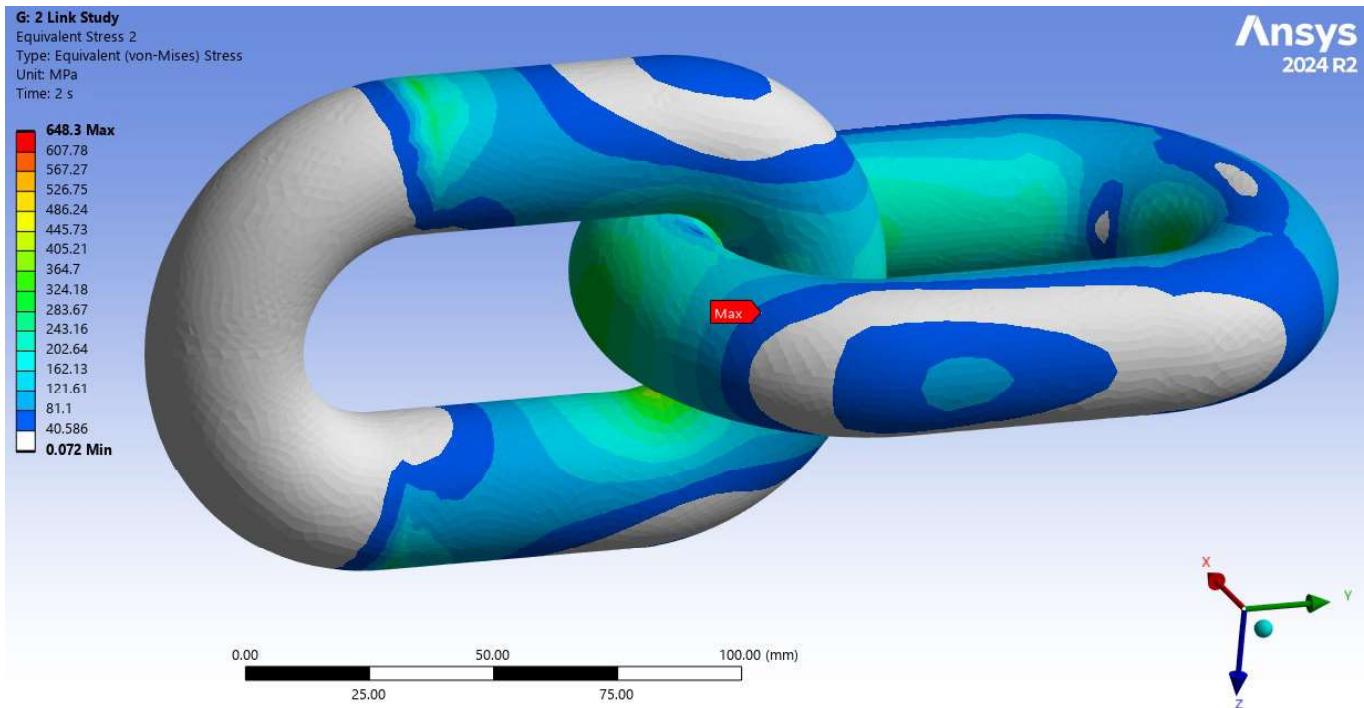
Figure 19 - Equivalent von-Mises Stress - LC3

The maximum equivalent stress is shown in Figure 19 and is 648.3 MPa. Figure 20 shows a cross section through the maximum stress location with the colour bar clipped at 640 MPa (yield stress). The stress exceeds the material yield strength of the link and therefore the plastic strain is also considered in Figure 21.

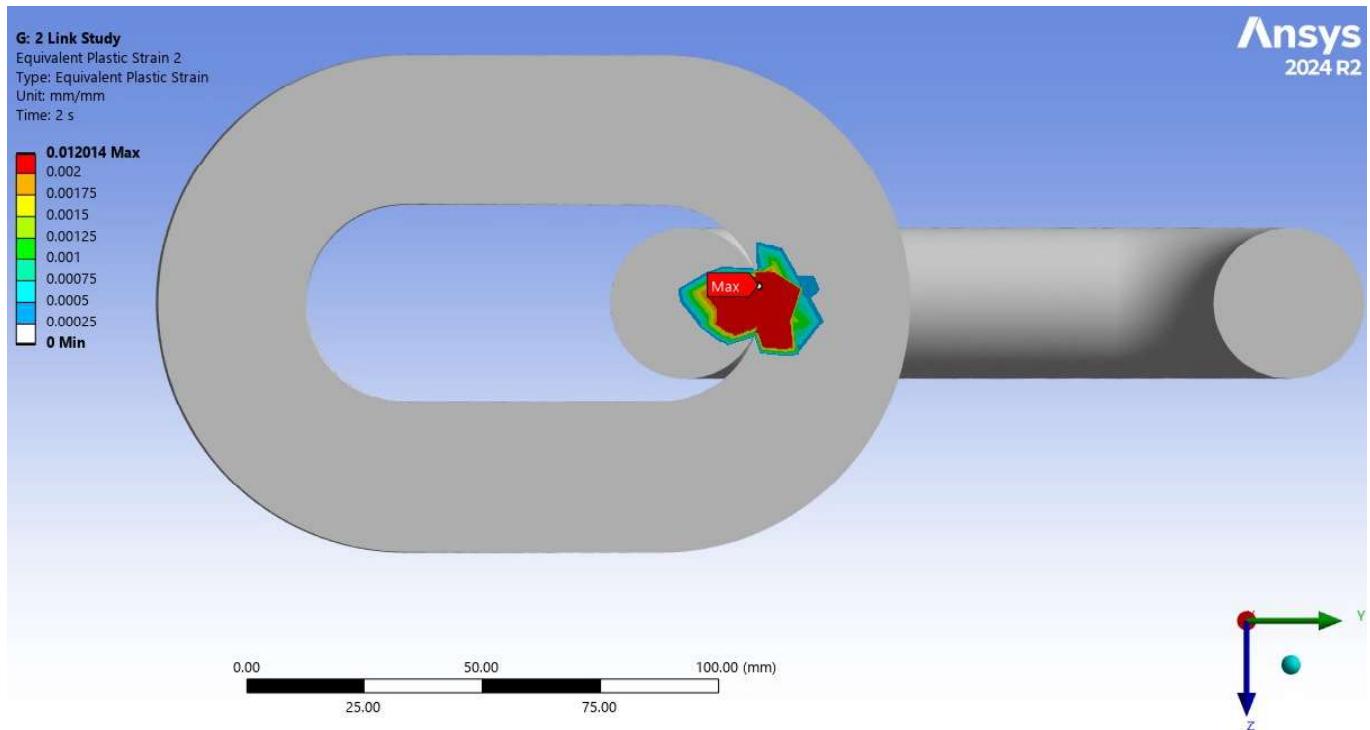
Figure 21 - Equivalent Plastic Strain - LC3

The equivalent plastic strain is shown in Figure 21. The maximum plastic strain is 1.2 % and the colour bar is clipped at 0.2% proof strength for visual clarity.

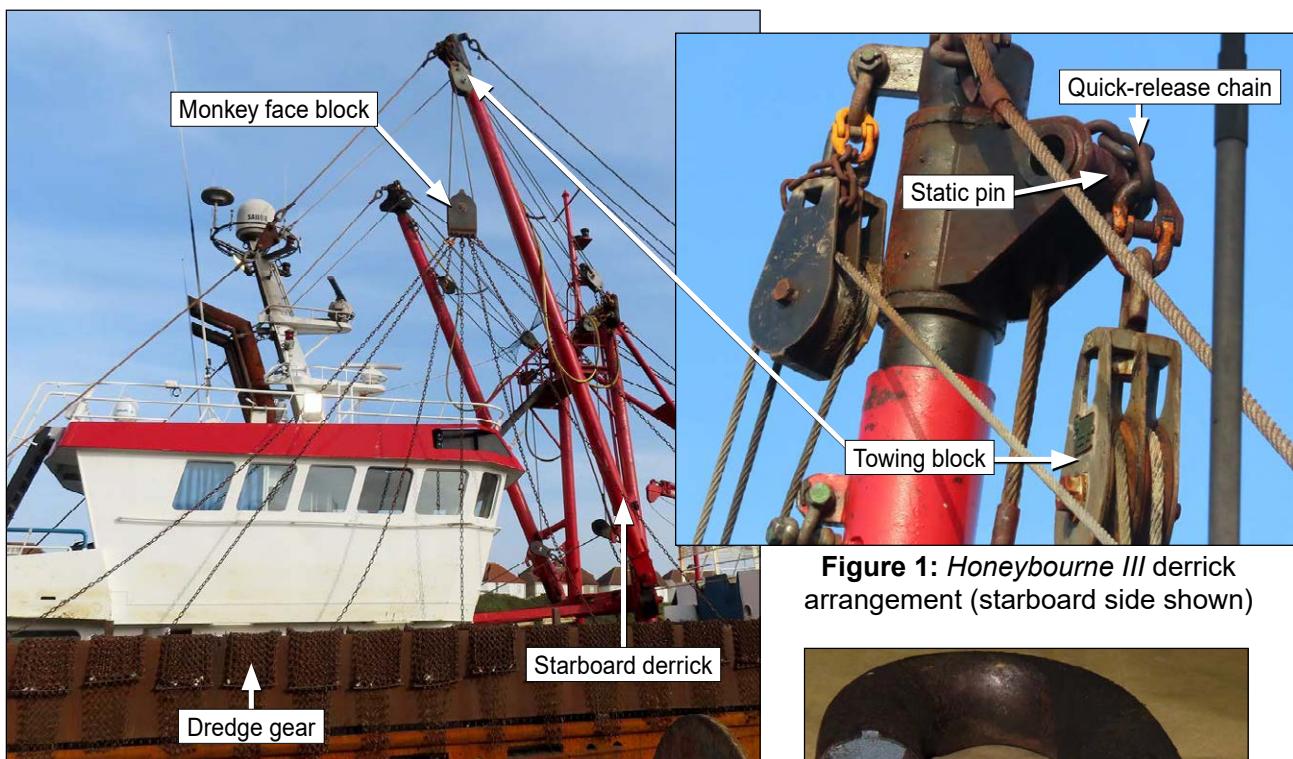
Figure 1: *Honeybourne III* derrick arrangement (starboard side shown)

The ongoing MAIB investigation has found that a section of chain in the port dredging gear quick-release assembly failed as the gear was being retrieved. A 32mm chain link, which was led over a static steel pin at the derrick head (**Figure 1**), parted (**Figure 2**) and allowed the towing block, monkey face block and associated gear to fall to the deck below.

It is therefore imperative in the short-term that these types of release mechanisms and derrick head pins are subject to regular inspection and replaced at the earliest sign of wear.
