Report on the investigation of
a fall from a pilot ladder, resulting in the death of a pilot
while boarding the cargo vessel
Finnhawk from pilot vessel ***Humber Saturn***
in the approaches to the Humber Estuary, England
on 8 January 2023

Finnhawk/Humber Saturn

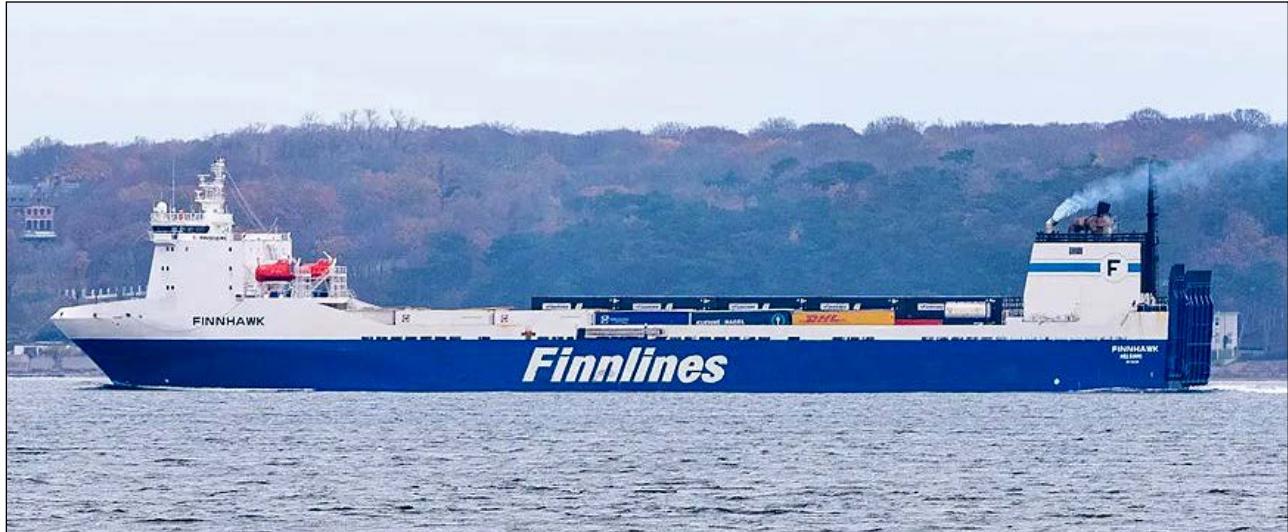
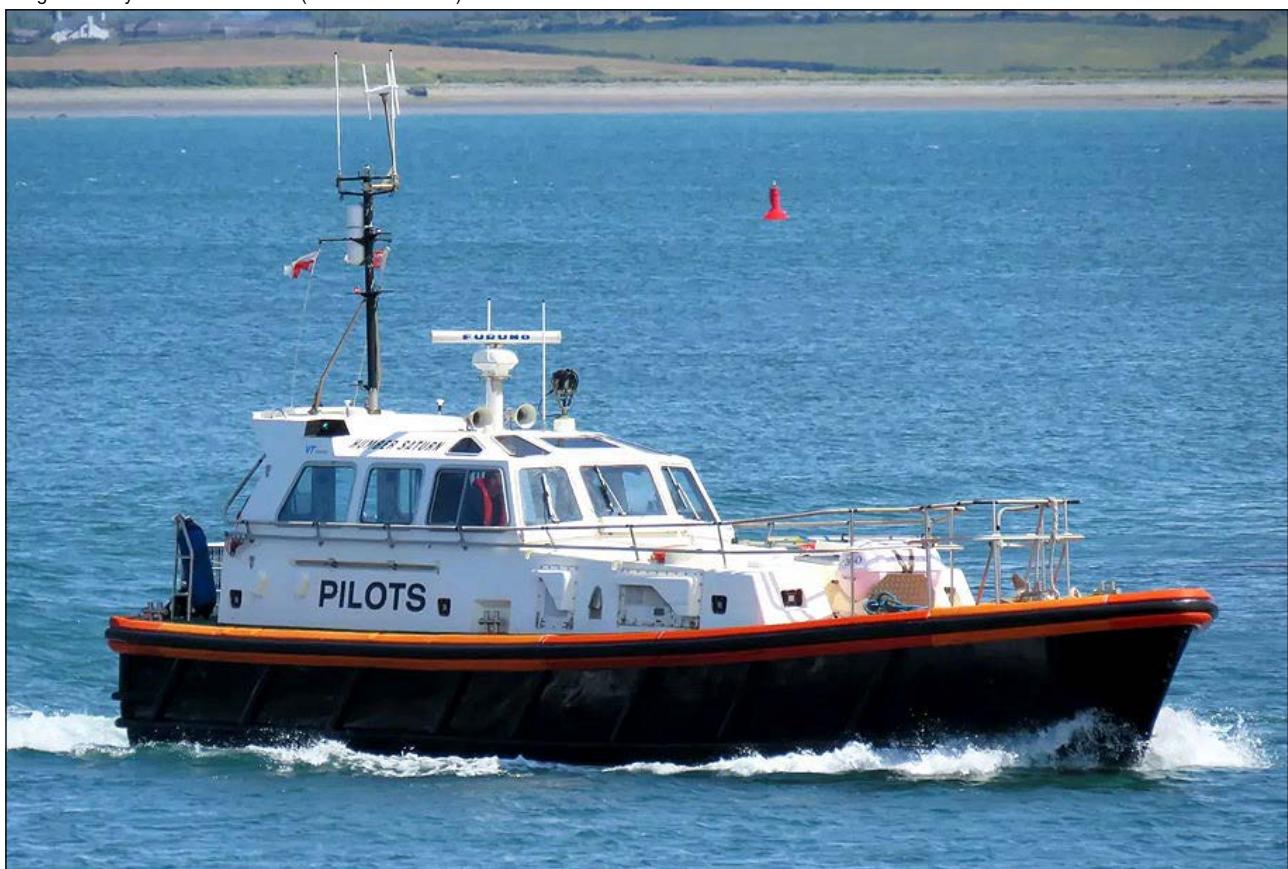
Figure 1: Finnhawk and Humber Saturn

At the MCC the pilot and the trainee pilot met another Class-1 pilot (the tanker pilot) who was to board the same pilot vessel, *Humber Saturn* (**Figure 1**), for transfer to an inbound tanker. The plan was that the tanker pilot would be the first to transfer from *Humber Saturn*, after which the pilot vessel would take the pilot and trainee pilot to *Finnhawk*.

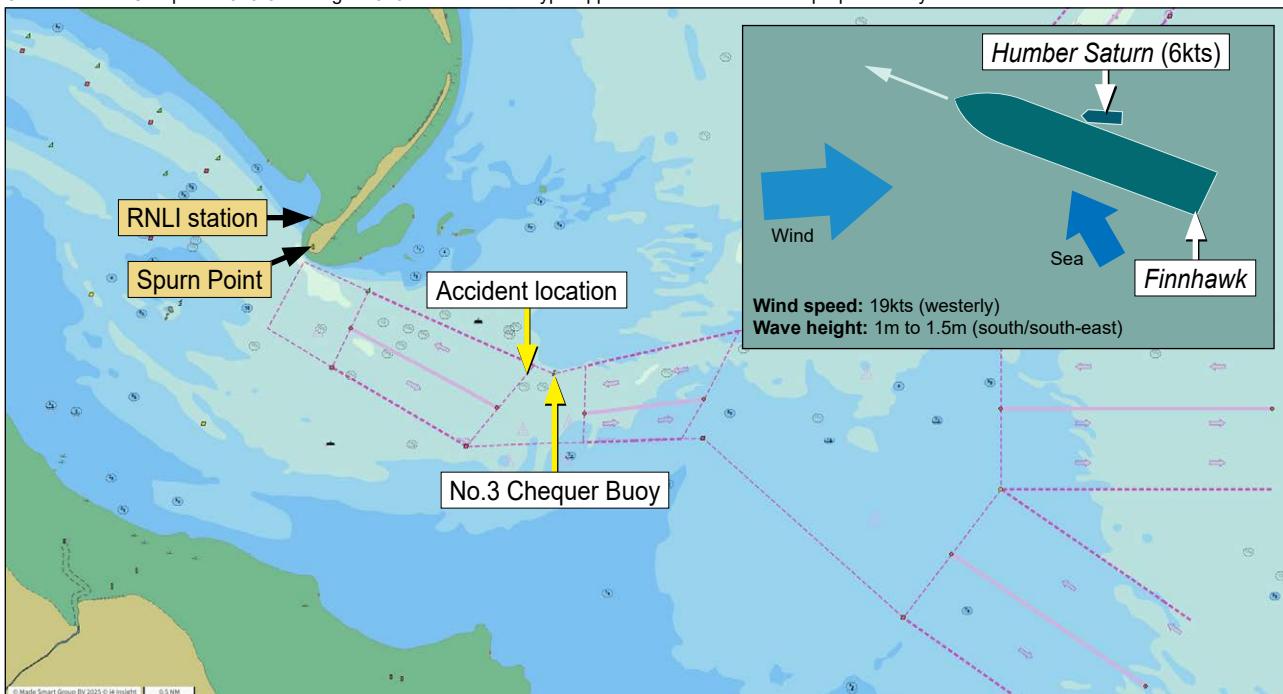
Figure 2: The accident location

At about 1257, at the agreed boarding position just west of No.3 Chequer Buoy (**Figure 2**), *Humber Saturn* rounded the stern of *Finnhawk*, matched its speed of about 6 knots (kts), and came into the lee along its starboard side adjacent to the rigged pilot boarding ladder. The ladder had been lowered to 1m above the waterline and the climb to *Finnhawk*'s upper deck was about 6.5m (**Figure 3**).

Before *Humber Saturn*'s deckhand left the cabin with the pilot and the trainee pilot, the coxswain again asked the pilot if he really wanted to climb the ladder, to which the pilot firmly replied that he did. The deckhand, pilot and trainee pilot then left the pilot vessel's cabin and clipped their harnesses to *Humber Saturn*'s safety rail⁴. They walked along the outboard side of the pilot vessel and passed in front of the wheelhouse to position themselves at the pilot boarding area. *Humber Saturn*'s port bow was pressed against *Finnhawk*'s hull, creating an angle between the two vessels (see **Figure 2**). The pilot was wearing his rucksack on his back.
