## Accident

<b>Aircraft Type and Registration:</b>	Robinson R66, G-WBRN	
<b>No &amp; Type of Engines:</b>	1 Rolls-Royce 250-C300/A1 turboshaft engine	
<b>Year of Manufacture:</b>	2023 (Serial no: 1223)	
<b>Date &amp; Time (UTC):</b>	11 June 2025 at 0714 hrs	
<b>Location:</b>	Chalfont St Peter, Buckinghamshire	
<b>Type of Flight:</b>	Private	
<b>Persons on Board:</b>	Crew - 1	Passengers - None
<b>Injuries:</b>	Crew - None	Passengers - N/A
<b>Nature of Damage:</b>	Significant damage to empennage and rotor blade	
<b>Commander's Licence:</b>	Private Pilot's Licence	
<b>Commander's Age:</b>	64 years	
<b>Commander's Flying Experience:</b>	1,020 hours (of which 380 were on type) Last 90 days - 33 hours Last 28 days - 16 hours	
<b>Information Source:</b>	Aircraft Accident Report Form submitted by the pilot

## Synopsis

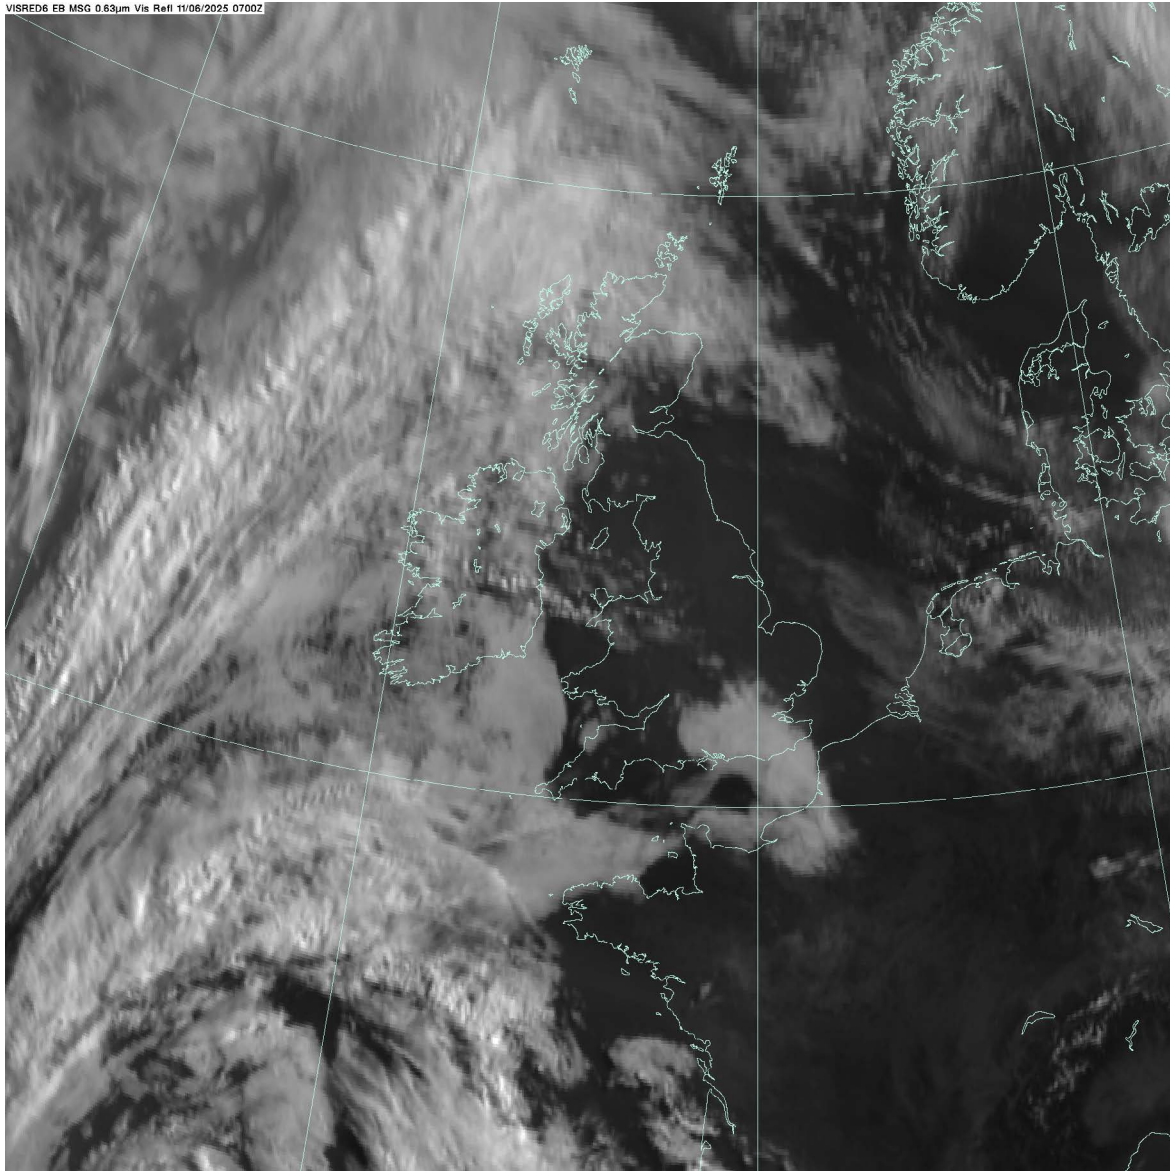
**Figure 1**

The weather in the UK was settled, with an area of high pressure covering the country giving good visibility and a light south-easterly wind. In the morning this gave rise to extensive low cloud in the south (Figure 1), which was forecast to gradually lift during the morning and break by midday.

Visible satellite imagery valid 0700 hrs 11 June 2025

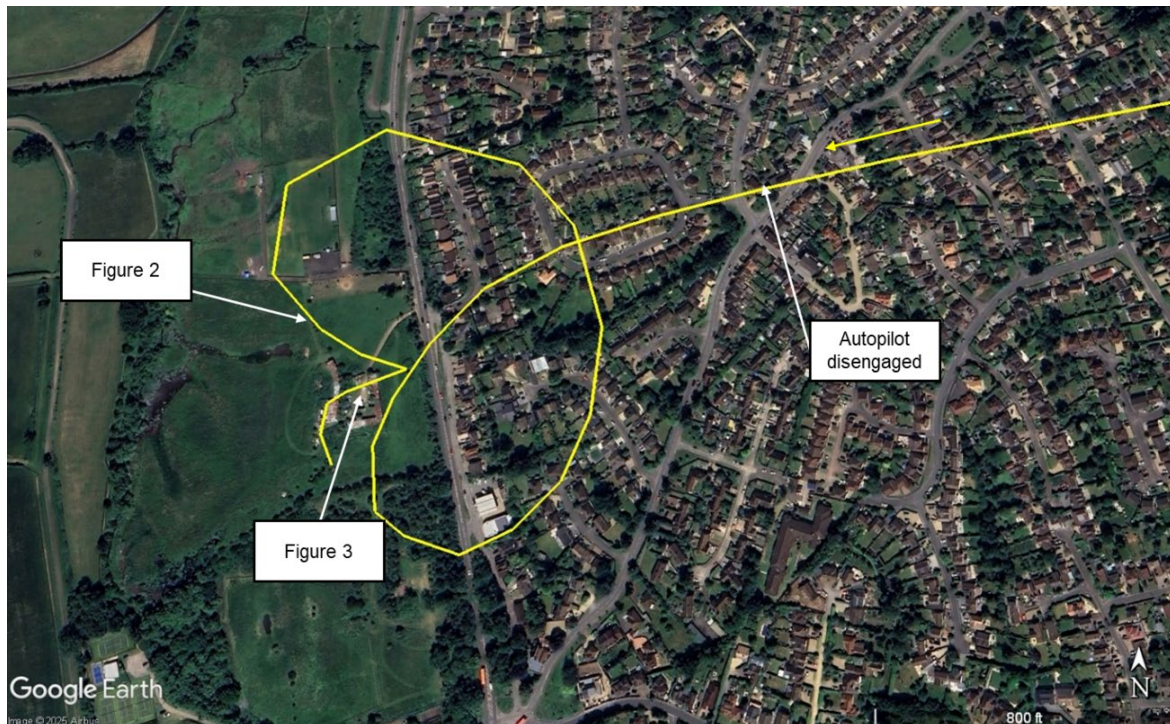
**Figure 4**  
ADS-B flightpath data from FlightAware

The helicopter rolled level with the pilot applying full power, but the main rotor RPM quickly fell below 80%, probably due to overpitching<sup>3</sup>. The pilot had been thrown to the left when the helicopter rolled inverted causing his left foot to push forward on the yaw pedal and it remained in that position as the helicopter entered a rapid yaw to the left. The yaw continued until the helicopter struck the ground in a field next to a paddock with outbuildings. A plan view of the flightpath is shown in Figure 4.

The subsequent impact with the ground was heavy. The skids were splayed and flattened, and the cross tubes that run laterally under the fuselage were fractured with the clamps deformed. The left skid that contacted the downward part of the slope collapsed, acting as a pivot point for the helicopter to roll over.

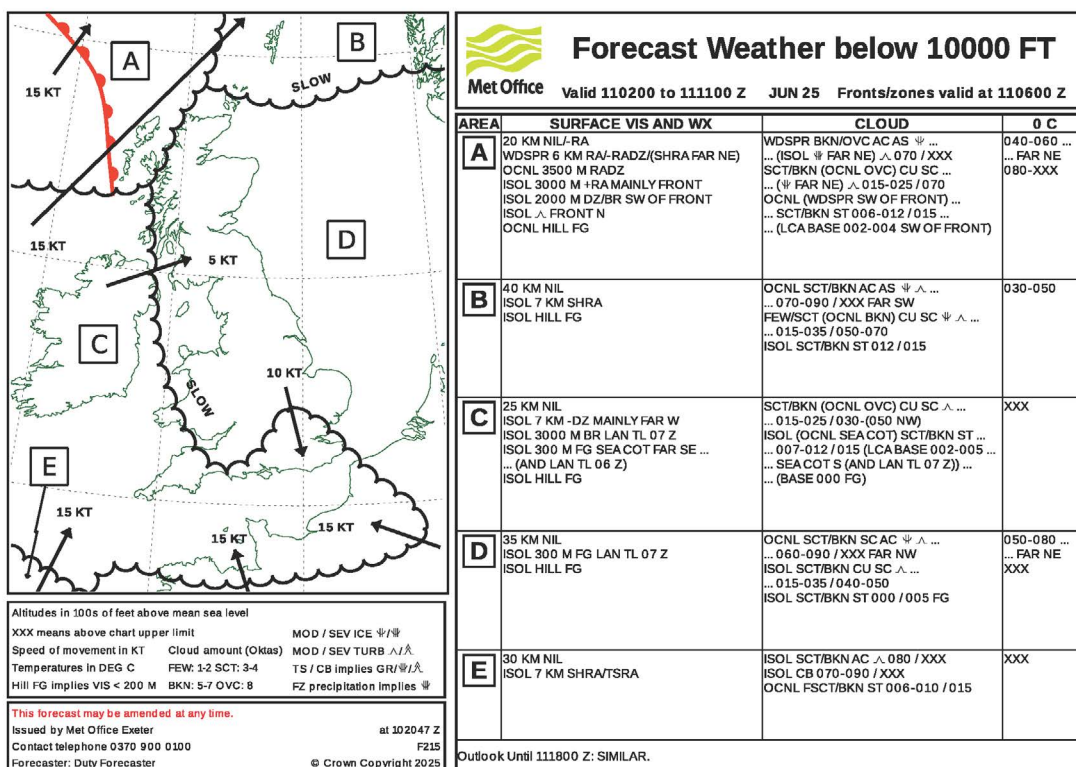
Figure 7

The flight was planned to be conducted within Areas C and D of the Metform 215 (F215) Low Level Significant Weather Chart (Figure 7). The F215 chart covers a wide area and conveys the most likely meteorological conditions for the period. Guidance provided by the Met Office<sup>4</sup> states that it is good practice to consult with observations along the route to obtain the fullest picture.

F215 Low Level Significant Weather Chart valid 0200 to 1100 hrs on 11 June 2025

The Met Office was forecasting isolated areas of scattered or broken cloud in Area C of the Metform 215, which included Denham airfield, with a base of between 700 and 1,200 ft amsl and with the top forecast to be 1,500 ft amsl. Although the pilot believed from his ground observation that conditions were suitable for flight, the actual weather observations from aerodromes in the locality indicated this would probably not be the case, with both Heathrow Airport and RAF Northolt reporting extensive low cloud. Denham airfield is at an elevation of 215 ft, which is higher than Northolt (126 ft) and Heathrow (83 ft). Northolt was reporting broken cloud between 500 and 800 ft agl, indicating that the cloud base in the locality of Denham was likely to have been between about 400 ft and 700 ft agl (615 ft and 915 ft amsl).

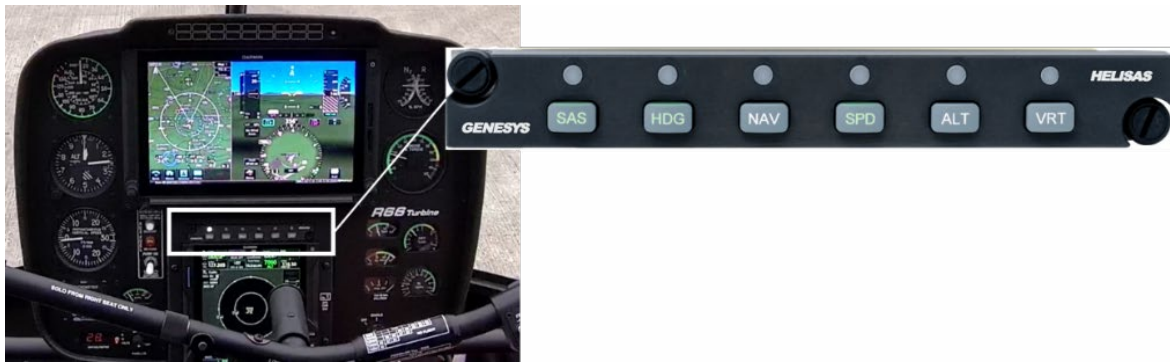
**Figure 8**

The HeliSAS control panel is located on the main instrument panel below the PFD. It consists of a row of buttons and corresponding annunciator lights. A dark annunciator indicates that the mode is off, white indicates that the mode is in standby or armed, and green indicates that the mode is engaged (Figure 8).

HeliSAS control panel
