Report on the investigation of
a serious injury to a passenger on the sea safari rigid
inflatable boat

Lundy Explorer

at Ilfracombe, England

on 7 June 2023

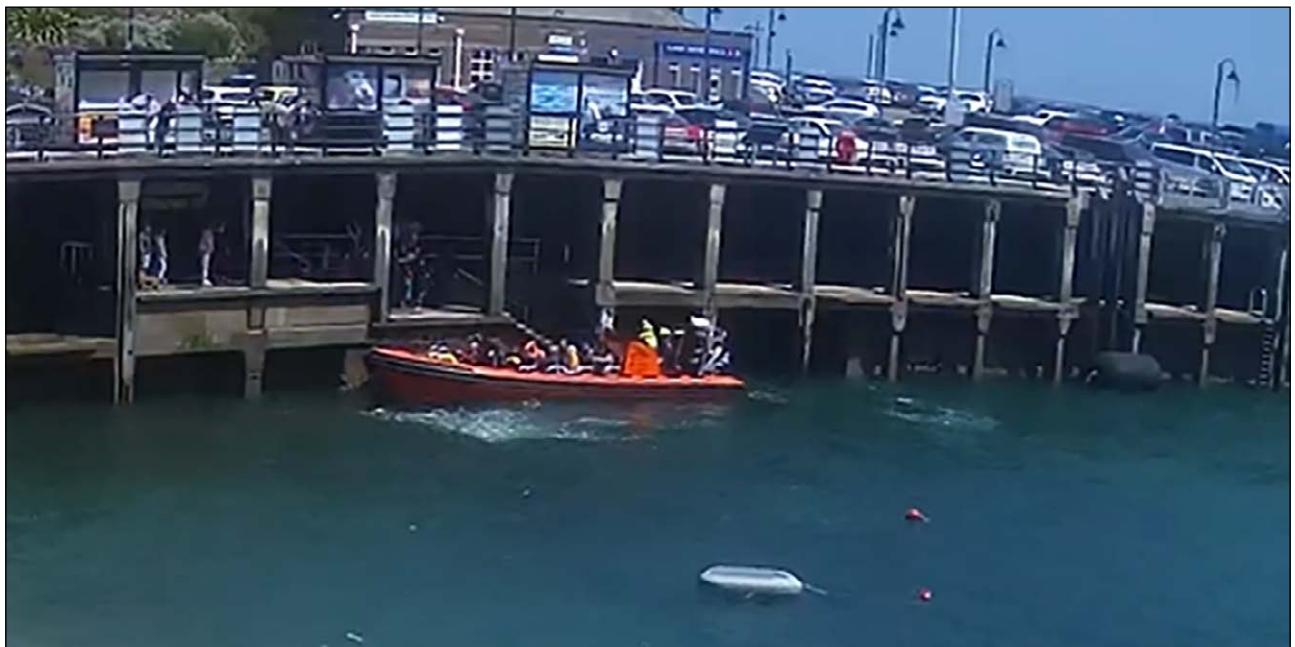
At 1201 on 7 June 2023, the 11m rigid inflatable boat (RIB) *Lundy Explorer* berthed alongside the pier at Ilfracombe Harbour, Devon, England to disembark passengers after a 2-hour trip (**Figure 1**). Waiting at the pier landing stages were the owner of the RIB company and 12 new passengers who had booked a 1-hour trip to see wildlife along the coast.

Figure 1: *Lundy Explorer* at pier landing stages about to disembark passengers

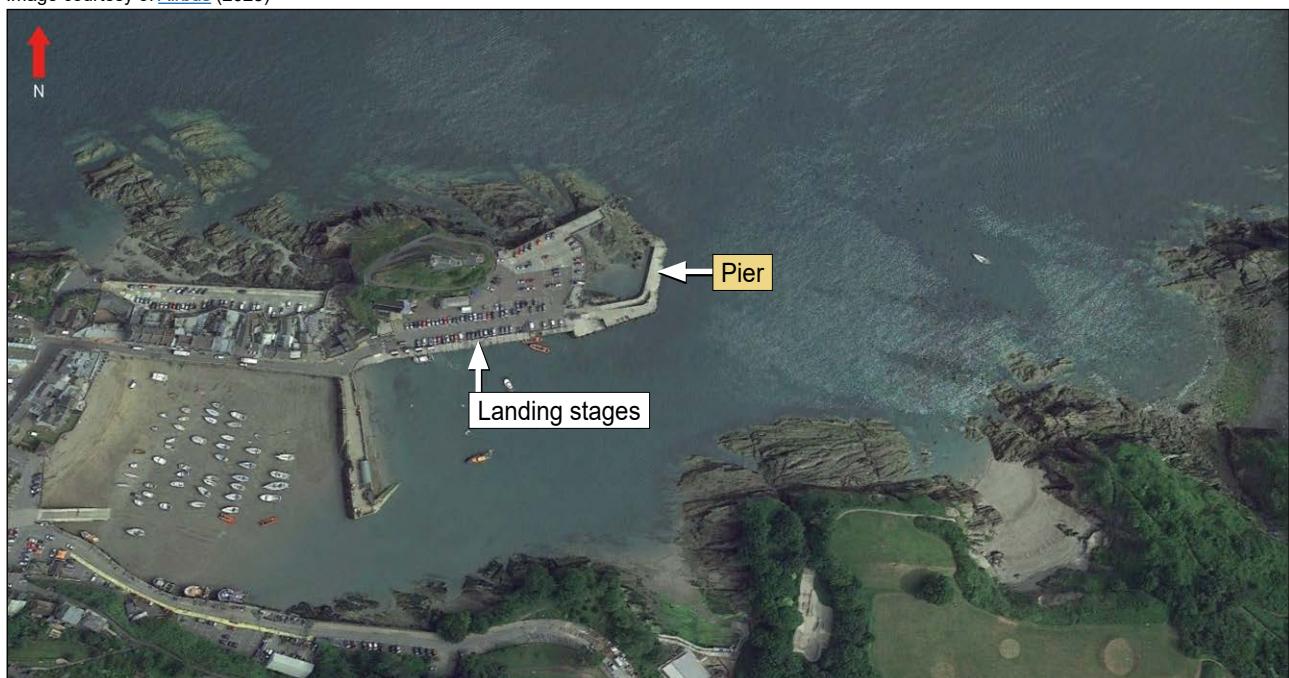
At 1205, *Lundy Explorer* departed and met *Voyager*, another of the company's RIBs that had developed an engine fault minutes earlier and was waiting in the harbour. *Lundy Explorer* went alongside *Voyager* and the two skippers swapped RIBs. At 1209, *Lundy Explorer* headed out of the harbour (**Figure 3**) at about 4 knots (kts).

Figure 3: Ilfracombe Harbour

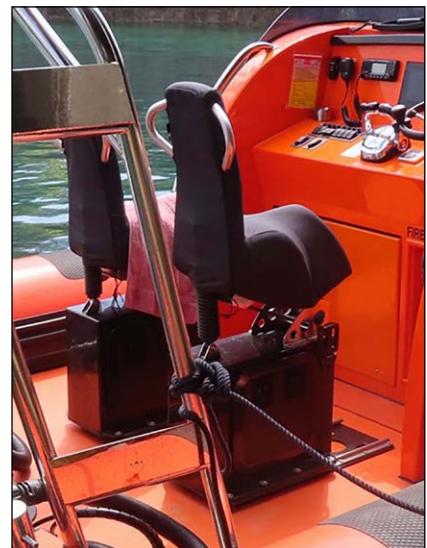
The RIB was operated from an aft steering console equipped with a radar, navigation plotter, and fixed very high frequency radio. The two crew positions had suspension seating⁴ (**Figure 8**), which were reportedly only used on long trips in low wave heights.

Figure 8: *Lundy Explorer*'s helm position suspension seat

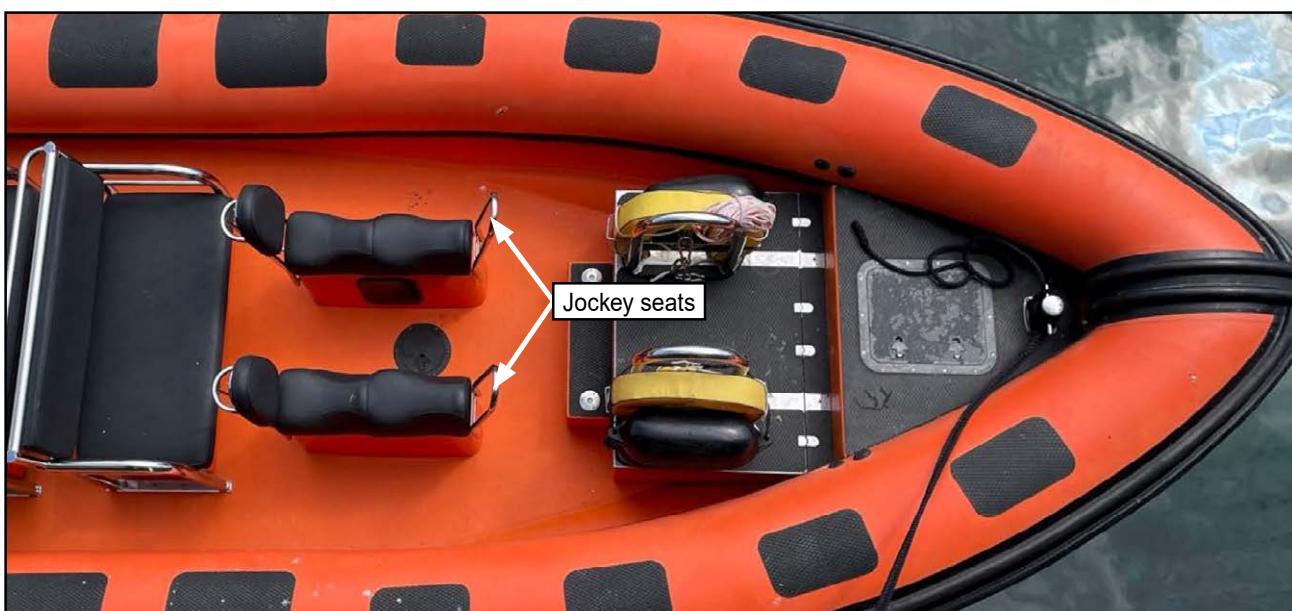
On 7 June 2023, a passenger on a rigid inflatable boat (RIB) sea safari suffered a spinal injury that left them paralysed from the waist downwards. Twelve passengers had boarded the RIB and, once it was clear of the jetty, the two crew gave them a safety briefing and instruction on the wearing of lifejackets. The RIB then proceeded out to sea and was increasing speed in choppy sea conditions when it encountered a steep-sided wave. The boat fell off the wave and slammed violently into the trough, dislodging a passenger from a forward jockey seat (**Figure 1**). The passenger immediately lost feeling in their legs.

Figure 1: Front of RIB with jockey seats
