Report on the investigation of
the collision between the crude oil tanker **Apache** and
the stern trawler **Serinah (GH 116)**
in the Firth of Clyde, Scotland
on 25 April 2024

Apache and Serinah

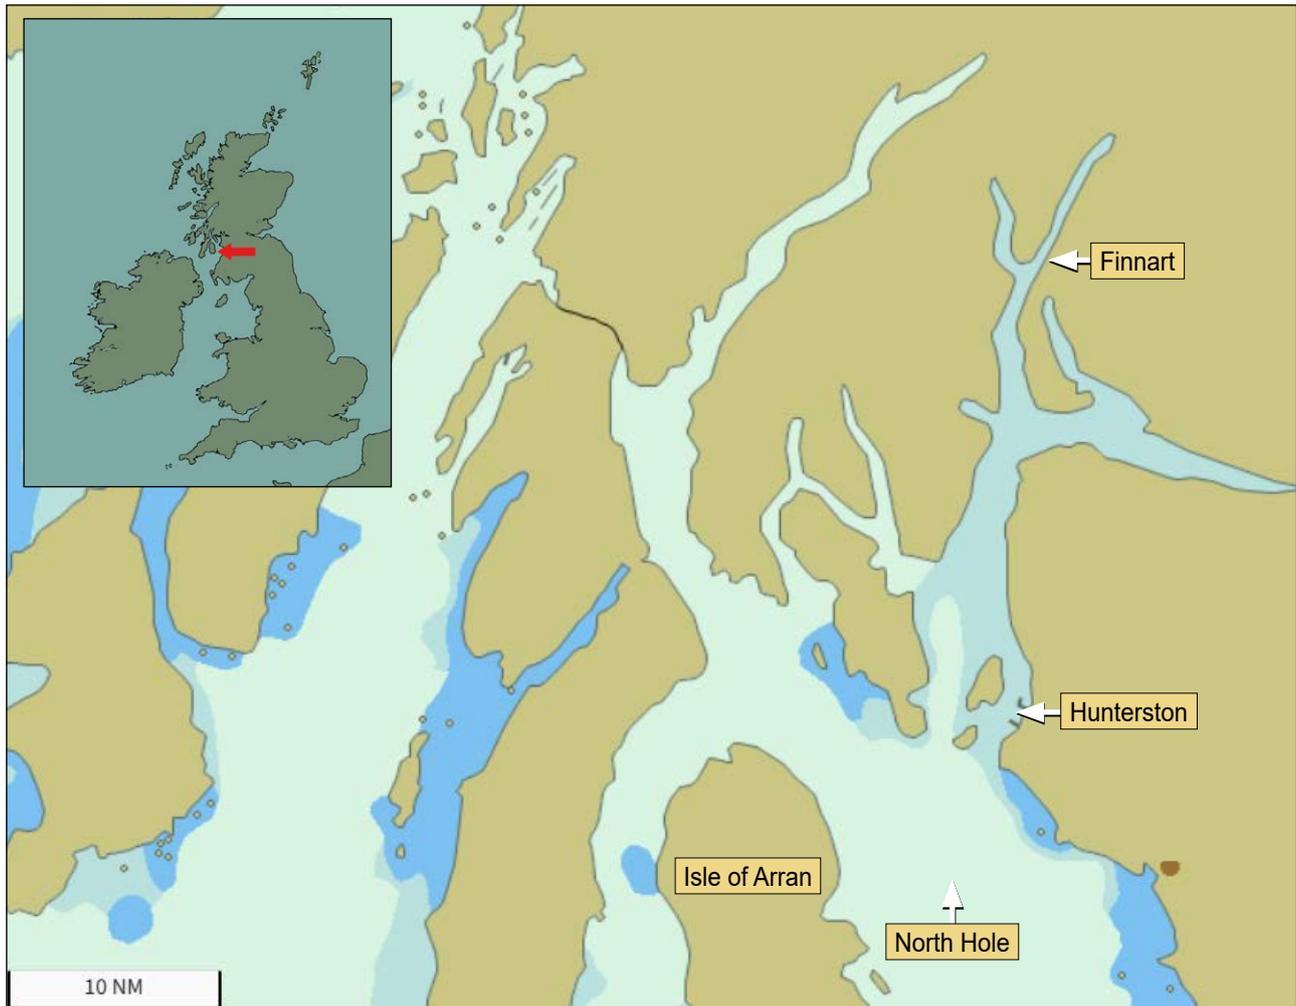
Figure 1: Location of the collision

At about 0820 on 25 April 2024, the UK registered 9.9m prawn trawler *Serinah* departed its home port of Troon, Scotland for a 2-day fishing trip with three crew on board. *Serinah* headed to the northern section of the Firth of Clyde and had completed two trawls by lunchtime. These trawls were unsuccessful, so the skipper decided to fish a depression on the seabed in the middle of the Firth of Clyde known locally as the North Hole (**Figure 1**). *Serinah* arrived at the North Hole at about 1300 and planned to complete three clockwise laps of it. Each lap of the hole would take about an hour.
