Report on the investigation of  
the collision between the bulk carrier  
***Polesie***  
and the general cargo ship  
***Verity***  
resulting in the sinking of *Verity* with five fatalities  
in the German Bight traffic separation scheme  
on 24 October 2023

**This investigation was carried out by the UK Marine Accident Investigation Branch (MAIB) on behalf of the Isle of Man Administration in accordance with the Memorandum of Understanding between the MAIB and the Red Ensign Group Category 1 registries of Isle of Man, Cayman Islands, Bermuda and Gibraltar.**

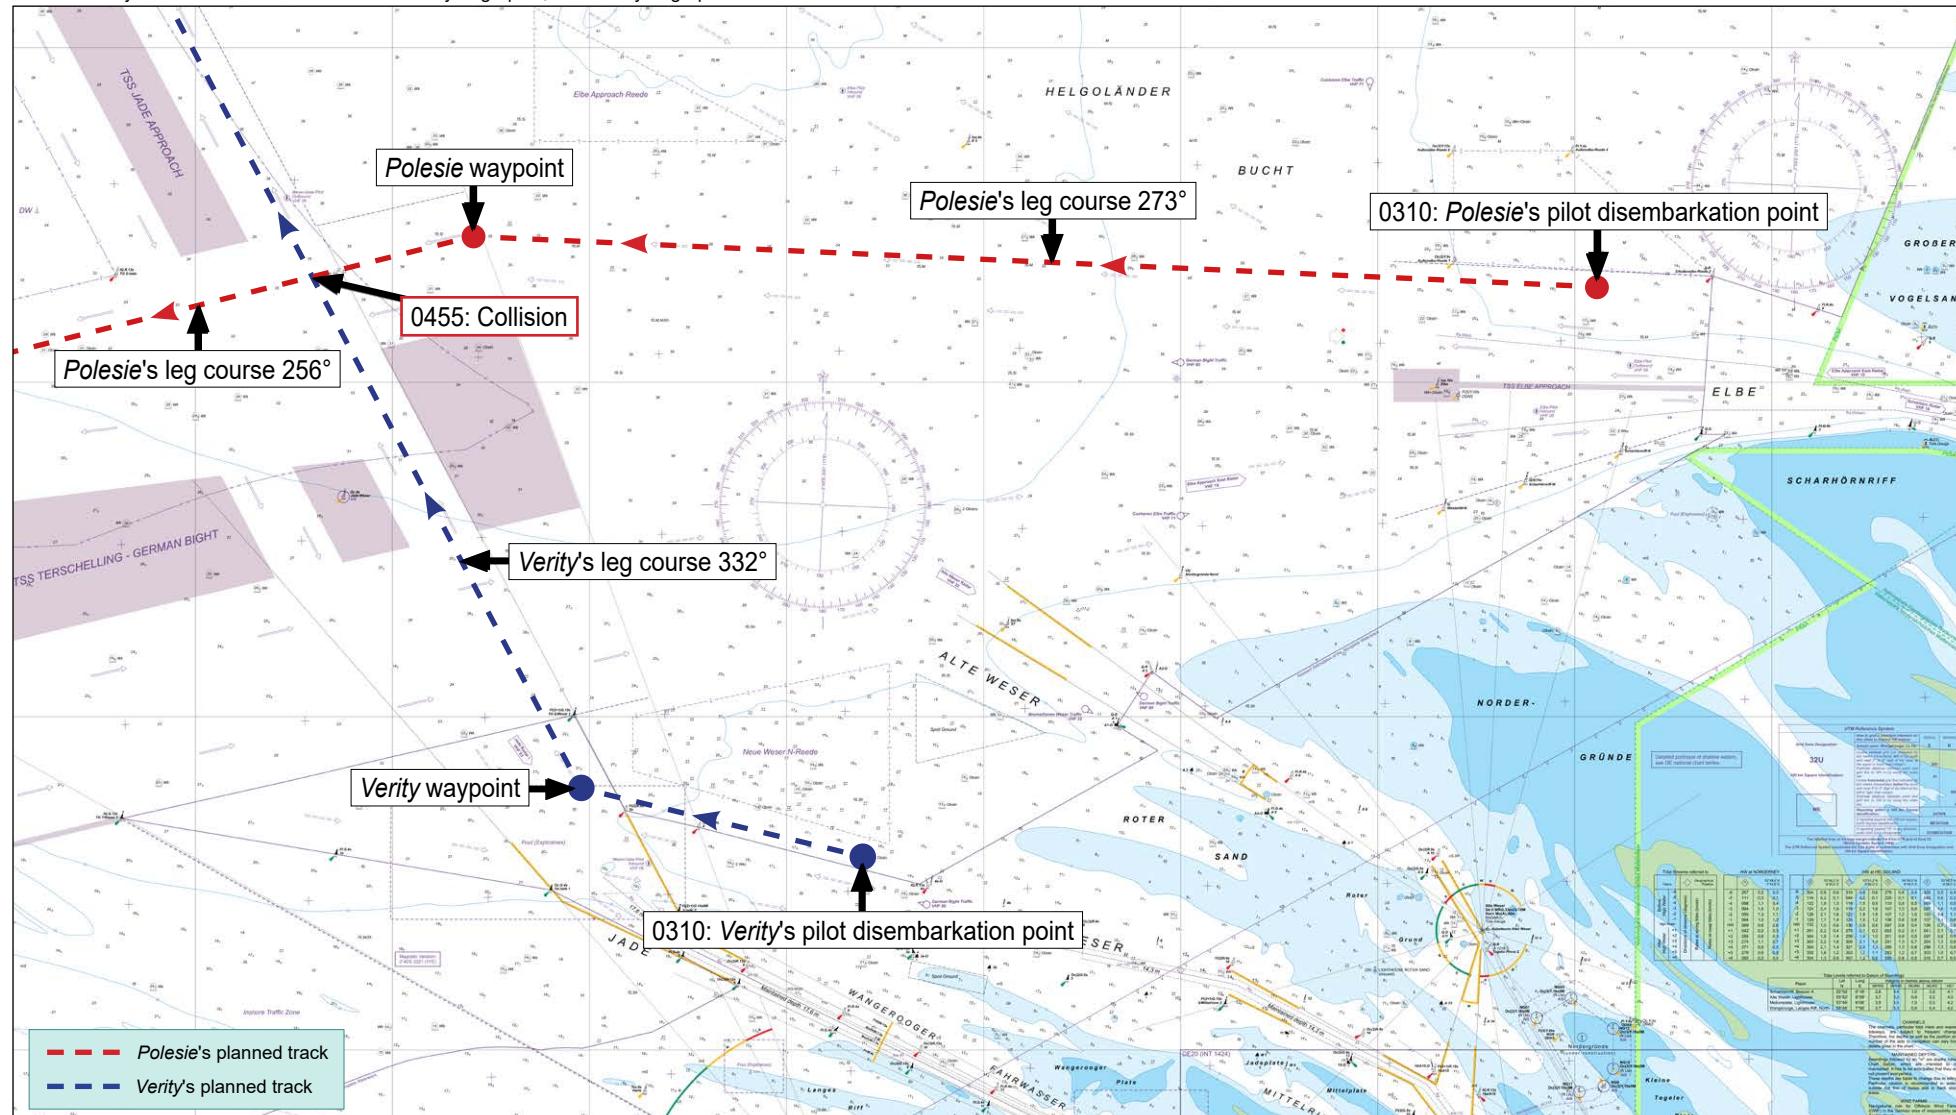
Figure 1: Admiralty Chart DE2 INT 1456 Approaches to rivers Jade, Weser and Elbe, showing the eastern part of the inner German Bight traffic separation scheme and planned tracks of *Polesie* (red) and *Verity* (blue)

At 0310 the following morning, *Polesie*'s pilots had disembarked, and the vessel began its sea passage (**Figure 1**). On the bridge (**Figure 2**) were the master, second officer (2/O) and a helmsman. The vessel was steered on a course of 273° towards its next waypoint at a speed of about 11 knots (kts)<sup>1</sup> with time in hand to reach its next port of call. The master handed control to the 2/O and shortly afterward left the bridge. The wind was easterly force 4 with a short steep swell from the same direction, partly cloudy with good visibility.

At about the same time, *Verity*'s pilot had disembarked, and the vessel's speed increased to about 8kts. The required speed to make the next port of call was being maintained. By 0348, *Verity* had reached the end of the main Jade/Weser navigation channel (**Figure 1**) and its course was set to 332° to transit the north-west bound lane of the German Bight traffic separation scheme (TSS). A VTS, call sign 'German Bight Traffic', controlled shipping transiting the area on duplex<sup>2</sup> very high frequency (VHF) radio channel 80<sup>3</sup>.

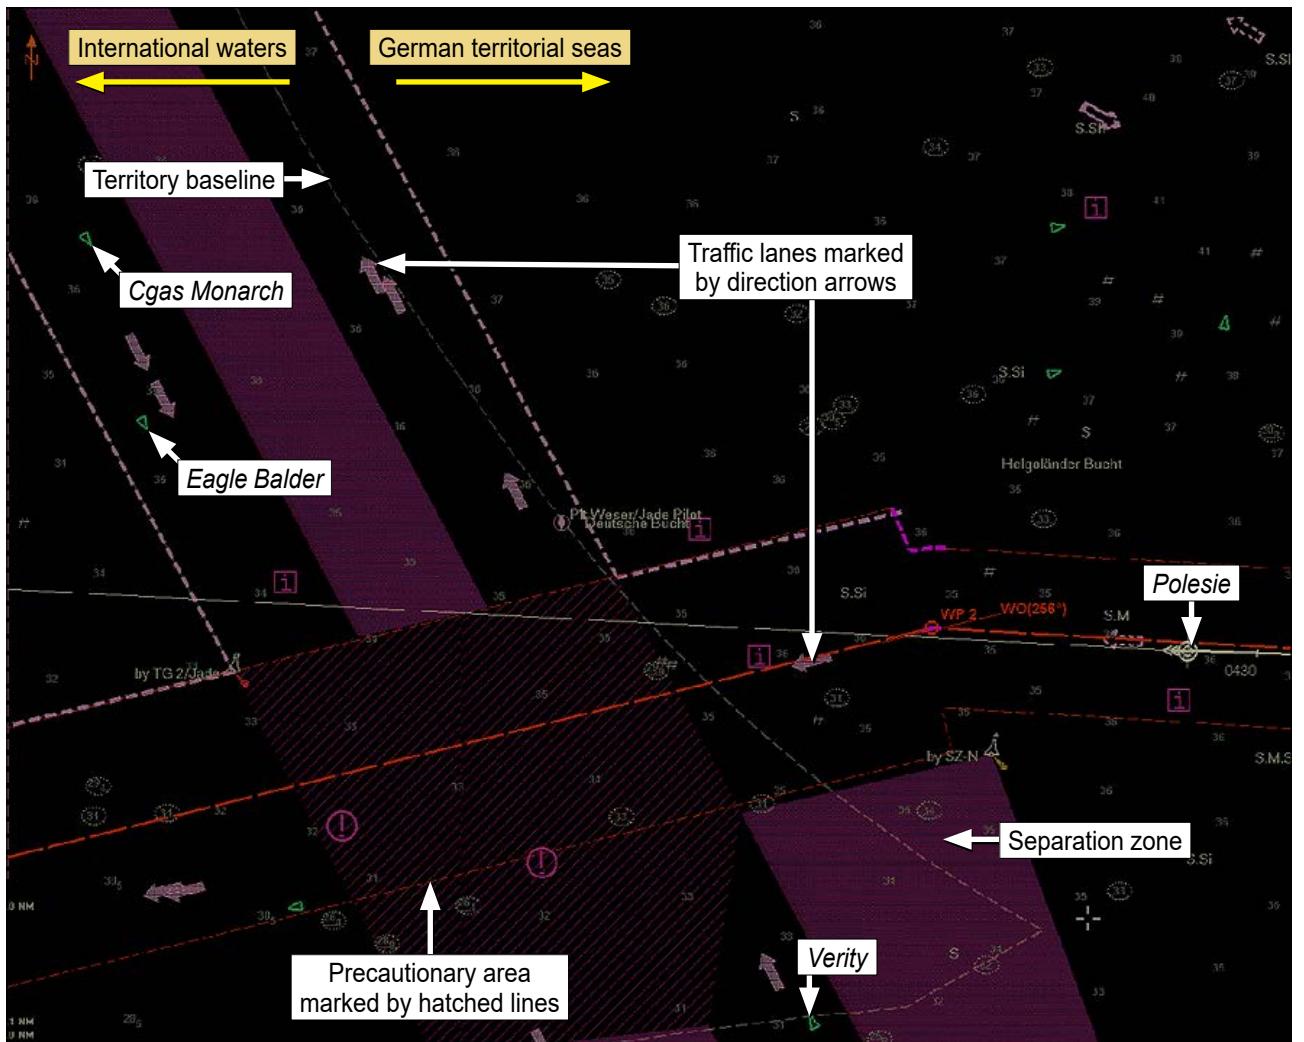
**Figure 5:** *Polesie*'s ECDIS display at 0433

At 0433, *Polesie*'s ECDIS recorded that *Verity* had passed from the German territorial sea into international waters (**Figure 5**).

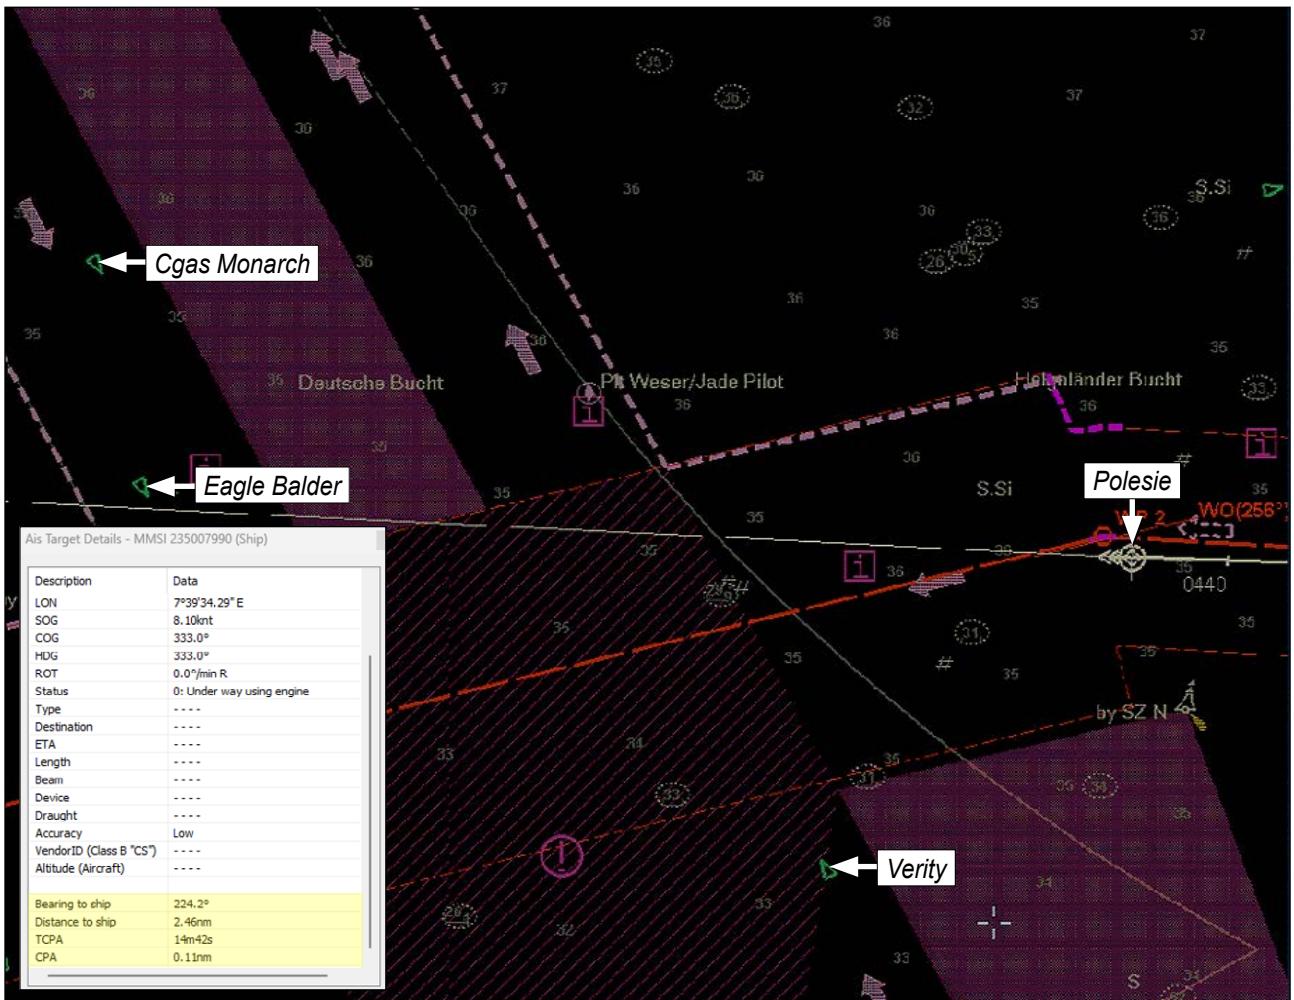
**Figure 6:** *Polesie's ECDIS display at 0443 and (inset) Verity's AIS information extracted from Polesie's VDR*

By 0443, *Polesie* was approaching its waypoint at the entrance to the westbound lane of the TSS and *Verity* was entering the crossing area of the TSS (**Figure 6**). *Verity* was on *Polesie*'s port bow, bearing 224° at 2.46nm range. *Polesie*'s AIS unit showed *Verity* would pass close astern at a CPA of 0.11nm, with a TCPA in 14 minutes and 42 seconds (**Figure 6** inset). The AIS also showed two vessels, *Eagle Balder* and *Cgas Monarch*, heading south in the TSS to the Jade river, and both passing clear ahead of *Polesie* by 5.2nm and 3nm respectively.

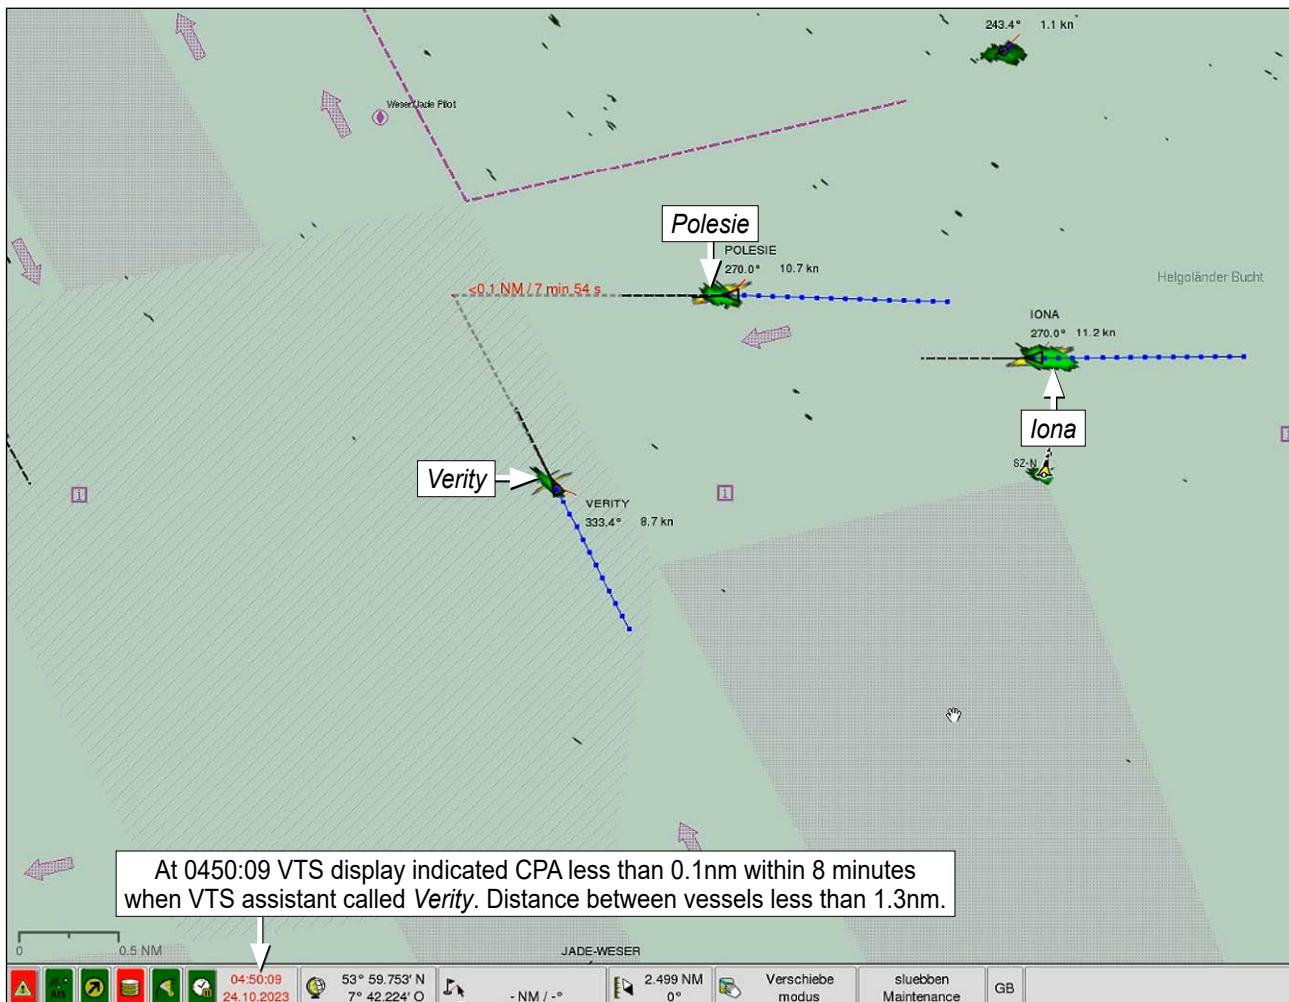
Figure 7: Reconstruction of 0450:09 VTS display when VTS assistant called *Verity*

The German Bight Traffic VTS assistant had been monitoring *Verity* and *Polesie*, identified that a risk of collision existed and noted that *Verity* had not acted as expected of a give-way vessel (**Figure 7**). At 0450:09, when the two vessels were less than 1.3nm apart, the VTS assistant called *Verity* and the exchanges shown in **Table 1** occurred, with both parties speaking in a conversational tone. The VTS assistant had also taken two routine shipping reports in the 3 minutes before contacting *Verity* but it is unknown what other watchkeeping tasks they were required to perform.

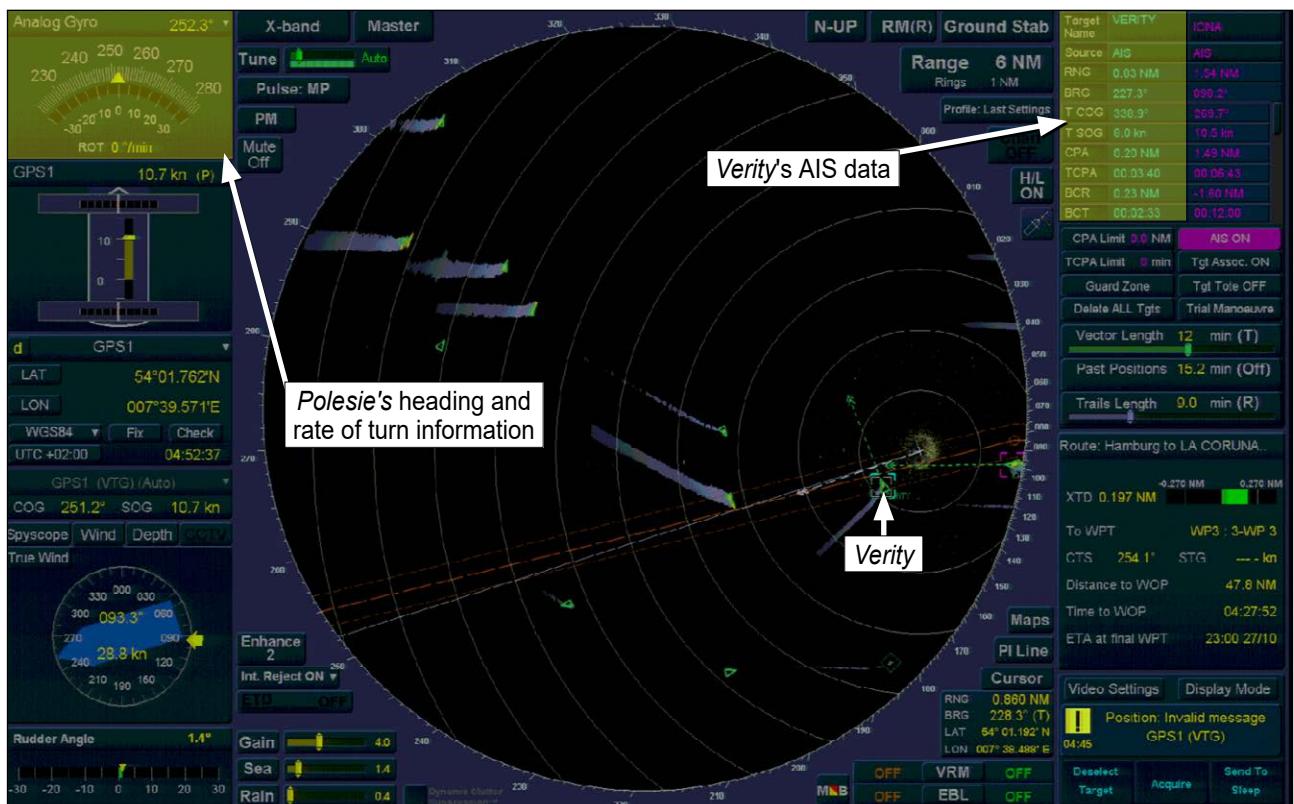
At 0452:26, *Verity*'s heading altered to starboard. Eleven seconds later, *Polesie*'s watchkeeper selected *Verity*'s AIS icon on the radar on the 6nm range (**Figure 8**), which showed its status information on the screen. It showed that *Verity* was at a range of 0.83nm, had a CPA of 0.2nm and a TCPA in 3 minutes and 40 seconds with a bow crossing range (BCR), passing ahead, of 0.23nm in 2 minutes and 33 seconds.

*Polesie*'s VDR shows that the OOW was very passive in their monitoring of other traffic in the vicinity. Figure 4 shows that at 0419 the only vessel being tracked was *Iona*, and it was not until after the VTS assistant's first call to *Polesie*, which completed at about 0452, that the OOW selected *Verity*'s AIS icon on the radar. At that time, *Verity*'s range was 0.83nm with a CPA of 0.2nm ahead of *Polesie* in 2 minutes and 33 seconds. While *Polesie*'s OOW might have been aware of *Verity* for some time before the VTS assistant's first intervention, they were not using the ARPA to provide them with accurate information about *Verity*'s CPA or TCPA and so were denying themselves the best information available.

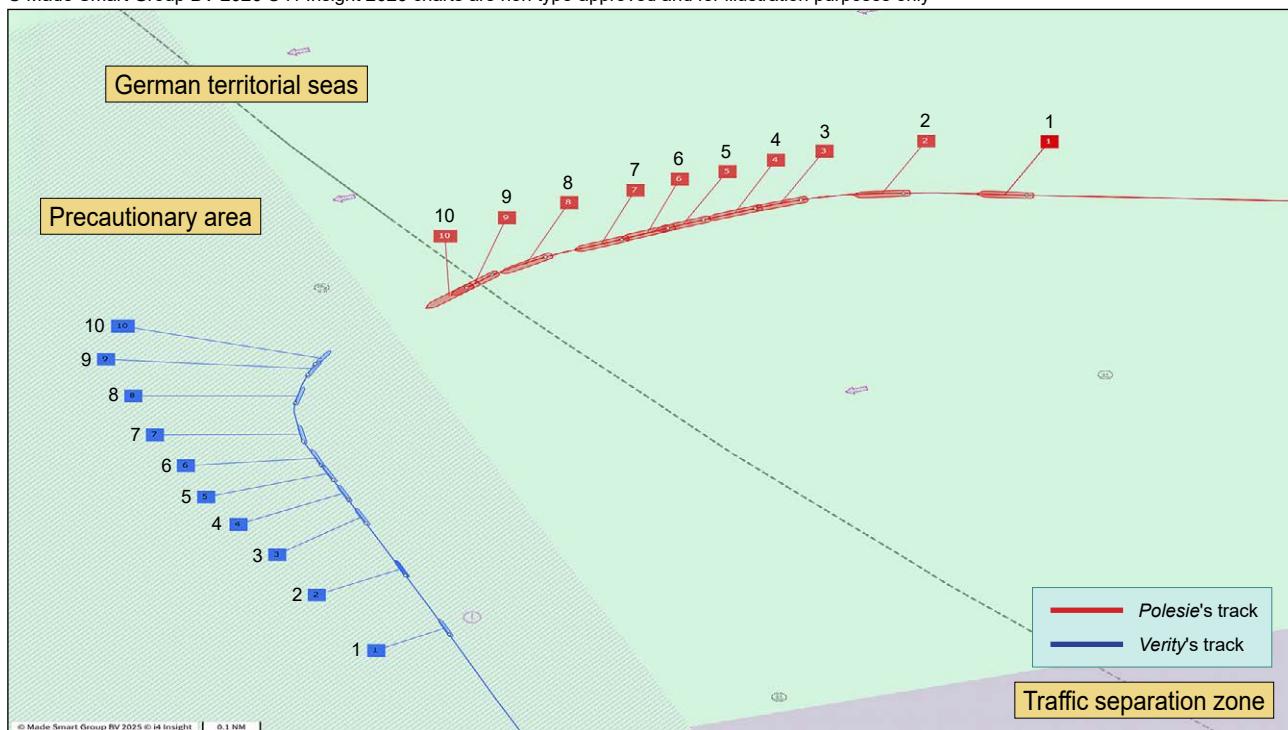
**Figure 10:** Made Smart Group reconstruction of relative positioning of both vessels between 0048 and 0454

At 0454:18, 9 seconds after their reply to VTS, *Polesie*'s C/O had switched to manual steering and put the vessel's rudder hard to starboard. Coincidentally, *Polesie* entered international waters. *Verity* was slowly altering course to starboard almost right ahead of *Polesie* at about 0.4nm (Figure 10).

Point	Verity bearing from Polesie	Range between vessels (nm)	Time	Event
1	222.8	1.5	0448:47	<i>Polesie</i> started alteration of course to port near waypoint 2
2	222.6	1.3	0450:00	VTS call to <i>Verity</i>
3	223.5	1.1	0451:02	<i>Polesie</i> autopilot set at 252°
4	224.6	1.0	0451:30	Not applicable
5	225.1	0.9	0452:03	Not applicable
6	225.9	0.9	0452:26	<i>Verity</i> started alteration to starboard
7	228	0.8	0452:55	Radar target acquired on <i>Polesie</i> 18 seconds earlier
8	230.4	0.6	0453:43	VTS call to <i>Polesie</i> "come to starboard" 6 seconds later
9	232.7	0.4	0454:19	<i>Polesie</i> 's rudder hard to starboard
10	234.6	0.3	0454:34	<i>Polesie</i> rate of turn zero

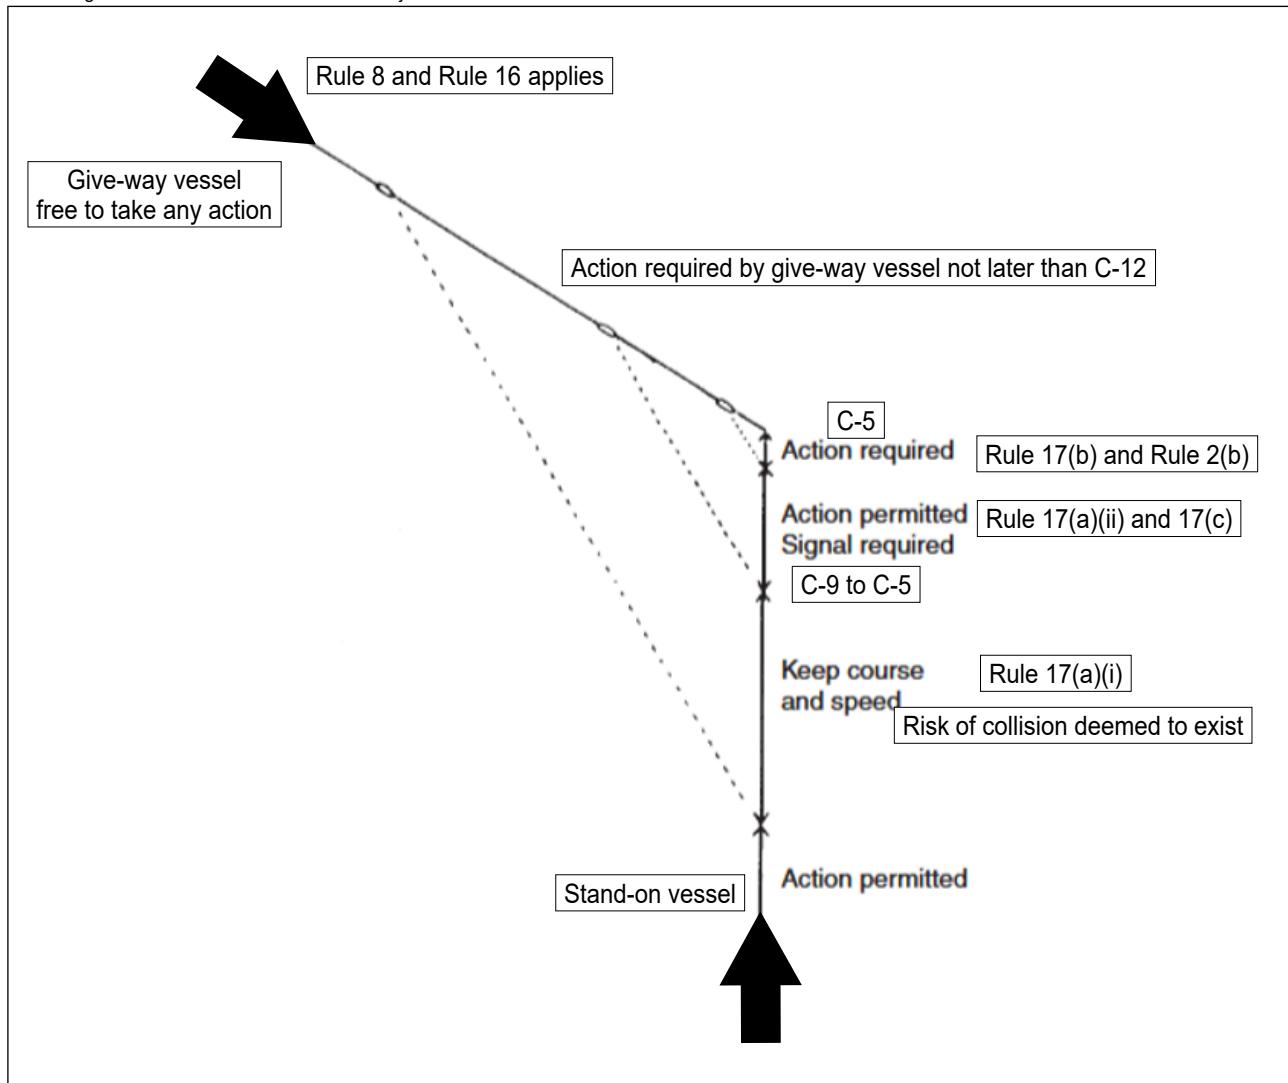
**Figure 16:** Suggested TCPA limits for open sea encounters; diagram adapted from *A Guide to the Collision Avoidance Rules*

The distance issue was unresolved but the guide's text was supported by a diagram to illustrate the phases of a crossing encounter, and subsequent text attempted to add ranges to those phases (**Figure 16**). Additionally, the issue of *all available means* in determining risk of collision discussed, among other things, the use of VHF and AIS. It noted that, while AIS was not recommended as the sole means to determine risk of collision, its information transmission time may be faster than the time needed to generate an accurate ARPA but was limited to the quality of data input on the ship it was fitted to. On VHF, it commented that:
