Serious Incident

Aircraft Type and Registration:	Boeing 737-8K5, G-TAWD	
No & Type of Engines:	2 CFM56-7B27E turbofan engines	
Year of Manufacture:	2011 (Serial no: 37265)	
Date & Time (UTC):	20 October 2023 at 1153 hrs	
Location:	Leeds Bradford Airport	
Type of Flight:	Commercial Air Transport (Passenger)	
Persons on Board:	Crew - 6	Passengers - 195
Injuries:	Crew - None	Passengers - None
Nature of Damage:	Main landing gear tyres and nosewheel tyres damaged. Left nosewheel inner axle bearing destroyed	
Commander's Licence:	Airline Transport Pilot's Licence	
Commander's Age:	41 years	
Commander's Flying Experience:	14,250 hours (2,800 hours on type) Last 90 days - not known Last 28 days - 88 hours	
Information Source:	AAIB Field Investigation

Synopsis

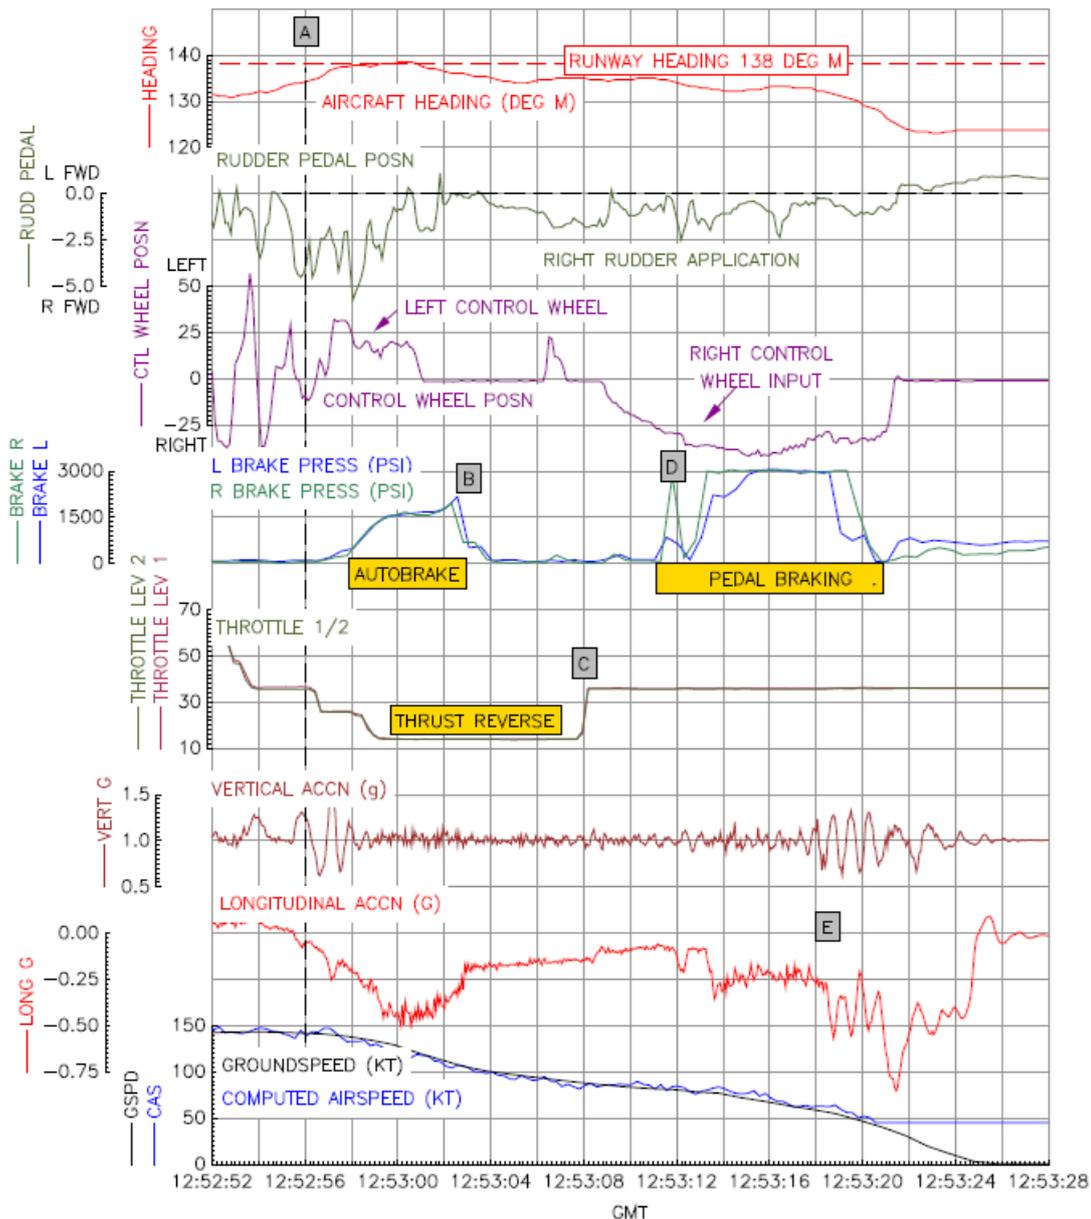
Figure 5

At 1252:10 hrs, whilst on the final approach at approximately 1.6 nm from the Runway 14 threshold, the autopilot and autothrottle were disconnected. The approach continued with touchdown at 1252:55 hrs at a recorded vertical acceleration of 1.3 g and Computed Airspeed (CAS) of approximately 140 kt (point A, Figure 5). During the flare, rudder inputs were recorded which reduced the drift on touchdown.

Seven seconds after touchdown at a CAS of 107 kt, the autobrake was disengaged and brake pressure reduced (point B, Figure 5). Six seconds later at a CAS of 86 kt, the throttles were returned to the 'Forward Idle' position and the thrust reversers were stowed. Throughout this time, up to 1.8° right rudder pedal continued to be applied (point C, Figure 5) and the Cockpit Area Mic (CAM) recorded what could be described as a juddering/rattling sound. This was more pronounced from point C onwards.

Once the thrust reversers were stowed, the recorded right rudder pedal deflection periodically returned to zero and the control wheel was progressively increased up to 42° to the right. Three seconds after the reversers were stowed, pedal braking was applied which was the same time the CVR recording captured the commander vocalising concerns (point D, Figure 5). Braking application was briefly asymmetric with a demand for full right braking after which the pedal demand for left braking increased to maximum to match that of the right brake pedal (point D, Figure 5). The aircraft deviated to the left of the runway and the recorded longitudinal and vertical acceleration deviations showed it departed the left side of the runway (point E, Figure 5) at approximately 64 kt CAS (groundspeed 55 kt), stopping six seconds later. Nosewheel steering position was not recorded.

FDR parameters during landing

After touchdown, the rudder pedal input reduced to zero at 12:53:02 (Figure 5) for two seconds and the aircraft heading began to turn into wind, as would be expected in a strong crosswind. The autobrake was disengaged, and the right rudder pedal input was increased to an average of about 2° over a period of about 10 seconds (from about 12:53:07 to 12:53:17), with a maximum of 2.5°. The increased rudder pedal input stabilised the aircraft's heading for about six seconds (until 12:53:11), although it was not sufficient to return the aircraft to runway heading. The manufacturer's report concluded that 2° to 3° of right rudder pedal would be required to maintain the runway centreline initially, increasing to

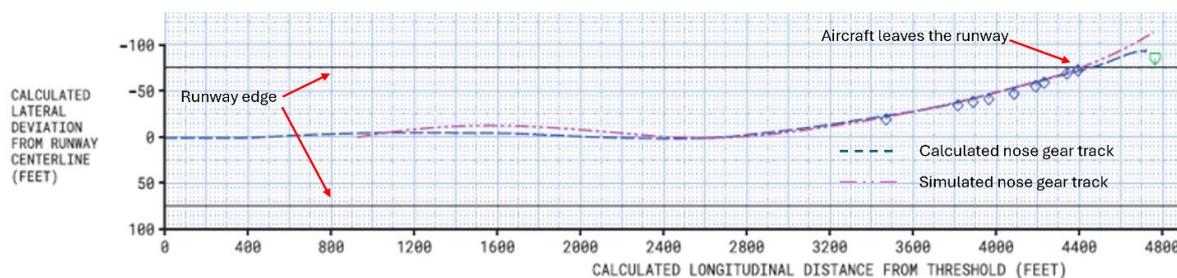
Figure 6

A desktop engineering simulation was used to recreate the landing rollout. The simulation was a six-degrees-of-freedom non-linear model updated to match flight data, and it was driven by recorded control positions from the actual landing, along with the METAR data nearest to the time of the event and a runway surface condition of wet. The simulation was used to assess aircraft lateral performance during the landing, and the simulated results were a reasonable match to the aircraft's actual track over the ground (Figure 6).

Landing simulation (The Boeing Company)
