AAIB Bulletin

12/2024

Aircraft Type and Registration:	Boeing 737-8K5, G-TAWD
No & Type of Engines:	2 CFM56-7B27E turbofan engines
Year of Manufacture:	2011 (Serial no: 37265)
Date & Time (UTC):	20 October 2023 at 1153 hrs
Location:	Leeds Bradford Airport
Type of Flight:	Commercial Air Transport (Passenger)
Persons on Board:	Crew - 6 Passengers - 195
Injuries:	Crew - None Passengers - None
Nature of Damage:	Main landing gear tyres and nosewheel tyres damaged. Left nosewheel inner axle bearing destroyed
Commander's Licence:	Airline Transport Pilot's Licence
Commander's Age:	41 years
Commander's Flying Experience:	14,250 hours (2,800 hours on type) Last 90 days - not known Last 28 days - 88 hours
Information Source:	AAIB Field Investigation

Aircraft Type and Registration:	Rotorsport UK Cavalon, G-CKYT	
No & Type of Engines:	1 Rotax 914-UL piston engine	
Year of Manufacture:	2018 (Serial no: RSUK/CVLN/027)	
Date & Time (UTC):	12 November 2020 at 1250 hrs	
Location:	Farmland between Avoch and Munloch, Black Isle	
Type of Flight:	Solo training flight	
Persons on Board:	Crew - 1	Passengers - None
Injuries:	Crew - 1 (Fatal)	Passengers - N/A
Nature of Damage:	Aircraft destroyed	
Commande

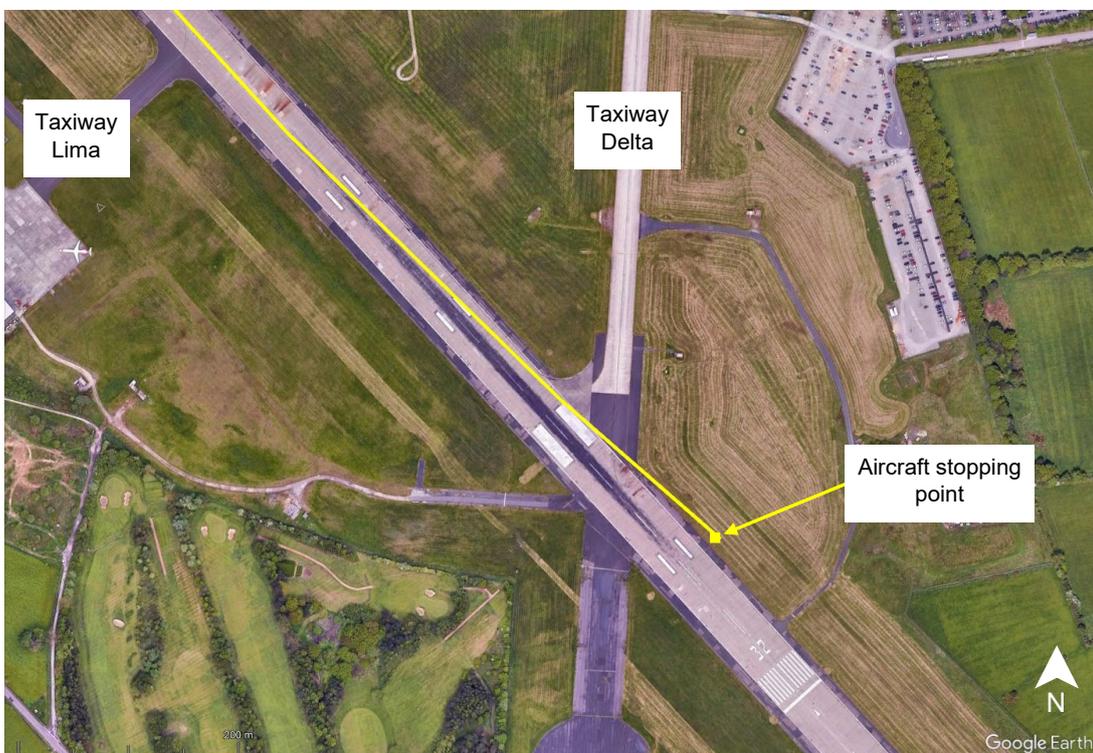
Figure 2
Aircraft ground track

The aircraft came to a stop six seconds later in muddy ground approximately 150 m beyond the D taxiway exit (Figures 1 and 2). The crew followed normal shutdown procedures to secure the aircraft. There were no injuries reported by passengers or crew.

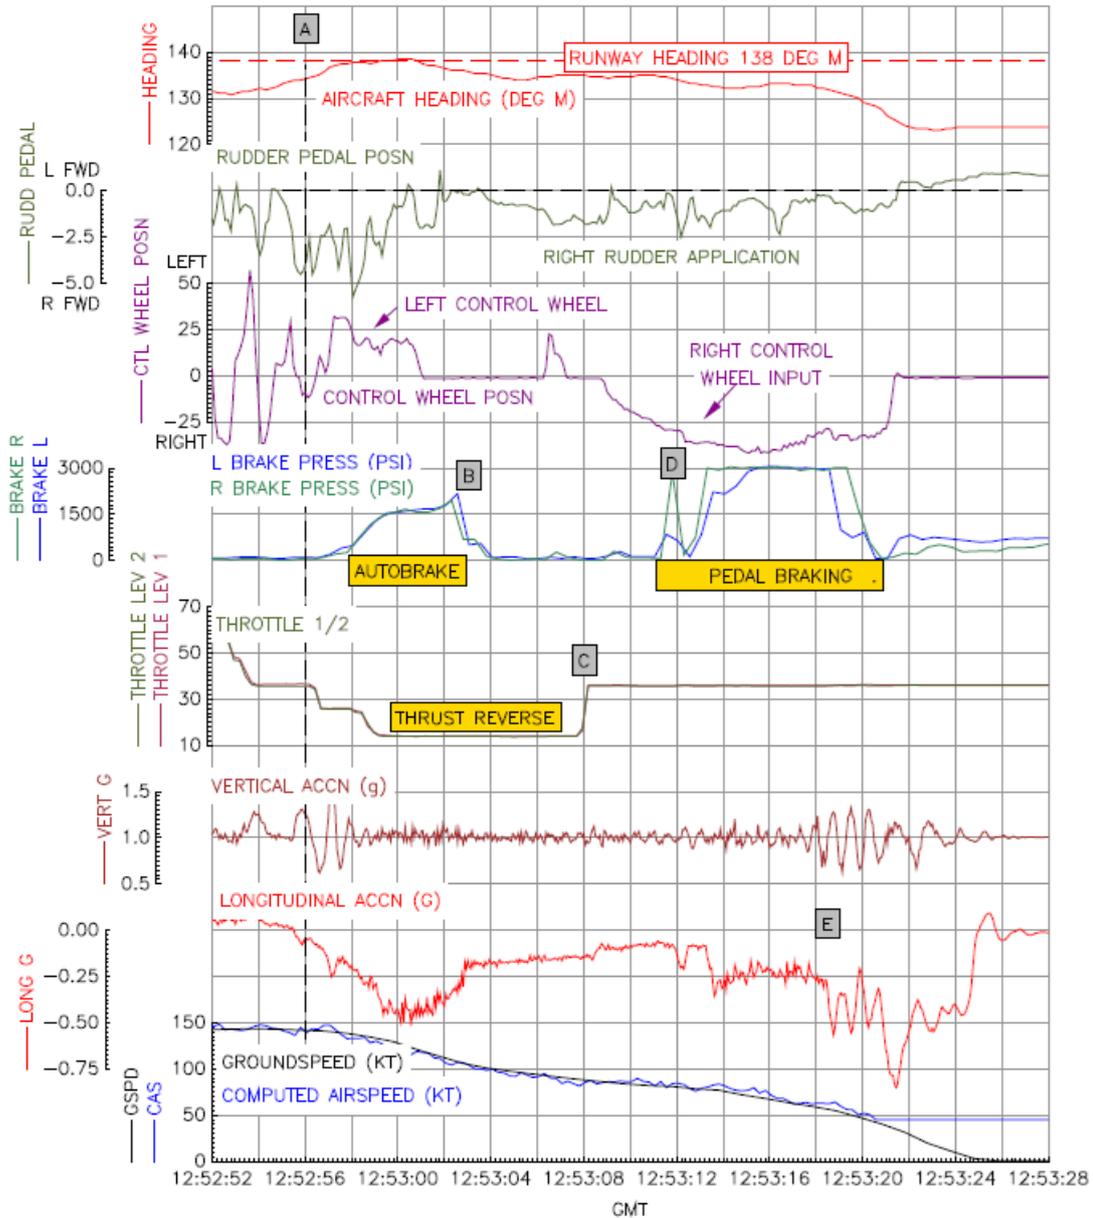
Figure 5

At 1252:10 hrs, whilst on the final approach at approximately 1.6 nm from the Runway 14 threshold, the autopilot and autothrottle were disconnected. The approach continued with touchdown at 1252:55 hrs at a recorded vertical acceleration of 1.3 g and Computed Airspeed (CAS) of approximately 140 kt (point A, Figure 5). During the flare, rudder inputs were recorded which reduced the drift on touchdown.

Seven seconds after touchdown at a CAS of 107 kt, the autobrake was disengaged and brake pressure reduced (point B, Figure 5). Six seconds later at a CAS of 86 kt, the throttles were returned to the 'Forward Idle' position and the thrust reversers were stowed. Throughout this time, up to 1.8° right rudder pedal continued to be applied (point C, Figure 5) and the Cockpit Area Mic (CAM) recorded what could be described as a juddering/rattling sound. This was more pronounced from point C onwards.

FDR parameters during landing

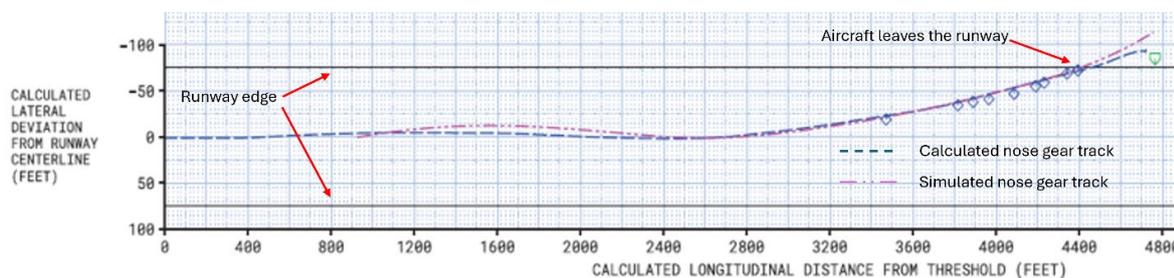
Figure 6

A desktop engineering simulation was used to recreate the landing rollout. The simulation was a six-degrees-of-freedom non-linear model updated to match flight data, and it was driven by recorded control positions from the actual landing, along with the METAR data nearest to the time of the event and a runway surface condition of wet. The simulation was used to assess aircraft lateral performance during the landing, and the simulated results were a reasonable match to the aircraft's actual track over the ground (Figure 6).

Landing simulation (The Boeing Company)

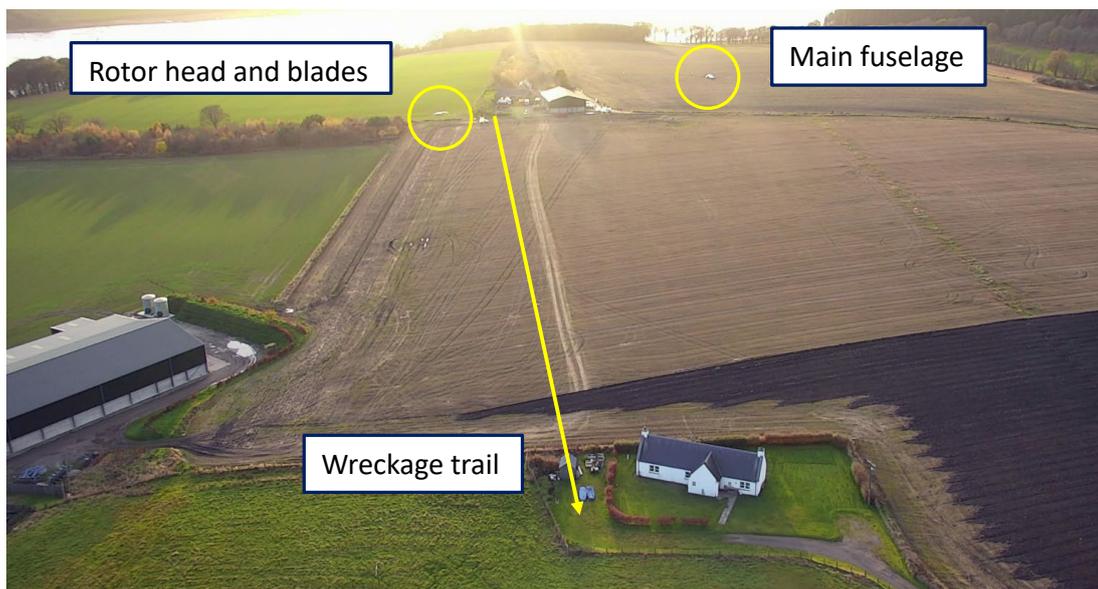
Figure 3
Wreckage location

The fuselage was located in a field approximately 150 m west of farm buildings and was surrounded by smaller items, which had been released when the fuselage initially struck the ground. The rotor head and blades had detached from the fuselage together and were located in an adjacent field to the fuselage, some 65 m south-south-east of the same farm buildings. Two ground marks from the leading edge of each blade striking the ground were positioned at an obtuse angle to each other. A trail of small items of wreckage stretched from the location of the detached rotor head east-north-east for approximately 500 m across farmland and into the garden of a private residence (Figure 3). These items of wreckage consisted of sections of the right door of the aircraft, along with the tip of one of the propeller blades.

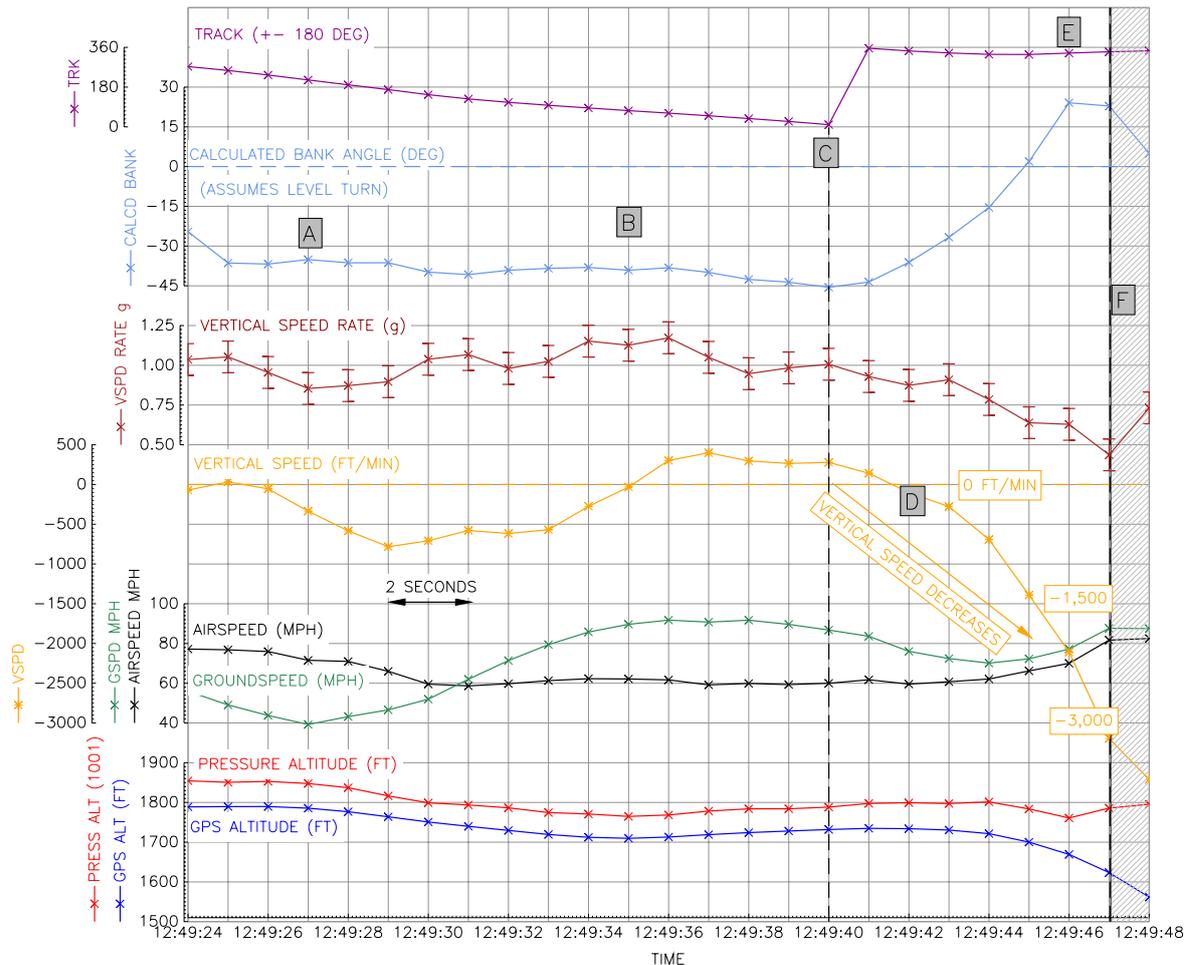
Figure 7
G-CKYT flight parameters

The turn started at a pressure altitude of 1,870 ft (GNSS altitude 1,799 ft) and airspeed of 73 mph. For the first 16 seconds of the turn, the estimated bank angle increased and remained at between approximately 35-40° to the left. During this time, the vertical speed fluctuated, at one point reaching a descent of 782 ft/min (Points A to B, Figure 7).

Towards the end of the left turn, at 1249:40 hrs, the estimated bank angle had increased to approximately 45° (point C). At this time, the aircraft was at a pressure altitude of 1,788 ft (GNSS altitude 1,732 ft), an airspeed of 60 mph and climbing at 278 ft/min. After this time, the vertical speed started to reduce. Over the next seven seconds, the vertical speed decreased progressively, from +278 ft/min to -3,195 ft/min.

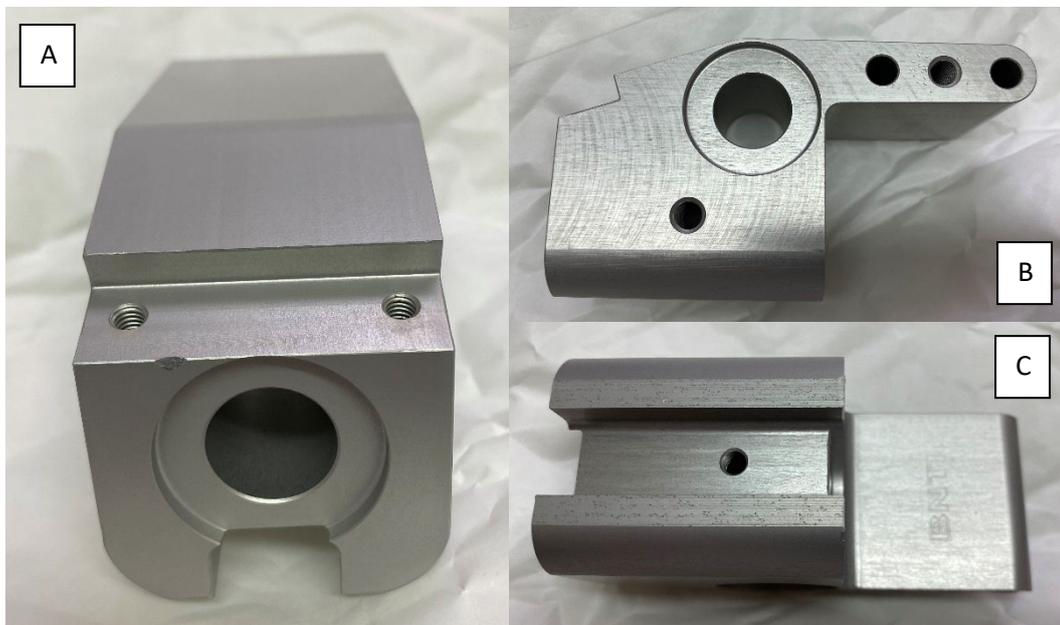
Figure 10

Gimbal block: A – rear, showing roll bolt hole and roll stop channel. B – right side, showing pitch bolt hole. C – bottom, showing roll stop channel and grub screw hole

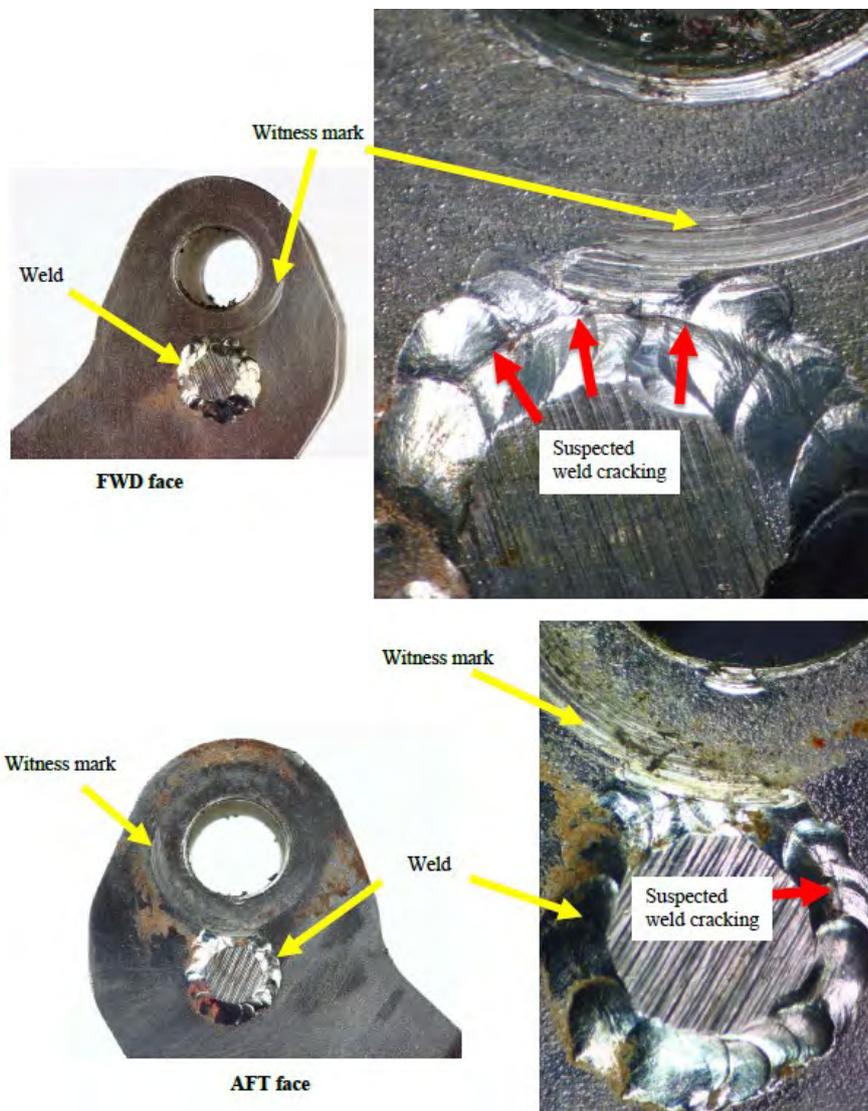
Figure 15

Detailed inspection of the roll stop bar end welds

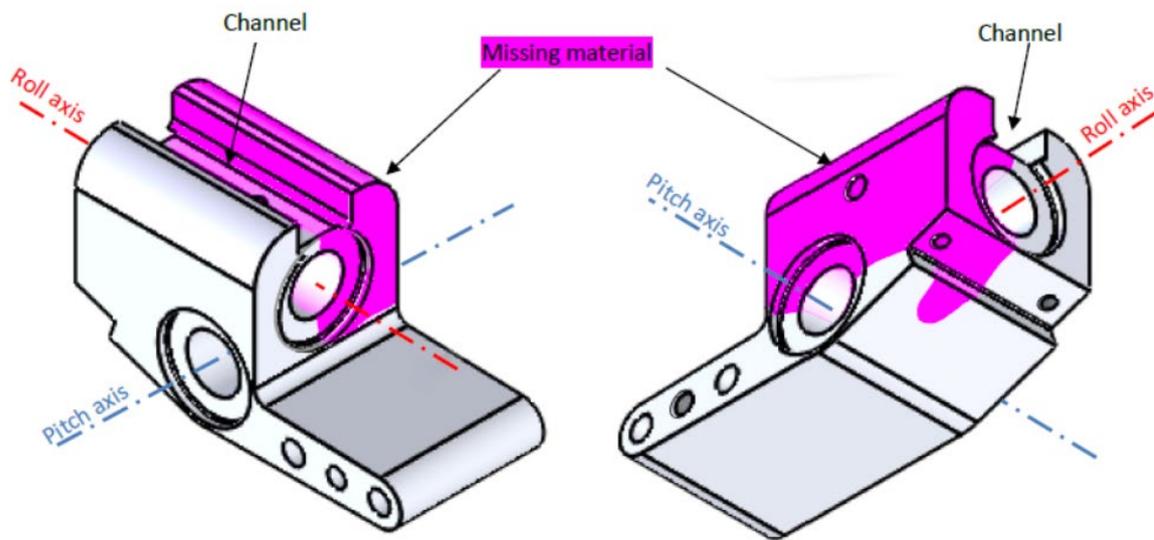
Figure 17

Extent of missing material from the gimbal block
(shown inverted relative to its installed orientation)

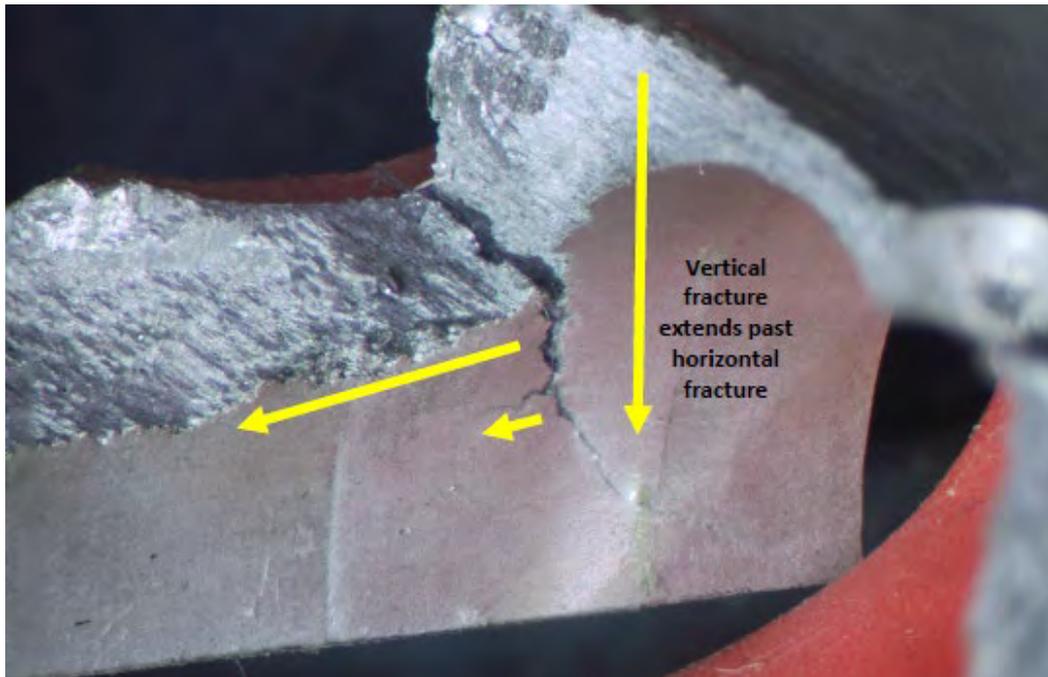
Figure 18

Image showing the vertical fracture surface extending past the horizontal fracture

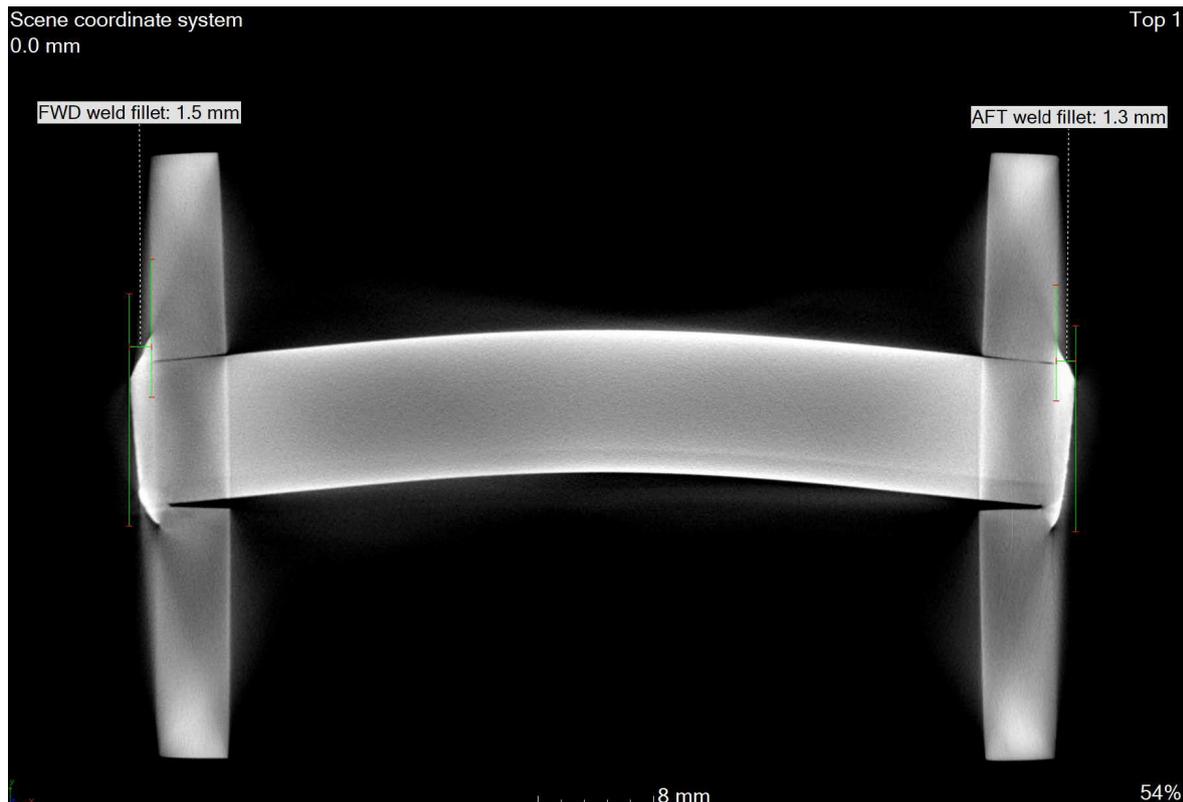
Figure 21

CT scan measurement of roll stop bar extension beyond the mast side plates

According to the design drawing dimensions, for a nominal plate width of 5 mm, the roll stop bar should extend between 1.5 mm and 1.25 mm, depending on manufacturing tolerances.

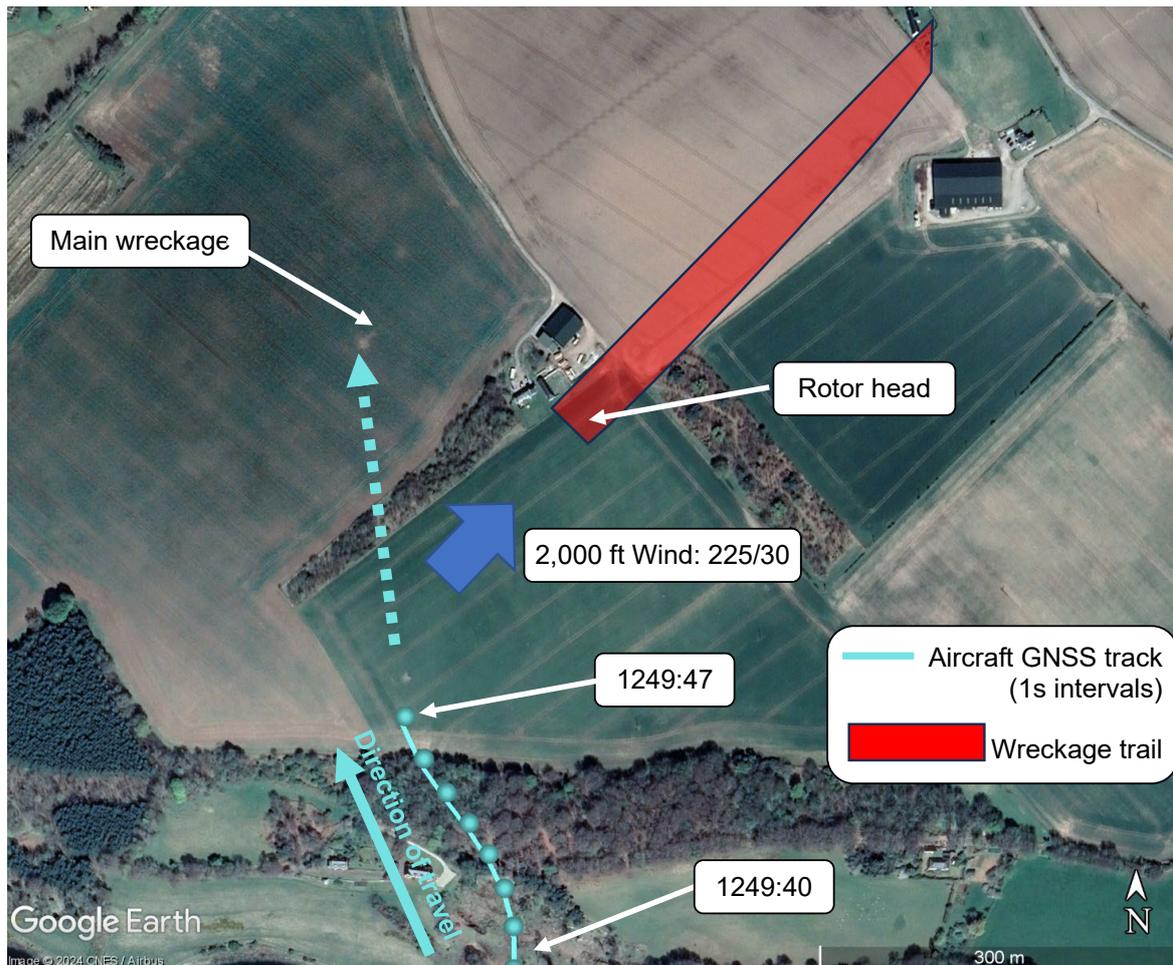
Figure 23

The recorded GNSS path up to 1249:47 hrs, wreckage location and estimated wind conditions were used to help estimate the approximate point of the rotor head failure (Figure 23). The gyroplane had sufficient height that the lightweight, low inertia debris released during the failure sequence was blown downwind to form a long wreckage trail roughly half a kilometre long. The wind direction at 2,000 ft was estimated by the Met Office but corresponds well to the direction of the wreckage trail. The gyroplane had a groundspeed of at least 70 mph during this period, so the debris would have travelled diagonally forward¹⁸ from the point of release. This gives some indication of when the failure must have occurred and is consistent with the period immediately before the data became unreliable.

Image showing wreckage trail and prevailing wind direction relative to the GNSS flightpath

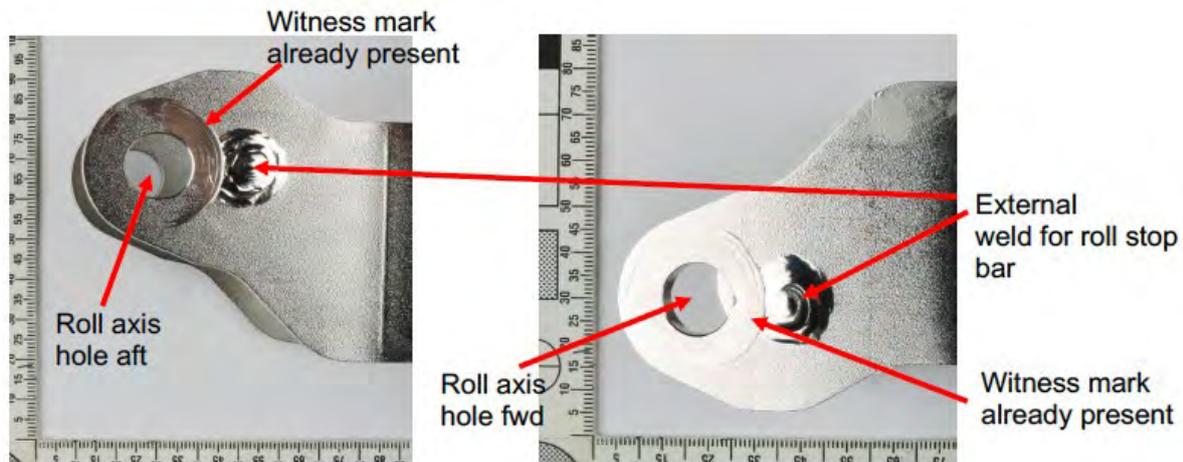
Figure 27

The mast arrived with an existing witness mark on the side plates. The manufacturer confirmed that these were machine marks, where the faces and weld had been machined flat during manufacture to accommodate the washers fitted during assembly of the roll pivot bolt. (Figure 27).

As received part showing damage to weld

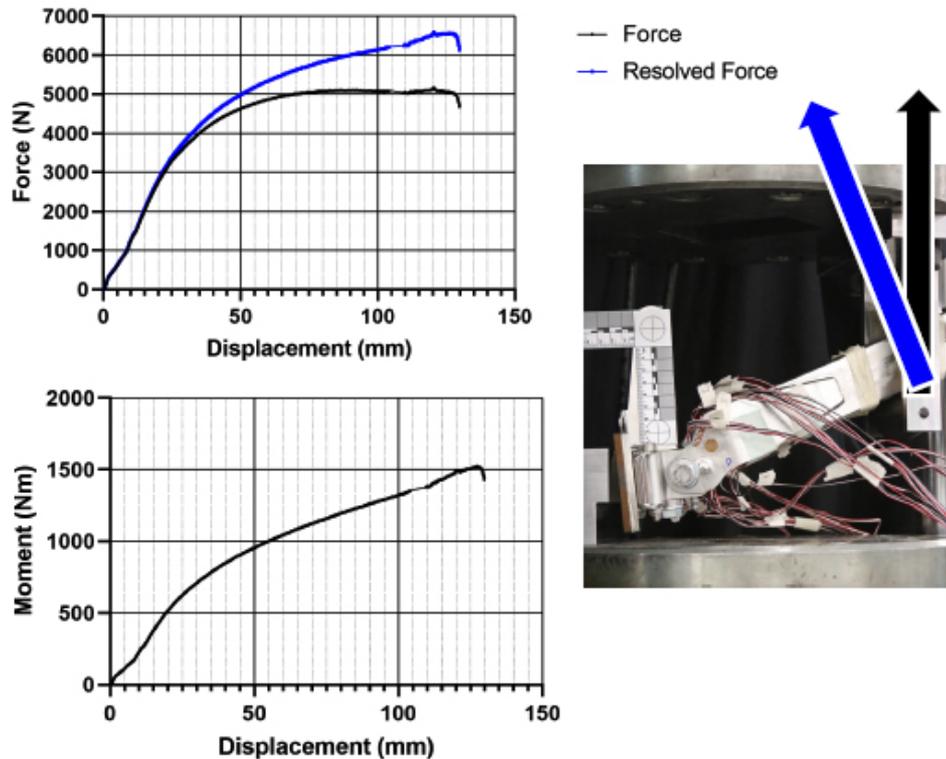
Figure 30

As the mast rotated around the roll bolt pivot continuously through the test, the vertical force readings from the test machine were resolved into a load and moment applied at the point of contact between the roll stop bar and the gimbal block. This raw data is shown in Figure 30.

Raw data test results showing the resolved force (blue) and moment acting on the gimbal block (black)

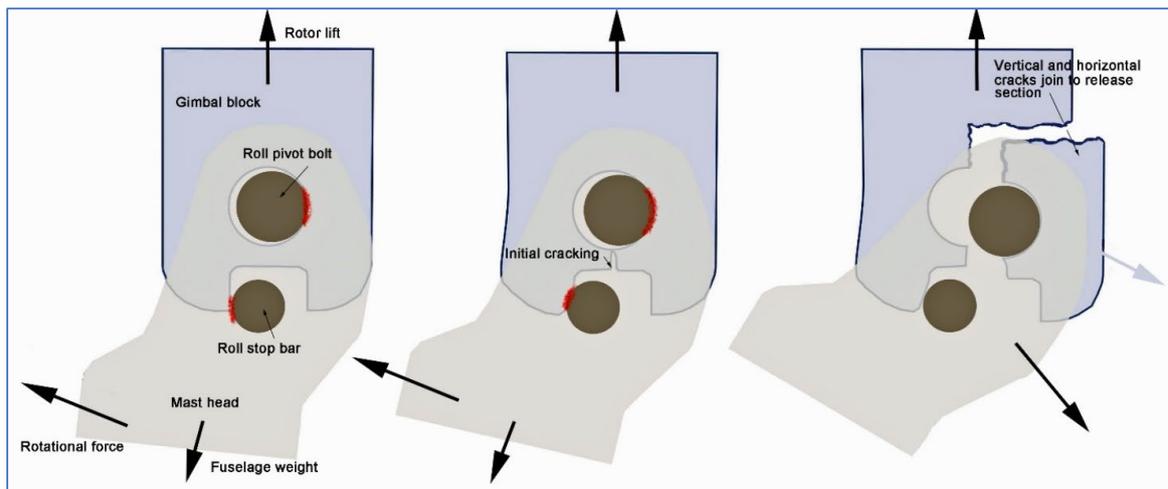
Figure 33

In flight, the gyroplane fuselage hangs from the roll pivot bolt fitted to the gimbal block. This also applies a vertical component to the force on the gimbal block equal to the weight of the fuselage (Figure 33). The damage to the accident gimbal block showed both vertical and horizontal fracture surfaces, with the vertical cracks occurring first, as seen in the rig test. Analysis of the fracture surfaces confirmed the overload had occurred during a single continuous event. As the cross-sectional area of the block carrying the weight of the fuselage was reduced by the vertical cracks during the accident flight, the horizontal cracks also formed due to overload. These cracks joined together resulting in a section of the gimbal block breaking off (Figure 33), allowing the rotor to detach from the fuselage. The separation of the rotor head was therefore caused by a structural failure of the gimbal block from exposure to dynamic flight loads during a single event.

Simple illustration of the final failure sequence of the gimbal block

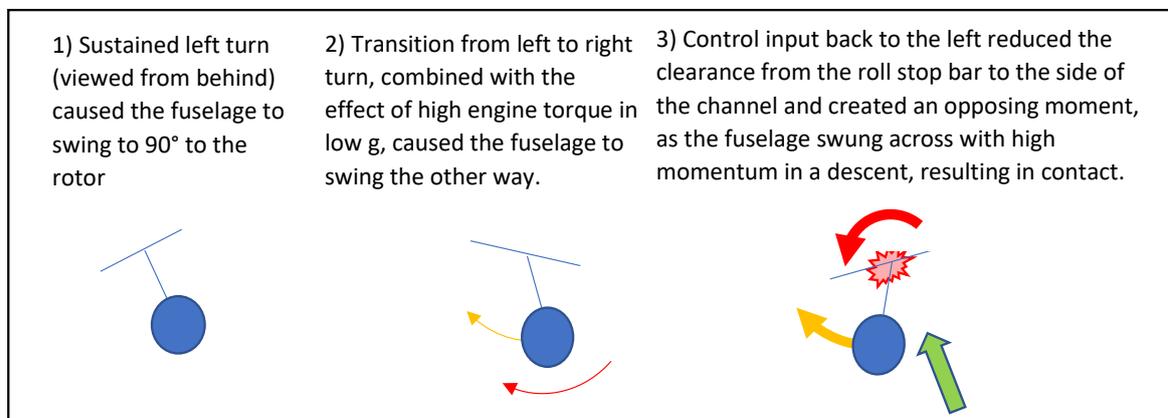
Figure 34

When the gyroplane transitioned between the left and right roll, the fuselage would have swung across with significant momentum. The torque induced rotation of the fuselage would probably have felt to the pilot like an uncommanded roll to the right, likely triggering an instinctive left roll input to counter it. This input would have changed the angle of the rotor relative to the horizontal. The lift and gyroscopic force and the weight of the rotor assembly opposing it effectively acts at the rotor pivot bolt which is a fixed distance away from the roll pivot bolt. The gyroscopic forces, the horizontal component of the lift and the weight vector would therefore create a moment around the roll pivot bolt and thus the contact point between the gimbal block and the roll stop bar. This would act to oppose the moment created by the fuselage rotating in the opposite direction, driven by the engine torque and inertia. This would likely have resulted in an impact between the bar and the gimbal block channel sufficient to generate the force required to cause the block to fracture, as confirmed during testing (Figure 34).

Response of the fuselage to the roll reversal inputs

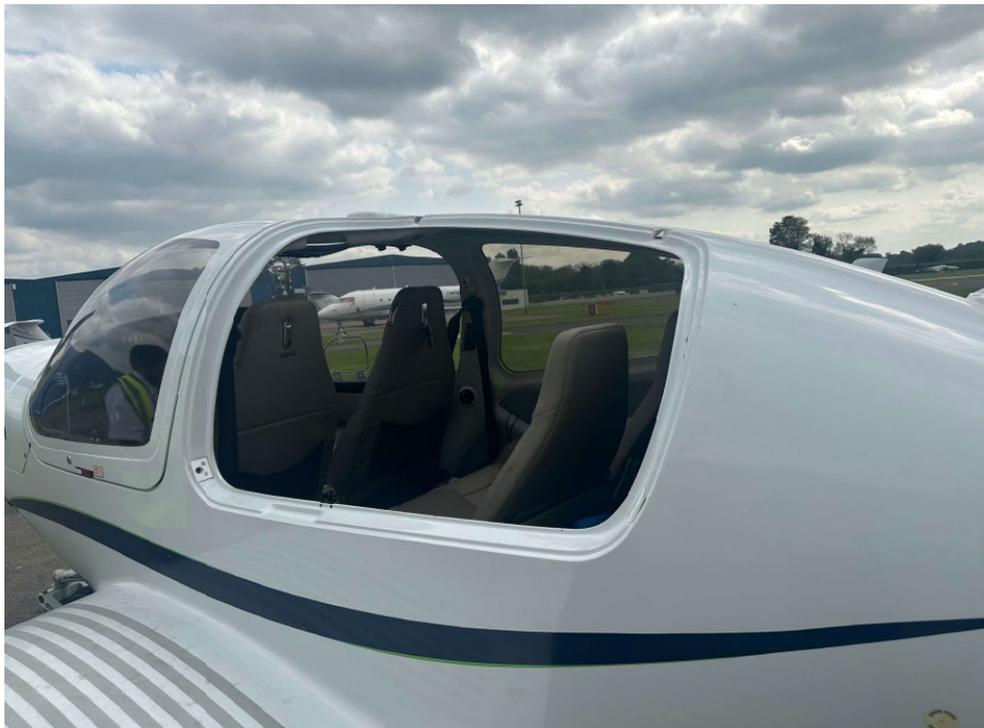
Figure 1

With the student pilot still flying, the instructor and rear seat student assessed the situation. The rear seat passenger could not reach the door to close it due to the seat restraint harnesses and shortly afterwards the door fully detached from the airframe. The instructor took control of the aircraft, contacted ATC to advise of the situation and was given clearance to land. The return to the airfield, landing and taxi were uneventful and there were no injuries to the occupants. The aircraft is shown below (Figure 1).

G-LDGB with rear door missing (image used with permission)

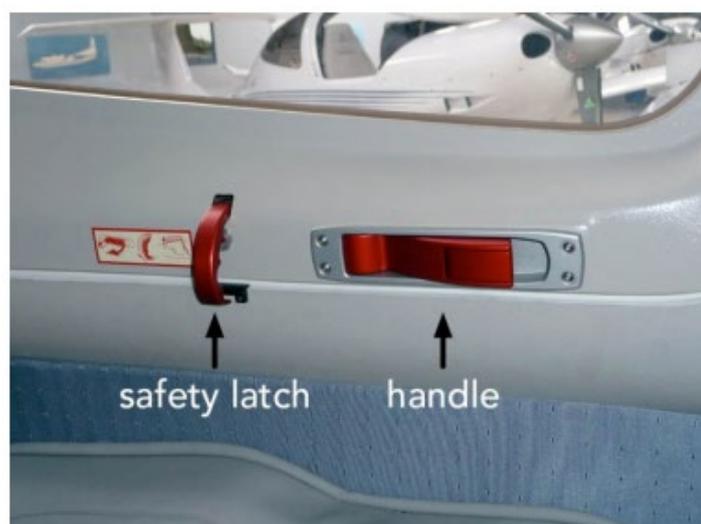
Figure 2

An additional safety latch is fitted (Figure 2). The function of this red safety latch is to hold the unlocked passenger door in a near closed position, whilst the aircraft is parked on the ground, protecting the passenger door from wind gusts. It also helps reduce the risk of a passenger door separation in case of an inadvertent opening of the door locking mechanism by a passenger during flight. Although it should be noted that the original design intent of the red safety latch was not to prevent a passenger door from separating from the aircraft because of a failure to lock the passenger door before flight.

Rear passenger door handle configuration (image used with permission)

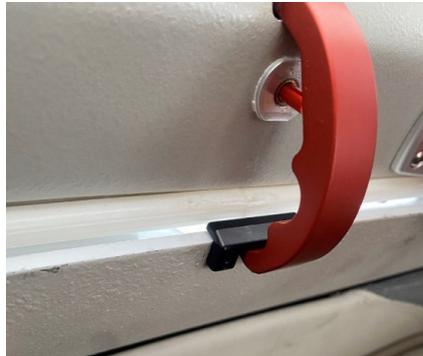
Figure 3

causing a de-activation of the red safety latch and the door separated from the aircraft. The Aircraft Maintenance Manual now requires hinges to be inspected as part of a scheduled maintenance check and this was carried out on G-LDGB on 17 April 2023.

Red safety latch in engaged position (Image used with permission)

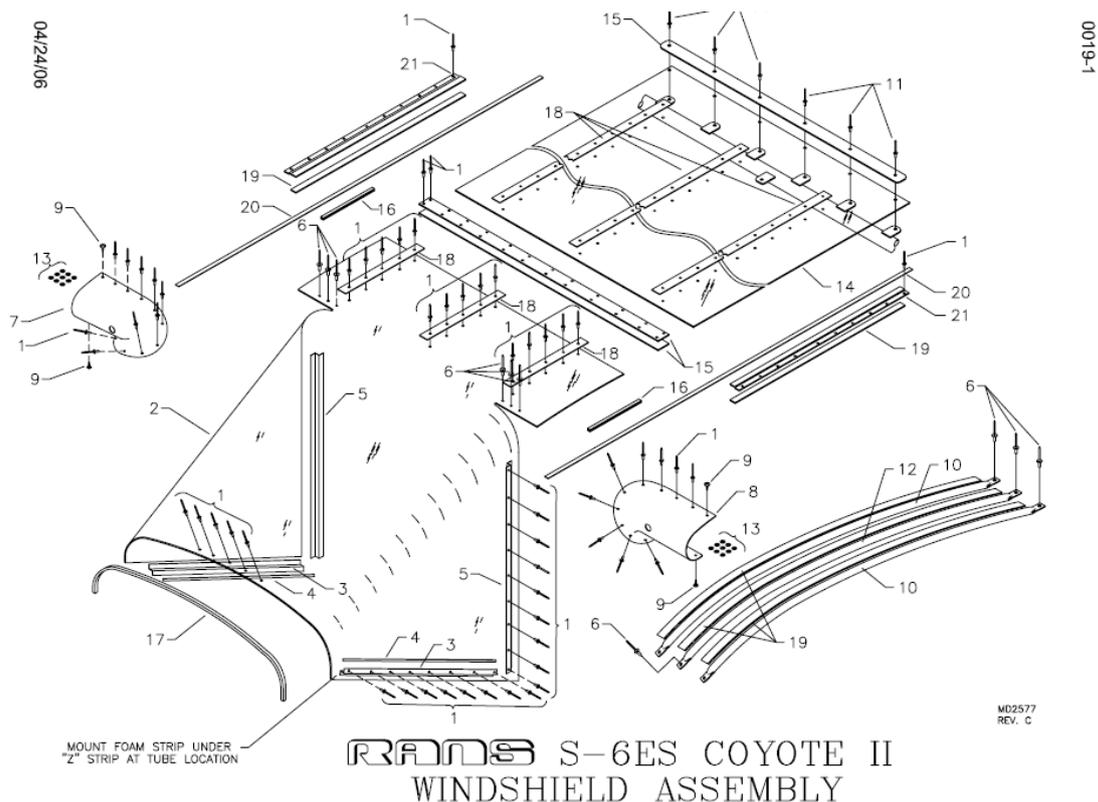
Figure 3

The windscreen and skylight assemblies are made of Lexan¹. The current aircraft parts catalogue and the build manual show the assemblies are rivetted to the aircraft framework, but 'sandwiched' between foam strips and metallic trim strips (Figure 3). The trim strips under the rivet heads spread the loads over a larger surface area, which reduces the risk of the Lexan cracking around the rivet holes. Photographs of G-BZKO after the accident showed that neither the foam strips nor the trim strips were fitted.

Parts catalogue showing the foam strips (items 19) and the trim strips (items 18)
