Rail Accident Investigation Branch

Rail Accident Report

Derailment of a freight train at Audenshaw, Greater Manchester 6 September 2024

Report 10/2025
December 2025

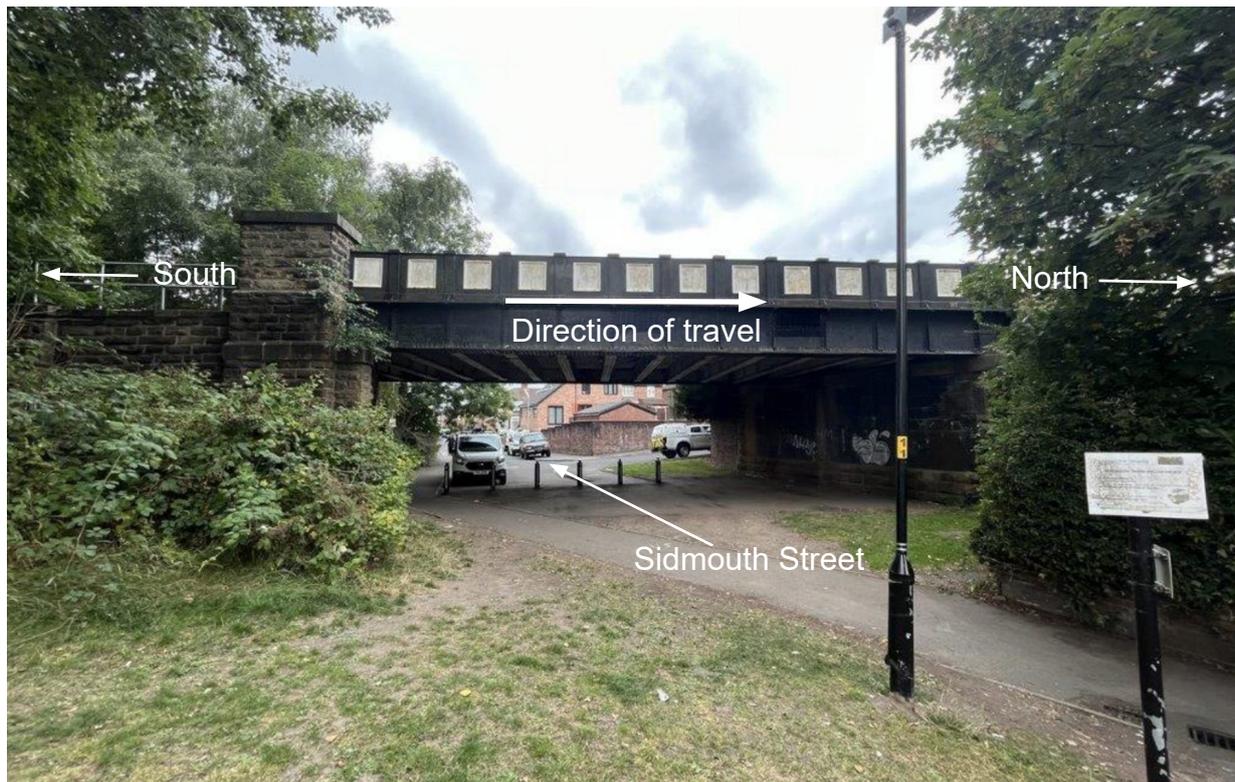
- 9 The derailment happened on a bridge, known as bridge 3, which carries a double track non-electrified railway over Sidmouth Street in Audenshaw. Sidmouth Street is a footpath at this location, closed to road traffic just before it passes under the bridge (figure 3). The tracks on both lines over the bridge are carried by a longitudinal bearer system (LBS).
- 10 Bridge 3 is located on the railway line between Denton Junction and Ashton Moss North Junction (4 miles 1083 yards to 4 miles 1105 yards, with a zero reference at Heaton Norris Junction, north of Stockport). The Network Rail reference for this section of line is DJO1, so Network Rail refers to the bridge as bridge DJO1/3.

Figure 3: The bridge from Sidmouth Street level (courtesy of Network Rail with RAIB annotations).

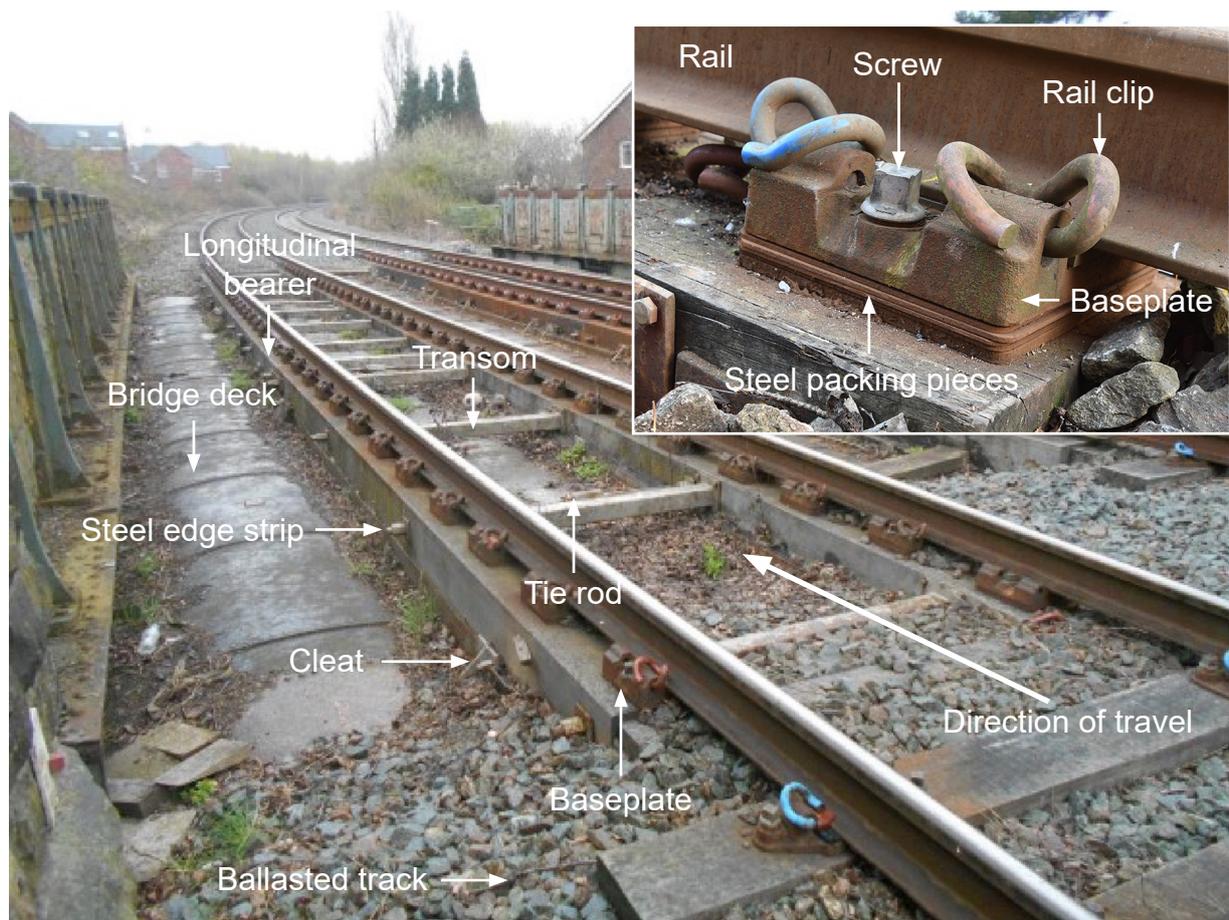
23 The main components of the LBS before the derailment are shown in figure 6. The LBS on the down line of bridge 3 comprised three longitudinal bearers (sometimes known as waybeams or wheel-timbers) running along the bridge under each rail, made from a hardwood timber known as Greenheart. The bearers of the south end section of the down line (which was at the point of derailment) were 6.5 m long, 280 mm deep and 410 mm wide.

24 The rails were seated on PAN M6 baseplates and held down by Pandrol PR401A/P402A rail clips. The baseplates were attached to the bearers using two LSA chair screws (referred to in the remainder of this report as 'screws') per plate, each fitted within a polymeric ferrule in the bossed hole of the baseplate. LSA screws are approximately 205 mm long, measured from under the head. They have a plain shank about 57 mm long, before a transition into the threaded part of the fastener. The markings on the heads of the screws recovered from site indicated that they were manufactured in 2021 and were of the normal grade of steel. Between the baseplates and the bearers over the full length of the LBS were varying thicknesses of steel packing pieces. These were used to achieve the track's designed cross-level (cant) of between 30 and 40 mm.

Figure 6: The main components of the LBS of the Down Crowthorne line on bridge 3 (courtesy of Network Rail with RAIB annotations).

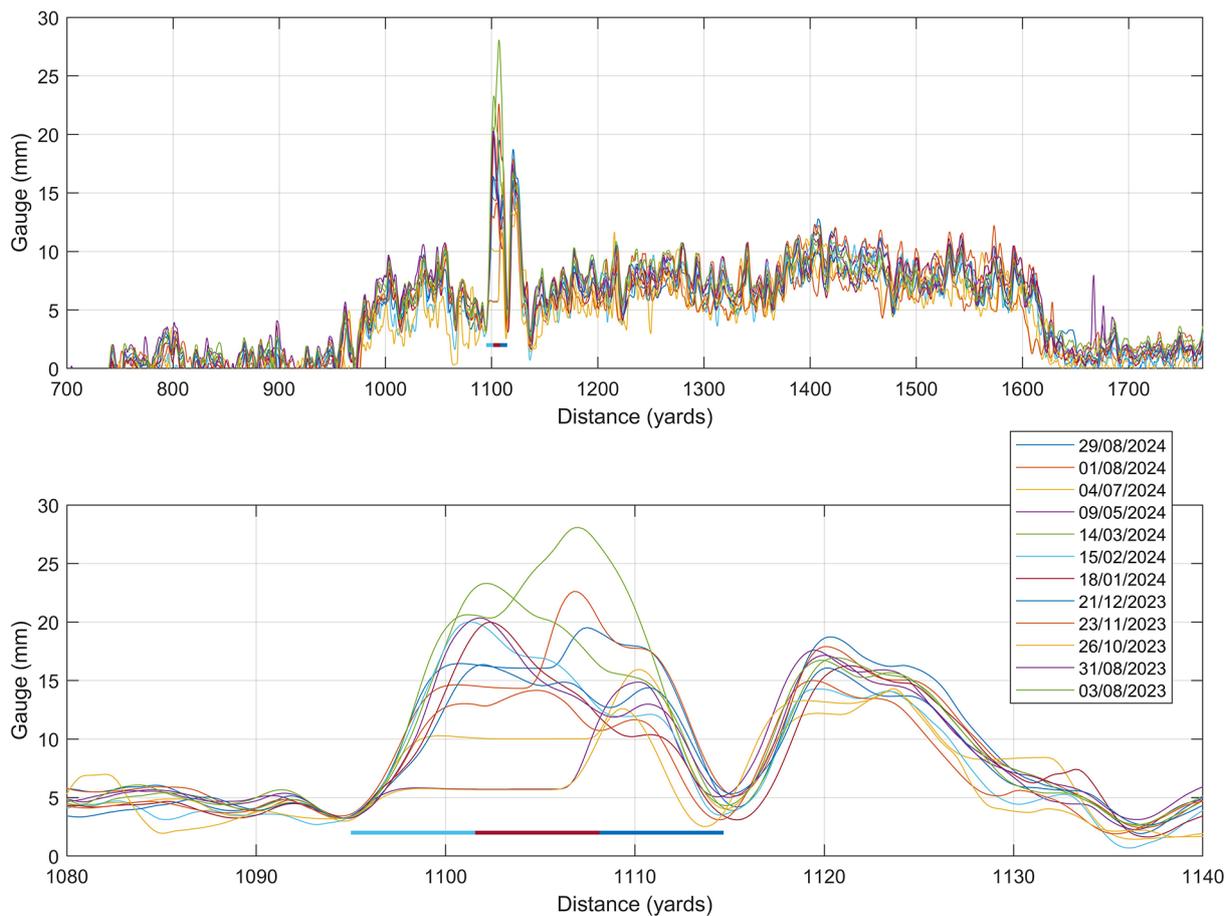
96 The gauge was found to have been historically wide across the bridge since 2018. Network Rail standard NR/L2/TRK/001 Module 11, 'Track geometry - Inspections and minimum actions', issue 11 dated 5 March 2022, requires that a recorded 35 mm variation in gauge width needs a correction within 36 hours, and that a 25 mm variation needs a correction within 28 days. It also defined a limit of 8 mm in gauge variation over a 3-metre length. In the year before the derailment, there had been more extensive variation in the gauge, but it was not sufficient to trigger the 36-hour correction limit (figure 28). The gauge variations within the 3-metre distance were also within limits. Periodic dip angle recordings were also evident on the entry to and exit from the bridge, suggesting that it was likely that the bridge had been moving relative to the embankments on either side.

Figure 28: Gauge width variation 2023 to 2024.

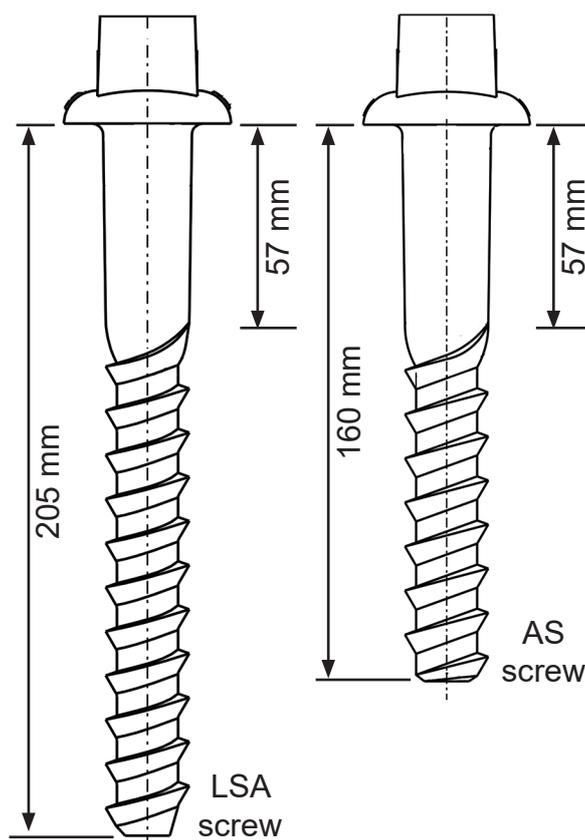
- 125 The screws fitted to the LBS at the time of the accident were of the LSA type. The more common type used across the network is known as an AS screw (figure 29). The LSA screws are longer than the AS type by around 45 mm, although the shanks (the plain, unthreaded portion under the head) are of an equal length. LSA screws are manufactured from both normal and high tensile grades of steel. Examinations of the markings on the head, and metallurgical testing, showed that those fitted to the LBS were of the normal grade.

Figure 29: LSA and AS screw comparison
(courtesy of Network Rail with RAIB annotations).

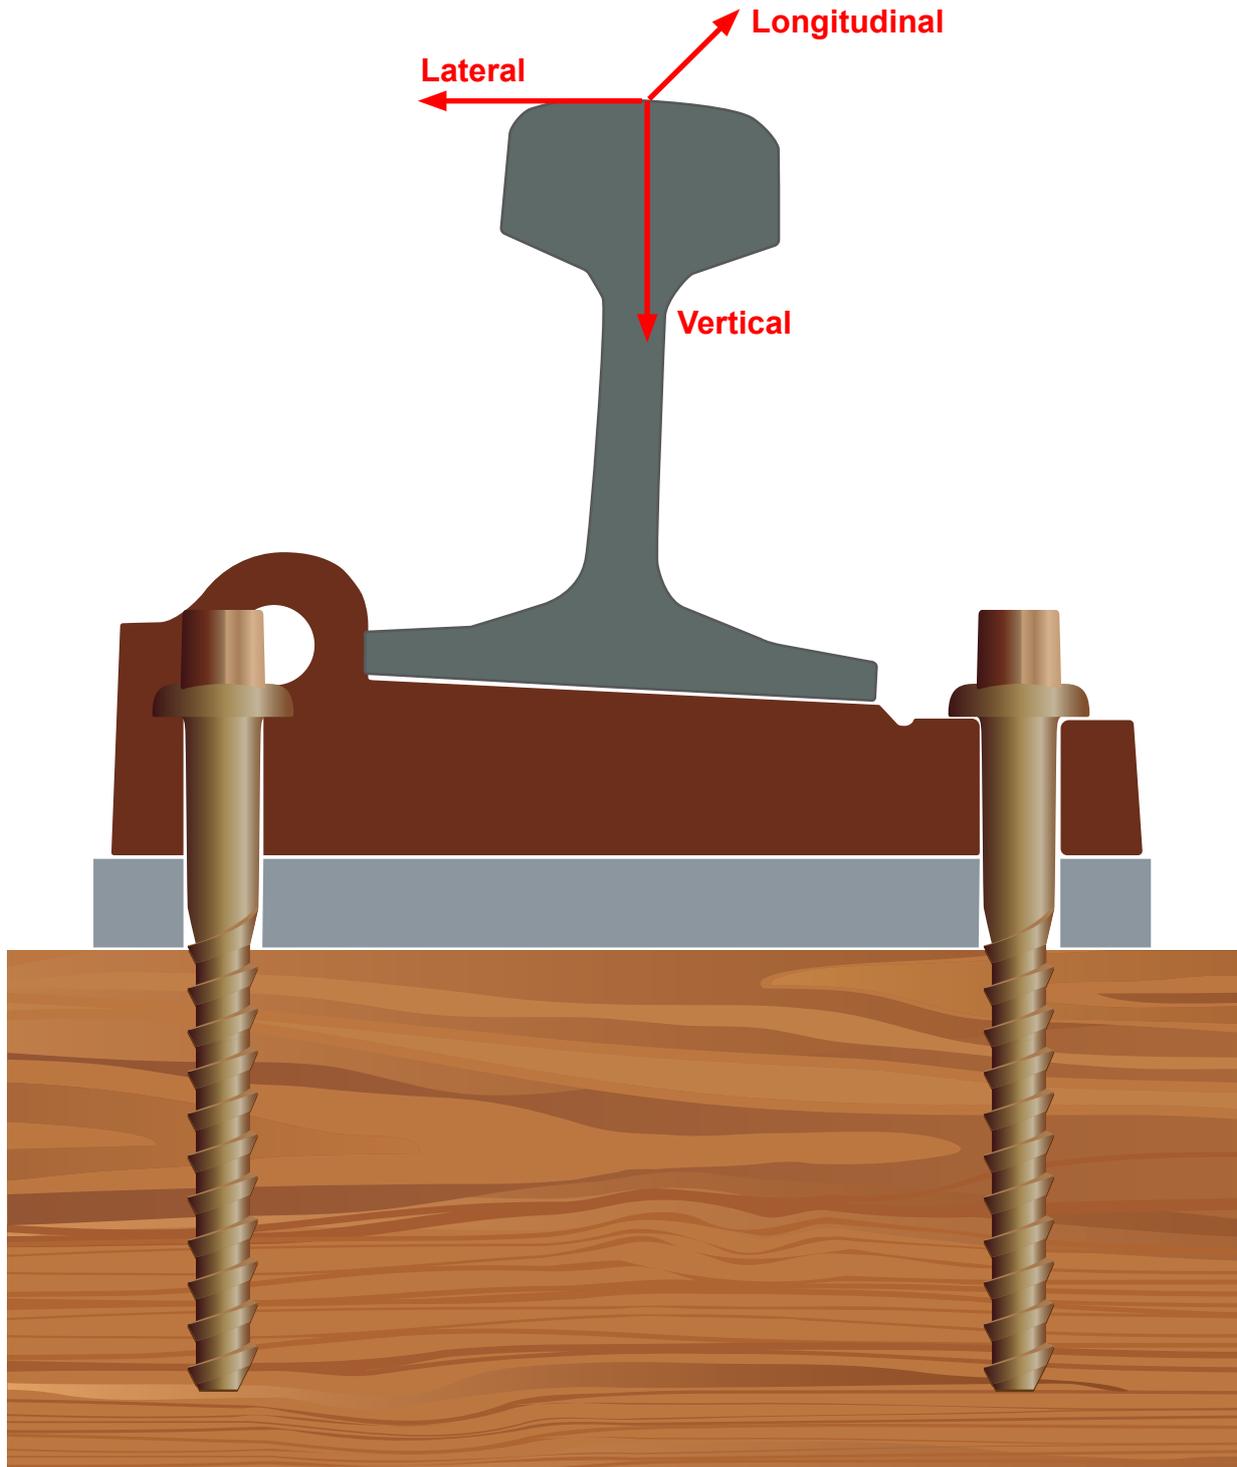
Figure 30: The effect of the forces applied by passing wheels on the top of the rail in three directions.

- 130 When the lateral forces on the rail were considered, it was found that these significantly loaded the screws, in both axial and shear directions (figure 30). The axial force is unlikely to create bending stresses in the screws, as witnessed in the failed screws (paragraph 64), whereas the shear force will. In the assessment, the shear force was applied to the screw at a plane level with the underside of the baseplate. This shear force leads to increasing bending stresses in the screw along its length up to the point where the threaded part of the screw is firmly embedded in the bearer.

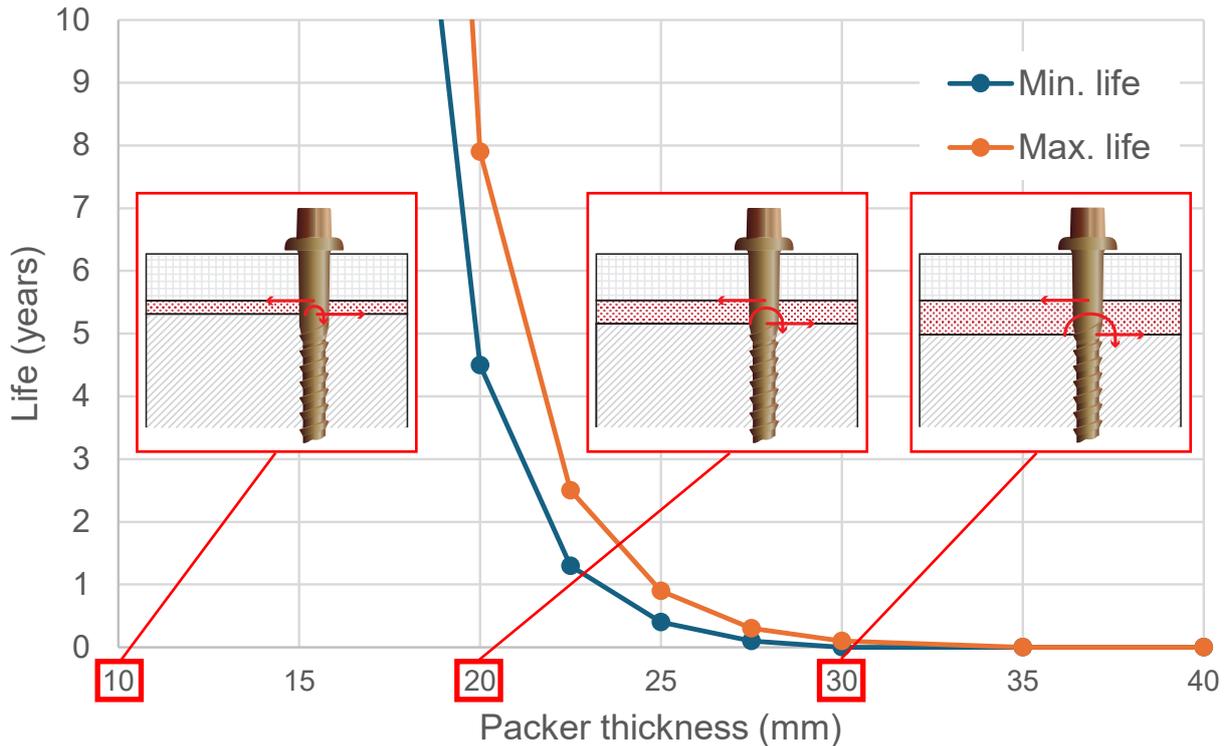
- 134 The main finding was that the expected life is strongly dependent on the thickness of packing pieces under the baseplate. The effect of the total thickness of the baseplate packing pieces and how this affects the fatigue failure of the screw is illustrated in figure 31. This shows that, as the thickness of the steel packing pieces increases, the point at which the lateral force acts on the screw moves from the larger diameter shank to the smaller diameter threaded section. All the broken screws examined afterwards were found to have broken through their threaded section, just below the upper surface of the bearer (paragraph 63).

Figure 31: The effect of the steel packing thickness on the fatigue failure of the screws.

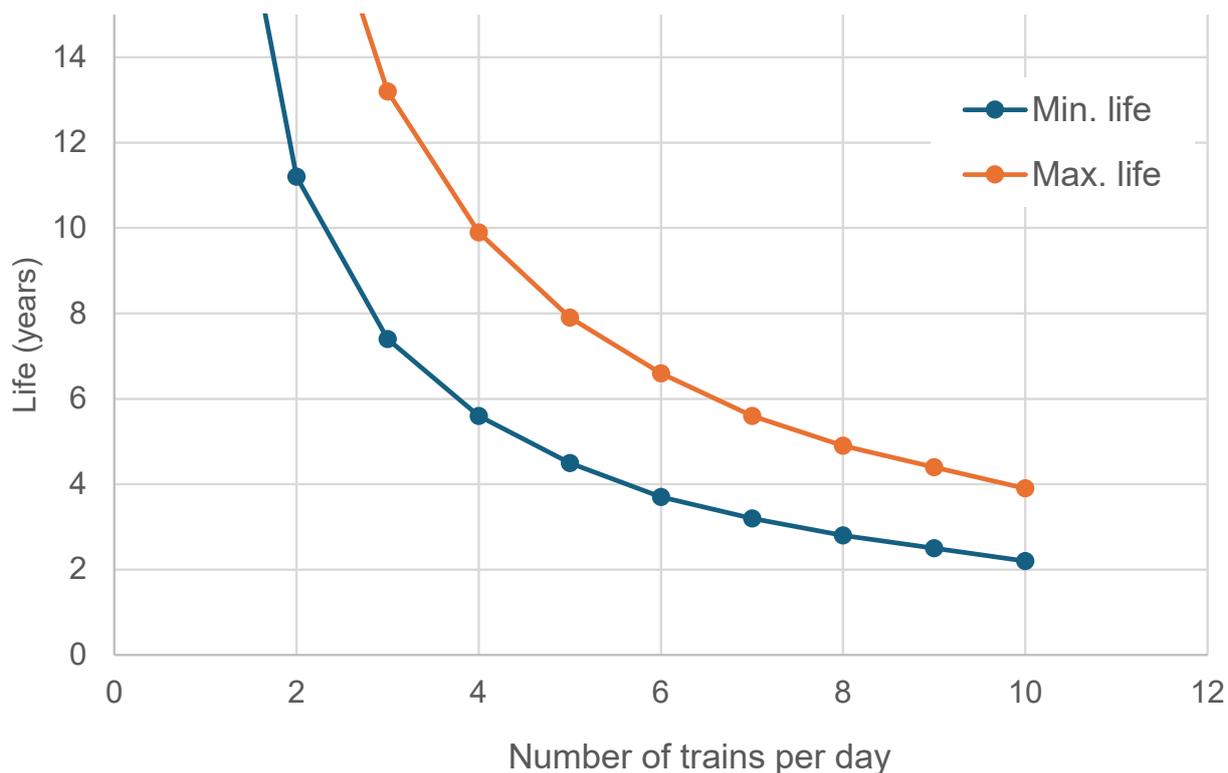
Figure 32: Graph showing how the number of trains affects the time before a screw would fail due to fatigue.

139 With a single daily train, the assessment showed that a screw of normal grade material was predicted to fail in fatigue after around 20 to 40 years. This decreased to about 7 to 14 years for three trains daily and to about 2 to 4 years for 10 trains daily. Screws of the high tensile grade performed better but followed a similar pattern.
