Maritime &  
Coastguard  
Agency

# SS Richard Montgomery: Survey report 2025

October 16<sup>th</sup> 2025

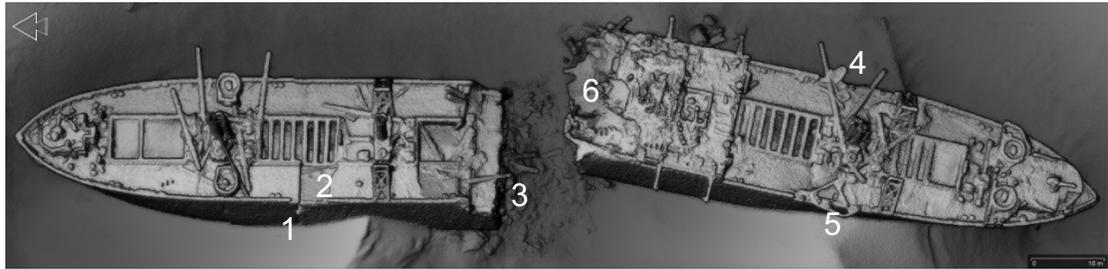
Figure 3. SSRM top-down image showing the six key areas.

- 4.2.1** In addition to the 96 features, six Key Areas across the wreck have been highlighted during previous surveys as key areas of significant structural change (Figure 3). The changes observed in the 2025 full survey is further described below.

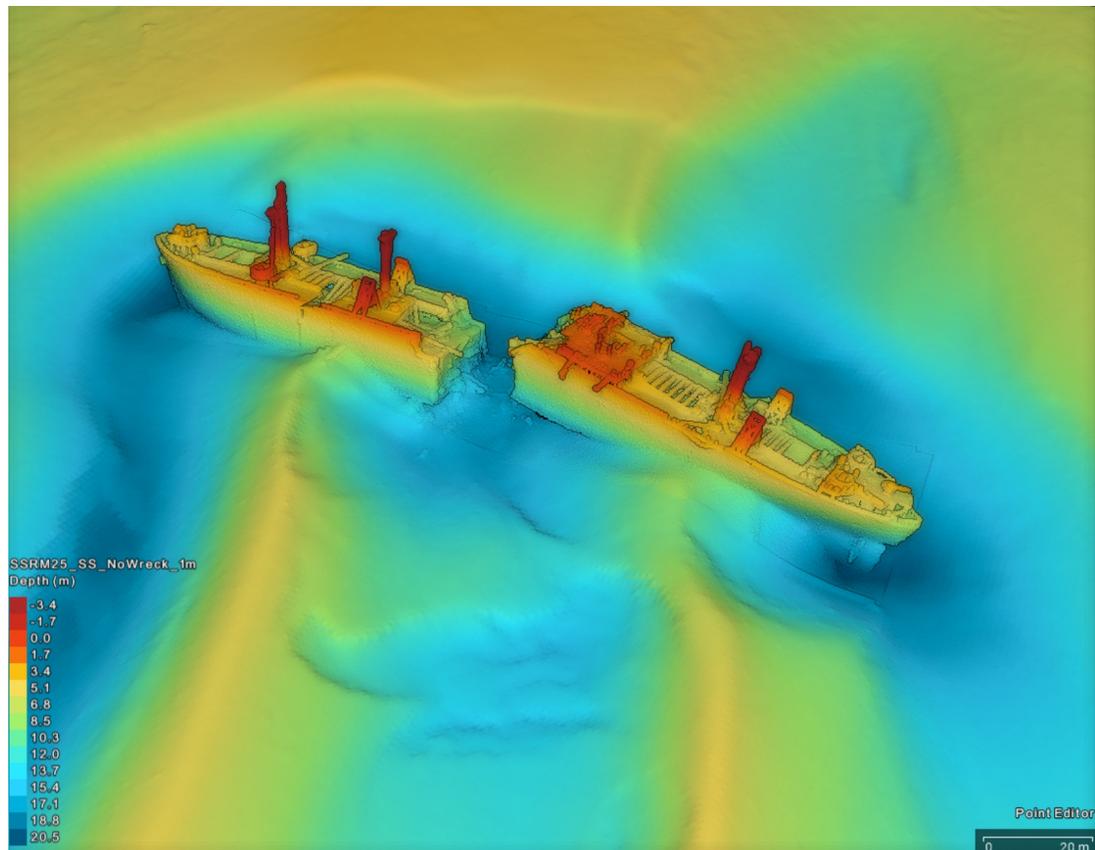
Figure 5. Overview picture of SSRM. Point cloud data, including lidar, overlaid on a digital terrain model of the surrounding seabed.

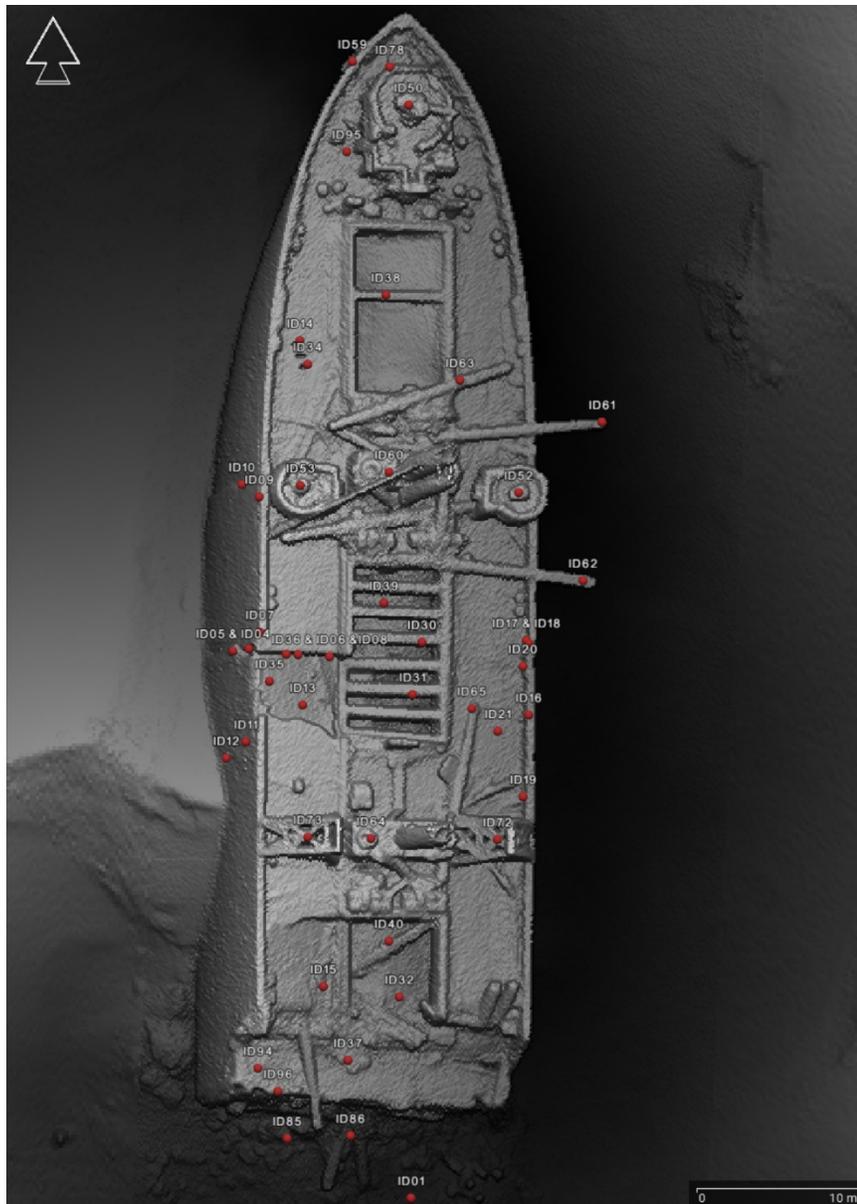
- 4.1.1** Over the whole of the wreck, 97 specific features have been used in successive surveys as comparison points for quantifying change and deterioration (Figure 6 and Figure 7).
- 4.1.2** As observed in previous surveys, the forward section has shown an increased tilt each year, and results from the 2025 survey shows a continued increased tilt, indicating continued instability in the forward section of the wreck (Figure 8 and Figure 9). A full list of the features and comments on observed changes between 2024 and 2025 full surveys is listed in Appendix C.

Figure 6. ID features on the forward section.

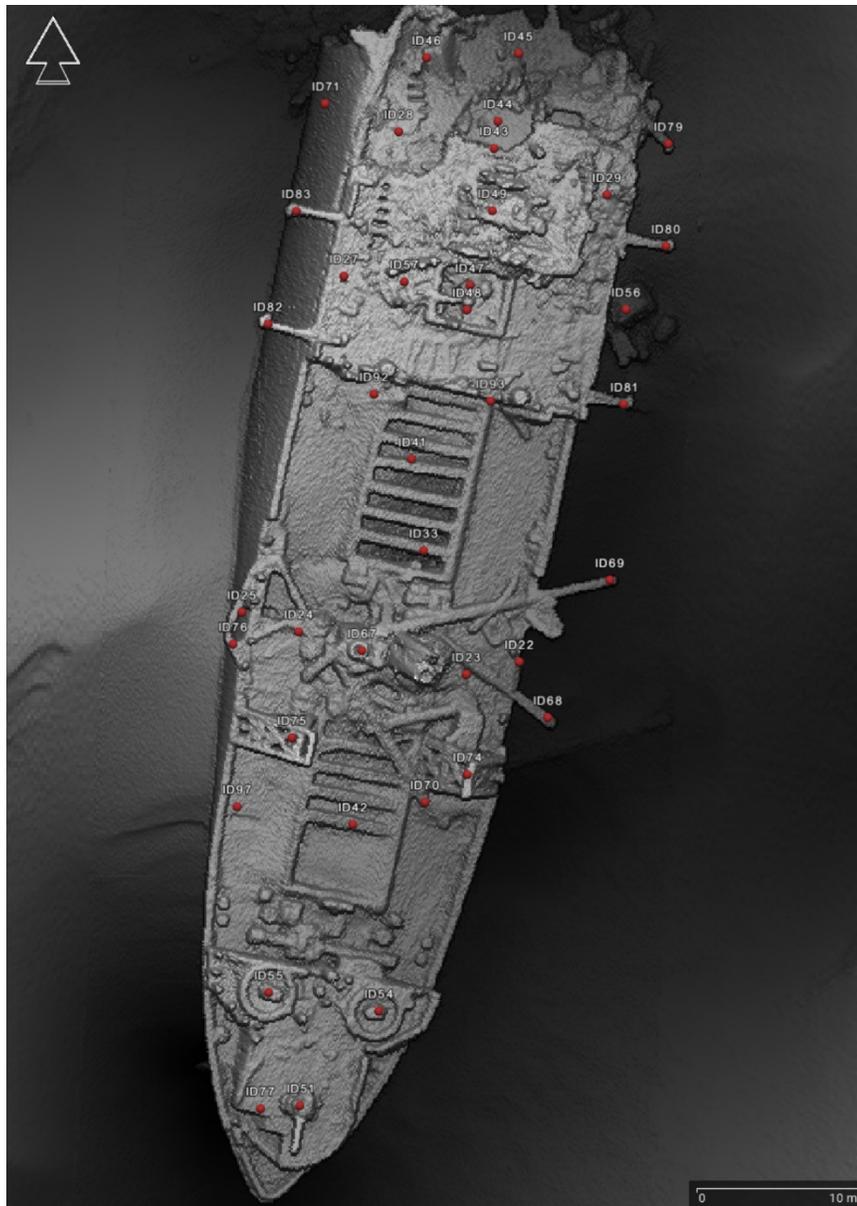
Figure 7. ID features on the stern section.

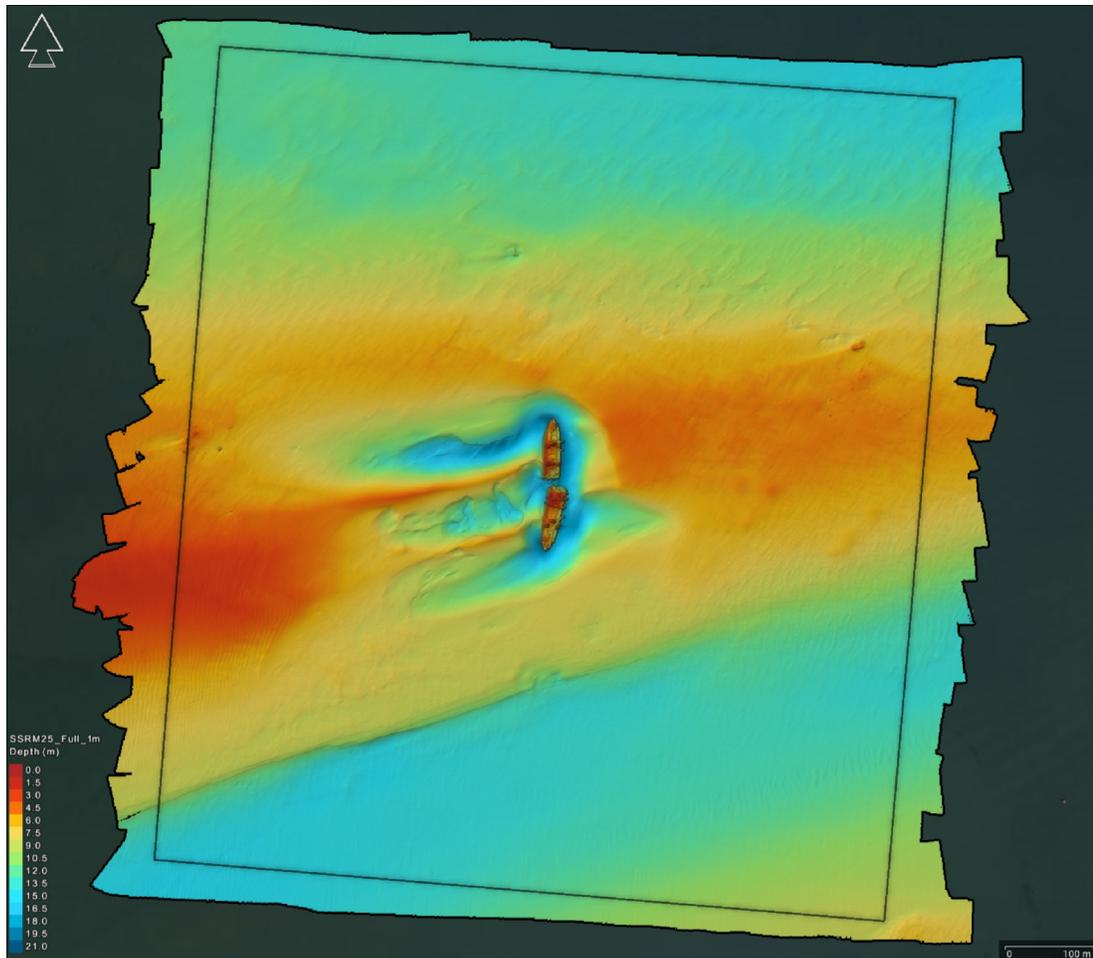
**5.1.2** An overview of the full survey area is illustrated in Figure 30.

Figure 30. Minimum surface of SSRM and the surrounding seabed.
