Report on the investigation of
the collision between the bulk carrier

Polesie

Verity

resulting in the sinking of *Verity* with five fatalities
in the German Bight traffic separation scheme

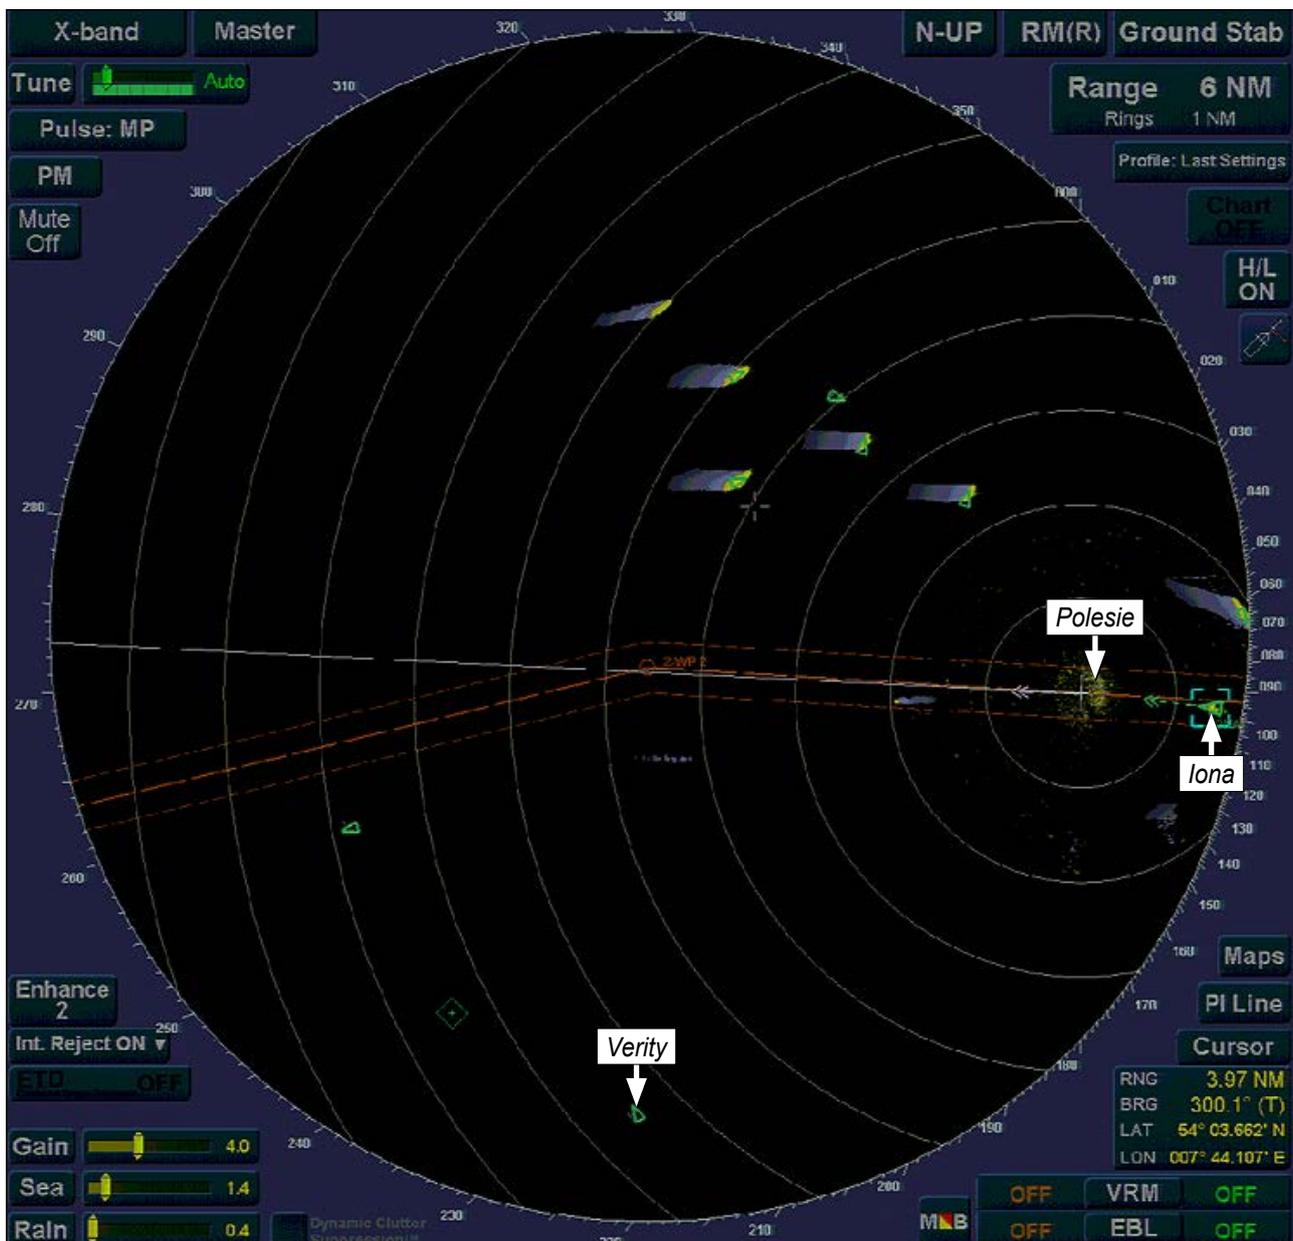
By 0410, a target had appeared on *Polesie's* starboard radar (X-band, offset, 6nm range scale in use) with a corresponding AIS icon – a green triangle indicating the vessel was reporting information via AIS (**Figure 4**). The AIS identified the radar contact as *Verity*, which was on a true⁴ bearing of 226° at a range of 6.4nm, on a course of 332° at a speed of 8.1kts. *Verity's* closest point of approach (CPA) was 0.15nm at a 'time to CPA' (TCPA) of 45 minutes. *Verity* had been marking on AIS and the S-Band radar, set to the 12nm range scale, since 0120 but was not tracked. No CPA alarms were in operation on either radar set.

Figure 4: *Polesie* starboard radar display, 6nm range (offset) at 0419. *Verity* marking as AIS contact but not acquired by ARPA. 4.5nm to run to waypoint 2

Polesie's VDR shows that the OOW was very passive in their monitoring of other traffic in the vicinity. Figure 4 shows that at 0419 the only vessel being tracked was *Iona*, and it was not until after the VTS assistant's first call to *Polesie*, which completed at about 0452, that the OOW selected *Verity*'s AIS icon on the radar. At that time, *Verity*'s range was 0.83nm with a CPA of 0.2nm ahead of *Polesie* in 2 minutes and 33 seconds. While *Polesie*'s OOW might have been aware of *Verity* for some time before the VTS assistant's first intervention, they were not using the ARPA to provide them with accurate information about *Verity*'s CPA or TCPA and so were denying themselves the best information available.

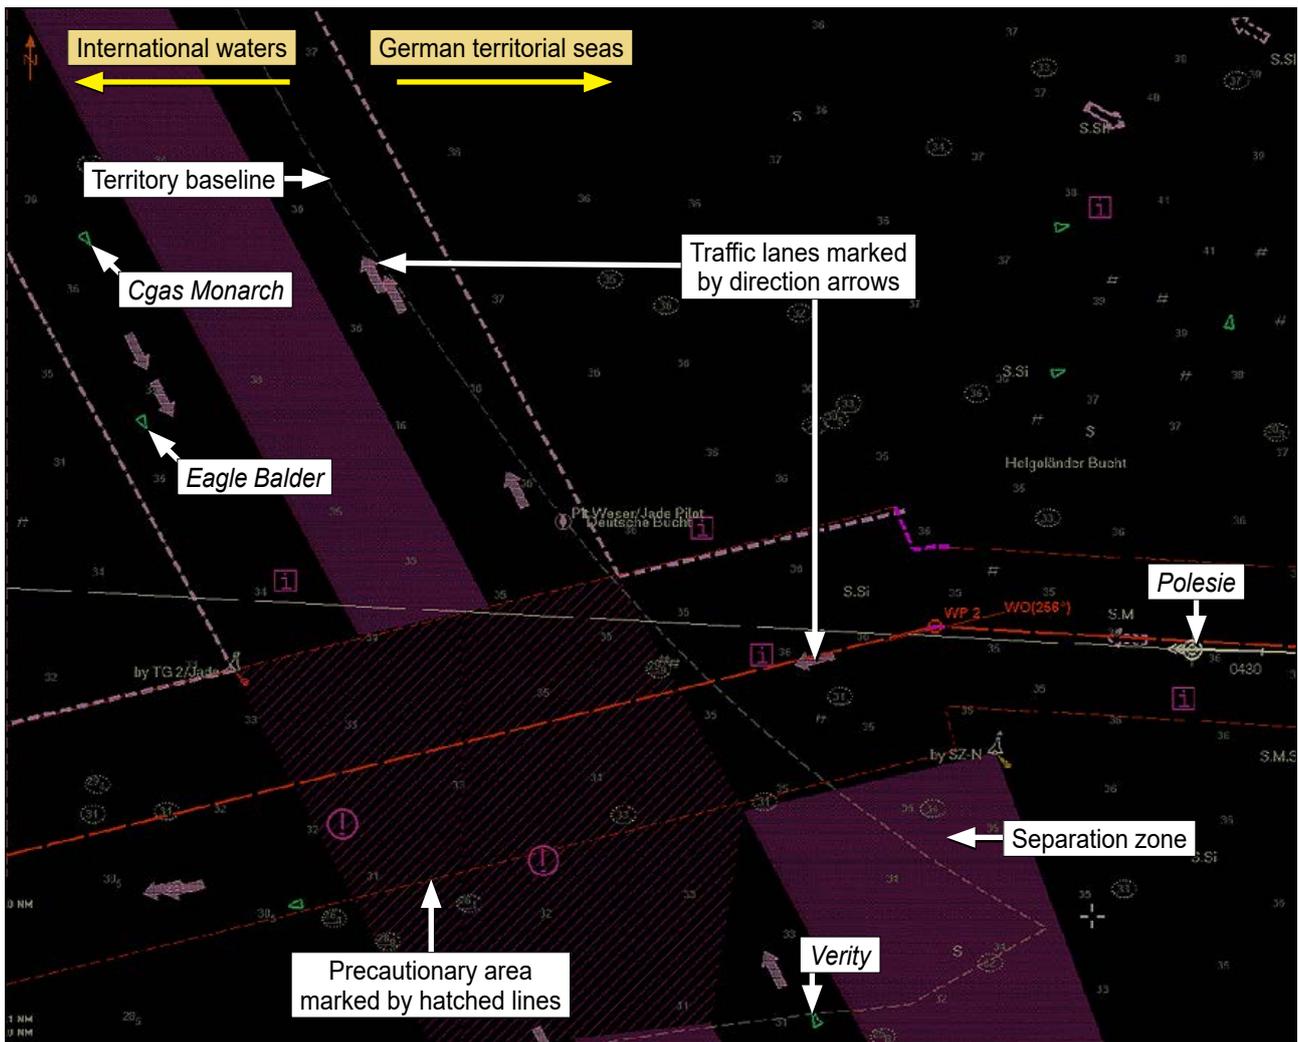
At 0433, *Polesie*'s ECDIS recorded that *Verity* had passed from the German territorial sea into international waters (**Figure 5**).

Figure 5: *Polesie*'s ECDIS display at 0433

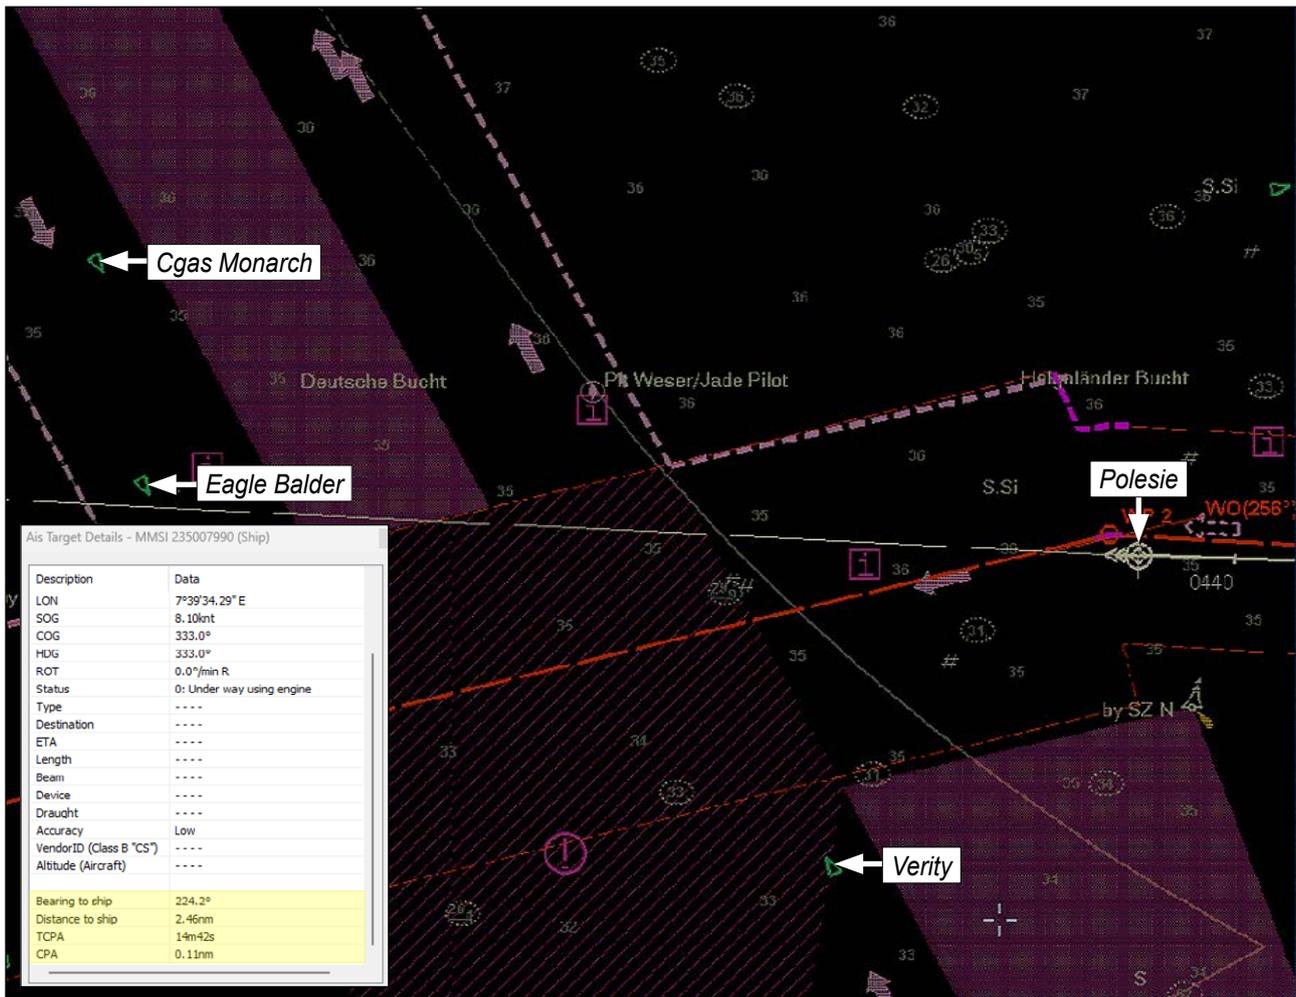
By 0443, *Polesie* was approaching its waypoint at the entrance to the westbound lane of the TSS and *Verity* was entering the crossing area of the TSS (**Figure 6**). *Verity* was on *Polesie*'s port bow, bearing 224° at 2.46nm range. *Polesie*'s AIS unit showed *Verity* would pass close astern at a CPA of 0.11nm, with a TCPA in 14 minutes and 42 seconds (**Figure 6** inset). The AIS also showed two vessels, *Eagle Balder* and *Cgas Monarch*, heading south in the TSS to the Jade river, and both passing clear ahead of *Polesie* by 5.2nm and 3nm respectively.

Figure 6: *Polesie's* ECDIS display at 0443 and (inset) *Verity's* AIS information extracted from *Polesie's* VDR

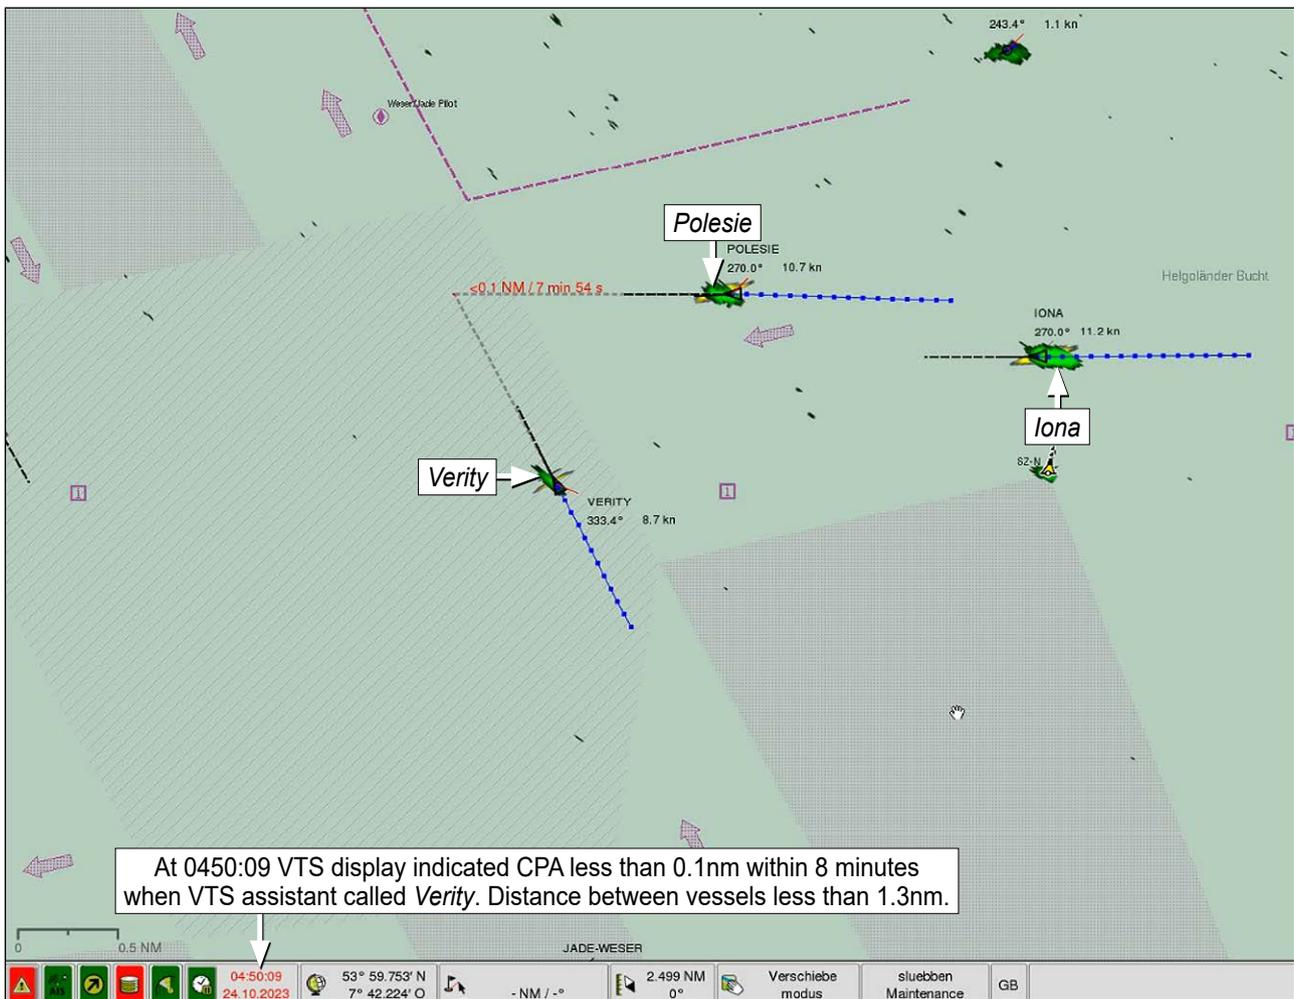
The German Bight Traffic VTS assistant had been monitoring *Verity* and *Polesie*, identified that a risk of collision existed and noted that *Verity* had not acted as expected of a give-way vessel (**Figure 7**). At 0450:09, when the two vessels were less than 1.3nm apart, the VTS assistant called *Verity* and the exchanges shown in **Table 1** occurred, with both parties speaking in a conversational tone. The VTS assistant had also taken two routine shipping reports in the 3 minutes before contacting *Verity* but it is unknown what other watchkeeping tasks they were required to perform.

Figure 7: Reconstruction of 0450:09 VTS display when VTS assistant called Verity

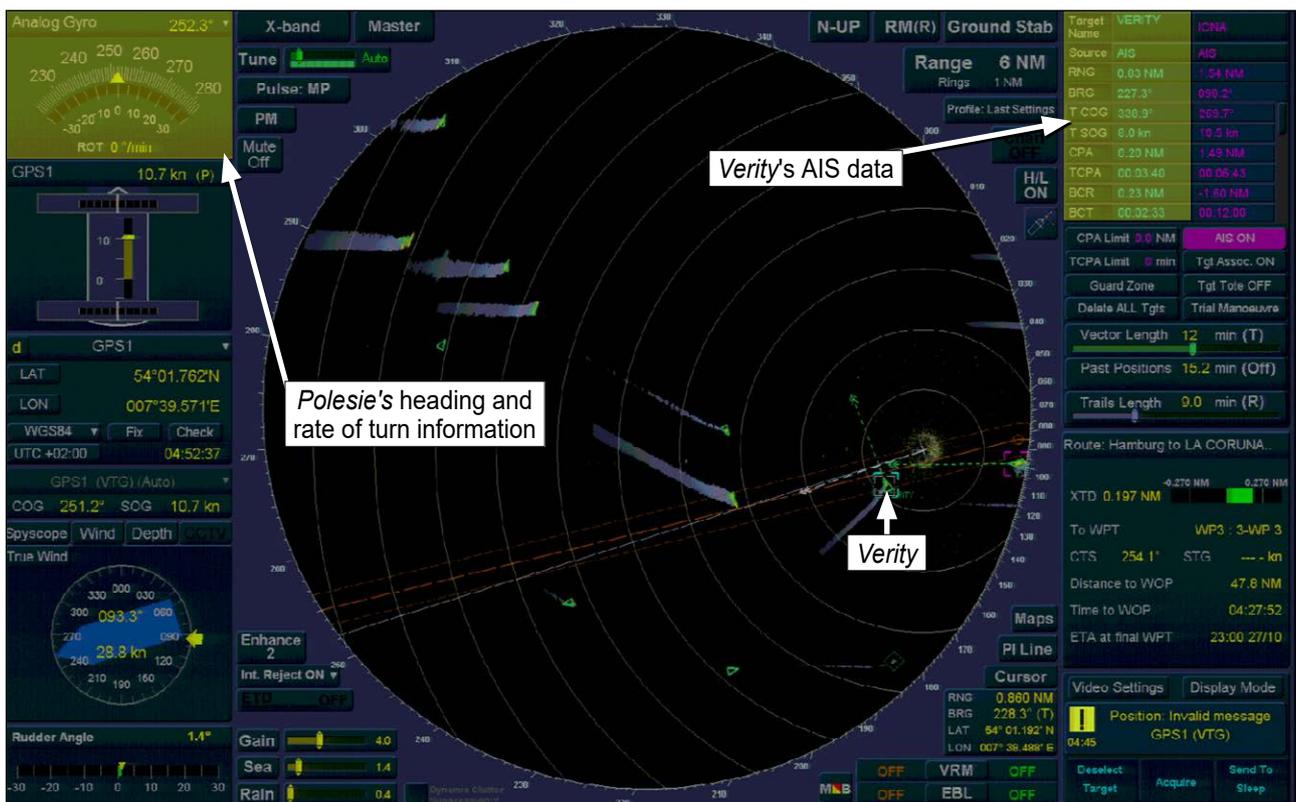
At 0452:26, *Verity's* heading altered to starboard. Eleven seconds later, *Polesie's* watchkeeper selected *Verity's* AIS icon on the radar on the 6nm range (**Figure 8**), which showed its status information on the screen. It showed that *Verity* was at a range of 0.83nm, had a CPA of 0.2nm and a TCPA in 3 minutes and 40 seconds with a bow crossing range (BCR), passing ahead, of 0.23nm in 2 minutes and 33 seconds.

Figure 8: *Polesie's* radar at 0452:37 with *Verity* selected
