Serious Incident

Aircraft Type and Registration:	ATR 42-500, G-LMRC	
No & Type of Engines:	2 Pratt & Whitney Canada PW127E turboprop engines	
Year of Manufacture:	1996 (Serial no: 480)	
Date & Time (UTC):	27 August 2022 at 1018 hrs	
Location:	During climb 14 nm north-east of Aberdeen Airport	
Type of Flight:	Commercial Air Transport (Passenger)	
Persons on Board:	Crew - 3	Passengers - 25
Injuries:	Crew - None	Passengers - None
Nature of Damage:	None	
Commander's Licence:	Airline Transport Pilot's Licence	
Commander's Age:	39 years	
Commander's Flying Experience:	4,900 hours (of which 243 were on type) Last 90 days - 147 hours Last 28 days - 36 hours	
Information Source:	AAIB Field Investigation

Synopsis

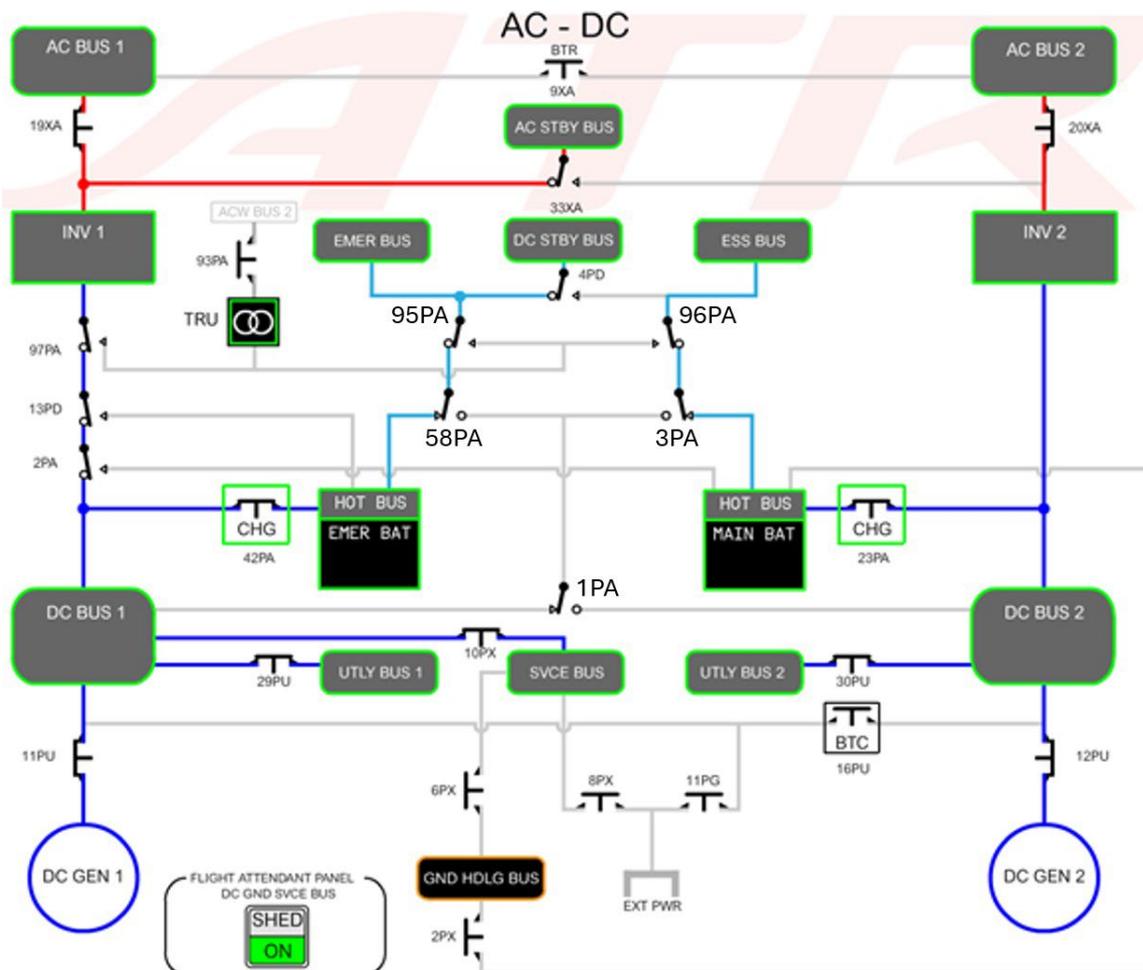
Figure 2

The distribution of the DC electrical network is shown in Figure 2, with the normal in-flight configuration shown with blue and red circuits. In normal in-flight configuration DC Gen 1 powers DC BUS 1 and DC Gen 2 powers DC BUS 2. These two main buses charge the emergency and main batteries which in turn provide power to the Emergency DC Bus (DC EMER BUS), DC Standby Bus (DC STBY BUS) and the DC Essential Bus² (DC ESS BUS) – these three buses are referred to as the ‘emergency electrical network’. If power to both DC BUS 1 and DC BUS 2 is lost, then critical flight systems and equipment are retained because the batteries would still provide power to the three buses in the emergency electrical network for about 30 minutes. If both batteries were to fail or were turned off, then either DC Bus 1 or DC Bus 2 can provide power to the emergency electrical network, via contactors³ 1PA, 58PA and 3PA shown in Figure 2.

Schematic of DC electrical network – normal in-flight configuration

With contactor 1PA failed in an intermediate position, the three buses on the emergency electrical network would have lost power if contactors 58PA and 3PA had de-energised, resulting in the three buses being connected to the 1PA contactor which could not supply power (Figure 2). The 58PA and 3PA contactors will both de-energise if both MFCs sense that the 7PA battery switch has been turned off. The battery switch is not near the landing light switches (Figure 3), and although it is possible that the co-pilot inadvertently turned off the battery switch instead of the landing light switches, this would not explain why the symptoms reoccurred on the ground when the commander turned off the landing light switches. It is unlikely that both the commander and co-pilot inadvertently turned off the battery switch instead of the landing light switches on separate occasions during the same flight.

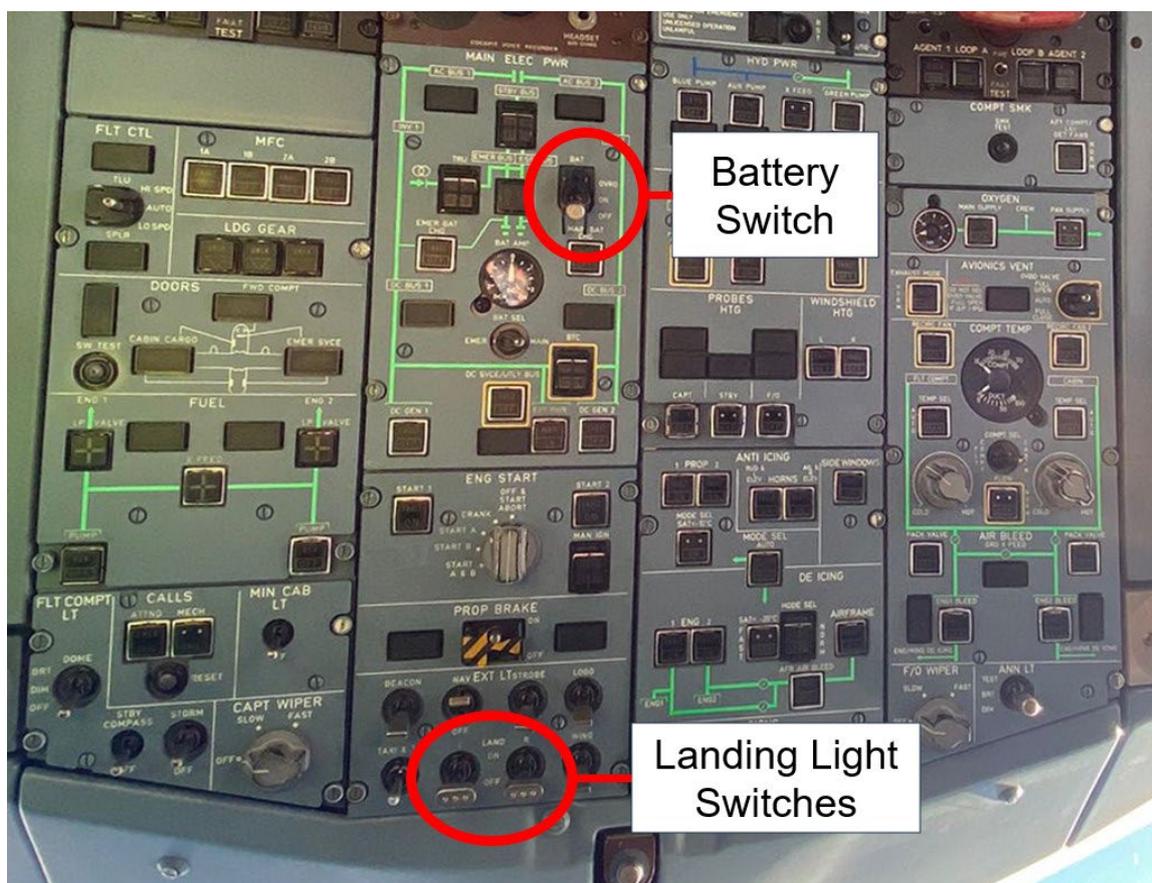
Figure 3

The battery switch is located on the overhead panel (Figure 3) and has three positions, ON, OFF and OVRD (override). The switch position sends a signal to both MFCs which command the position of the 3PA and 58PA contactors. When the battery switch is in the OFF position, the MFCs see an open circuit which causes the 3PA and 58PA contactors to de-energise which disconnects the emergency and main batteries from the buses in the emergency electrical network. When the battery switch is in the ON position, the MFCs see a closed circuit which causes them to energise the 3PA and 58PA contactors which results in power being supplied from both hot battery buses to the emergency electrical network. The hot battery buses are powered by DC BUS 1 and DC BUS 2 respectively, or by their respective batteries if its DC bus has lost power. The OVRD position is used in the event of a failure when it is desired to override the logic and protections in the MFC and maintain battery power to the emergency electrical network. If in the event of a fault only one MFC sees an open circuit from the battery switch, the batteries are not disconnected from the emergency electrical network.

Location of battery switch and landing light switches on the overhead panel

There are two landing lights, left and right, mounted on either side of the forward part of the main landing gear fairing. They are controlled by two switches, left and right, mounted on the forward section of the overhead panel (Figure 3). Each switch is connected to a relay; when the relay is energised by the switch using 28V DC, 115V wild AC is supplied to the respective landing light.

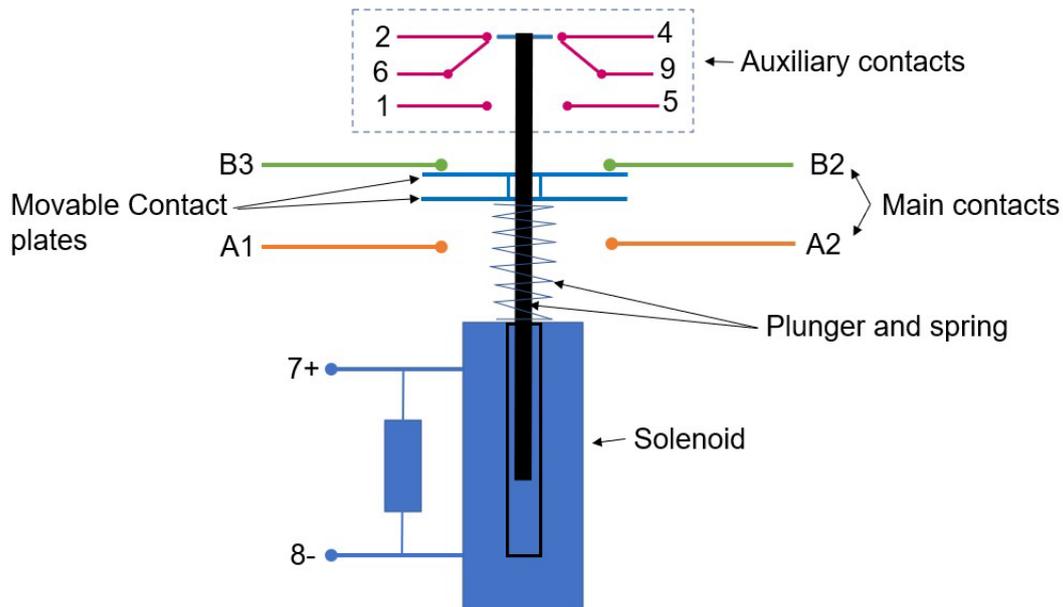
Figure 5

A schematic of the contactor is shown in Figure 5. In the deenergised condition, a spring holds a plunger carrying the movable contact plate (shown in blue) against the upper main

contacts B3 and B2. When the contactor is energised, by applying a 28V DC voltage between the solenoid terminals 7 and 8, the plunger moves downward against the spring force and the upper movable contact plate moves away from contacts B3 and B2, and the lower movable contact plate is pulled against contacts A1 and A2. At the same time, auxiliary contacts transition from 6/2 to 6/1, and from 9/4 to 9/5; these provide contactor state information to other systems. While the solenoid is energised there is continuity between main contacts A1 and A2.

Contactor schematic diagram (shown de-energised)
