Rail Accident Investigation Branch

# Rail Accident Report

## Passenger trapped and dragged at Ealing Broadway 24 November 2024

Report 01/2026  
March 2026

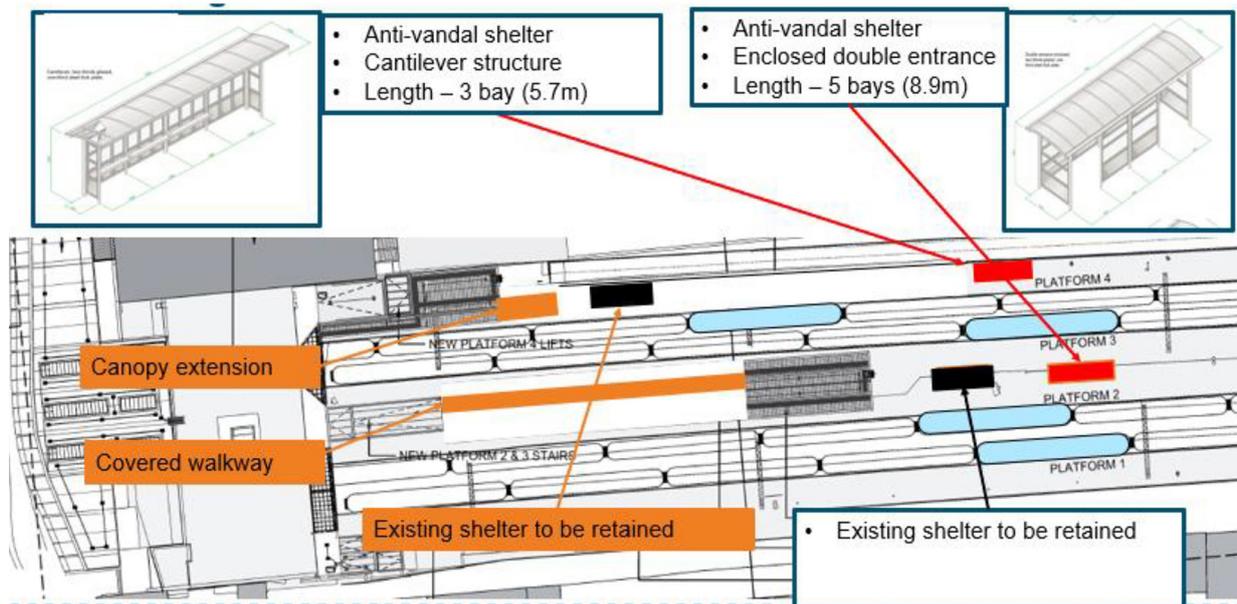
- 34 In November 2021, additional works (figure 6) included a new canopy and new passenger waiting shelters. Consultation was undertaken with the operators of services using the station, with the changes agreed by TfL in June 2023 and by MTREL in August 2023. These installations were fully completed in October 2023.

Figure 6: Network Rail drawing showing proposed station changes implemented in 2023 (courtesy of Network Rail).

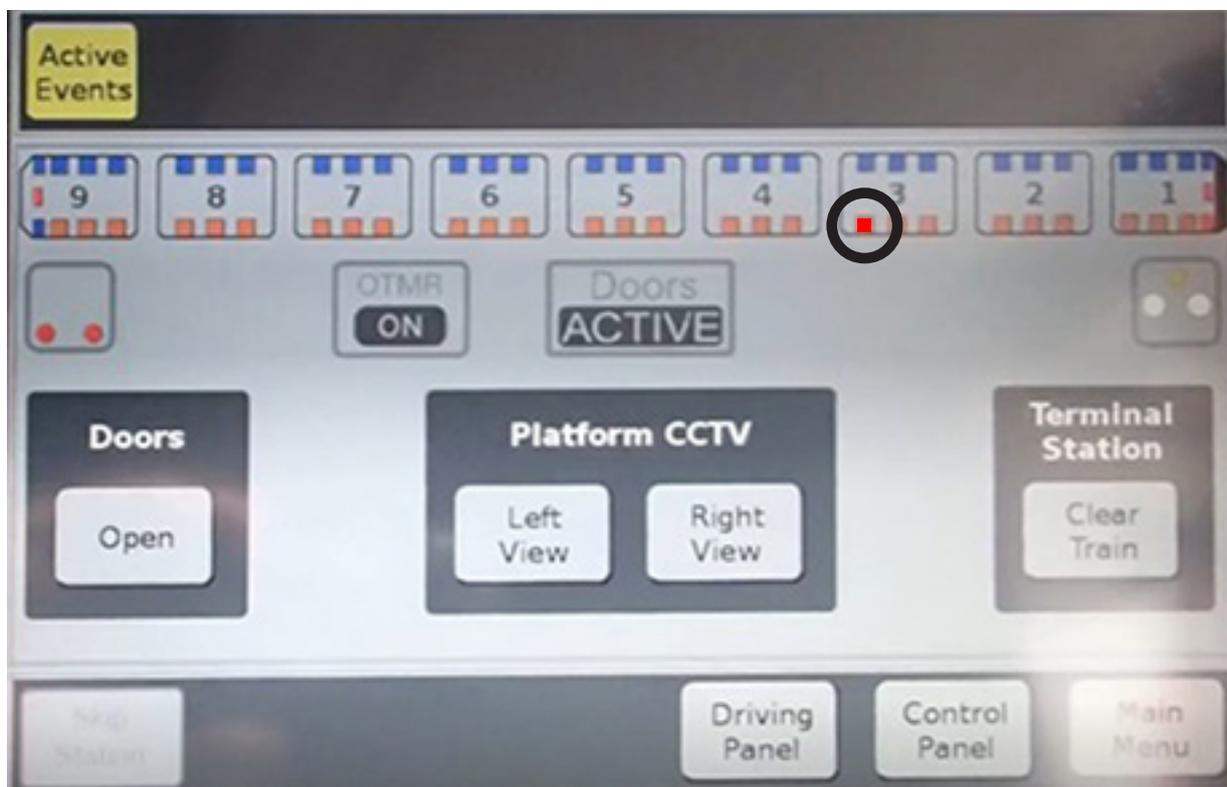
- 102 The doors on class 345 trains remain compliant with the requirements of BS EN 14752:2005 to detect obstructions greater than 30 mm in thickness and 60 mm in height. When an obstruction of this size is detected while the doors are closing, the doors will open, pause and then try to close up to another three times (recycling). After this, if the doors remain obstructed and traction interlock cannot be achieved, then the doors will 'fault' and remain open. The driver will receive a notification on a display in the cab (figure 13) with the relevant door illuminated, showing that there is an obstruction. Although traction power can only be applied once the traction interlock circuit is complete (that is, when all doors are closed and locked) smaller diameter items may not be detected by the system if they become trapped in doors. Traction power will still be available in these circumstances.

Figure 13: An example of a driver's panel displaying an item detected in the train's door.

103 The average dimension of a small adult hand<sup>3</sup> is 75 mm in height, with a finger thickness of 18 mm. These dimensions are not within the detection parameters of the obstacle detection system on class 345 trains. It is, therefore, likely that the dimension of the passenger's hand involved in the trap and drag accident was too small to be detected, resulting in doors not recycling and the interlock circuit being made.

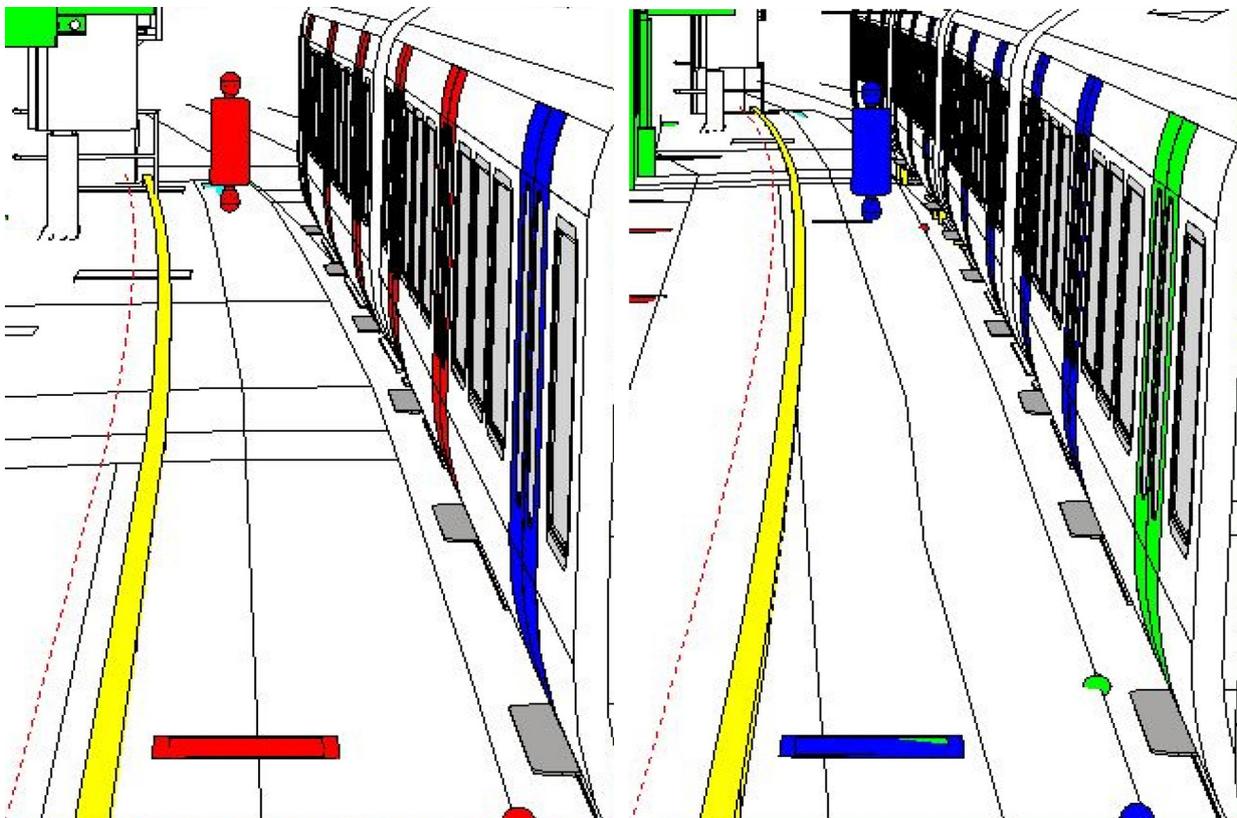
#### **158 Crossrail and rail industry standards do not mandate that the testing and commissioning of DOO CCTV replicate a realistic platform environment.**

159 The DOO CCTV at Ealing Broadway station was assessed during its commissioning against internal Crossrail standard CCTV C160-MMD-R1-RGN-CR001-50043 rev 2.0, issued in 2013. As required by the standard, a non-intrusive survey was first undertaken in early 2017 with digital models produced for proposed camera locations and perceived camera coverage (figure 18). The full detailed design assessment was then signed off in April 2017.

Figure 18: The digital representation of the DOO CCTV from the detailed design undertaken by Network Rail (courtesy of Network Rail).
