# Rail Accident Report

## Passenger trapped and dragged at Ealing Broadway 24 November 2024

Report 01/2026  
March 2026

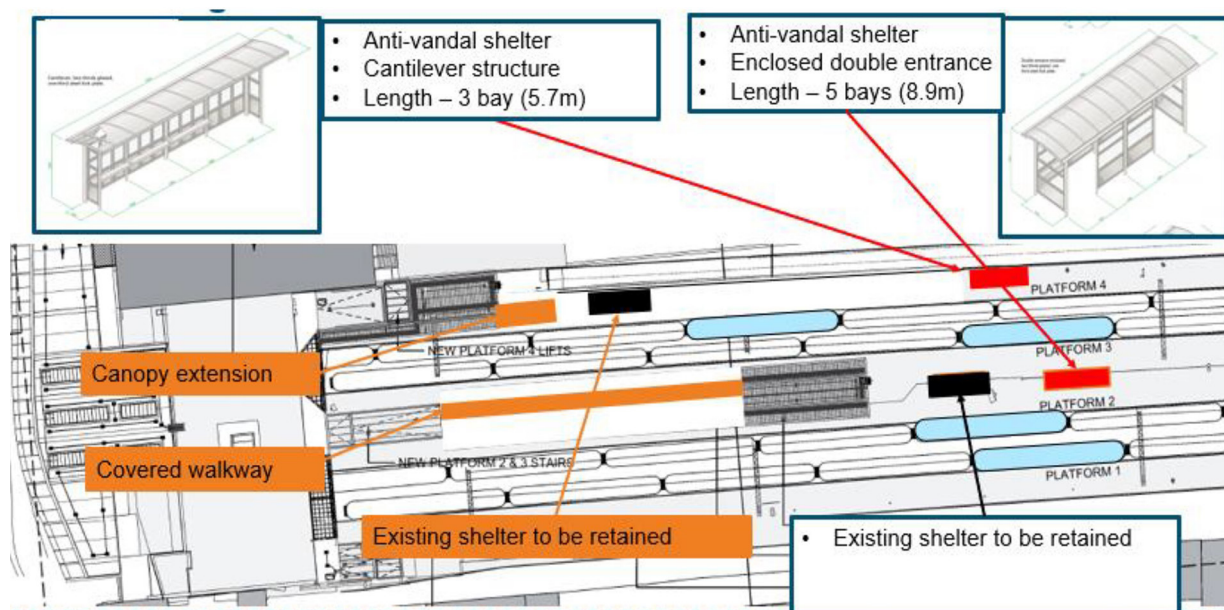
- 34 In November 2021, additional works (figure 6) included a new canopy and new passenger waiting shelters. Consultation was undertaken with the operators of services using the station, with the changes agreed by TfL in June 2023 and by MTREL in August 2023. These installations were fully completed in October 2023.

Figure 6: Network Rail drawing showing proposed station changes implemented in 2023 (courtesy of Network Rail).

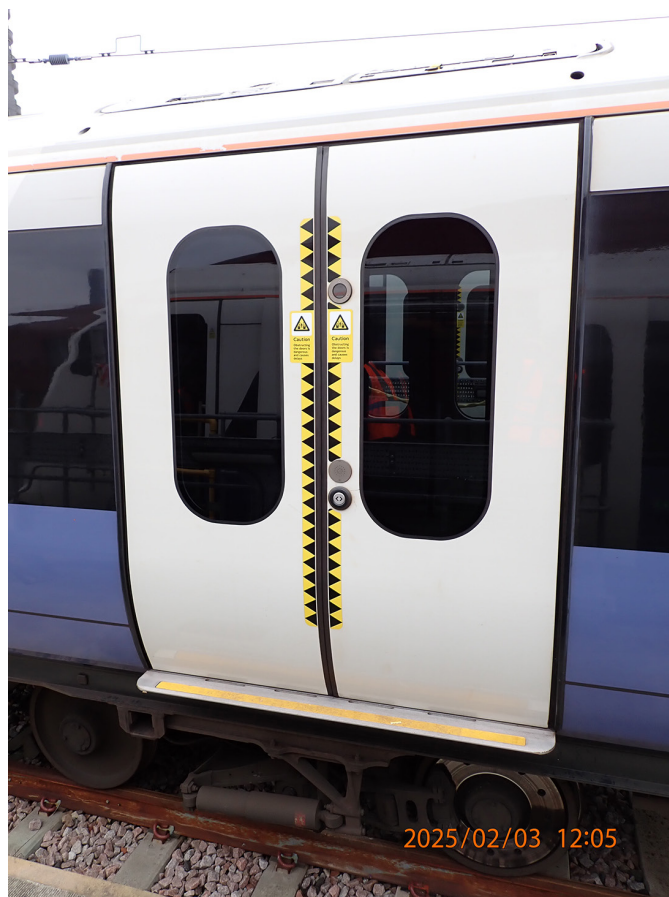
- 36 Each train car has three pairs of electrically operated, sliding plug doors per side (figure 7).

*Figure 7: The class 345 electrically operated, sliding plug doors.*

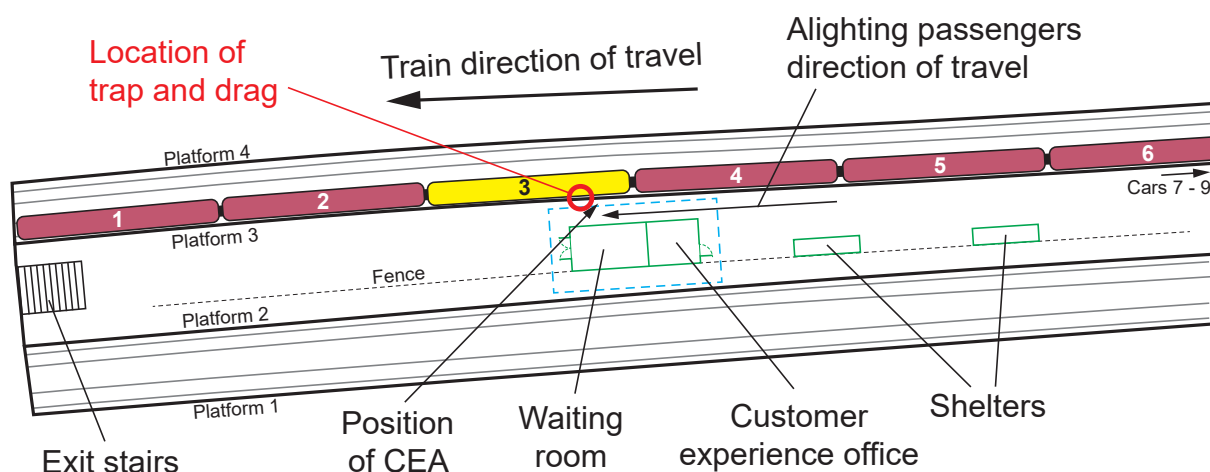
- 49 By the time the train had come to a stop in platform 3 at its correct position, the CEA had positioned themselves by the rear doors of car 3 (figure 8). The driver released the doors, which opened, and passengers began to alight from the length of the train, making their way towards the platform exit near the front of the train. Passengers from the middle and rear of the train had to walk through a narrowed section between the platform edge and the waiting room building to reach the exit (figure 10). This area was adjacent to cars 3 and 4.

Figure 8: Diagram showing train 9N68 stationary on platform 3.

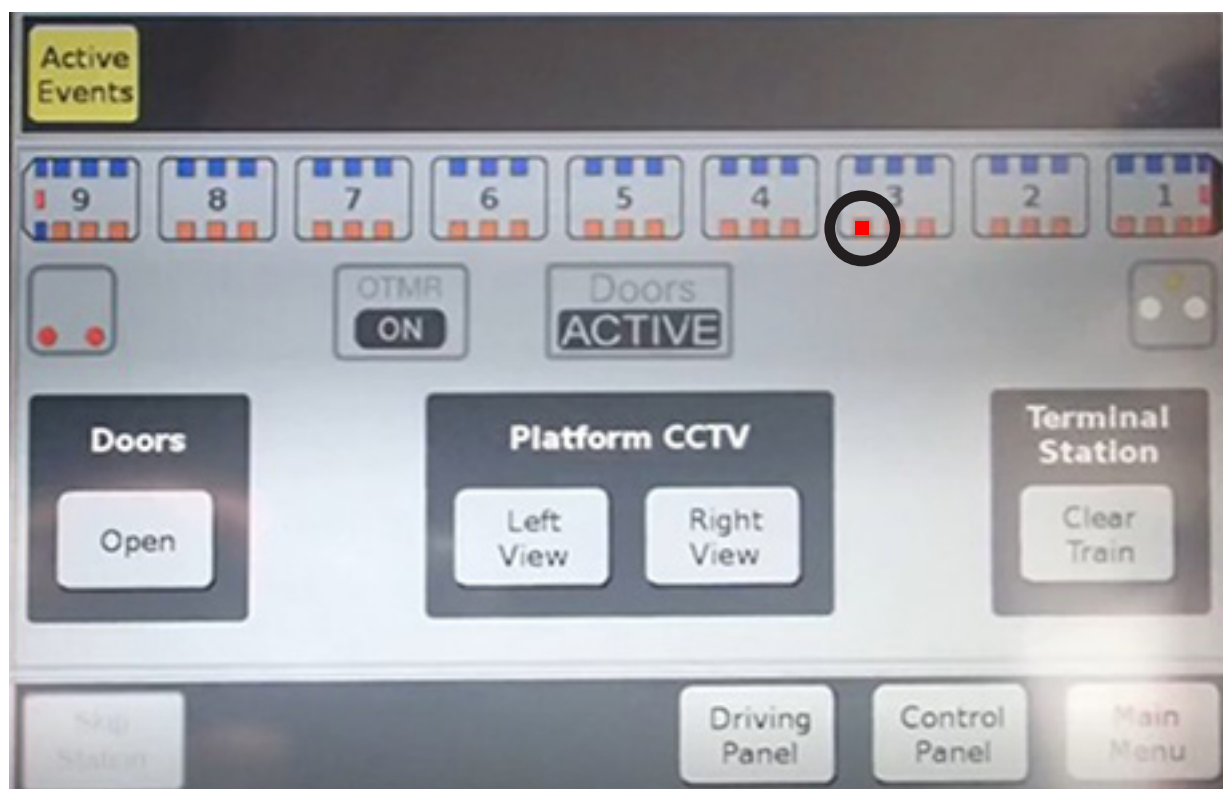
- 102 The doors on class 345 trains remain compliant with the requirements of BS EN 14752:2005 to detect obstructions greater than 30 mm in thickness and 60 mm in height. When an obstruction of this size is detected while the doors are closing, the doors will open, pause and then try to close up to another three times (recycling). After this, if the doors remain obstructed and traction interlock cannot be achieved, then the doors will 'fault' and remain open. The driver will receive a notification on a display in the cab (figure 13) with the relevant door illuminated, showing that there is an obstruction. Although traction power can only be applied once the traction interlock circuit is complete (that is, when all doors are closed and locked) smaller diameter items may not be detected by the system if they become trapped in doors. Traction power will still be available in these circumstances.

Figure 13: An example of a driver's panel displaying an item detected in the train's door.

- 103 The average dimension of a small adult hand<sup>3</sup> is 75 mm in height, with a finger thickness of 18 mm. These dimensions are not within the detection parameters of the obstacle detection system on class 345 trains. It is, therefore, likely that the dimension of the passenger's hand involved in the trap and drag accident was too small to be detected, resulting in doors not recycling and the interlock circuit being made.

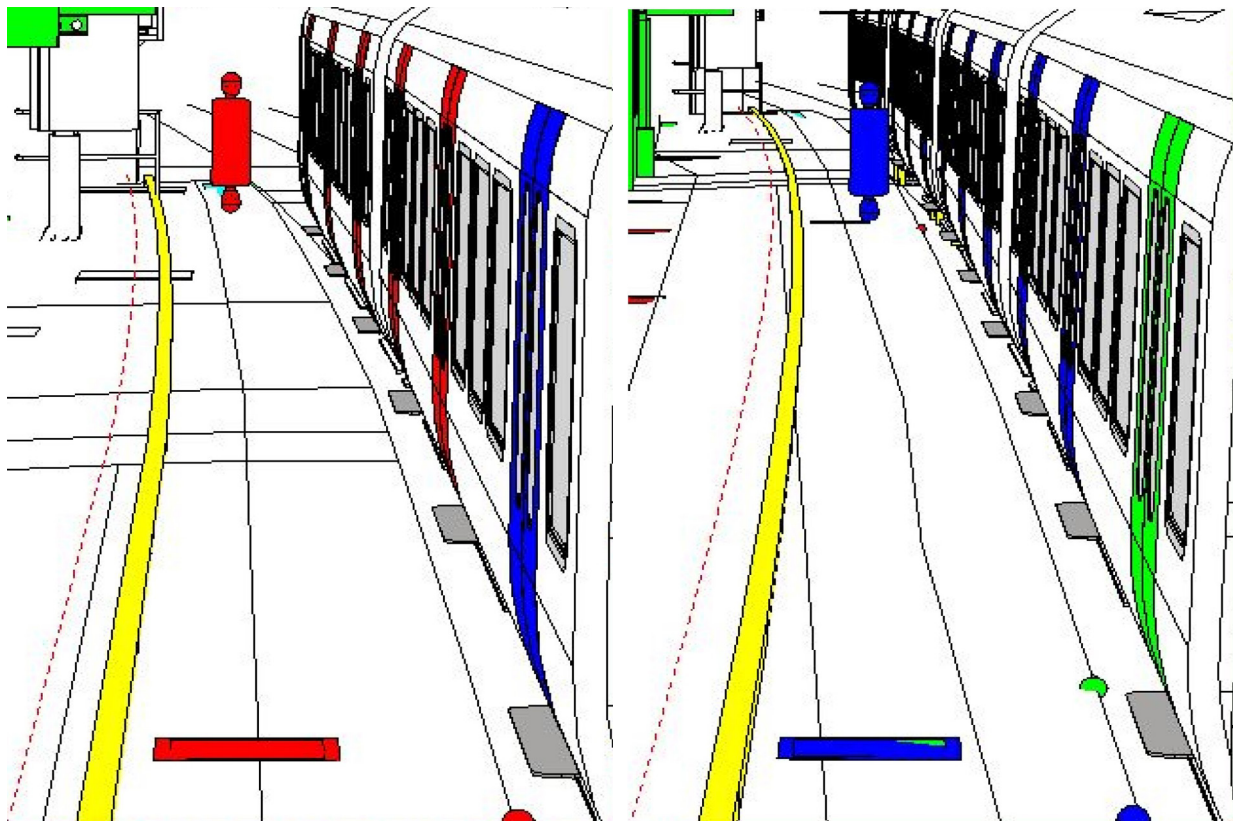
#### **158 Crossrail and rail industry standards do not mandate that the testing and commissioning of DOO CCTV replicate a realistic platform environment.**

159 The DOO CCTV at Ealing Broadway station was assessed during its commissioning against internal Crossrail standard CCTV C160-MMD-R1-RGN-CR001-50043 rev 2.0, issued in 2013. As required by the standard, a non-intrusive survey was first undertaken in early 2017 with digital models produced for proposed camera locations and perceived camera coverage (figure 18). The full detailed design assessment was then signed off in April 2017.

Figure 18: The digital representation of the DOO CCTV from the detailed design undertaken by Network Rail (courtesy of Network Rail).
