Rail Accident Investigation Branch

Rail Accident Report

Fatal accident at Ickenham London Underground station 28 March 2025

Report 02/2026
March 2026

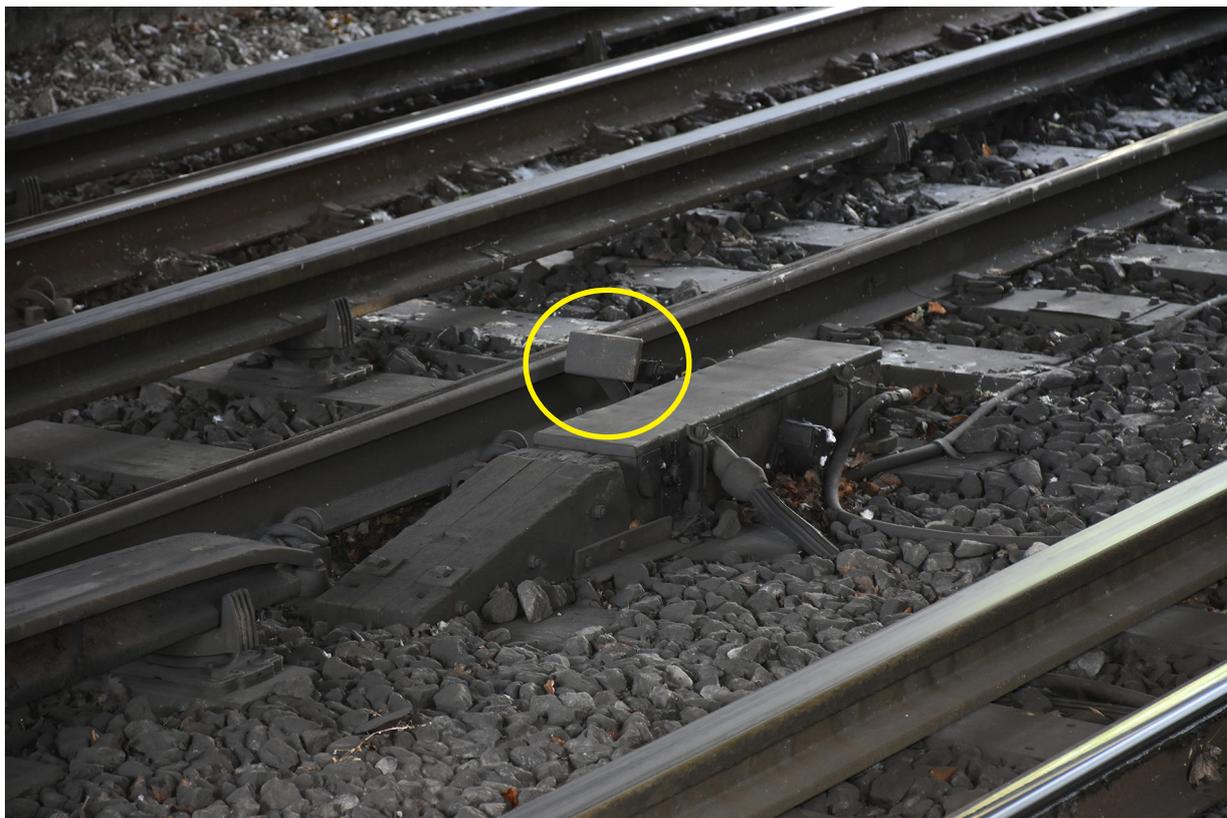
- 22 When signal MUX 743 is displaying a red aspect, an on-track device known as a trainstop, has its arm raised (figure 4). If the signal is displaying a green (proceed) aspect, then this arm is maintained in a lowered position (figure 5).

Figure 4: Trainstop associated with signal MUX 743 with its arm in the raised position.

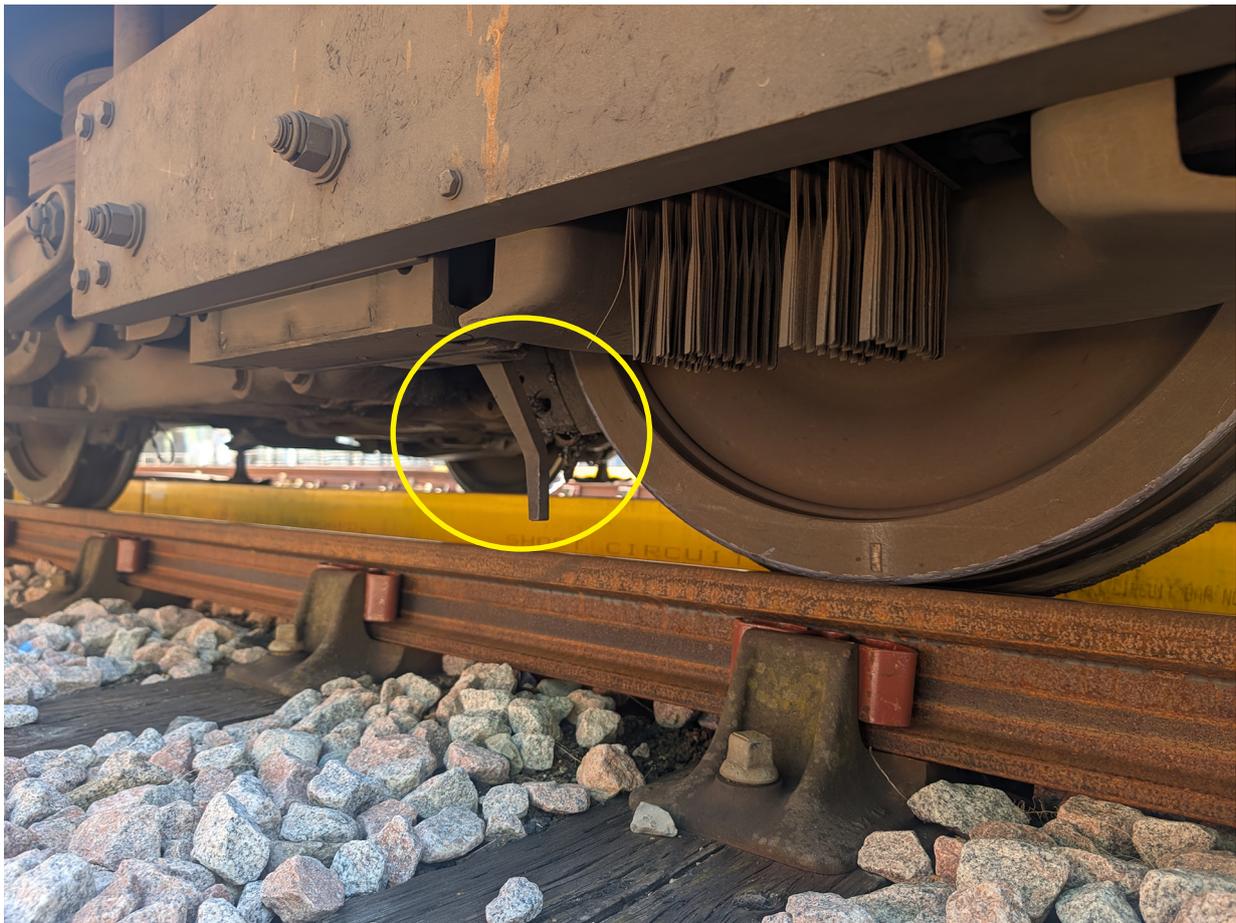
- 23 If a train passes the trainstop arm in the raised position, then it will engage with a train-mounted device known as a tripcock (figure 6). If a tripcock is activated in this way, for example, if a red signal is passed, then the train will automatically make an emergency brake application. There is a tripcock under the train on the front right side (in the direction of travel). The tripcock for the rear driving cab is located at the rear of the train on the left side in the direction of travel. Only the front tripcock will contact a raised trainstop during normal operational service.

Figure 6: A tripcock on an S-Stock train.

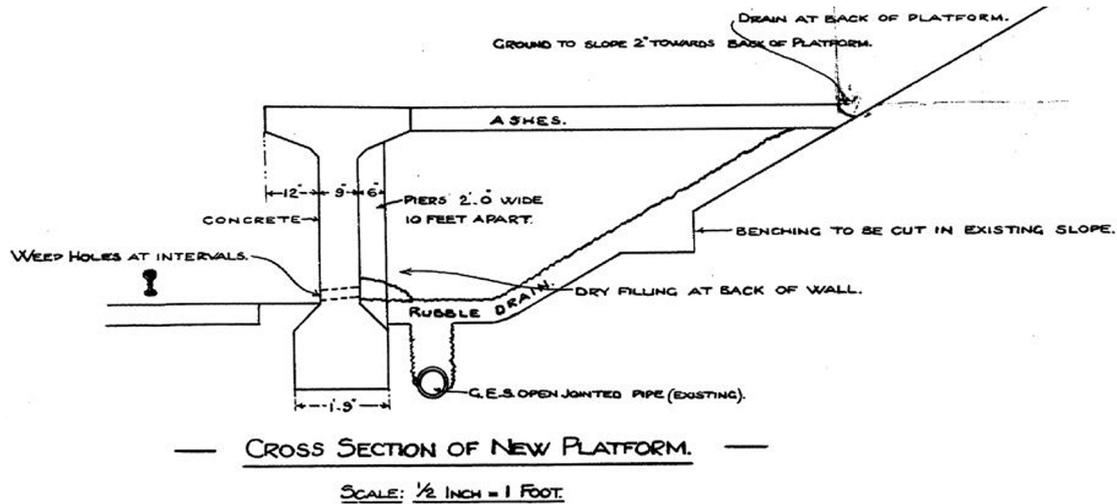
Figure 8: Design drawing for platform 2 at Ickenham station (courtesy of TfL).

- 51 The platforms were rebuilt in July 1922 to accommodate longer trains. This work also created the basic platform profile which remained at the time of the accident. As part of the rebuild, a set of design drawings were produced which showed the platform being constructed with a 12-inch recess (figure 8). The 'as built' drawing filed in November 1924 showed that, as part of the construction, a single 'signal wire' had been fitted to the under-platform recess of platform 2 (figure 9). At this time, there was no specific restriction on fitting cables in under-platform recesses.

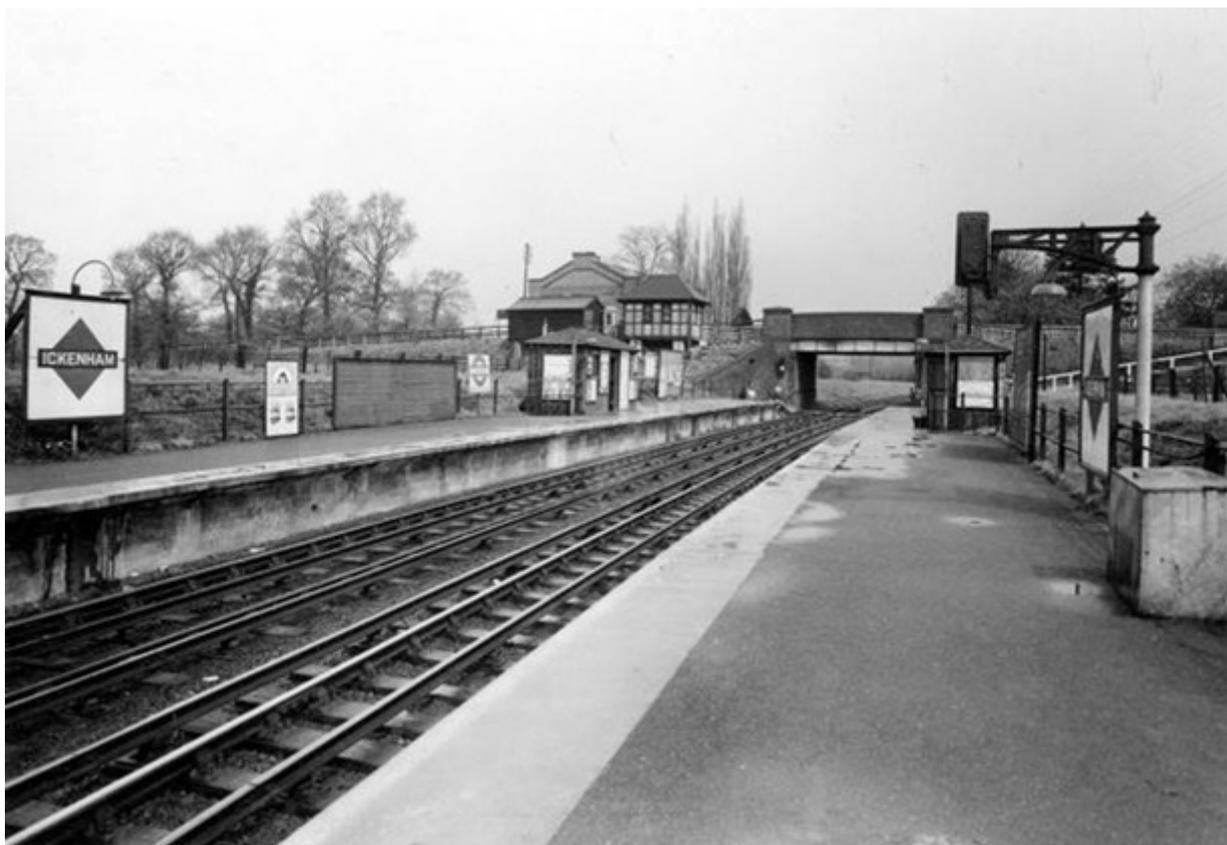
Figure 10: Ickenham station platforms in 1934 (courtesy of the London Transport Museum).

- 52 The first available photograph RAIB was able to locate of the rebuilt platform showed that, by April 1934, the signal wire shown on the 1922 drawing was not present and there were no cables in the under-platform recess of platform 2 (figure 10). This might have been in response to the change in guidance with regards to obstructions (see paragraph 57) or connected to the change in signalling system to electrically controlled colour light signals in the 1930s, which would have presented an opportunity to run the associated electric cables away from the recess.

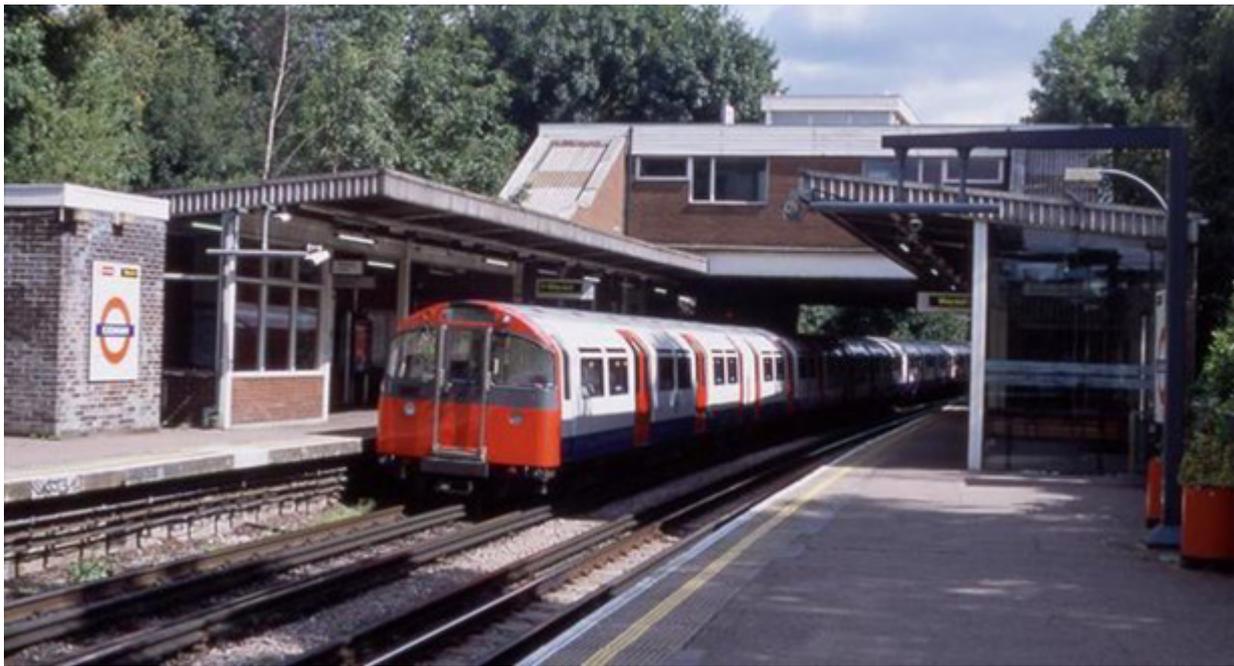
Figure 12: Ickenham station platforms in 2001 (courtesy of the London Transport Museum).

- 53 By July 1958, a photograph of the station (figure 11) shows a substantial cable run had been installed in the under-platform recess of platform 2. Cable runs of a similar appearance can also be seen in a photograph from 2001 (figure 12). This is representative of the current status of the recess.

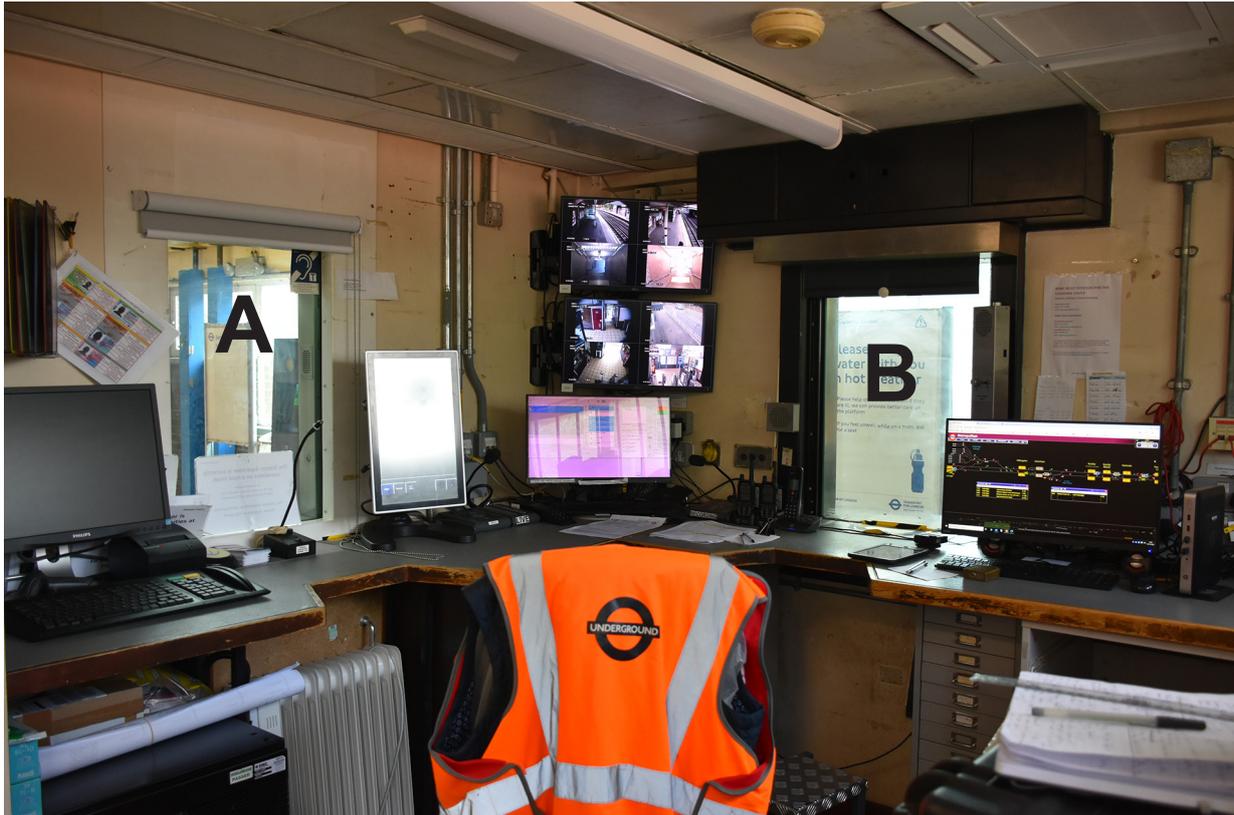
- 74 At Ickenham station office there are two windows providing views into the ticket hall. One window overlooks the gate line, and the other overlooks part of the route to the stairs giving access to platform 2 (figure 13). At the time the passenger moved through the ticket hall, CCTV images show the late shift CSS's hands are engaging with a touch screen monitor which controls opening and closing of the ticket gates (this monitor is shown in figure 13). Witness evidence was that the CSS did not notice the passenger at this point. However, CCTV shows that the passenger was not behaving in a way that was likely to draw the late shift CSS's attention had they been looking out of the control office at the time (paragraph 32).

Figure 13: Inside Ickenham station office showing the window to the ticket hall (A) and the route to platform 2 (B).

- 77 Between the time the passenger moved past the station office window until 22:27:46, CCTV images intermittently show the late shift CSS in the station office near to window A (figure 13), and therefore near the CCTV monitors. The passenger fell three times in this period. After this point, the late shift CSS is not seen again on CCTV before the night shift CSS arrives, by which point the accident had already occurred. Witness evidence is that the late shift CSS was still preparing to hand over to the night shift CSS and that they were tidying the office and writing a handover note around this time. Data from the personal mobile phone belonging to the late shift CSS shows it was not being used during the time the passenger was on the station.

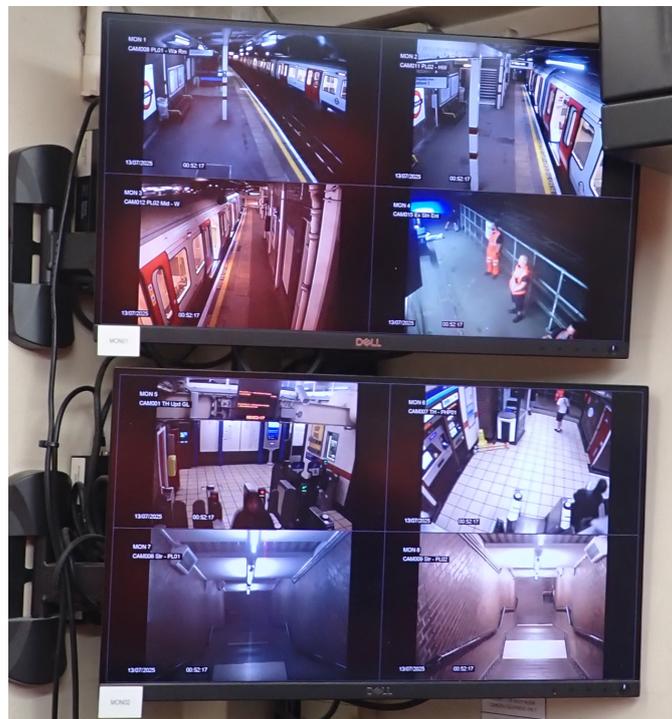
- 76 Images from the CCTV camera capturing the staircase that the passenger was struggling to navigate were fed back to the station office, as were images of platform 2 (figure 14 illustrates this). However it is not possible to say which images were being displayed on the monitors within the office (see paragraphs 10 and 84).

Figure 14: Typical view available from the CCTV cameras at Ickenham station. Relevant staircase bottom right.

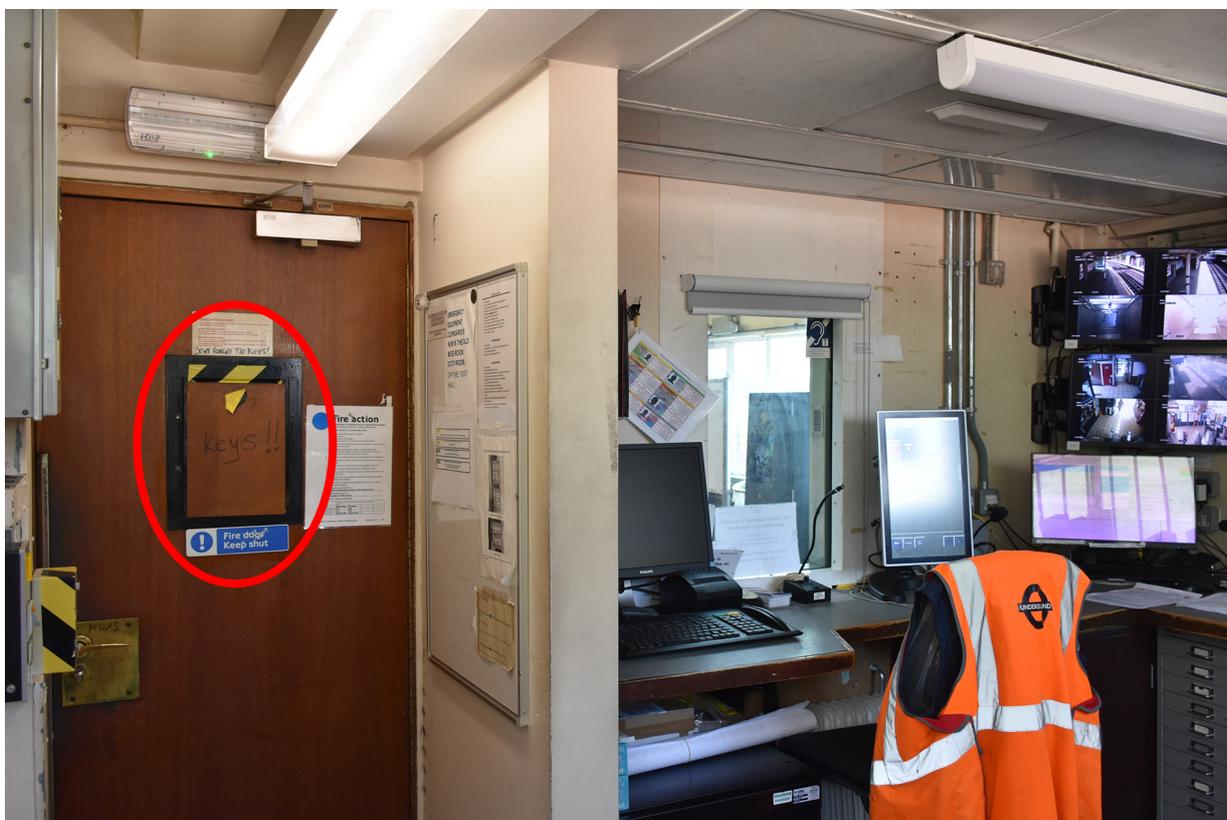
- 78 As the passenger reached platform 2, a lift repair contractor was captured on CCTV walking through the ticket hall. The contractor had been working at the upper lobby of the lift to platform 2 (figure 2), from where it is not possible to see down onto the platform. The lift repair contractor is captured on CCTV waving to someone in the ticket office through the office door hatch between 22:29:45 and 22:29:48 while on route to their van. This occurred shortly before the passenger fell from the platform at 22:30:05. Since the hatch must be physically held open, RAIB has concluded that the late shift CSS must have been in the office doorway holding it open around the time of the fall. When positioned in the office doorway, it is not possible to see the CCTV monitors due to a privacy wall between the doorway and bank of monitors (figure 15).

Figure 15: The door to the station office from the inside (hatch highlighted).

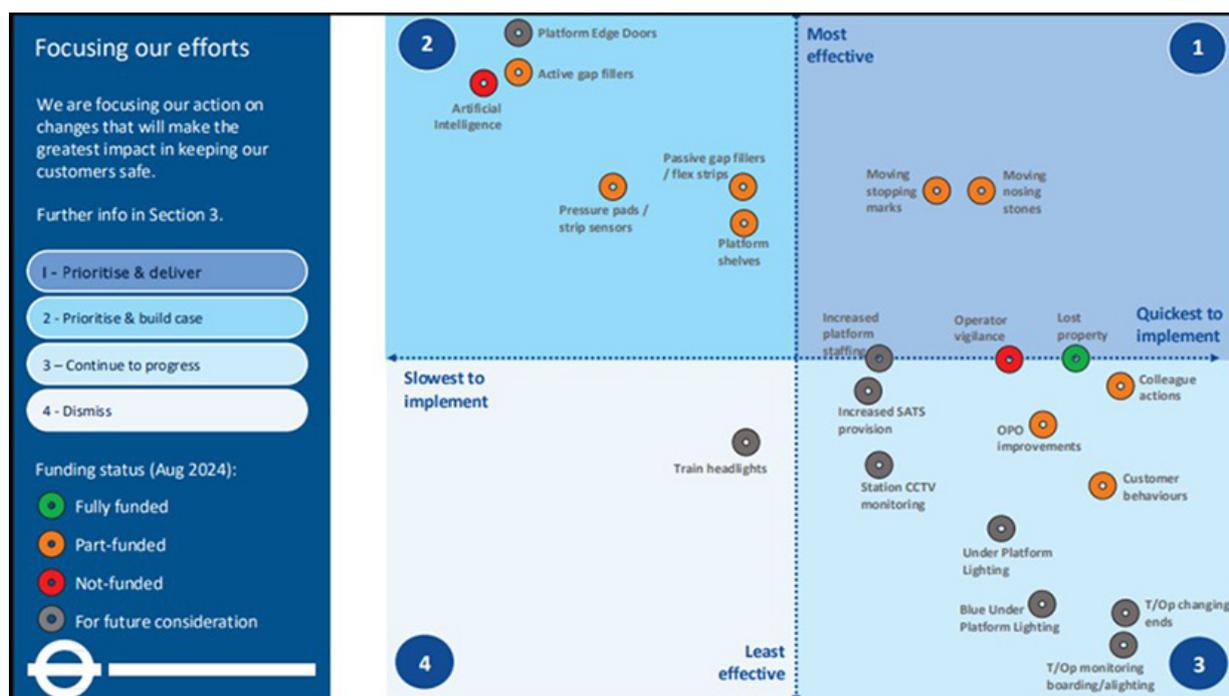
- 143 In total, 16 types of mitigation measure were considered as part of the 2024 review. Only one of these mitigations was regarded as ‘fully-funded’ by the time of the publication of the platform-train interface plan in October 2024. This plan briefed staff to look for the owner of lost property found on platforms and was expected to have no actual financial cost (figure 23).

Figure 23: Extract from Transport for London's passenger train interface plan showing which mitigations have been funded (courtesy of Transport for London).
