Near miss at Helpston manually controlled barrier level crossing, 21 October 2025

At 08:16 on Tuesday 21 October 2025, a near miss occurred at Helpston manually controlled barrier (MCB) level crossing, situated near Peterborough.

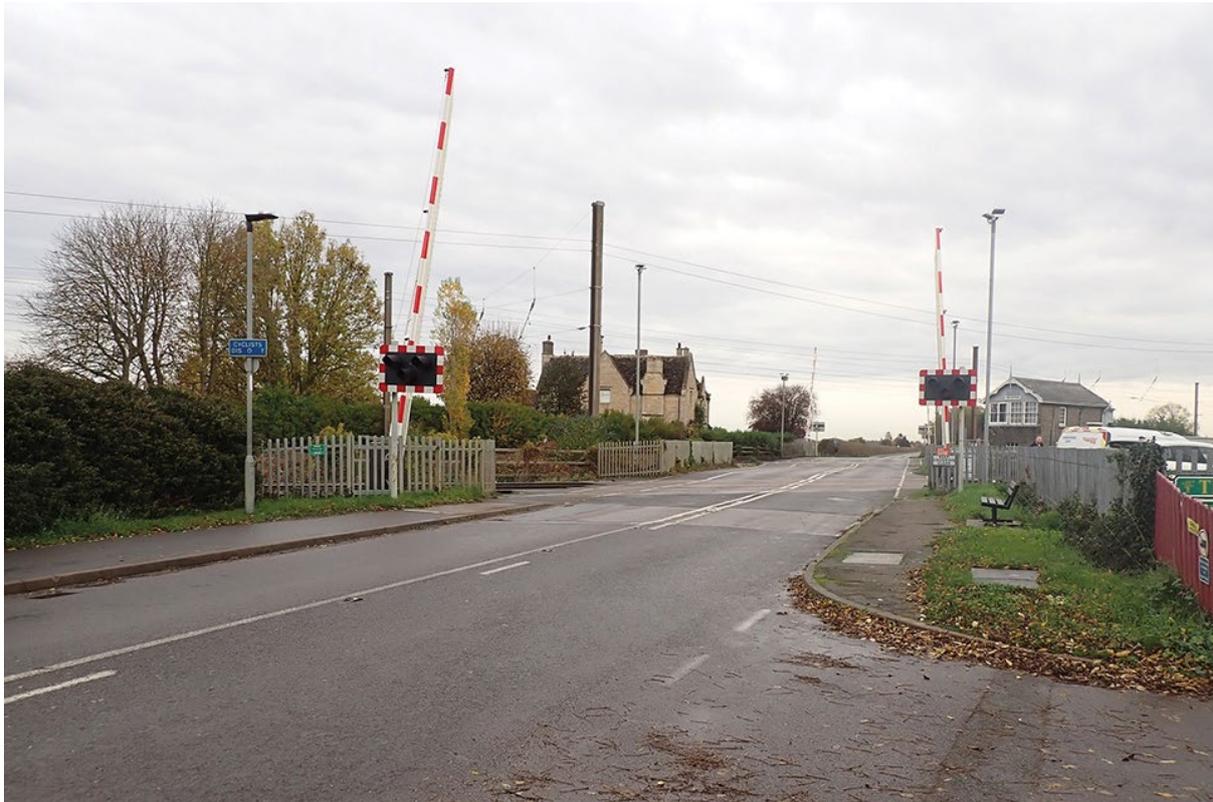
Helpston MCB level crossing with (on right side) Helpston signal box.
