AAIB Bulletin

3/2026

Aircraft Type and Registration:	ATR 42-500, G-LMRC	
No & Type of Engines:	2 Pratt & Whitney Canada PW127E turboprop engines	
Year of Manufacture:	1996 (Serial no: 480)	
Date & Time (UTC):	27 August 2022 at 1018 hrs	
Location:	During climb 14 nm north-east of Aberdeen Airport	
Type of Flight:	Commercial Air Transport (Passenger)	
Persons on Board:	Crew - 3	Passengers - 25
Injuries:	Crew - None	Passengers - None
Nature of Damage:	None	
Commander's Licence:	Airline Transport Pilot's Licence	
Commander's Age:	39 years	
Commander's Flying Experience:	4,900 hours (of which 243 were on type) Last 90 days - 147 hours Last 28 days - 36 hours	
Information Source:	AAIB Field Investigation

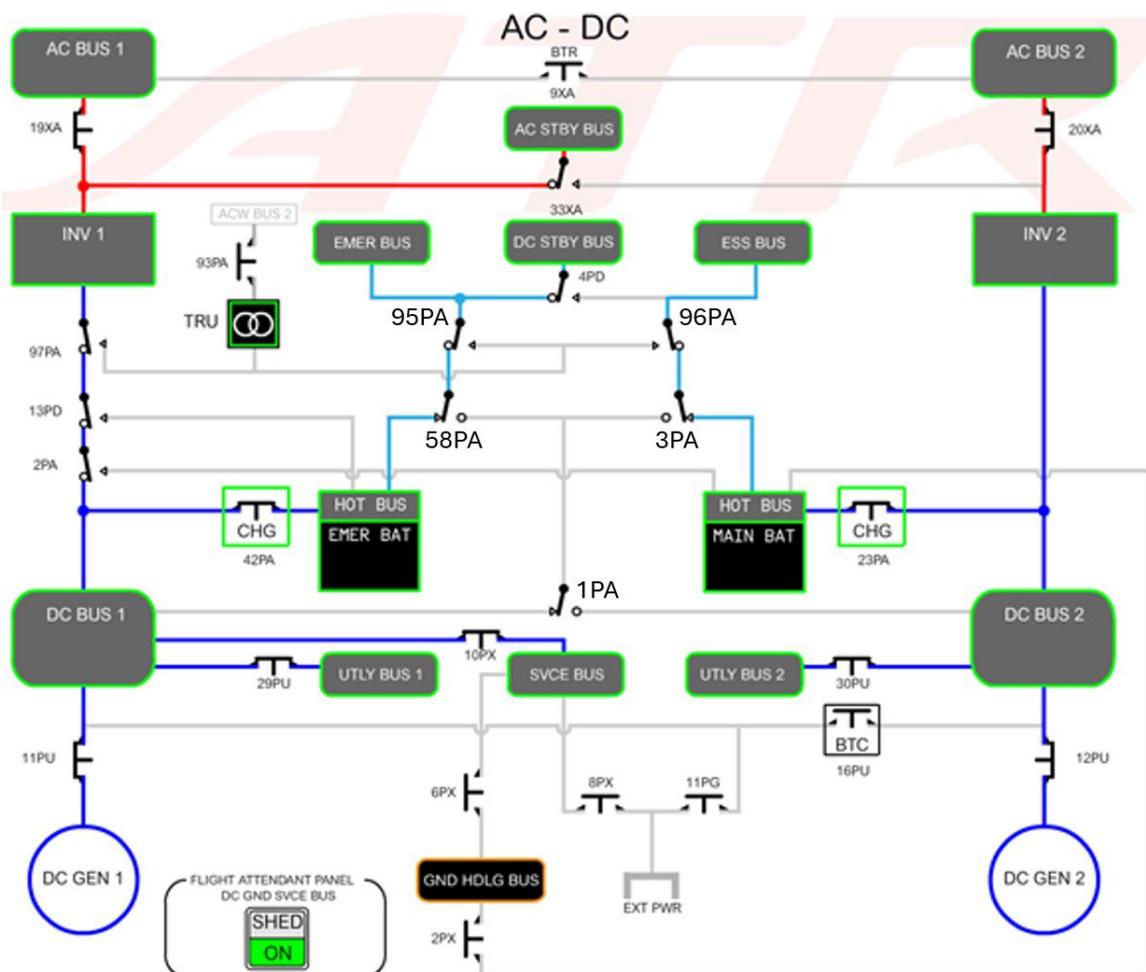
Figure 2

The distribution of the DC electrical network is shown in Figure 2, with the normal in-flight configuration shown with blue and red circuits. In normal in-flight configuration DC Gen 1 powers DC BUS 1 and DC Gen 2 powers DC BUS 2. These two main buses charge the emergency and main batteries which in turn provide power to the Emergency DC Bus (DC EMER BUS), DC Standby Bus (DC STBY BUS) and the DC Essential Bus² (DC ESS BUS) – these three buses are referred to as the ‘emergency electrical network’. If power to both DC BUS 1 and DC BUS 2 is lost, then critical flight systems and equipment are retained because the batteries would still provide power to the three buses in the emergency electrical network for about 30 minutes. If both batteries were to fail or were turned off, then either DC Bus 1 or DC Bus 2 can provide power to the emergency electrical network, via contactors³ 1PA, 58PA and 3PA shown in Figure 2.

Schematic of DC electrical network – normal in-flight configuration

With contactor 1PA failed in an intermediate position, the three buses on the emergency electrical network would have lost power if contactors 58PA and 3PA had de-energised, resulting in the three buses being connected to the 1PA contactor which could not supply power (Figure 2). The 58PA and 3PA contactors will both de-energise if both MFCs sense that the 7PA battery switch has been turned off. The battery switch is not near the landing light switches (Figure 3), and although it is possible that the co-pilot inadvertently turned off the battery switch instead of the landing light switches, this would not explain why the symptoms reoccurred on the ground when the commander turned off the landing light switches. It is unlikely that both the commander and co-pilot inadvertently turned off the battery switch instead of the landing light switches on separate occasions during the same flight.

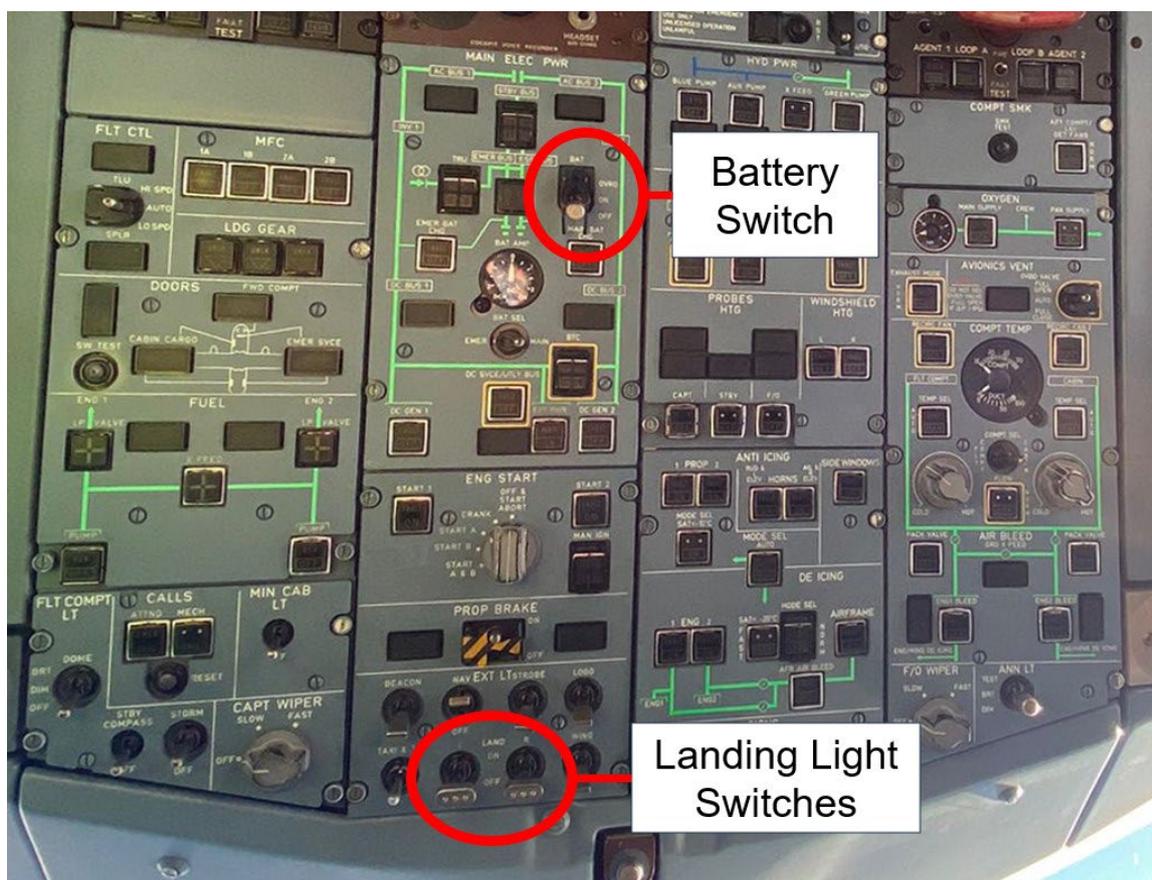
Figure 3

The battery switch is located on the overhead panel (Figure 3) and has three positions, ON, OFF and OVRD (override). The switch position sends a signal to both MFCs which command the position of the 3PA and 58PA contactors. When the battery switch is in the OFF position, the MFCs see an open circuit which causes the 3PA and 58PA contactors to de-energise which disconnects the emergency and main batteries from the buses in the emergency electrical network. When the battery switch is in the ON position, the MFCs see a closed circuit which causes them to energise the 3PA and 58PA contactors which results in power being supplied from both hot battery buses to the emergency electrical network. The hot battery buses are powered by DC BUS 1 and DC BUS 2 respectively, or by their respective batteries if its DC bus has lost power. The OVRD position is used in the event of a failure when it is desired to override the logic and protections in the MFC and maintain battery power to the emergency electrical network. If in the event of a fault only one MFC sees an open circuit from the battery switch, the batteries are not disconnected from the emergency electrical network.

Location of battery switch and landing light switches on the overhead panel

There are two landing lights, left and right, mounted on either side of the forward part of the main landing gear fairing. They are controlled by two switches, left and right, mounted on the forward section of the overhead panel (Figure 3). Each switch is connected to a relay; when the relay is energised by the switch using 28V DC, 115V wild AC is supplied to the respective landing light.

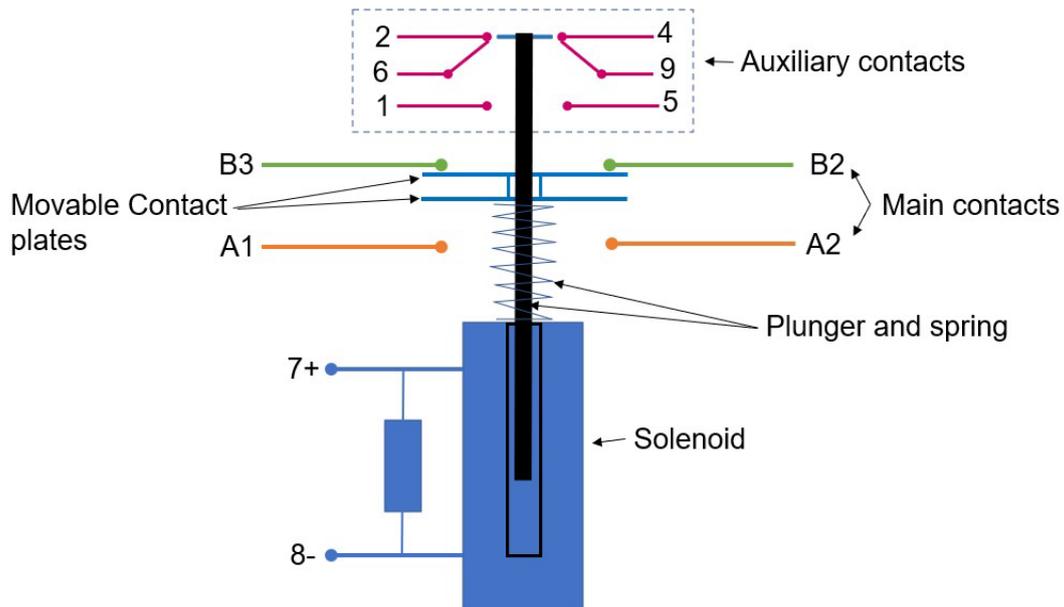
Figure 5

A schematic of the contactor is shown in Figure 5. In the deenergised condition, a spring holds a plunger carrying the movable contact plate (shown in blue) against the upper main

contacts B3 and B2. When the contactor is energised, by applying a 28V DC voltage between the solenoid terminals 7 and 8, the plunger moves downward against the spring force and the upper movable contact plate moves away from contacts B3 and B2, and the lower movable contact plate is pulled against contacts A1 and A2. At the same time, auxiliary contacts transition from 6/2 to 6/1, and from 9/4 to 9/5; these provide contactor state information to other systems. While the solenoid is energised there is continuity between main contacts A1 and A2.

Contactor schematic diagram (shown de-energised)

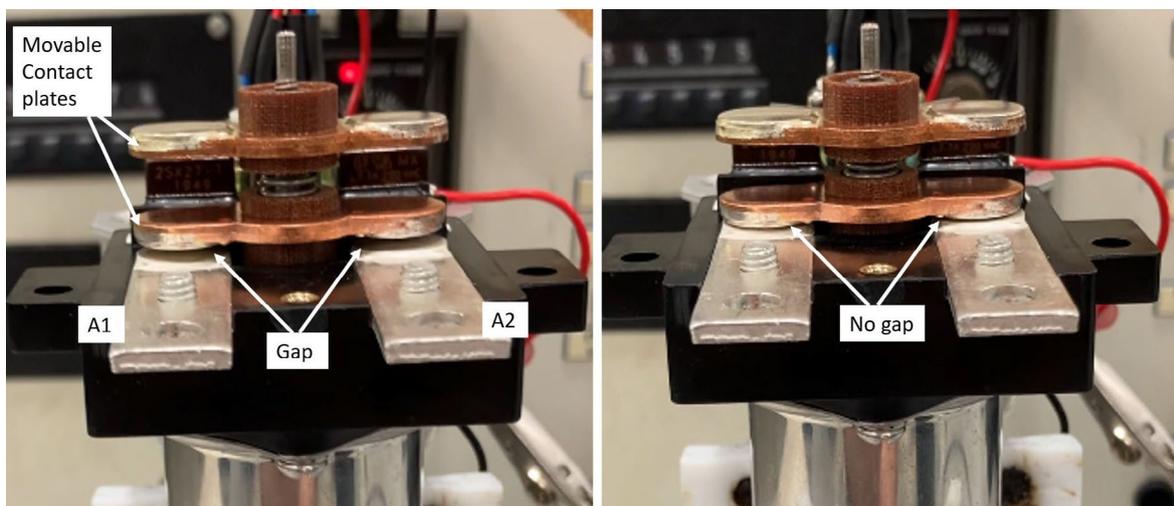
Figure 6

The movable contact plates and spring assembly of the contactor, with main contacts B2 and B3 removed, are shown in Figure 6.

De-energised (A1 and A2 open) left; energised (A1 and A2 closed) right

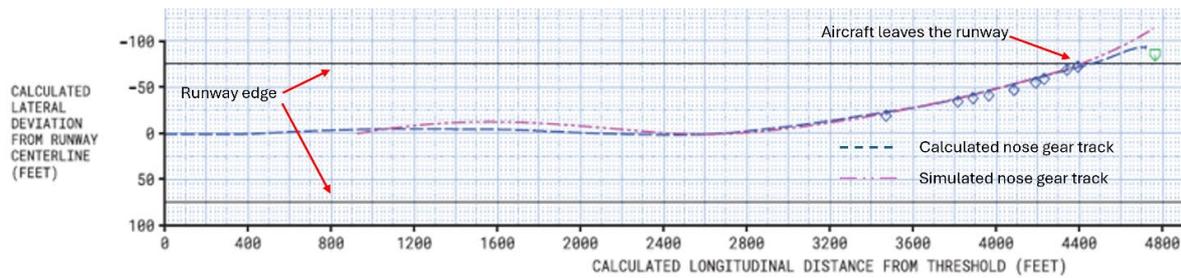
Figure 6

A desktop engineering simulation was used to recreate the landing rollout. The simulation was a six-degrees-of-freedom non-linear model updated to match flight data, and it was driven by recorded control positions from the actual landing, along with the METAR data nearest to the time of the event and a runway surface condition of wet. The simulation was used to assess aircraft lateral performance during the landing, and the simulated results were a reasonable match to the aircraft's actual track over the ground (Figure 6).

Landing simulation (The Boeing Company)

Had increasing right rudder input led directly to left yaw, it would have been an unexpected aerodynamic response and it is likely that the manufacturer's simulated landing data would have diverged from the recorded data (Figure 6). However, the manufacturer's modelling of the landing was closely correlated with the actual performance of the aircraft, and so the left yaw response reported by the PF was likely to have been an indication that even the increased rudder input was insufficient to counter the left yaw in the strong crosswind.
