Accident

Aircraft Type and Registration:	Rockwell Commander 112 TCA, N4698W	
No & Type of Engines:	1 Lycoming TO-360-C1A6D piston engine	
Year of Manufacture:	1978 (Serial no: 13274)	
Date & Time (UTC):	23 December 2024 at 1135 hrs	
Location:	Kinglassie, Fife	
Type of Flight:	Private	
Persons on Board:	Crew - 1	Passengers - None
Injuries:	Crew - 1 (Fatal)	Passengers - N/A
Nature of Damage:	Aircraft destroyed	
Commander's Licence:	Private Pilot's Licence	
Commander's Age:	50 years	
Commander's Flying Experience:	187 hours (of which 92 were on type) Last 90 days - 19 hours Last 28 days - 0 hours	
Information Source:	AAIB Field Investigation

Synopsis

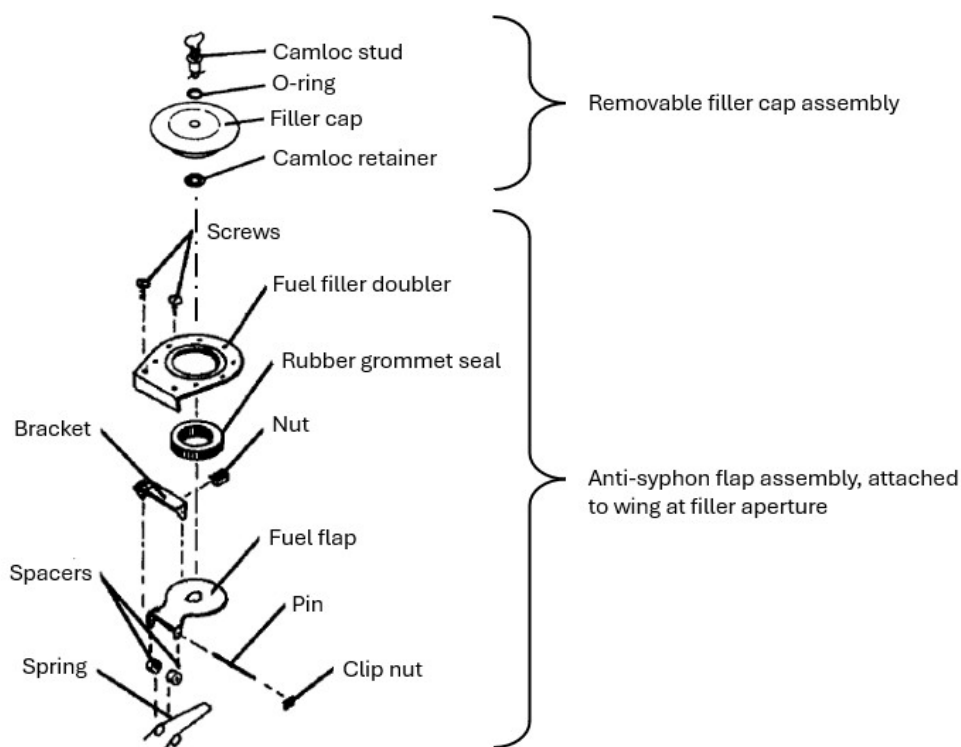
Figure 4

Each wing fuel tank has a single filler cap that is secured in place by a quick-release Camloc stud (Figure 4). The stud engages with a hinged flap immediately beneath the fuel filler aperture. The hinged flap provides an anti-syphon function in case the filler cap releases in-flight. When the stud is engaged in the hinged flap, the filler cap is pulled downwards against a rubber grommet seal, to seal the filler cap to the wing. The stud's shaft has an O-ring seal that is compressed when the filler cap is locked, to provide sealing between the head of the stud and the top of the filler cap.

Wing fuel tank filler cap and anti-syphon flap assembly (adapted from Rockwell Commander 112TCA Illustrated Parts Catalogue, courtesy of Commander Aircraft Corp)

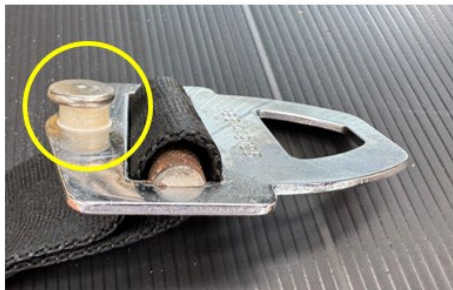
(b) Co-pilot lap strap

remained attached to the lap belt during the accident. The co-pilot lap strap buckle had a plastic collar fitted, but this was cracked and loose on the pin (Figure 9 (b)). The passenger lap belts had plastic collars fitted and these were in good condition (Figure 9 (c) and (d)).
